**42 MAIN STREET, EAST HADDON,
NORTHAMPTONSHIRE**

HISTORIC BUILDING RECORDING

Authors:	Tansy Collins BSc Antony RR Mustchin MSc (Editor)	
Illustrations:	Kathren Henry	
NGR: SP 6689 6817		Report No. 4403
District: Daventry		Site Code: AS 1591
Approved: C. Halpin MIFA		Project No. 5263
Signed:		Date: 6 September 2013 Revised: 27/09/2013

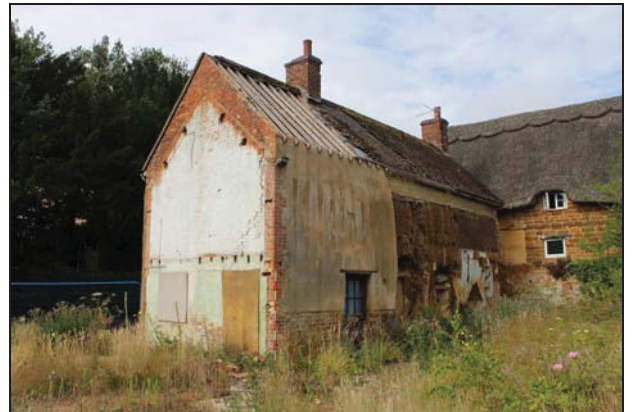
DP 10

View of the east and north elevations of the house, taken from the north-east

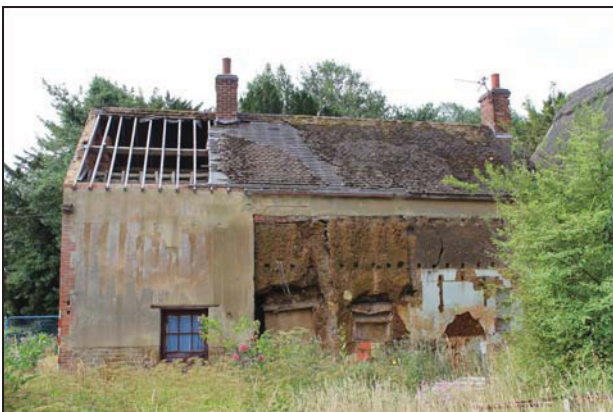
DP 11

5.6 The rear north elevation reflects the phases of development as seen elsewhere but here the structure is deteriorating and areas have collapsed (Plate 2). This has, however, exposed the construction of the building. Although not clear from this side, evidence within suggests the east bay is a later addition although of similar construction and perhaps added only a short time after initial construction. The general construction is of lias stone walling to approximately 1m height. Where visible on the historic core to the west this is of fairly large blocks laid in courses with larger blocks framing apertures. This alters to the east where more slender blocks are used, these well-coursed with larger blocks again marking the corners and apertures. Above this, the construction is of cob walling, a fairly buff-coloured clay matrix with a high straw content and frequent rounded and angular small pebbles and stones. This is now exposed in the western two bays which was formerly enclosed by a kitchen/bathroom lean-to extension which has been previously removed. Some internal plasterwork survives in this area but has fallen away in places and the upper area in the roof space of the lean-to appears to have always been exposed cob, between which there are empty sockets for lost floor joists. There is no evidence at upper level for any original window apertures.

North elevation of the house, taken from the north

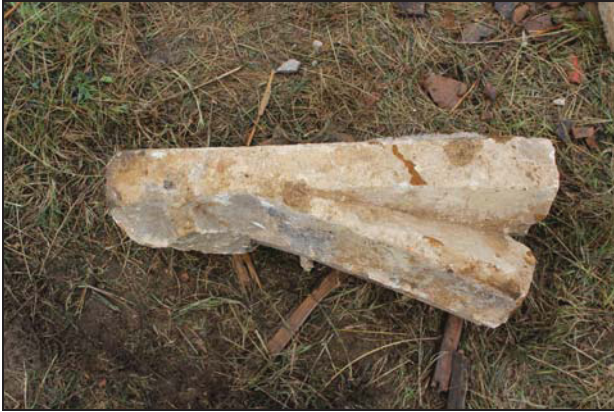
DP 118

Reused stonework (Piece 1) from a probable ecclesiastical building, taken during demolition

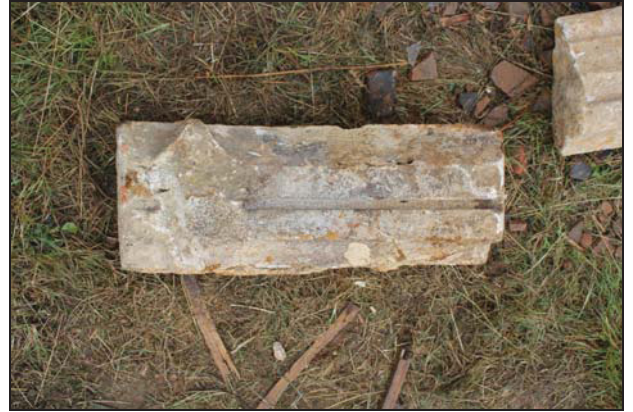
DP 119

Reused stonework (Piece 2) from a probable ecclesiastical building, taken during demolition
