THE BLACK HORSE PUBLIC HOUSE
7 POTTERS CROSS, WOOTTON
BEDFORDSHIRE

HISTORIC BUILDING RECORDING AND MONITORING

Level 3

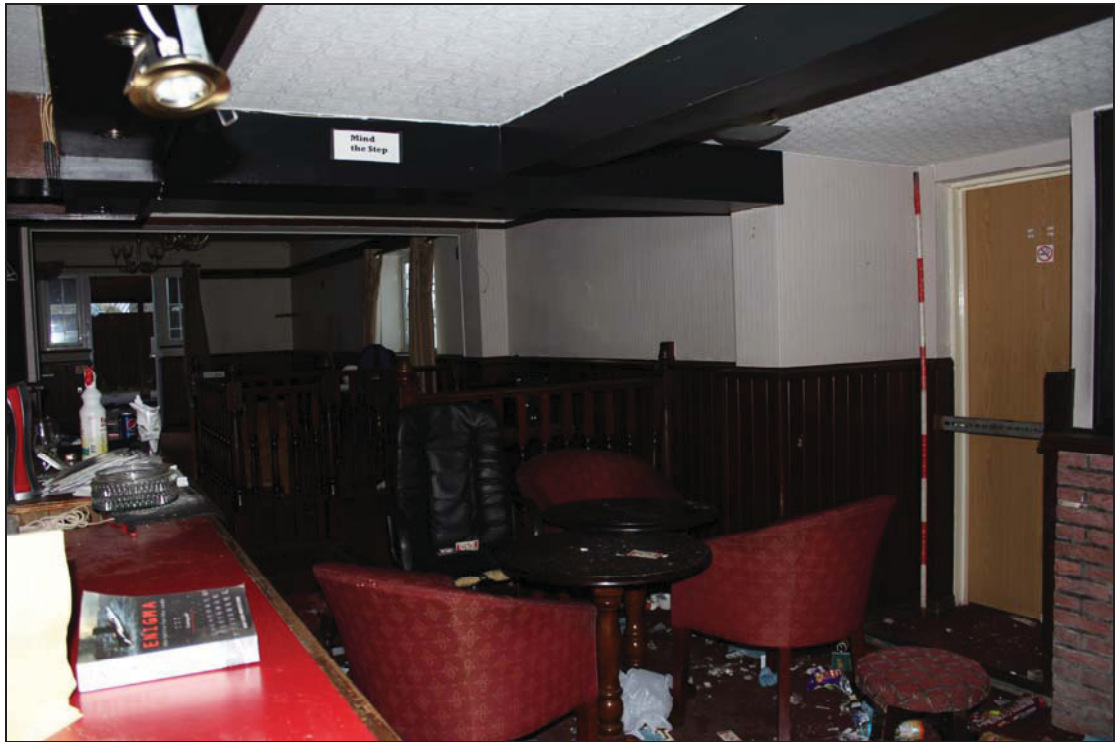
5.16 A large lounge and restaurant lies to the north of the lobby. This occupies the northern bay of the historic core, the northern addition, the rear pent-roof extension and modern addition to the rear which has all now been consolidated as a single open space (Plate 7). As within GF02 the lower sections of the historic core have been wholly modified with the loss of all original fabric below mid-rail level. On the east brickwork replaces the original timber-framing while on the west a large I-girder supported on brick plinths spans a wide aperture. Here the mid-rail has also been lost due to later alteration.

Plate 7 Lounge bar, GF03, taken from the south-east (DP 23)

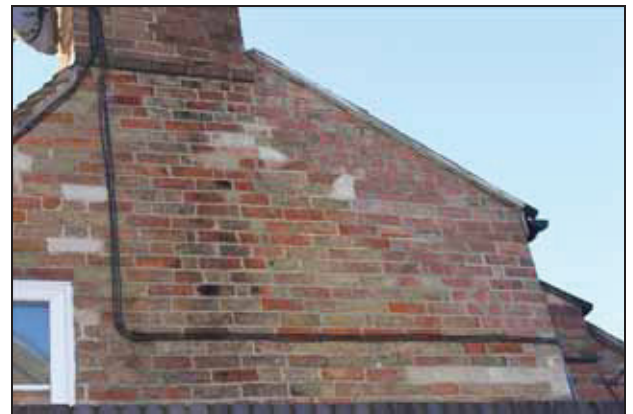
12

Evidence of the western roof pitch being raised, north-east elevation, taken from the north-east

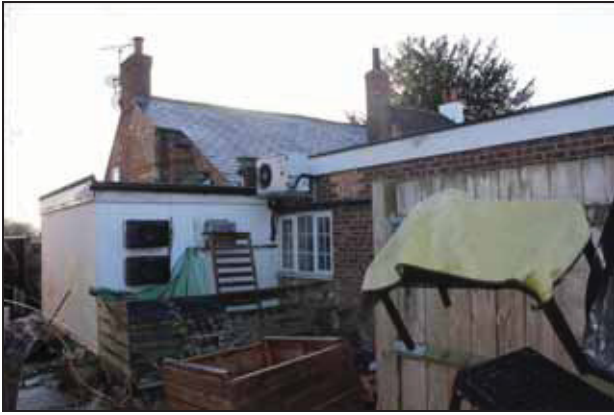
13

Modern single-storey extensions to the rear of the Black Horse, north-west elevation, taken from the north-west

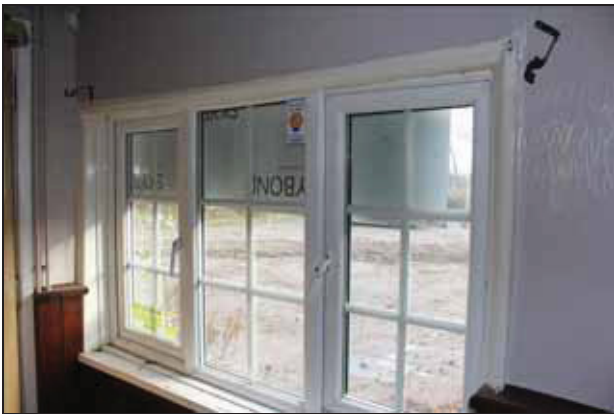
21

Modern window set within an earlier timber frame, public bar, GF02, taken from the south-west

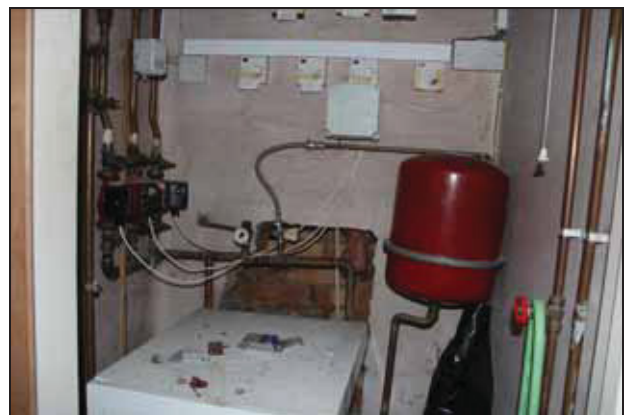
30
Boiler cupboard at western end of corridor, GF04, taken from the south-east

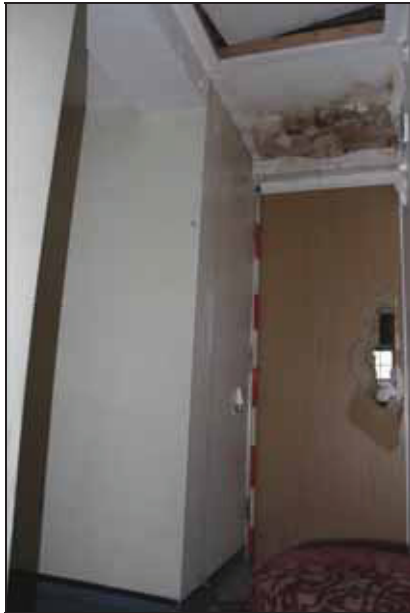
31

Door leading off the corridor to GF02, GF04, taken from the north-west

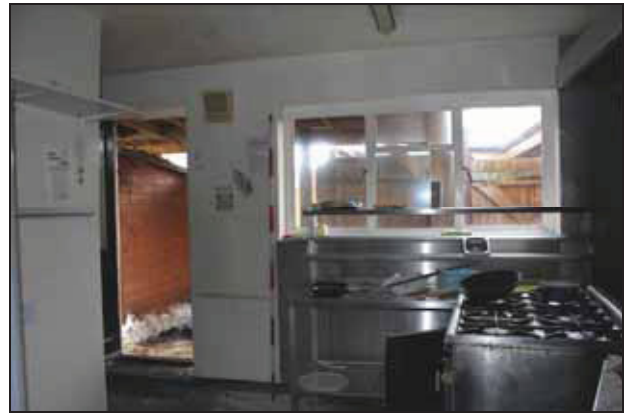
32

Modern kitchen, GF07, taken from the south-east

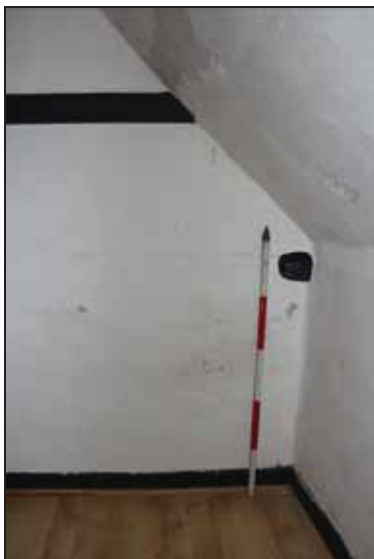
35

Nub of wall-plate, FF03, taken from the north-east

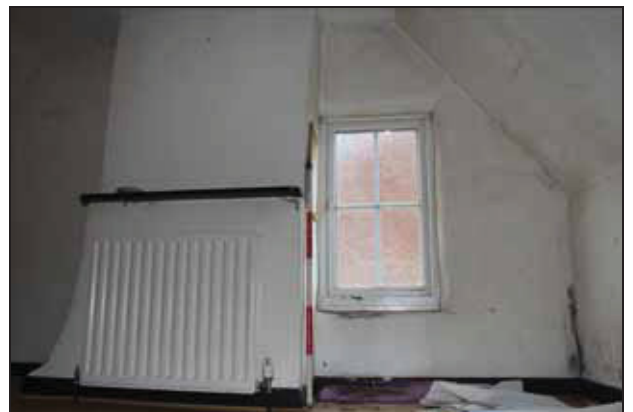
36

Blocked chimney stack and window, FF03, taken from the south-west

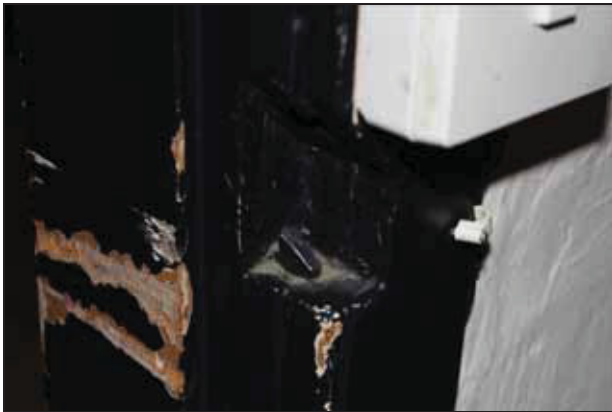
39

Latch catch preserved on door frame, FF03, taken from the north-east

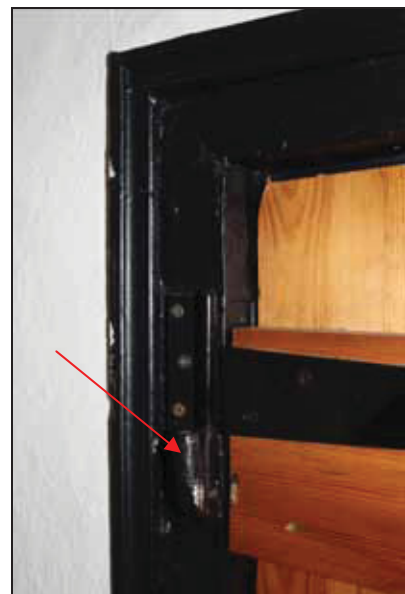
42

5.33 On the south the door frame retains pintels attached to a pegged frame, though as noted the existing door is modern (Plate 16).

Surviving pintel to door frame, FF02, taken from the north

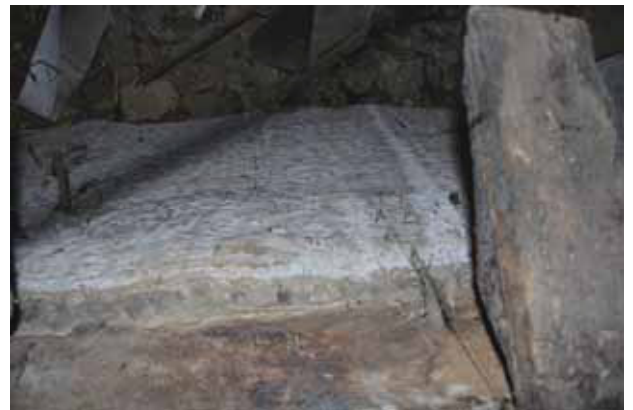
60

Sections of render preserved by the pent-roof extension seen from FF05, taken from the north-west

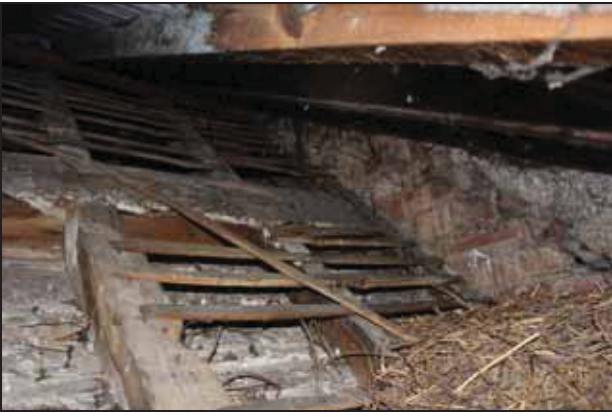
61

Surviving external batons once carrying peg-tiles at the junction with pent-roof seen from FF05, taken from the north-west

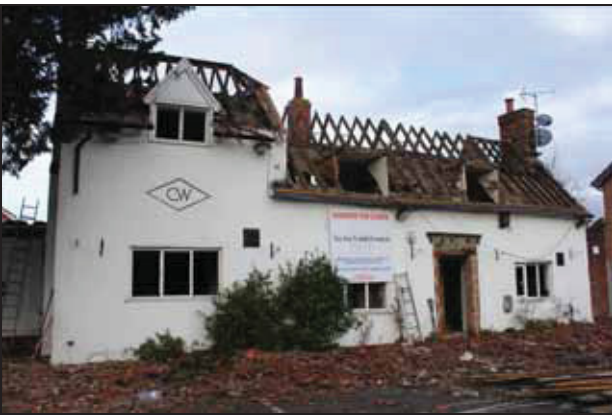
63

The Black Horse, entire roof stripped of tiles, taken from the south

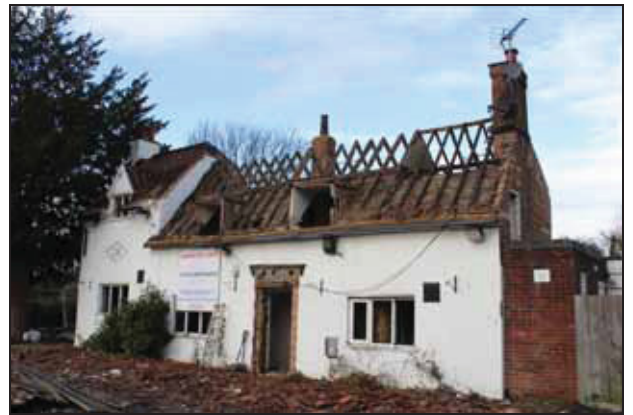
64

The Black Horse, entire roof stripped of tiles, taken from the north-east

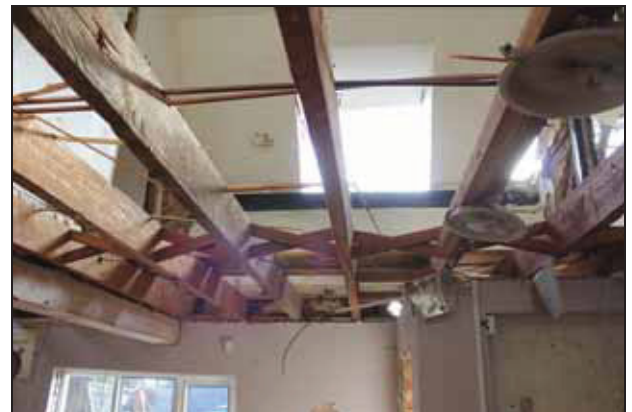
71

Softwood rafters above the pent-roof extension keyed into a parapet wall, taken from the south-east

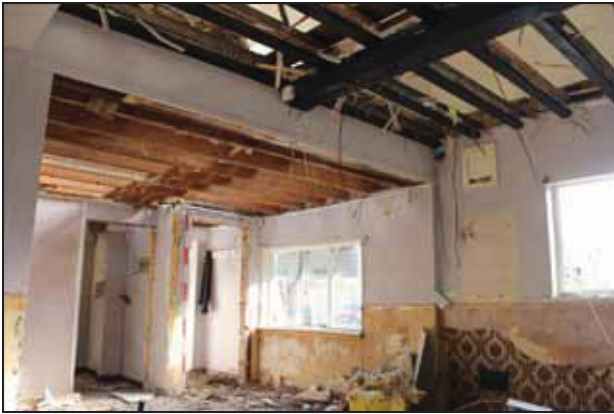
72

Modern joisting above GF03, taken from the north-west

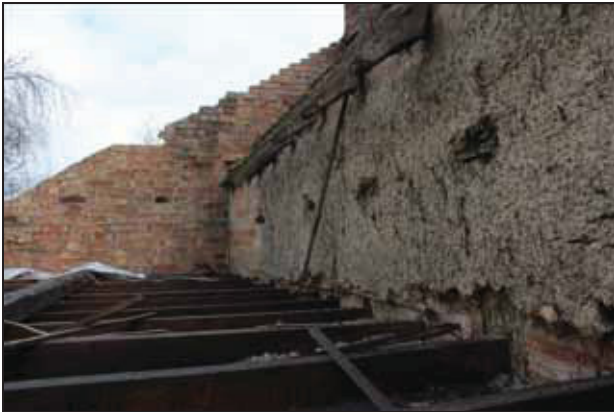
80

Original wall-plate extending along north-west elevation of historic core, GF04, taken from the north-west

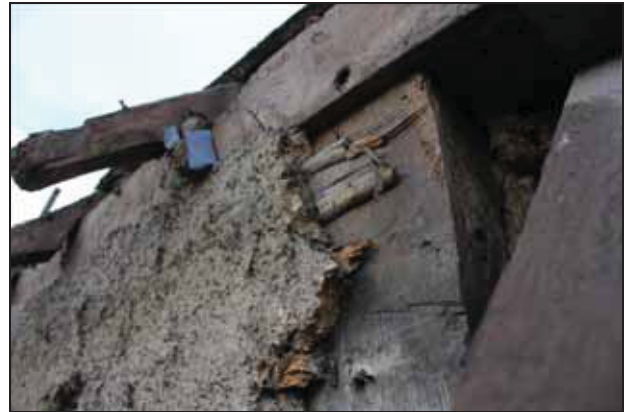
81

Sections of external render to north-west elevation, taken from the south-west

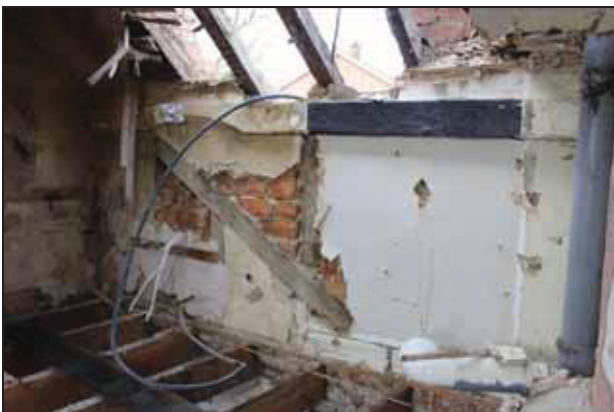
82

External Render over lath and plaster at the principal-post, north-west elevation, taken from the south-west

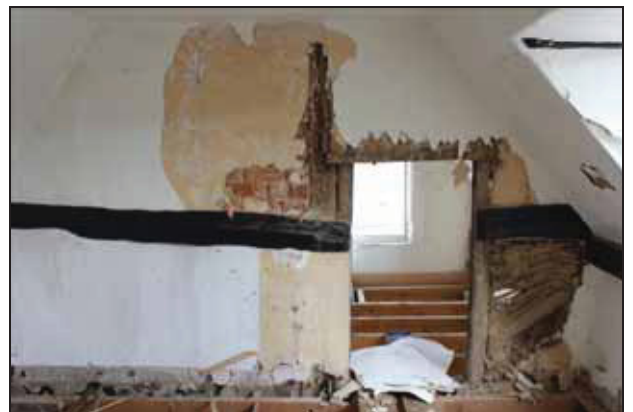
83

Primary braced studwork with brick infill to north-west elevation, FF01, taken from the north-east

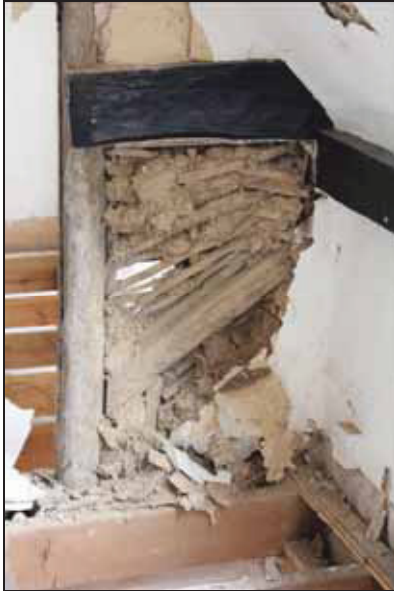
84

North gable preserving original timber-framing infilled with wattle and daub below the tie-beam, FF02, taken from the south

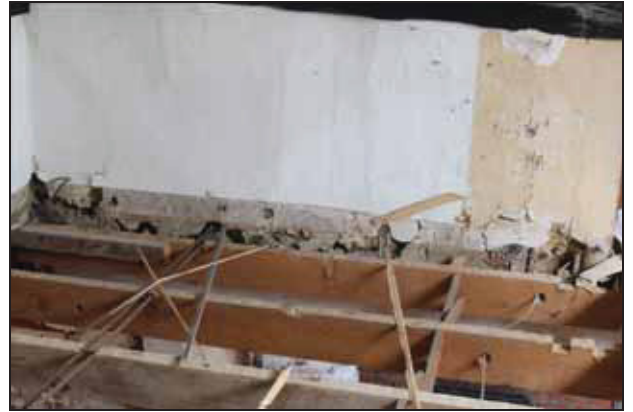
85

Wattle and daub infill around a brace, north gable, FF02, taken from the south-west

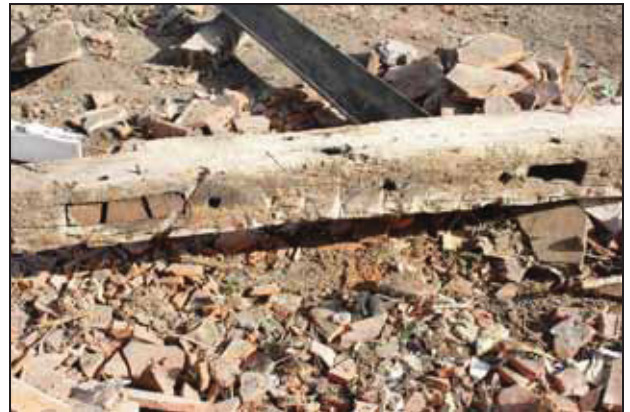
111

Mid-rail with empty mortices for studs to soffit

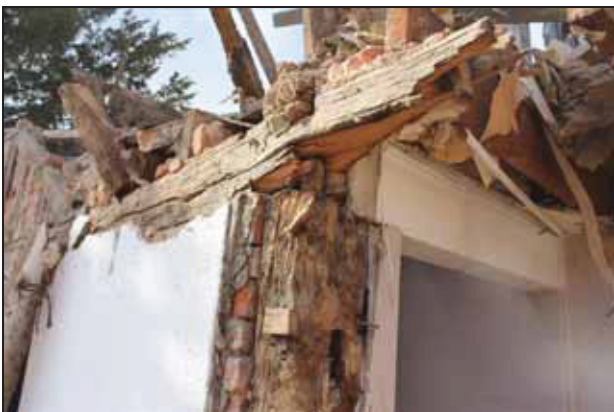
112

Mortices interspersed with stave holes for wattle and daub to mid-rail soffit

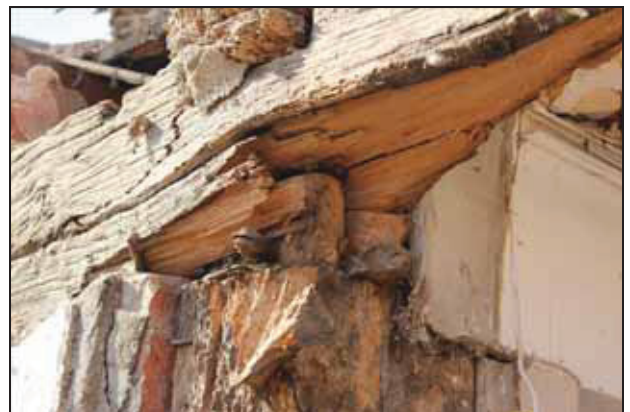
113

Principal-post morticed to the mid-rail, taken from the east

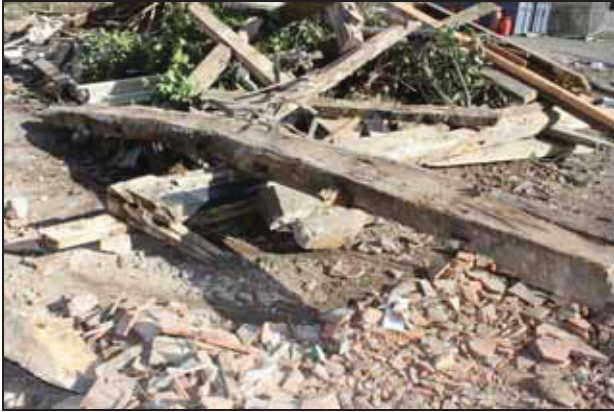
114

Principal-post morticed to the mid-rail, taken from the east

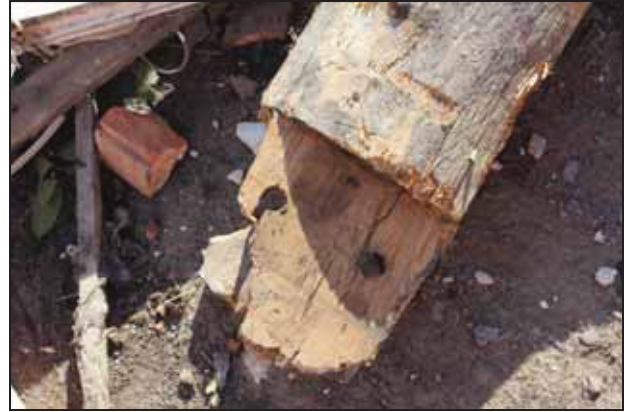
115

Purlin retaining mortices for common-rafters

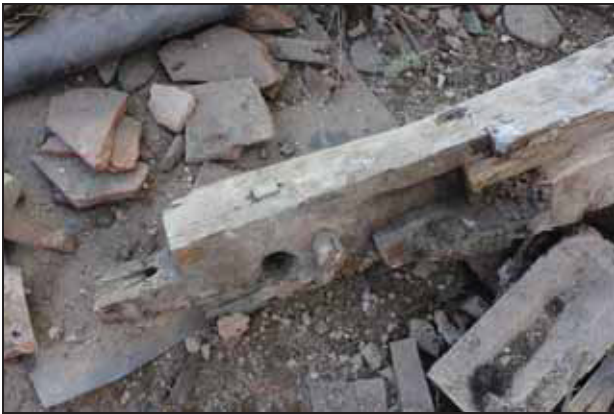
116

Double pegged mortice to purlin

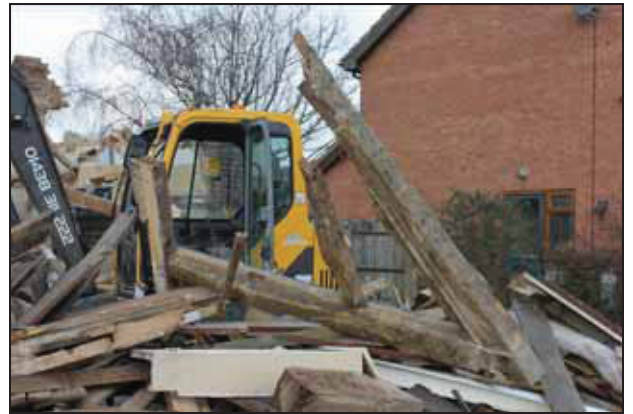
117

Mid-rail section showing exposed scarf joint

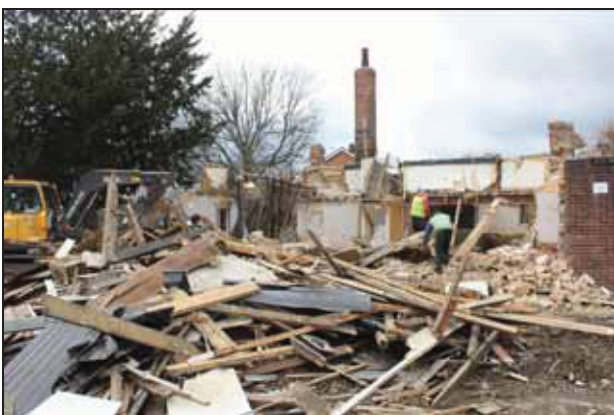
118

Tie-beam and principal-rafter with one remaining stud
