THE POND HOUSE,
BUGBY'S FARM, GREAT MUNDEN,
HERTFORDSHIRE

HISTORIC BUILDING
MONITORING AND RECORDING OF BUILDING
INVESTIGATION WORKS (PHASES 1 & 2)

Authors: Dr Lee Prosser BA PhD Lisa Smith BA Kathren Henry	
NGR: TL 3475 2392	Report No. 4549
District: East Herts	Site Code: AS1431
Approved: Claire Halpin	Project No. 3692
MIFA	Date: 22 April 2014
Signed:

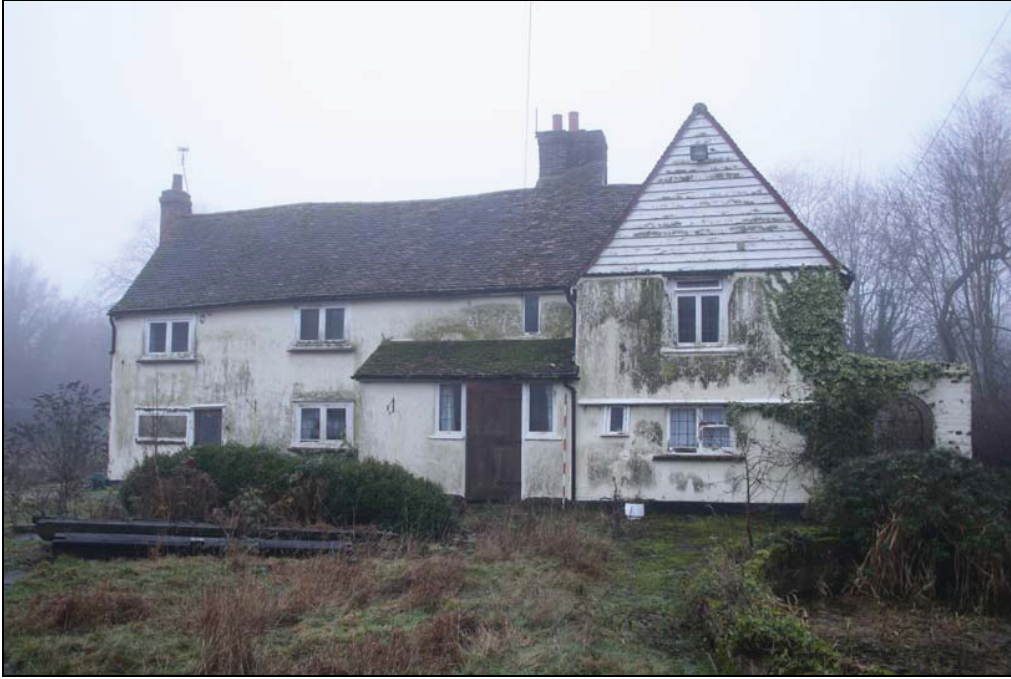
Plate 1 The Pond House, northern elevation, taken from the north-west

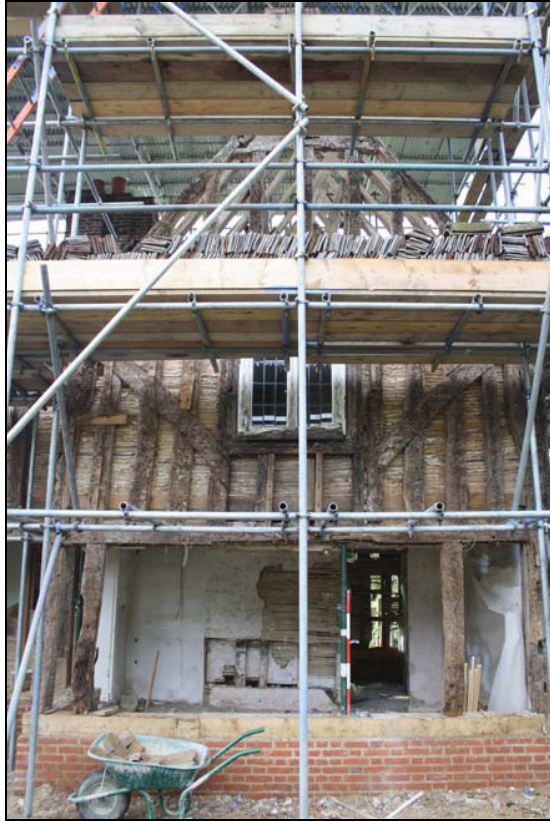
Plate 3 Cross-wing, timber-frame fully exposed, north elevation, taken from the north-east (DP 60)

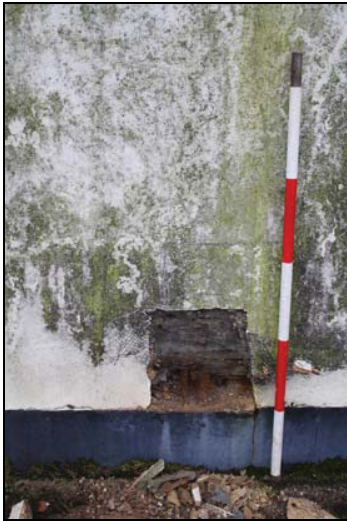
3

Render removed revealing the weatherboarding behind, north elevation, taken from the north-east

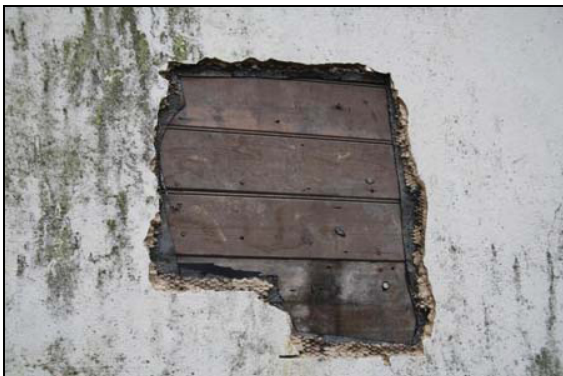
5

Match-lined boarding beneath the render, north elevation, taken from the north-east

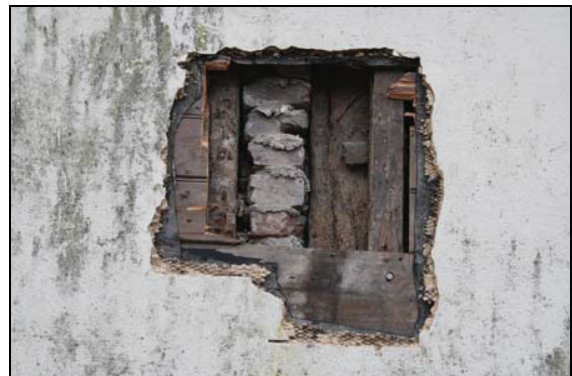
6

Removal of match-lined boarding revealing timber-frame below, north elevation, taken from the north-east

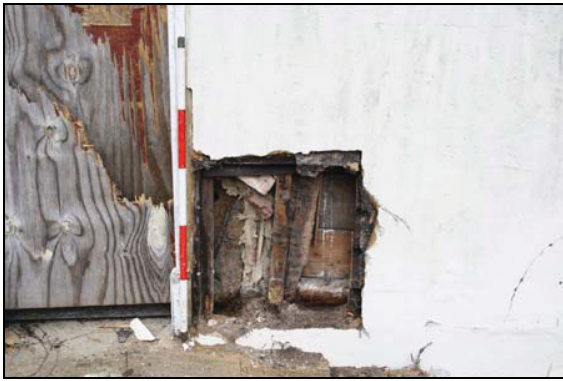
7

Render and weatherboarding removed exposing timber frame below, south elevation, taken from the south-west

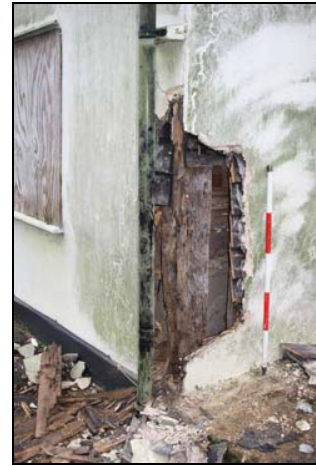
8

Exposure of the north-west corner-post, taken from the west

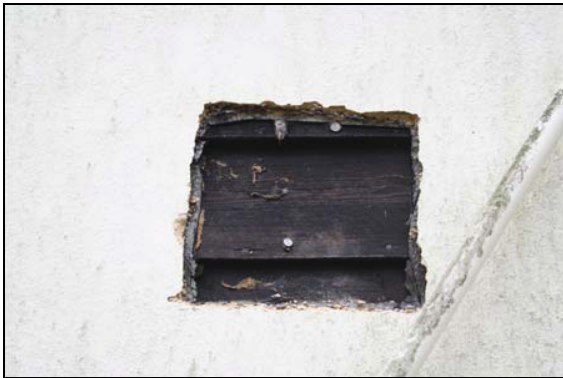
9

Crude weatherboarding beneath the render, west elevation, taken from the north-west

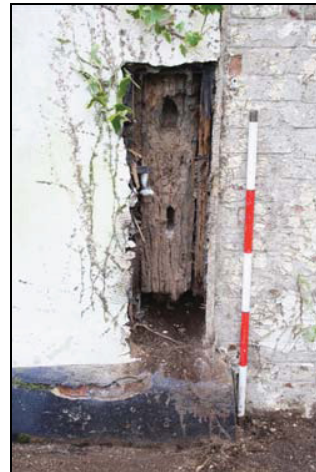
10

Exposure of the north-east corner-post, taken from the north-east

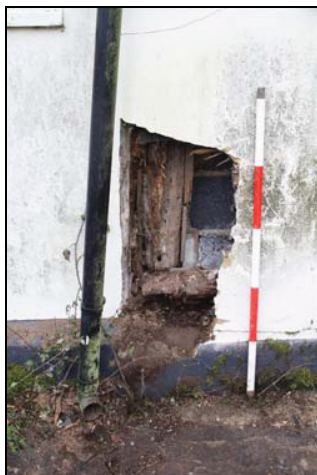
11

Timber-frame of the cross-wing revealed beneath the render, north elevation, taken from the north-east

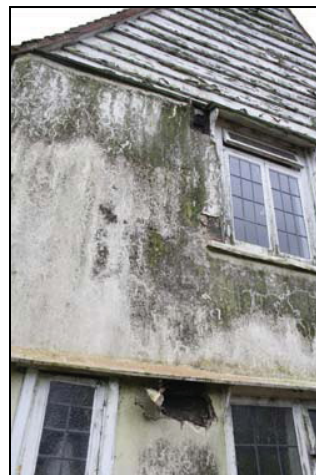
12

Two areas of render removed with weatherboarding beneath, cross-wing, north elevation, taken from the east

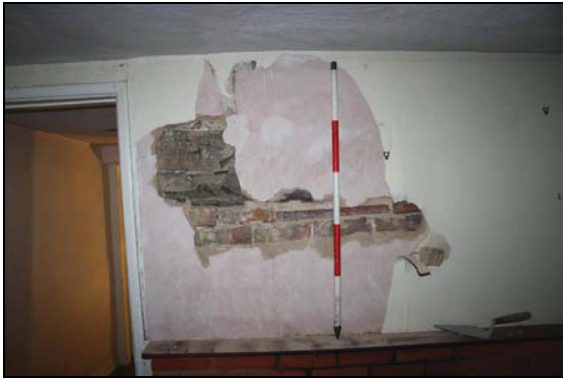
13

Plasterwork partially removed above the fireplace revealing a large timber bressummer, Room 1, taken from the south-east

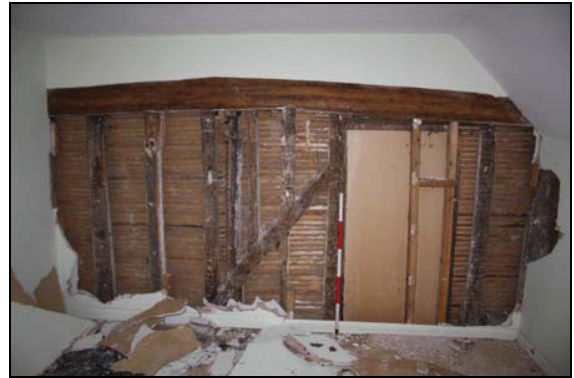
14

Modern wall coverings removed with studwork beneath, Room 7, taken from the north-west

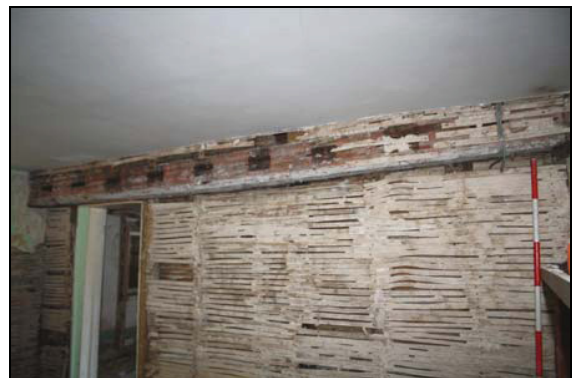
18

Central joist between Rooms 3 and 4 covered in red pigment with redundant mortices for common-joists, Room 4, taken from the south

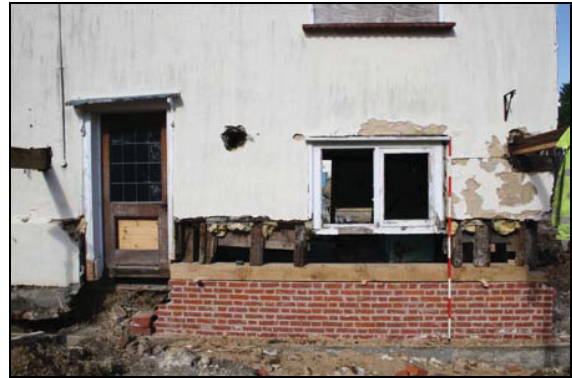
20

New dwarf-wall with exposed studs, south elevation, taken from the south-west

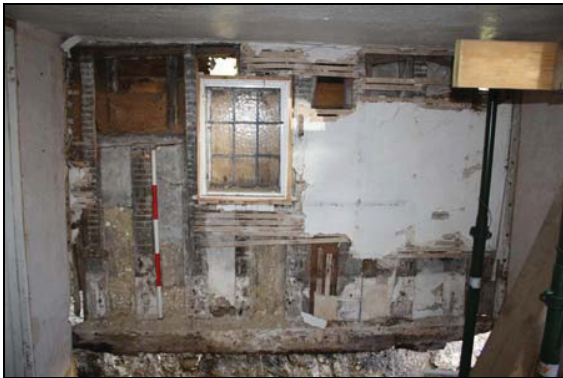
21

Soft stripping of the walls in Room 3, revealing early 17th century window and timber-framing, taken from the south-east

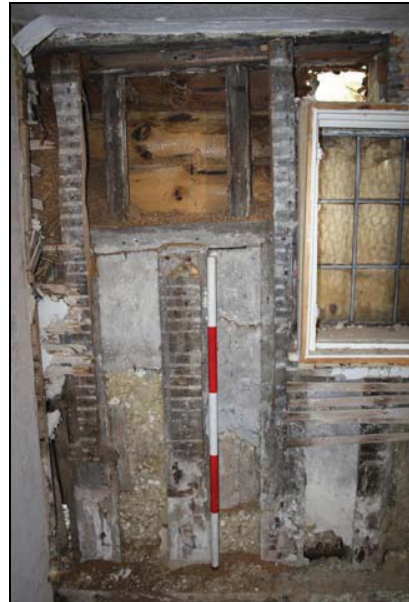
22

Studwork with intermediate wattle and daub panelling with early 17th century window above, Room 3, taken from the south-east

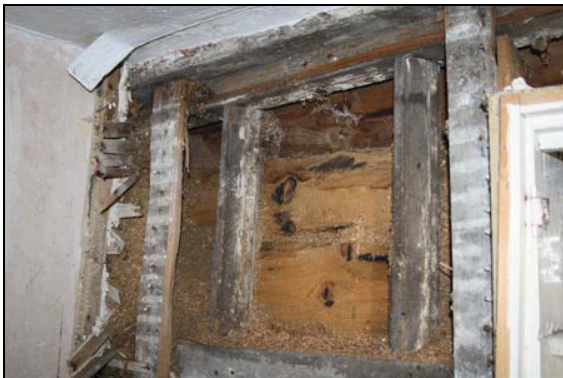
23

Early 17th century window with ovolo moulded mullions and fillets, Room 3, taken from the east

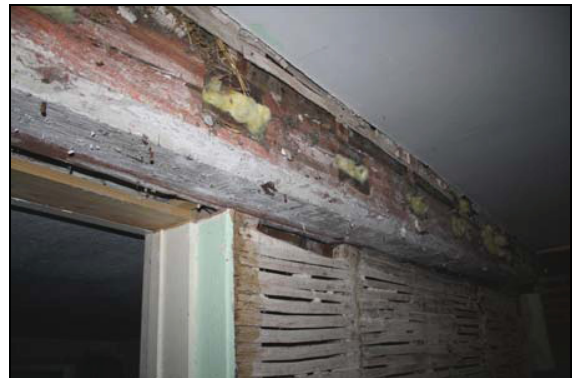
24

Central joist between Rooms 3 and 4 covered in red pigment with redundant mortices for common-joists, Room 4, taken from the west

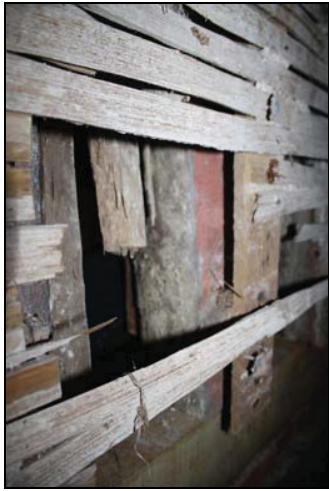
25

5.15 Less fabric was exposed in the south room, but this displays 19th or 20th century laths over original studwork as seen elsewhere. Some of the studs preserve extensive traces of red and green pigments, typical of so-called plain schemes of interior decoration seen in the 16th century. At the bay division a large chamfered beam retains a regular arrangement of redundant mortices for common-joists and is also covered in the red pigment (Plate 8). It is not found in the mortice recesses for the common-joists suggesting that the pigment is the original wall decoration. The ceiling has been lifted from its original position and the lower sections of the upper studs are visible.

Red and green pigment applied to a stud and soleplate, Room 4, taken from the east

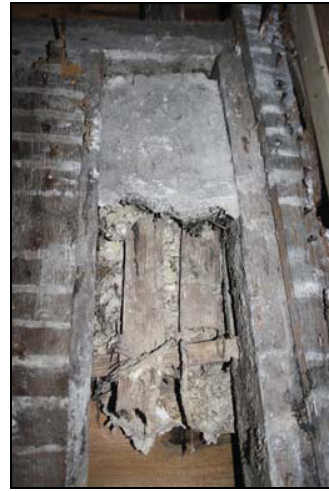
26

Wattle and daub panel, Room 3, taken from the south-east

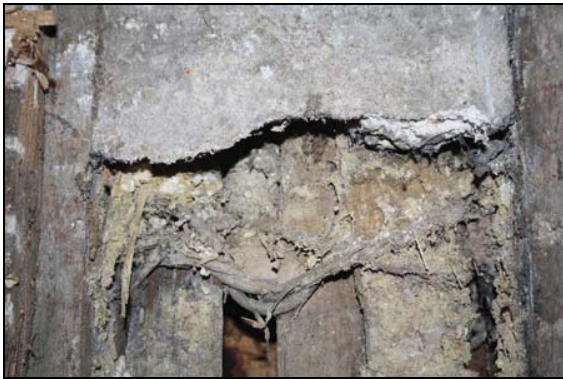
27

Detailed shot of wattle and daub panel, Room 3, taken from the south-east

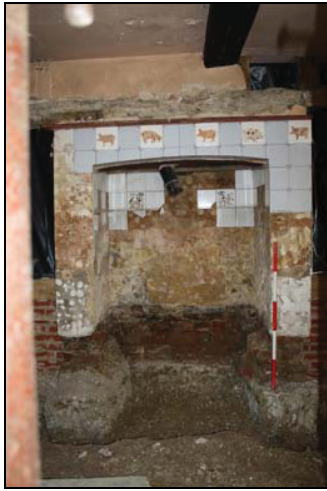
31

Chimney stack revealed after the lowering of ground levels, Room 2, taken from the north-west

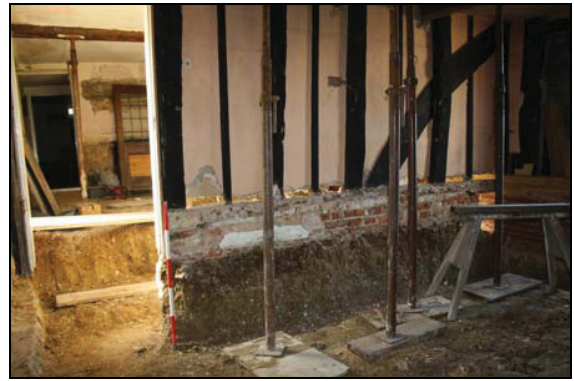
32

Lowering of floor levels, Rooms 1 & 2, taken from the south-east

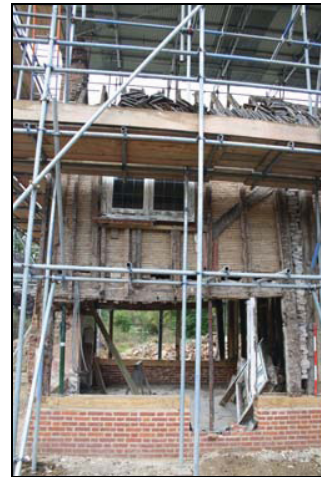
33

Pond house, all render removed, taken from the east

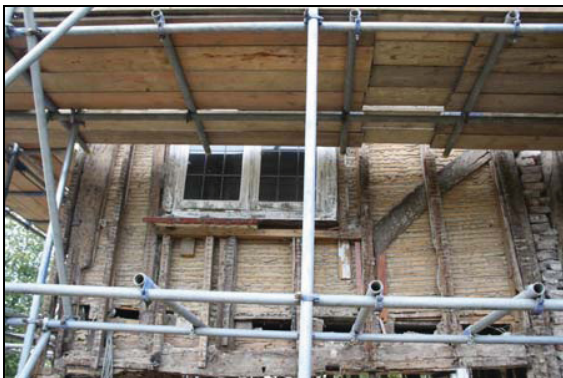
34

The kitchen bay, north elevation, fully exposed, taken from the north-east

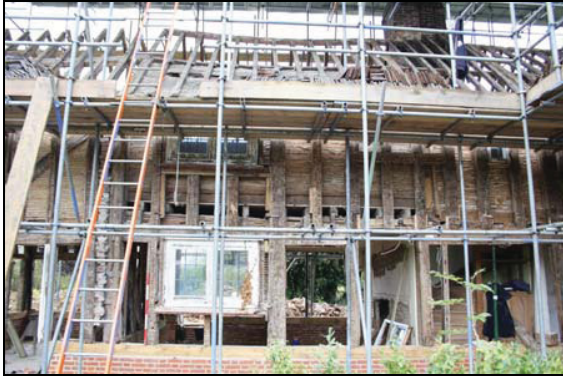
36

Jowled corner-post to the kitchen bay, north elevation, taken from the north

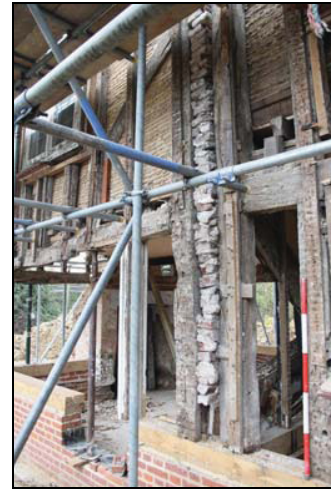
37

Central hall range, fully exposed, north elevation, taken from the north-east

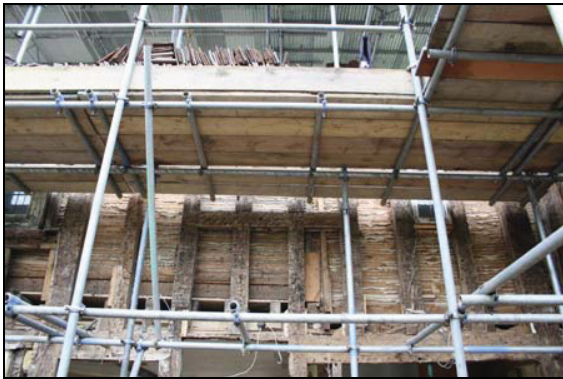
38

Junction between kitchen bay and hall range, north elevation, taken from the north

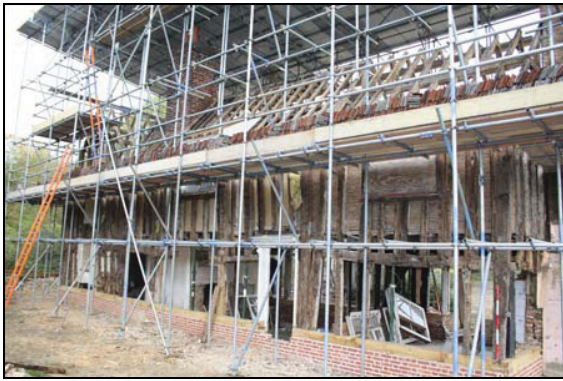
42

Corner-post to the kitchen range, taken from the east

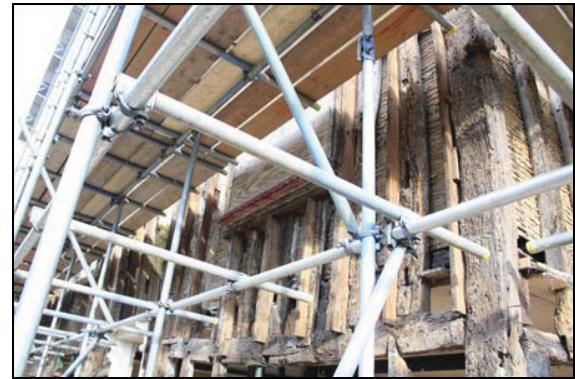
45

Timber-framing to the kitchen bay, south elevation, taken from the south-east

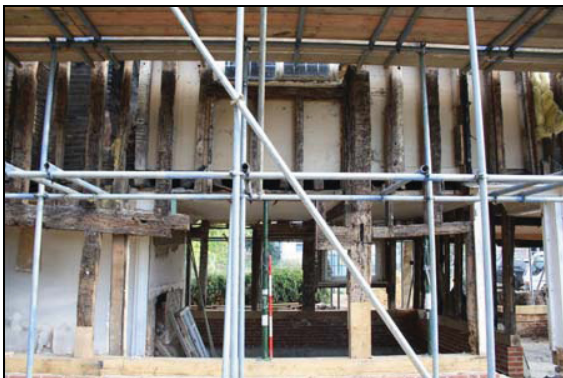
46

Upper level timber-framing to the kitchen bay, south elevation, taken from the south-east

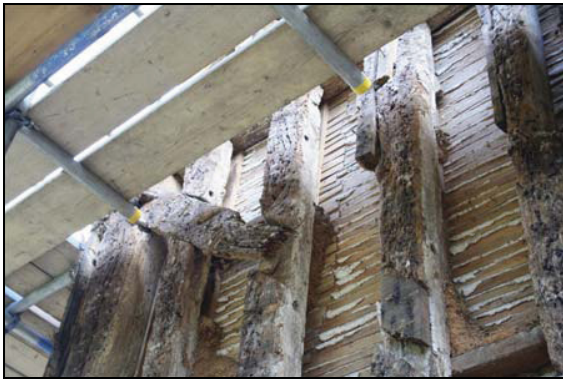
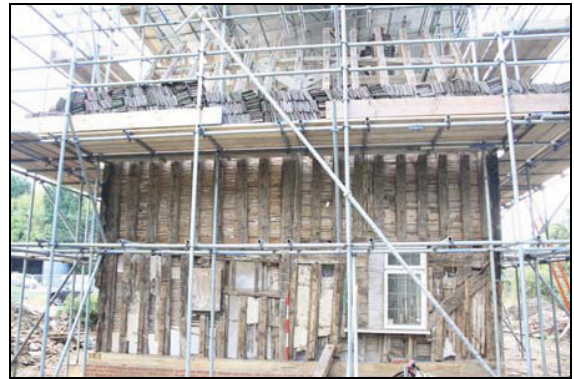
Brace, cogged over studs at first floor level, cross-wing, south elevation, taken from the south-west

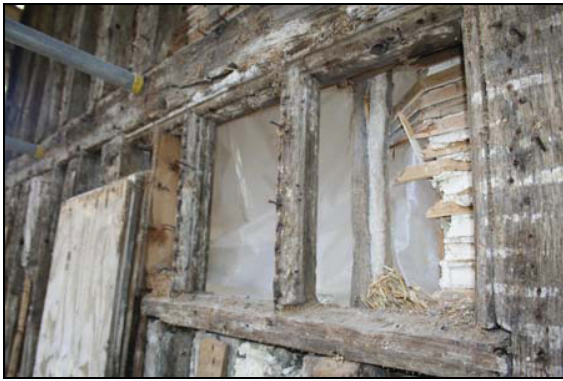
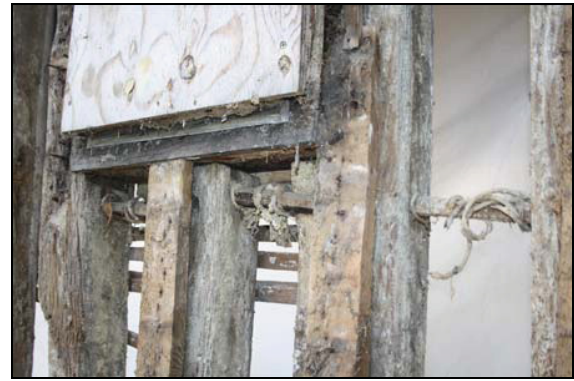
Early 17th century window, west elevation of cross-wing, taken from the north-west

Early 17th century window, west elevation of cross-wing, taken from the west

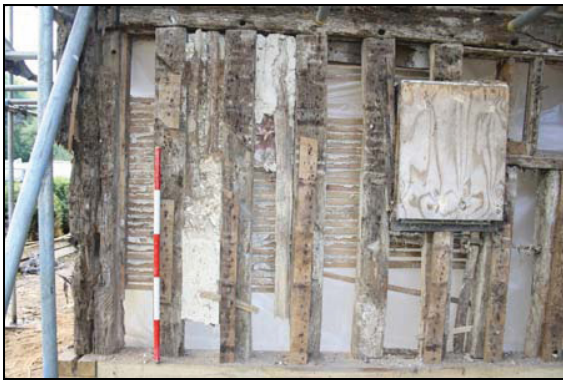
56

Wattle and daub staves in situ west elevation of cross-wing, taken from the west

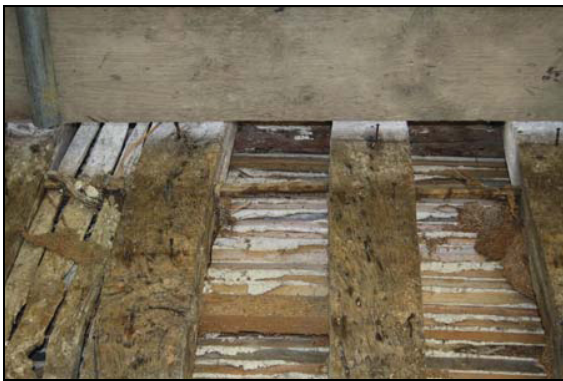
58

Downward brace cogged over studwork, west elevation of cross-wing, taken from the north-west

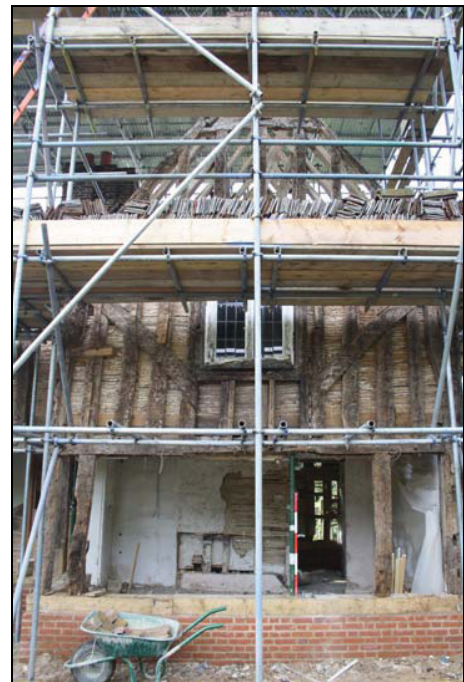
59

Wattle and daub staves in situ, first floor, west elevation of cross-wing, taken from the west

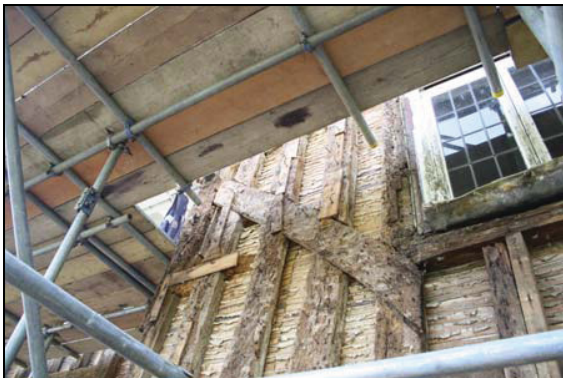
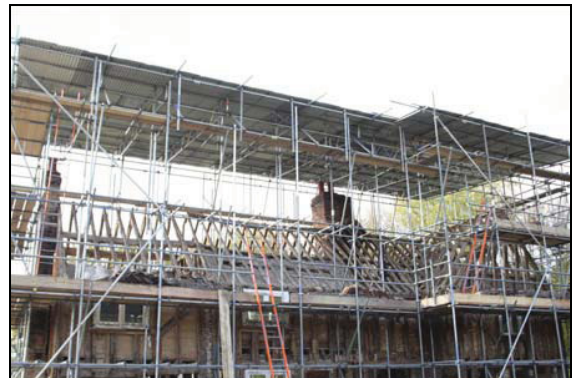
Brace and jowled corner-post, upper floor of cross-wing, timber-frame fully exposed, north elevation, taken from the north-east

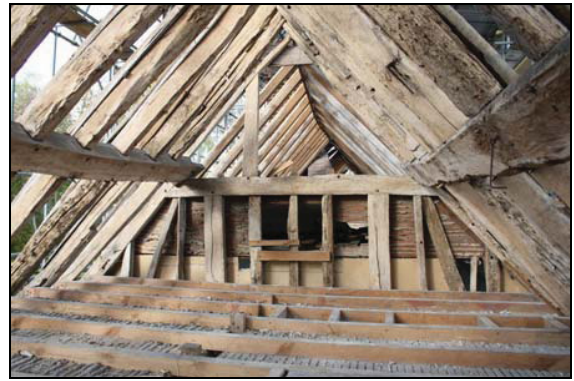
67

Common-rafters above and below robust purlins, roof above the kitchen range, north pitch taken from the north-east

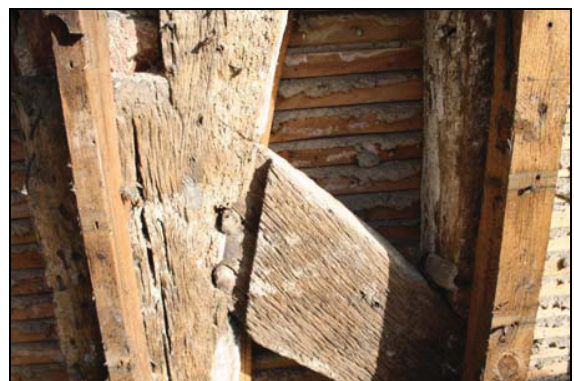
71

Junction between the kitchen bay roof and that of the central hall range, southern pitch, taken from the south-west

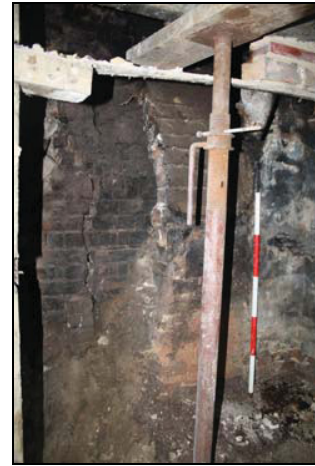
91

Poorly preserved southern corner of the chimney stack, ground floor, Room 1, taken from the south-east

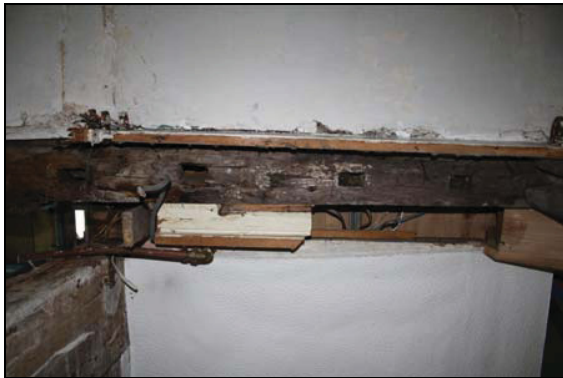
92

Poorly preserved chimney stack, ground floor, Room 1, taken from the south-east

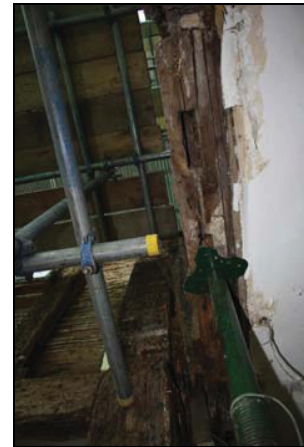
93

Redundant mortices for a window located along the mid-rail at junction between the cross-wing and the central hall range, taken from the north-west

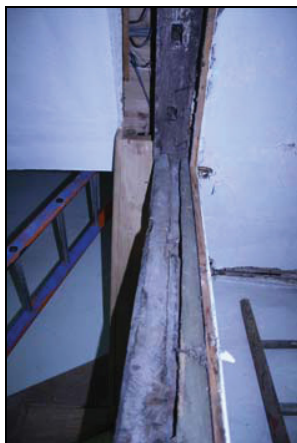
94

Redundant mortices for studwork located along the mid-rail at junction between the cross-wing and the central hall range, taken from the east

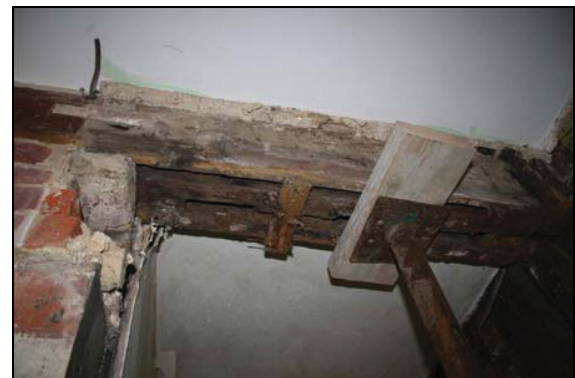
95

Redundant mortices for a possible window located along the mid-rail at junction between the cross-wing and the central hall range, taken from the east

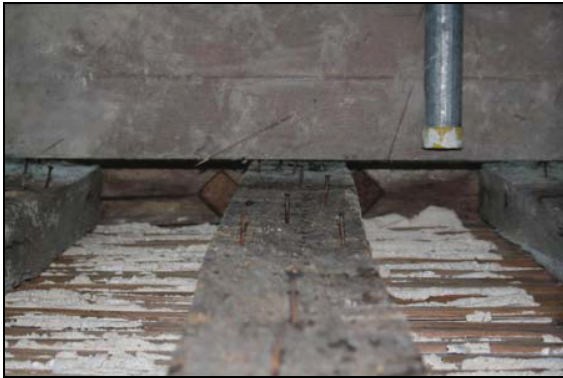
96

Redundant mortices for a possible window located along the mid-rail at junction between the cross-wing and the central hall range, taken from the north-west

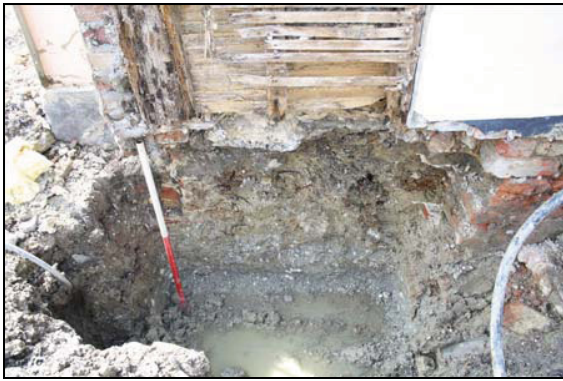
102

8.1 The monitoring of the foundation trenches and the reduction in floor levels did not reveal any archaeological features or finds. The dwarf wall varied in depth and quality and had been replaced along the southern extents by modern concrete underpinning. The wall was deepest at the north-western corner of the building where closest to the pond. Here, it measured up to 1.26m deep. After the removal of the wall the deposits were categorised and examined for features and finds. There was some disturbance from modern services.

Dwarf-wall partially removed from the north elevation, taken from the north-west

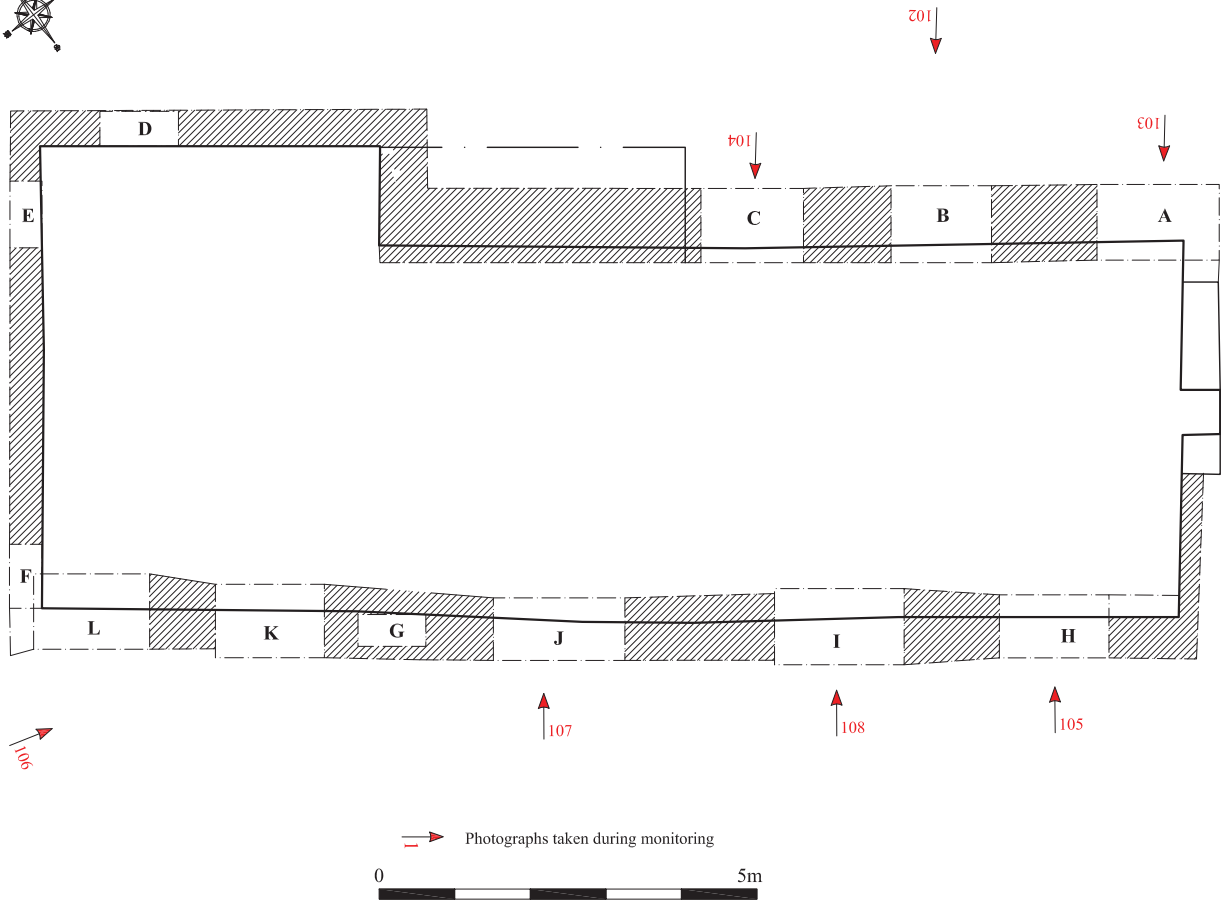
Fig. 5 Excavations for underpinning works

7.1 The groundworks consisted of the underpinning of the structure and the reduction of floor levels within the building itself. A series of trenches were excavated along the building's footprint to a depth of up to 1.10m in order to create concrete foundations and replace the dwarf wall and sole-plate (Fig.5). Exposed surfaces were cleaned as appropriate and examined for archaeological features and finds. Archaeological features and deposits were recorded using *pro-forma* recording sheets, drawn to scale and photographed as necessary.
