ARCHAEOLOGICAL SOLUTIONS LTD

PEARSE HOUSE,  
PARSONAGE LANE, BISHOP'S STORTFORD,  
HERTFORDSHIRE,

HISTORIC BUILDING RECORDING  
AND MONITORING

Authors: Dr Lee Prosser PhD Lisa Smith BA Tansy Collins Bsc Kate Higgs MA (Oxon.)	
NGR: TL 50355 21665	Report No. 4500
District: East Hertfordshire	Site Code: AS1644
Approved: Claire Halpin	Project No. 5506
MIFA	Date: 30 January 2014
Signed:

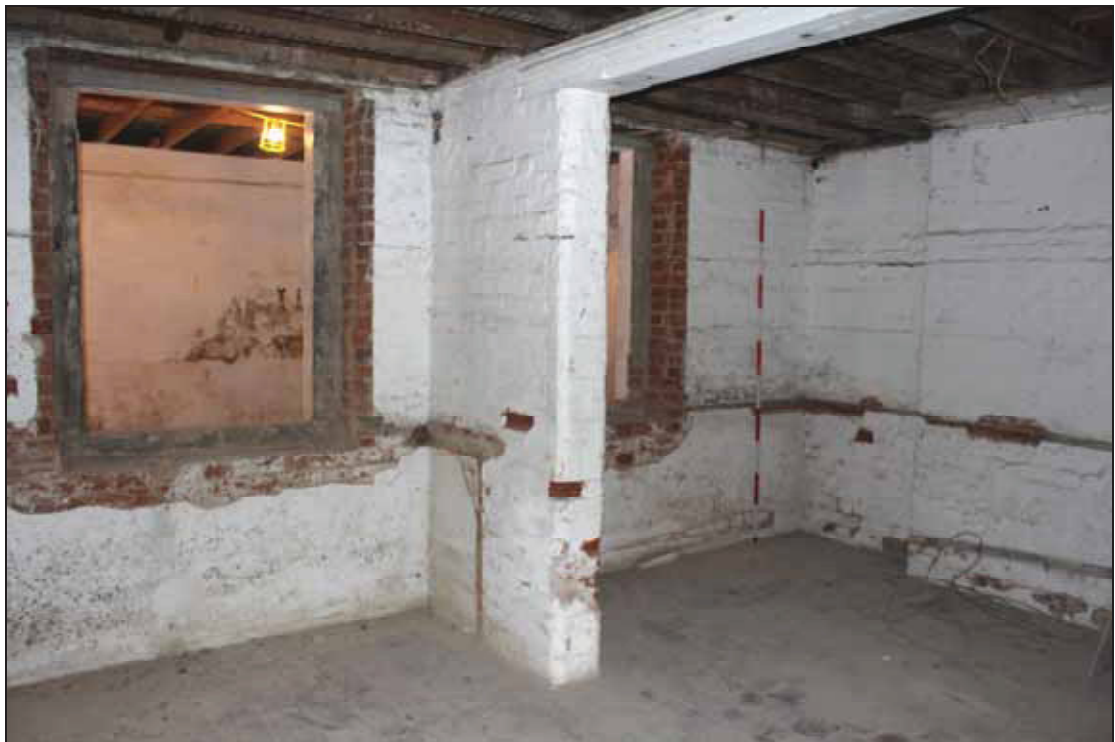
Plate 10 BF05, taken from the north (DP 124)

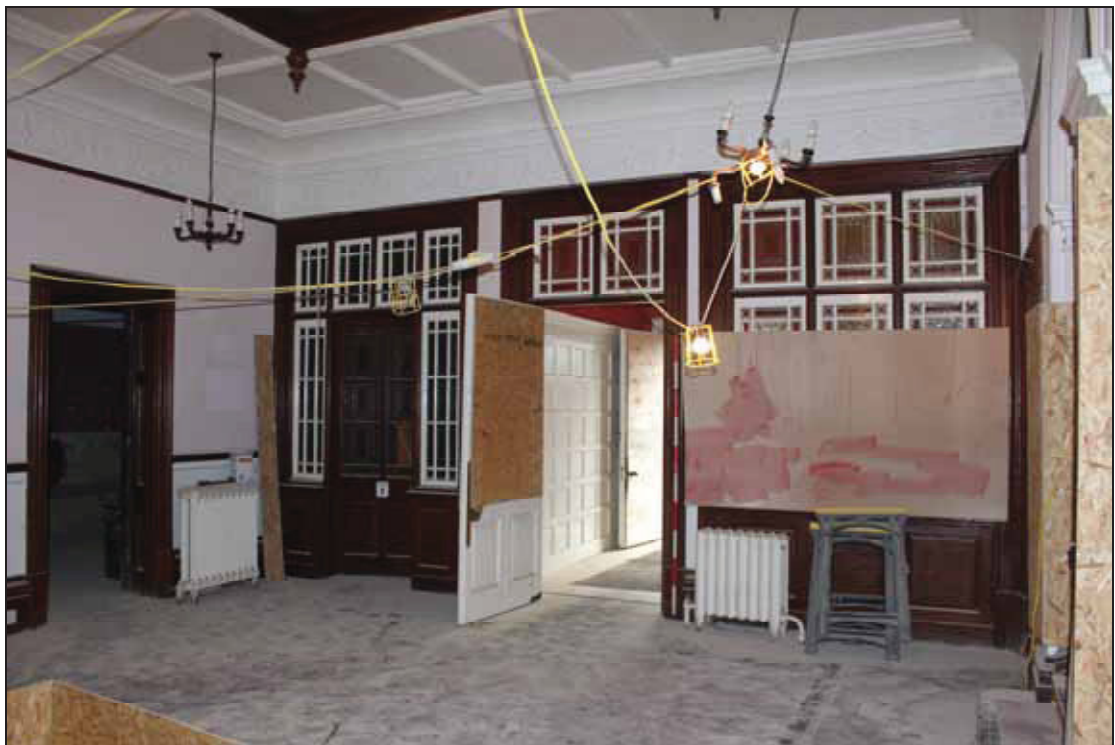
Plate 12 GF02, taken from the west (DP 152)

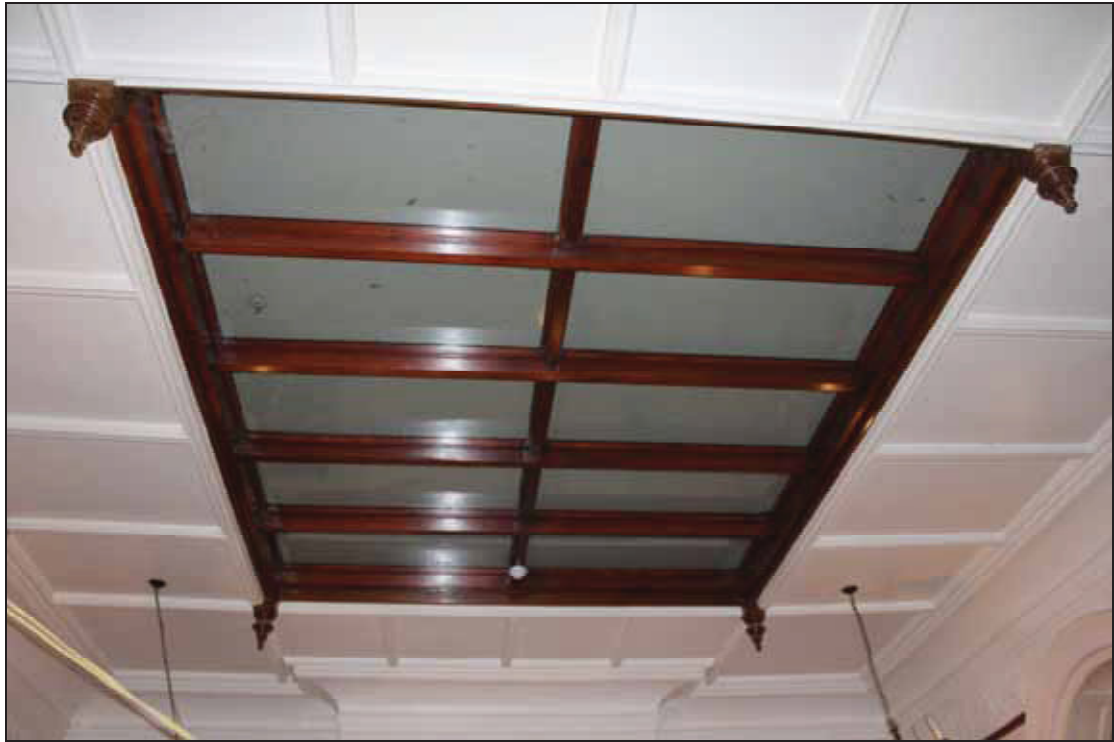
Plate 13 Ceiling light above, GF02, taken from the south-east (DP 175)

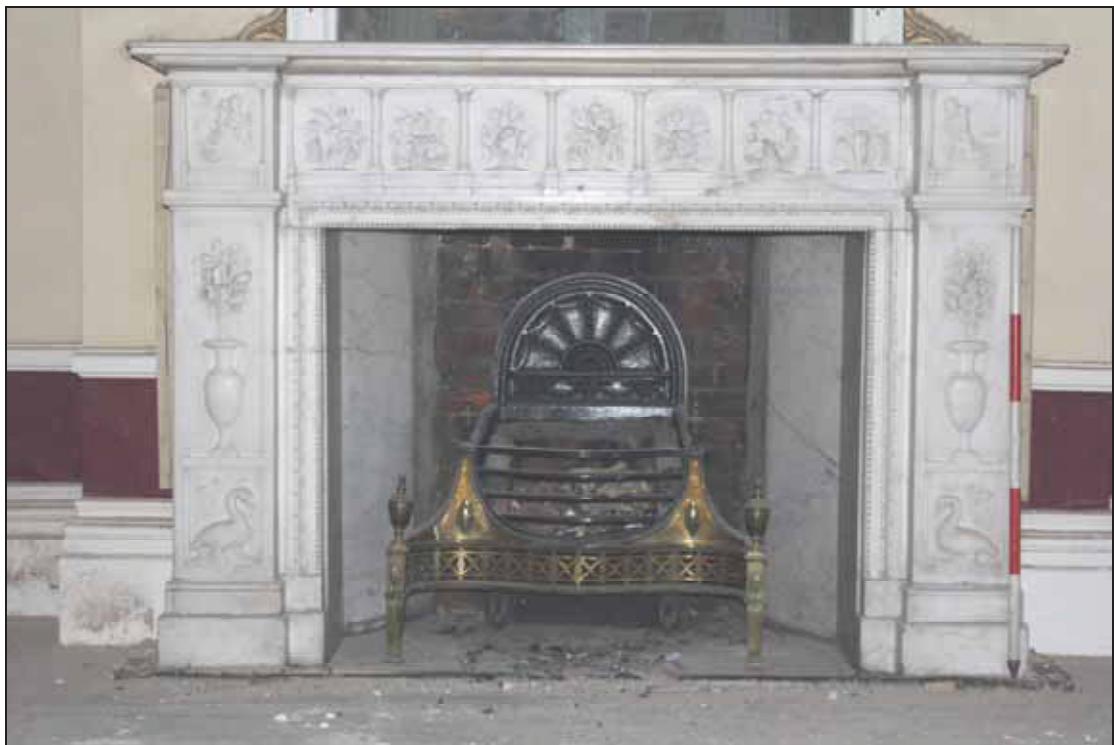
Plate 18 Central fireplace within GF08, taken from the south-west (DP 137)

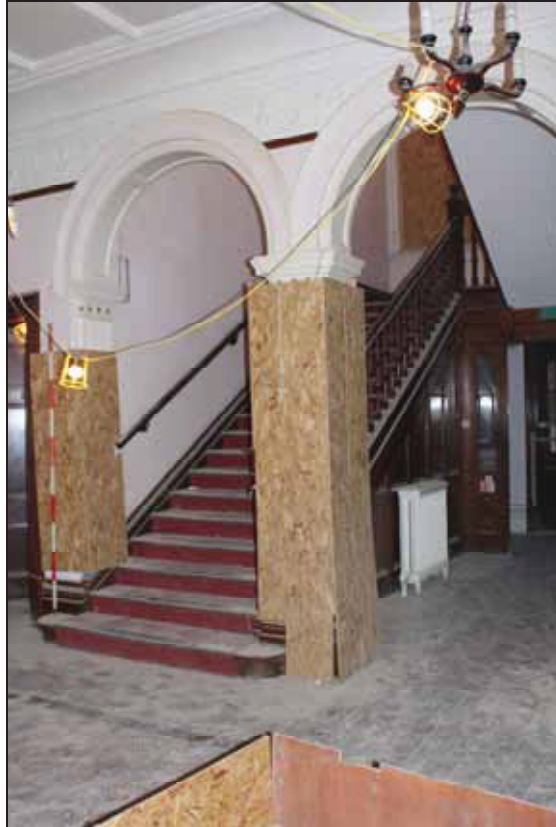
Plate 19 Main staircase leading up from GF02, taken from the north (DP 165)

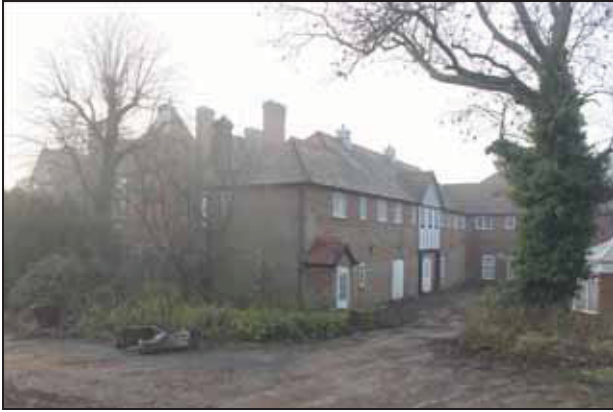
1

*The stable range with Pearse house beyond, taken from the east*

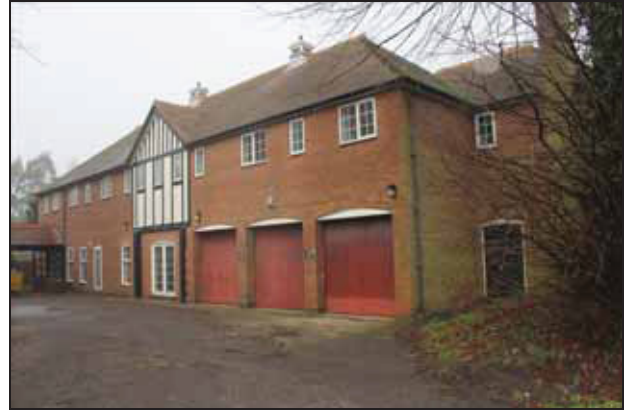
2

*South-west block of the stable range, south-west elevation, taken from the south-east*

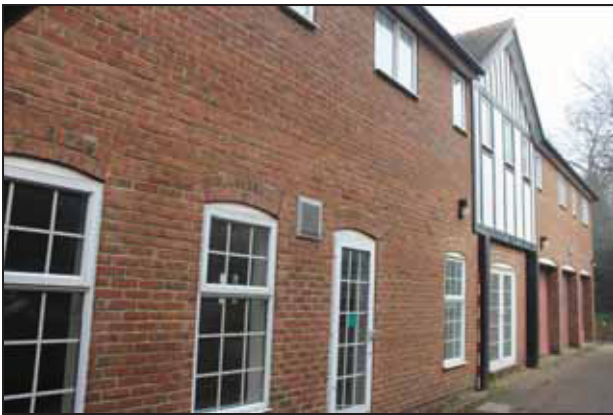
3

*South-west block of the stable range, south-west elevation, taken from the west*

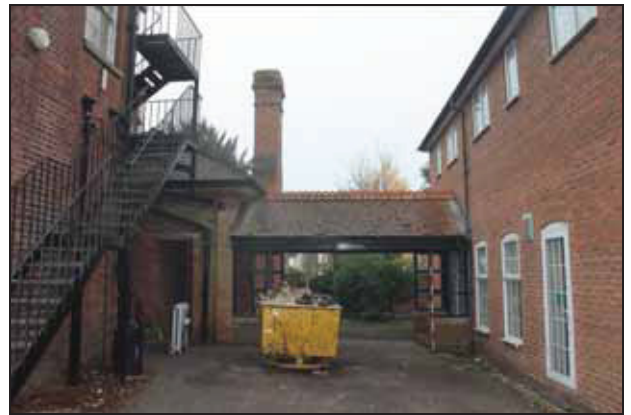
4

*Short linking corridor between the stable range and the main house, taken from the south-east*

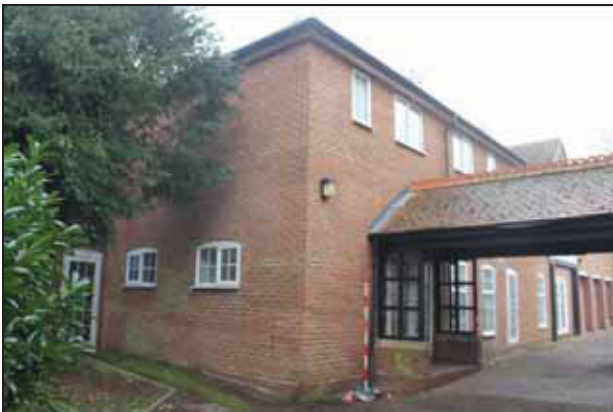
5

*Junction between the south-west and north-west stable block ranges, taken from the south-west*

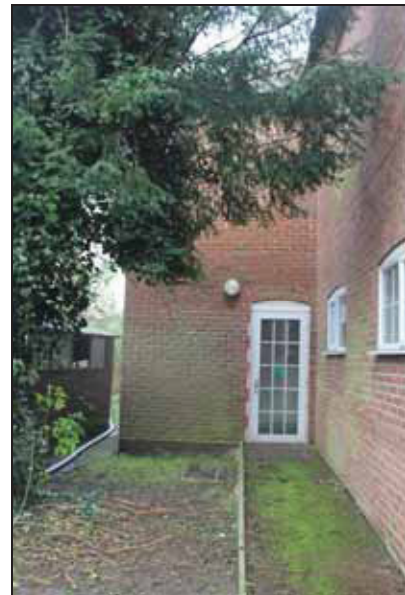
6

*North-west range of the stable block, north-west elevation, taken from the south-west*

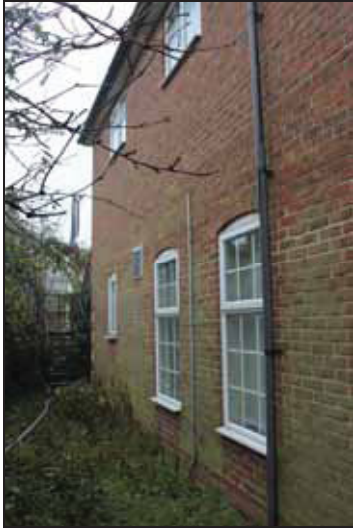
7

*North-west block of the stable range, north-west elevation, taken from the south-west*

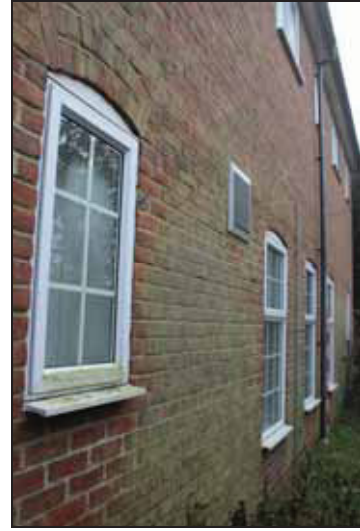
8

*North-west block of the stable range, north-west elevation, taken from the north*

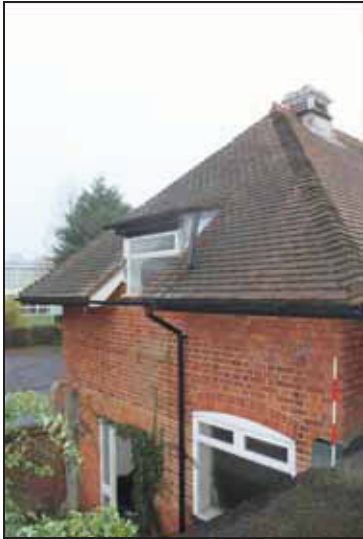
9

*North-east block of the stable range, upper portions of the north-west elevation, taken from the south-west*

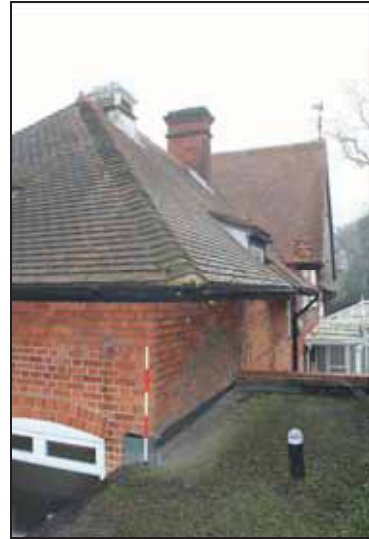
10

*North-east block of the stable range, north-west elevation, taken from the west*

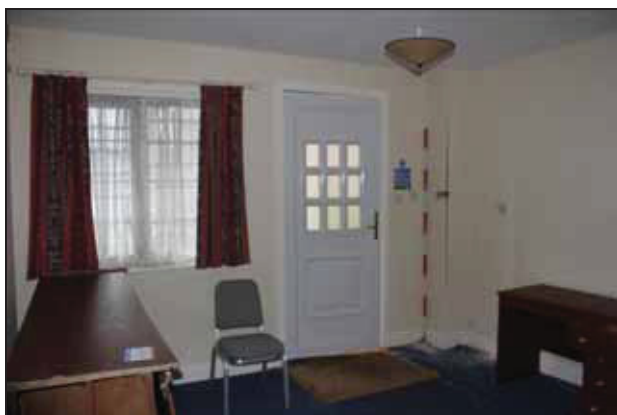
50

*GF05, north-east block, taken from the south*

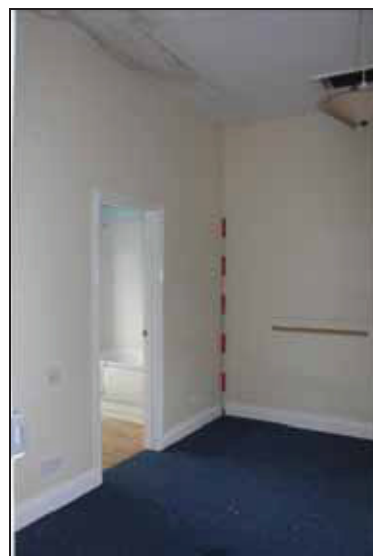
51

*GF05, north-east block, taken from the north-east*

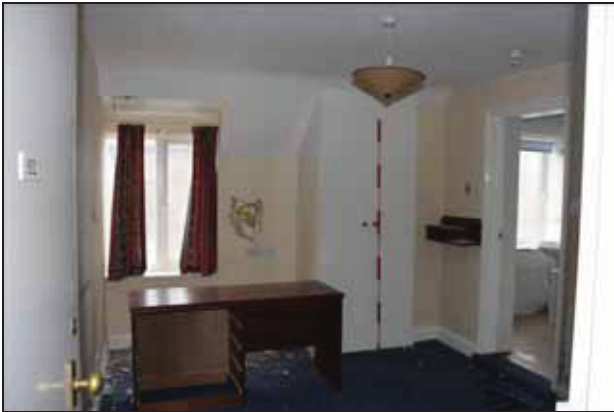
54

*FF07, north-east block, taken from the north-west*

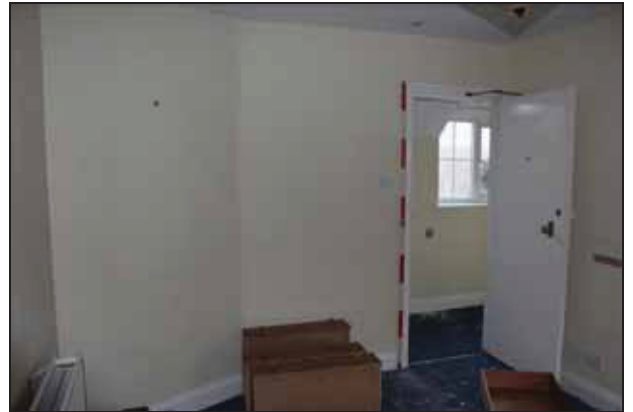
55

*FF08, north-east block, taken from the north-east*

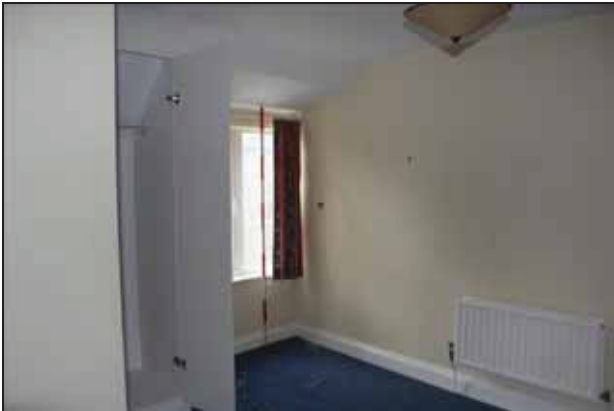
56

*FF08, north-east block, taken from the south-west*

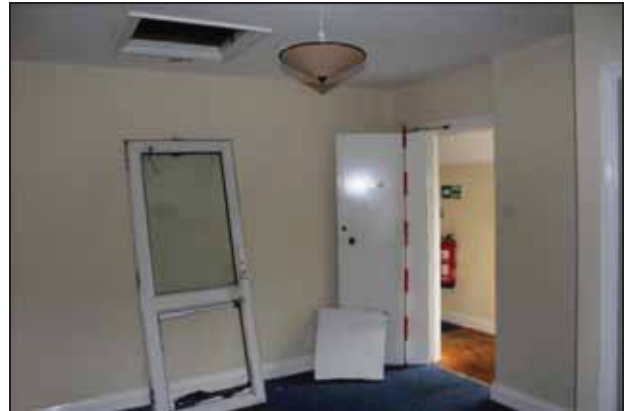
57

*FF09, north-east block, taken from the north-east*

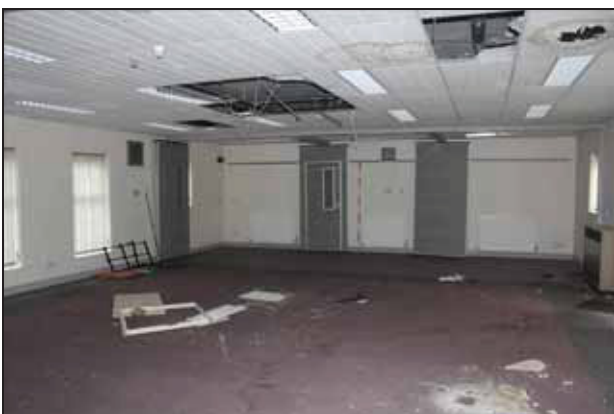
58

*FF09, north-east block, taken from the south-west*

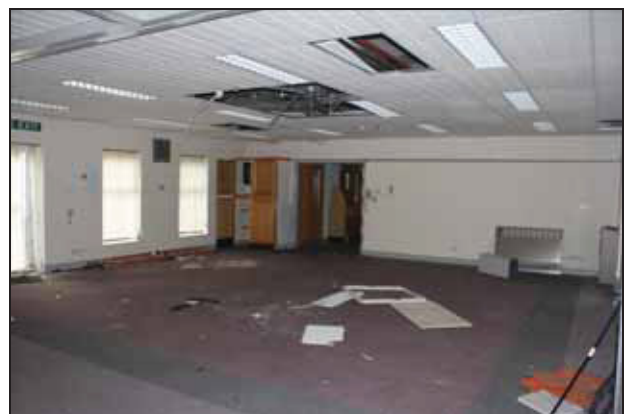
59

*GF08, north-west block, taken from the south*

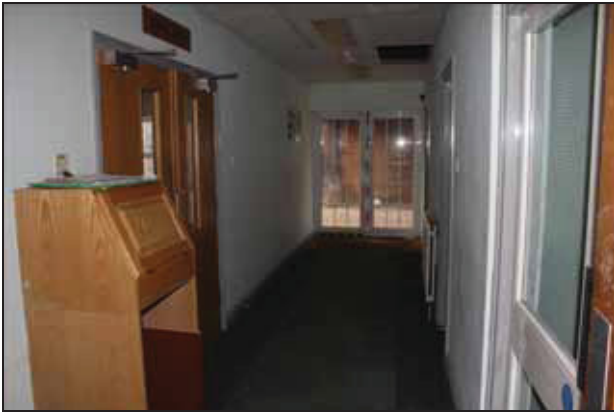
60

*GF08, north-west block, taken from the north*

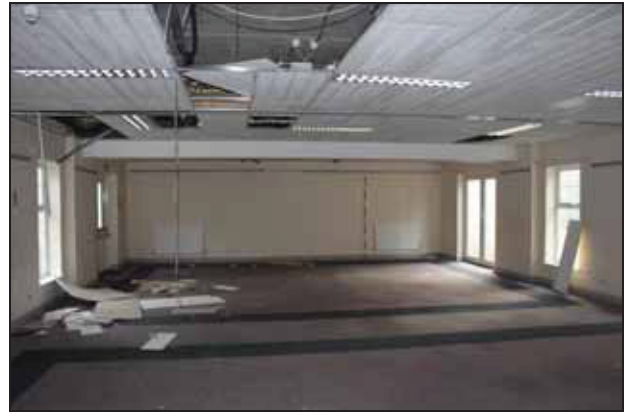
61

*GF10, south-west block, taken from the north-east*

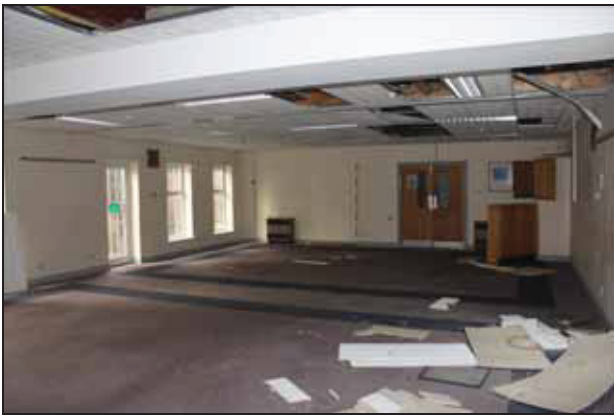
62

*GF09, south-west block, taken from the north-west*

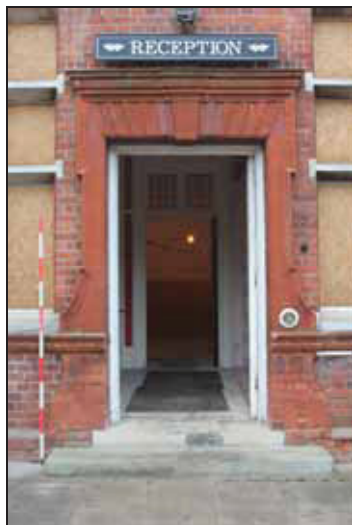
70

*Pearse House, south-east elevation, taken from the south-east*

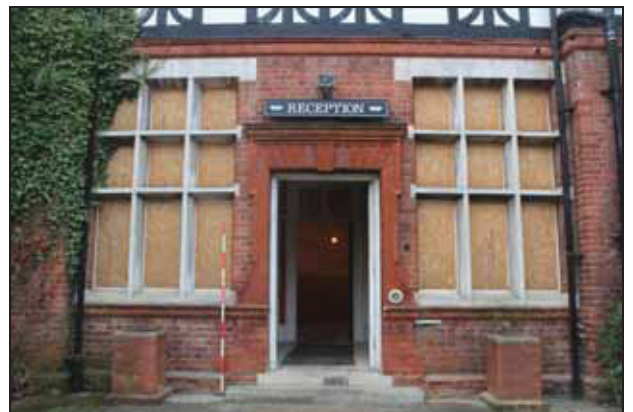
71

*Decorative brick surround to main entrance, south-east elevation, taken from the south-east*

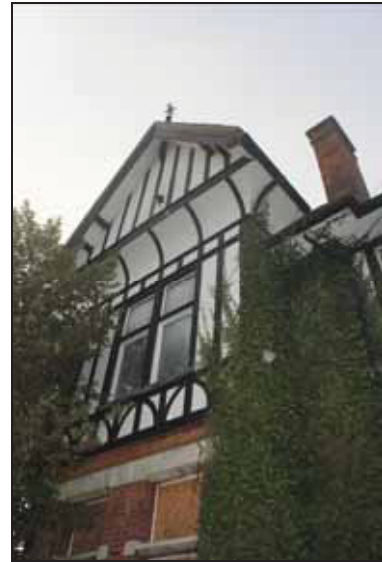
73

*Upper decorative timber framing with jettied gable to south-east elevation, taken from the south*

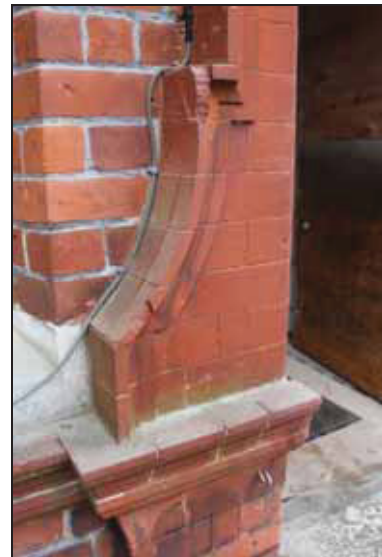
75

*Detail of the decorative brick surround to main entrance, south-east elevation, taken from the south-east*

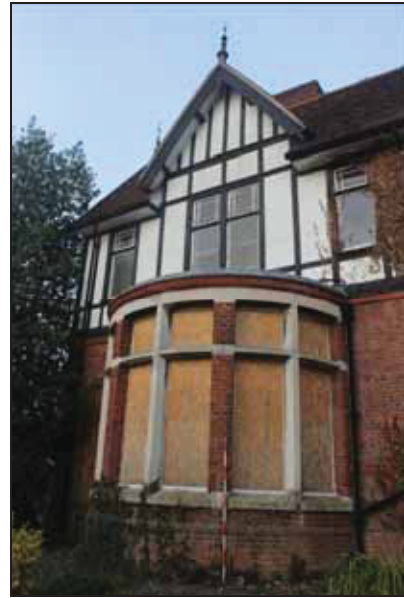
79

*South-west elevation, taken from the south-east*

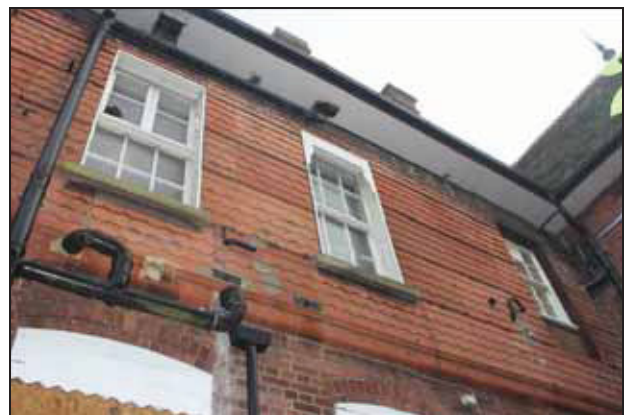
89

*Service range, north-west elevation, taken from the north-west*

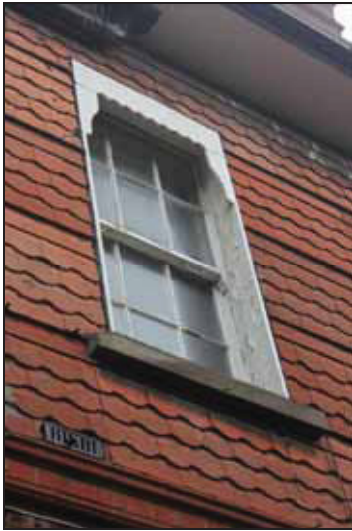
90

*Upper tile-hung portions of the north-west elevation of the service range, taken from the north*

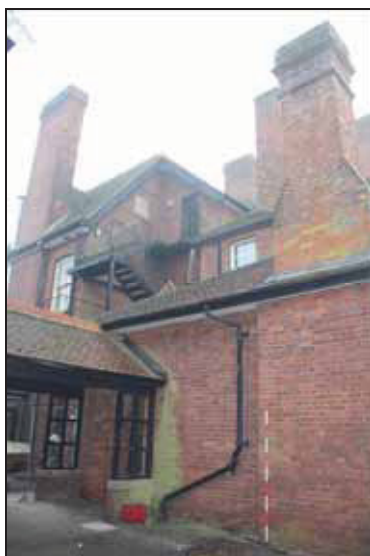
94

*North-east elevation of the service range, taken from the north*

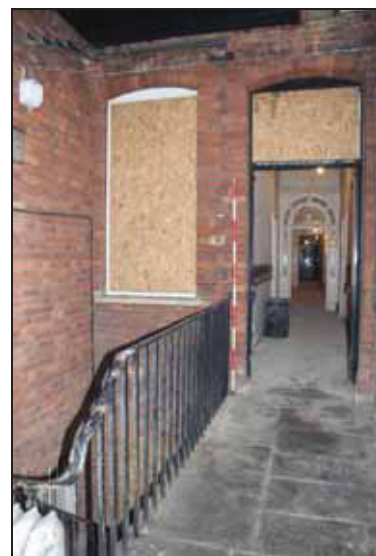
95

*North-east elevation of the service range, taken from the north-west*

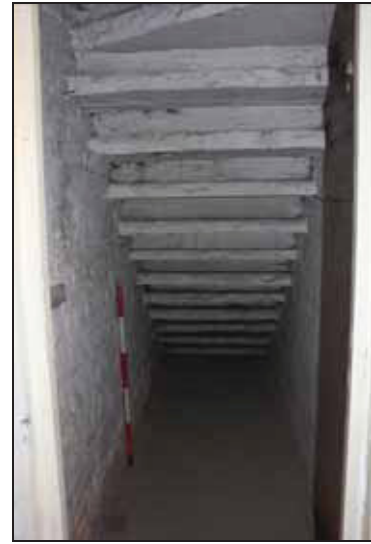
109

*Space beneath the stair and entrance to BF04, taken from the south*

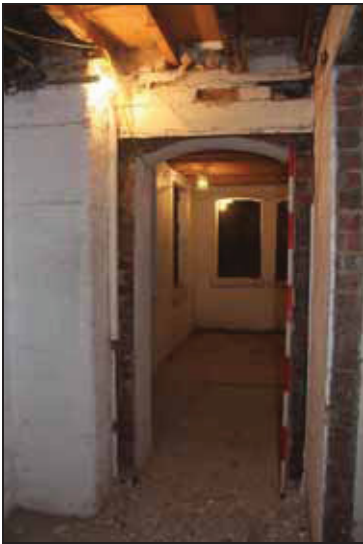
110

*Space beneath the stair, taken from the south-east*

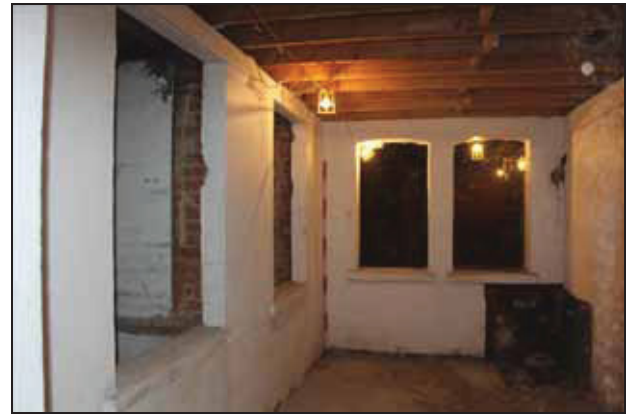
111

*Entrance to BF02, taken from the south-west*

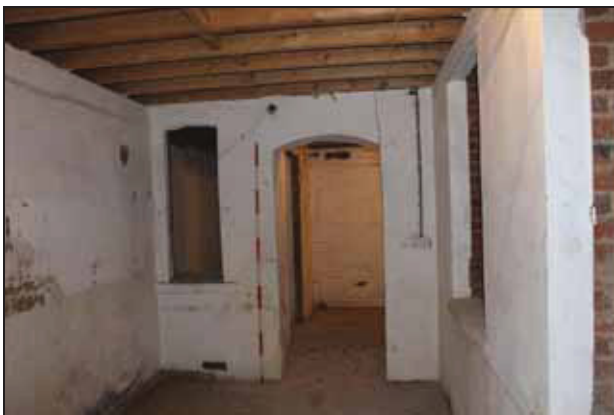
112

*Original external space now boxed in and floored over, BF02, taken from the south*

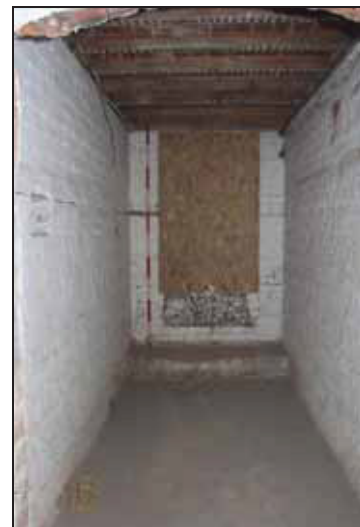
113

*Original external access to the cellar, BF02, taken from the north*

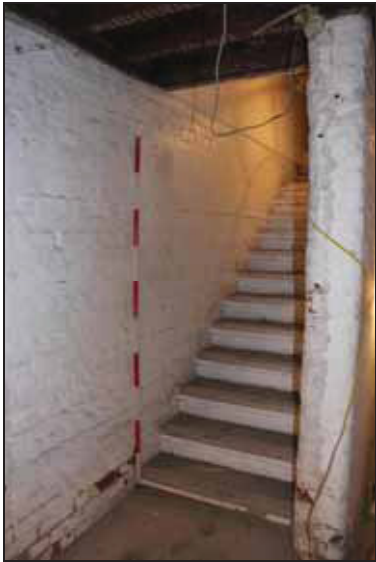
114

*BF08, taken from the north-east*

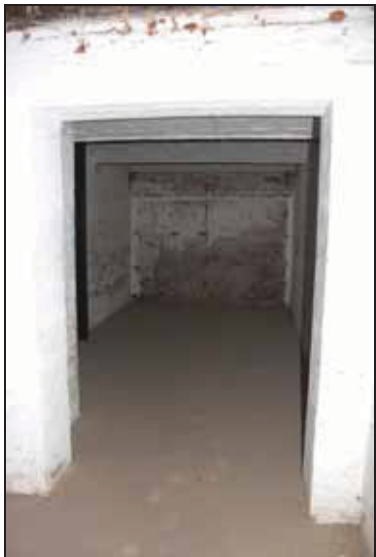
116

*Northern arm of BF01, taken from south-west*

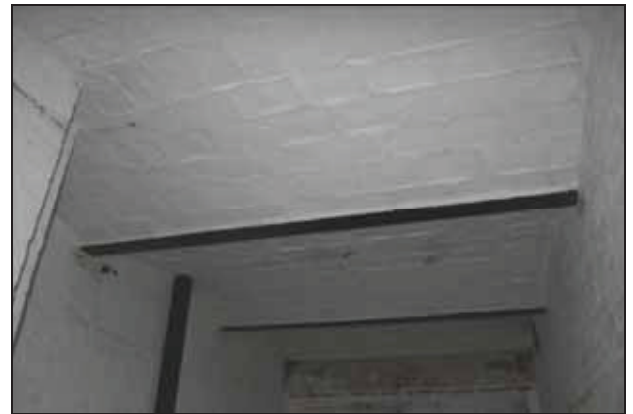
117

*BF06, taken from the south-west*

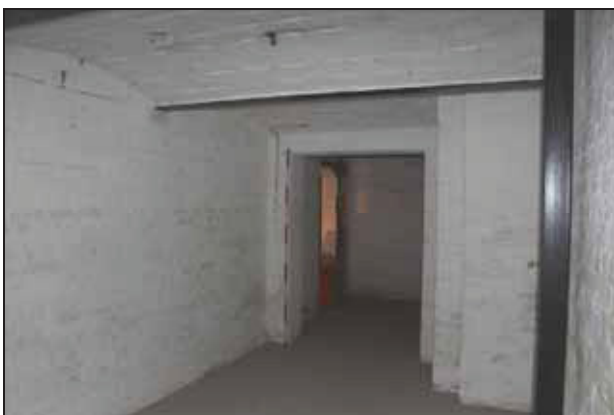
118

*Jack-arch ceiling supports above BF06, taken from the south*

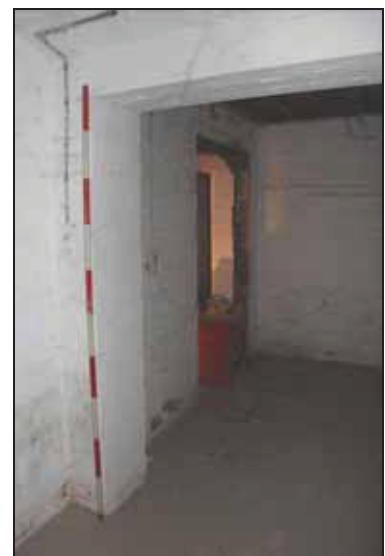
119

*BF06, taken from the south*

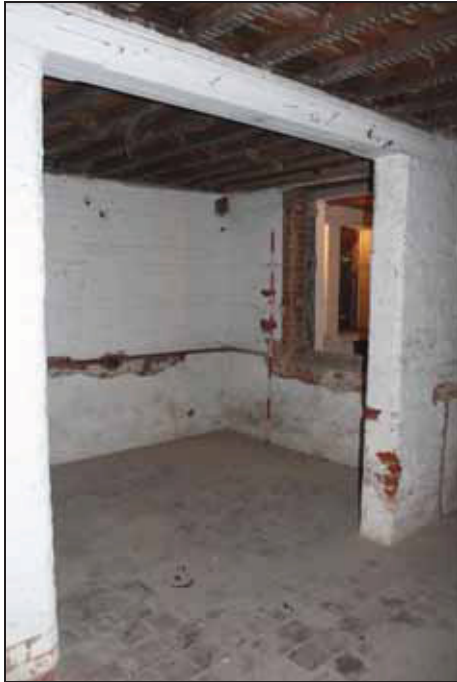
120

*BF06, taken from the north*

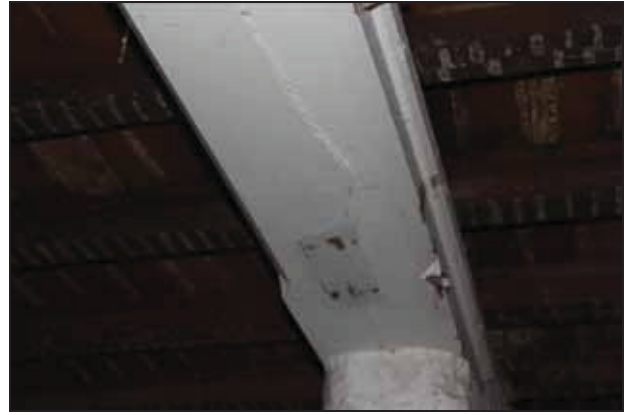
121

*BF05, taken from the west*

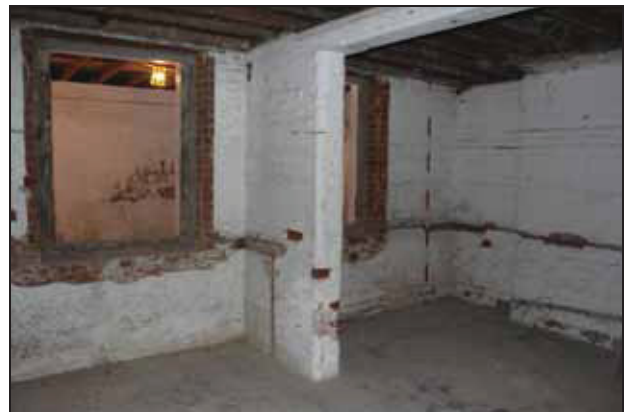
123

*BF05, taken from the north-east*

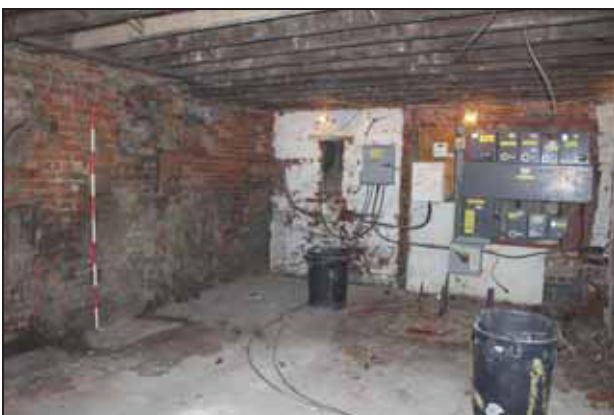
124

*BF05, taken from the north*

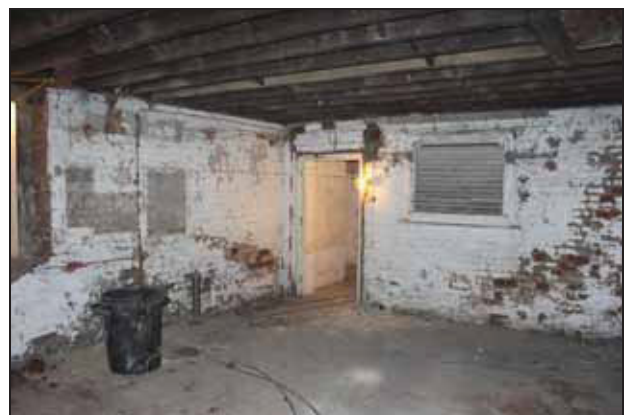
125

*BF07, taken from the west*

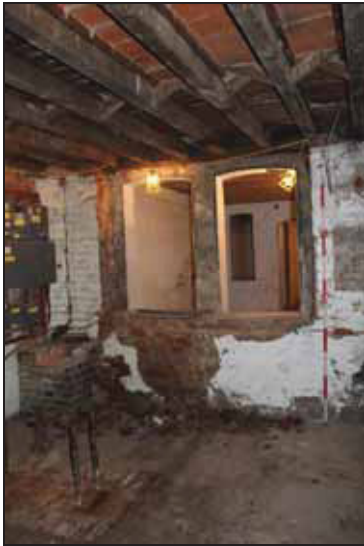
126

*BF07, taken from the east*

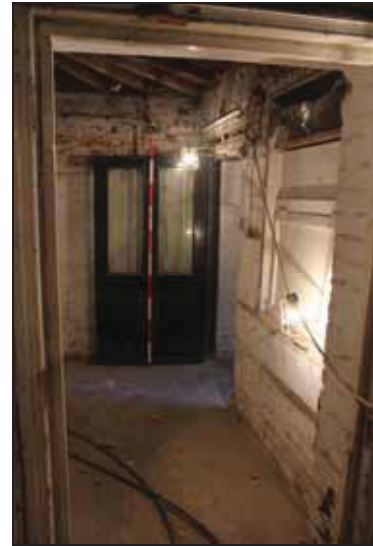
127

*BF07, taken from the north-east*

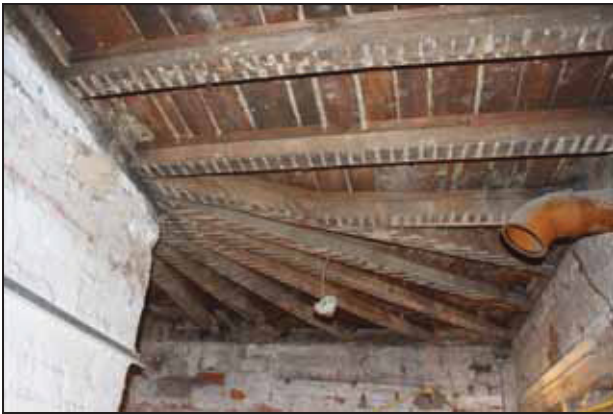
128

*BF01, taken from the south-east*

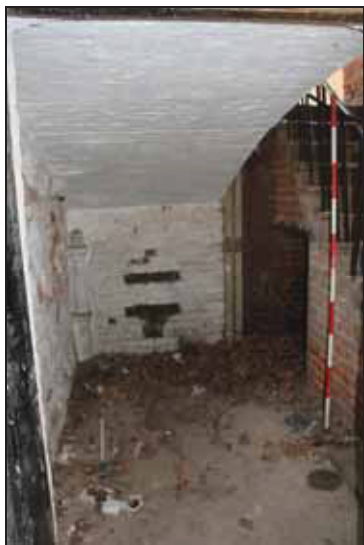
130

*External door to basement stair, BF01, taken from the south-east*

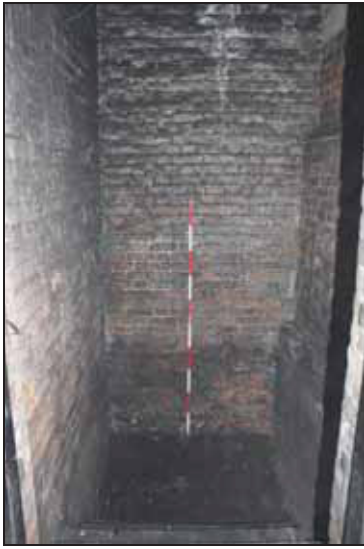
132

*Basement stair, taken from the west*

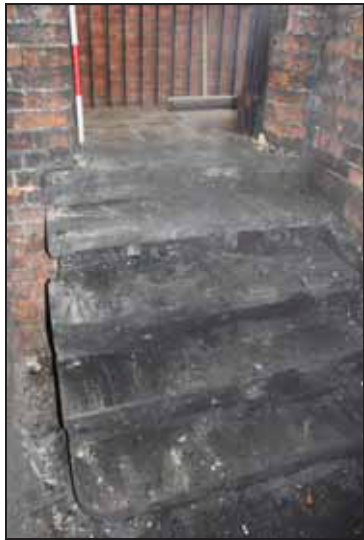
134

*Access to coal store, GF19, taken from the north-west*

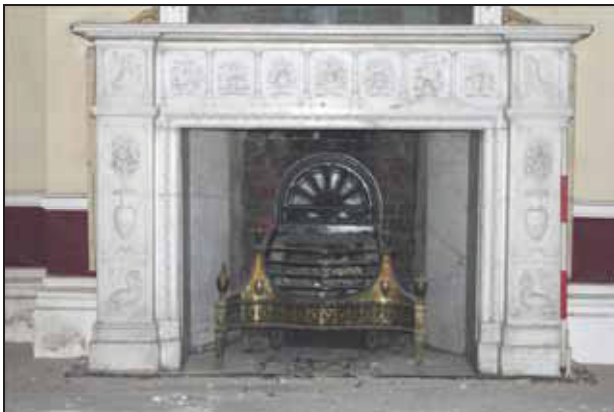
136

*Central fireplace within GF08, taken from the south-west*

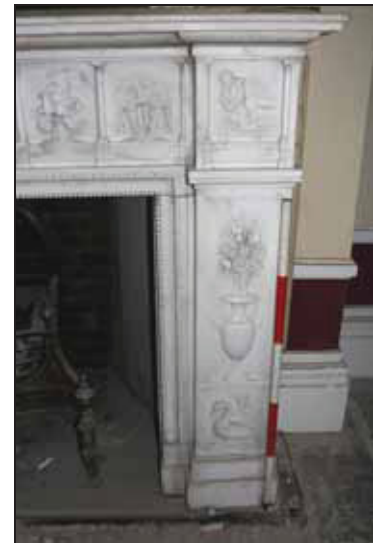
137

*Central fireplace within GF08, taken from the south-west*

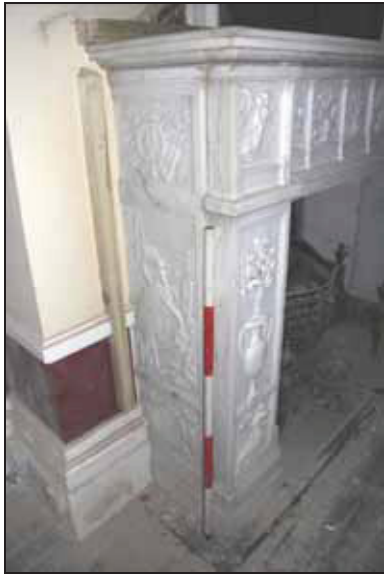
138

*Detail of fireplace decoration, GF08, taken from the south-west*

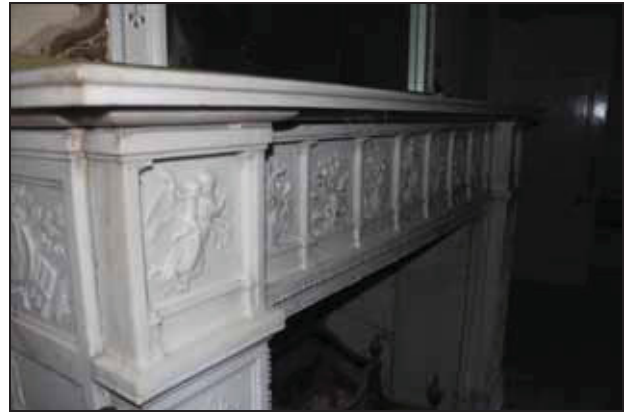
139

*Detail of fireplace decoration, GF08, taken from the south-west*

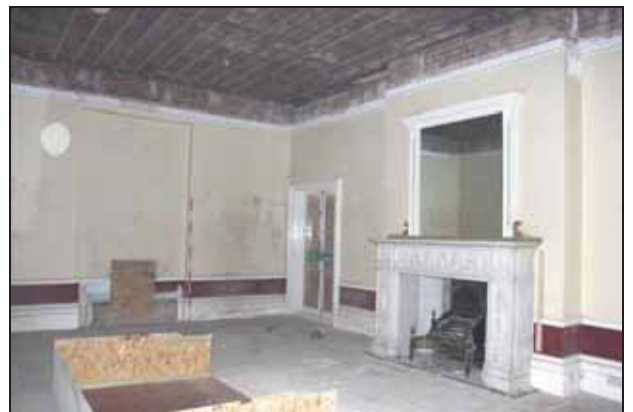
143

*Exposed arch for large window now blocked, GF08, taken from the south-east*

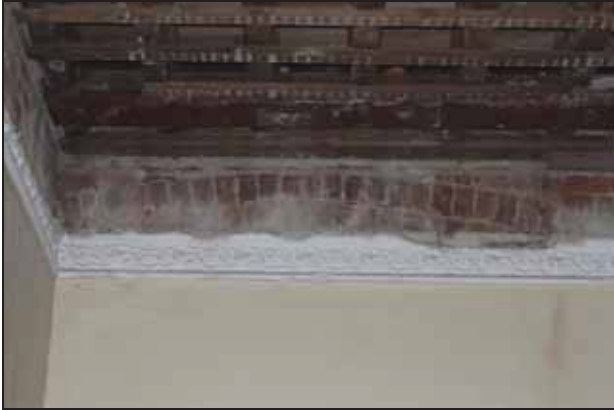
144

*GF08, taken from the south*

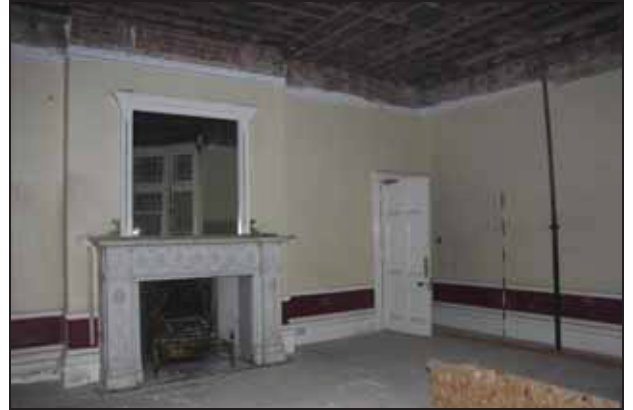
145

*Exposed arch possibly for a large window or door now reduced to a domestic sized door, GF08, taken from the south-west*

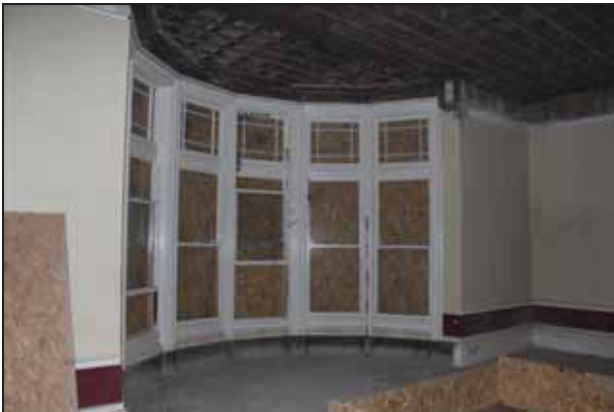
146

*GF08, taken from the south-west*

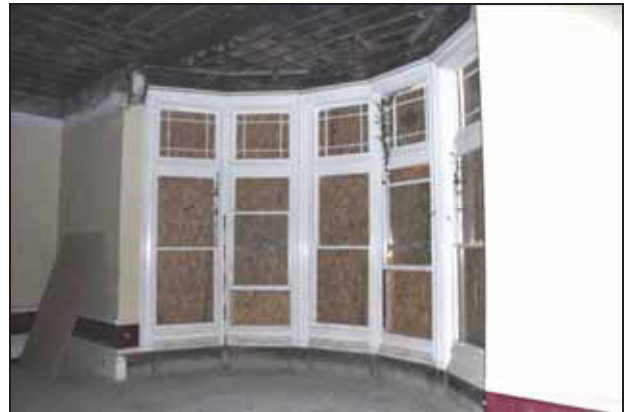
147

*Large bay window, GF08, taken from the east*

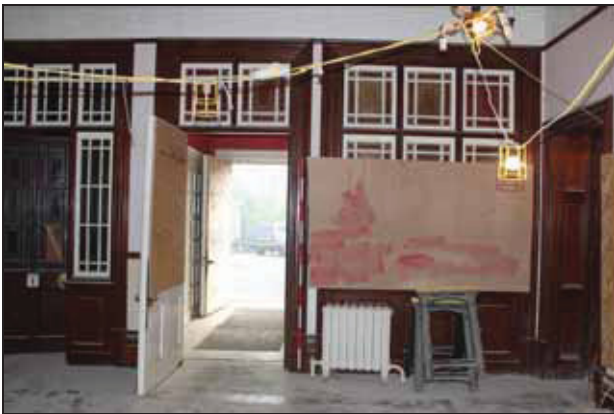
152

*GF02, taken from the west*

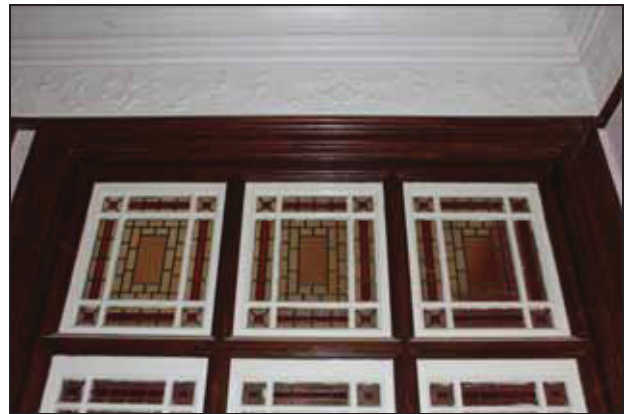
153

*Glazed partition between the entrance lobby GF01 and GF03, taken from the north-west*

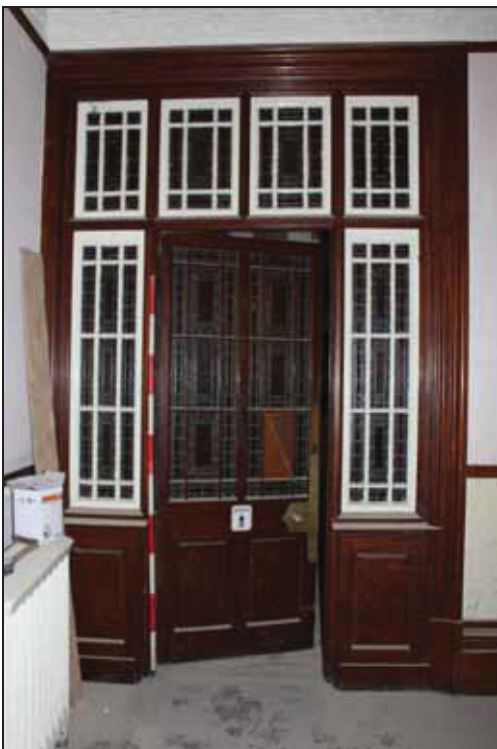
154

*Upper glazed panels to partition with GF01, taken from the north-west*

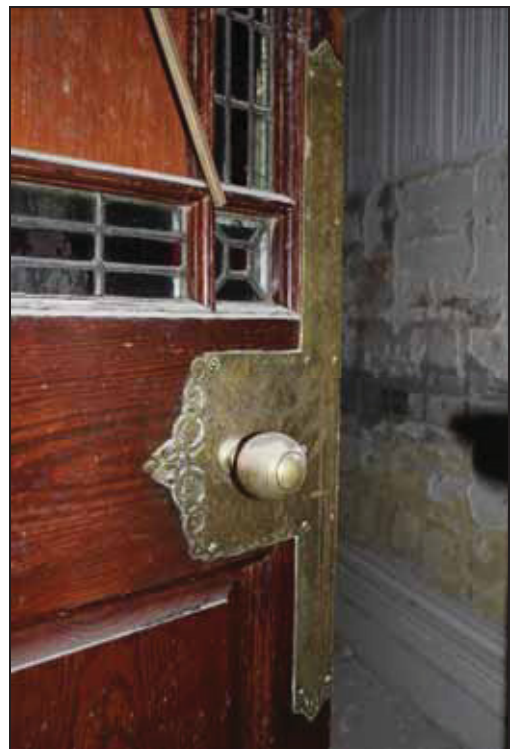
155

*Glazed partition to GF03, taken from the north-west*

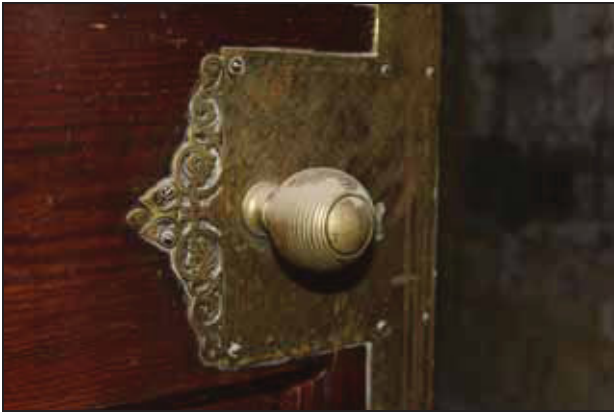
156

*Decorative finger and lock plate, door to GF03, GF02, taken from the west*

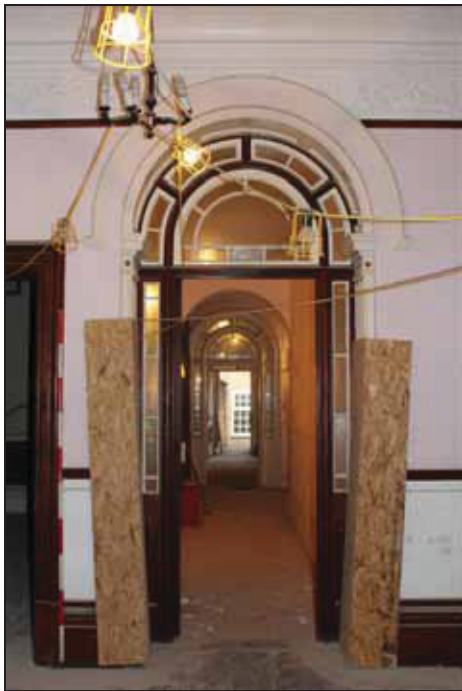
158

*GF02, taken from the south*

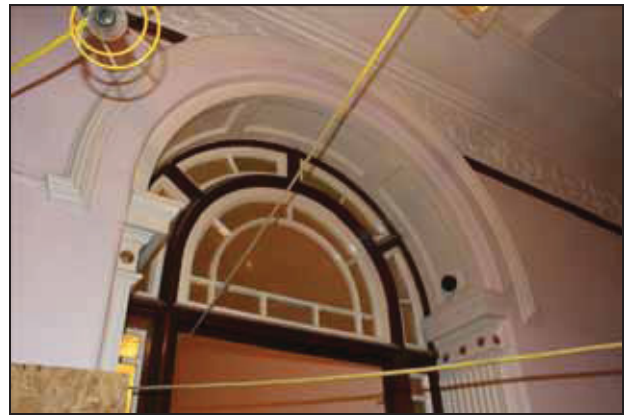
159

*Arched and glazed aperture leading to service wing corridor GF10, GF02, taken from the south-west*

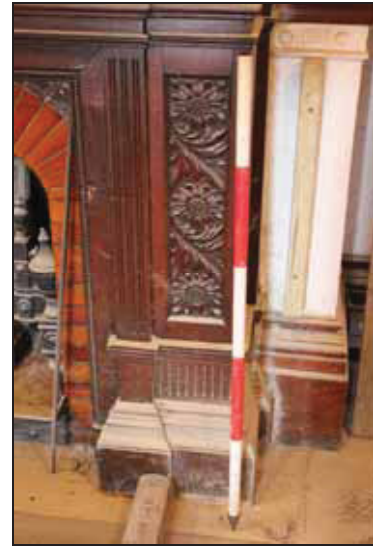
163

*Detail of fireplace decoration, GF02, taken from the south*

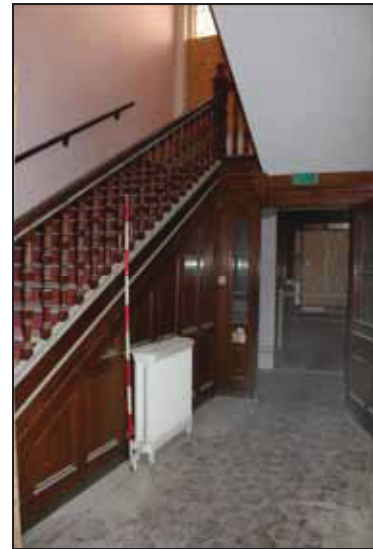
165

*Main staircase leading up from GF02, taken from the north*

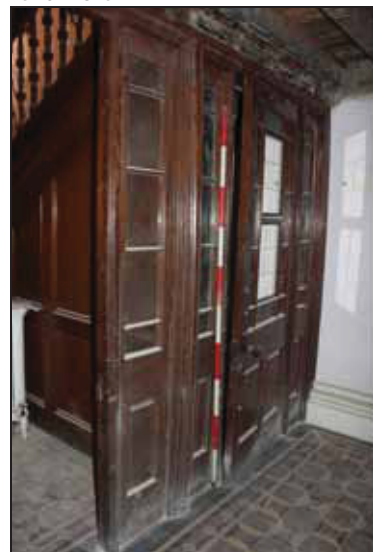
167

*Glazed and panelled door leading to a small lobby and external access, GF09, taken from the north-east*

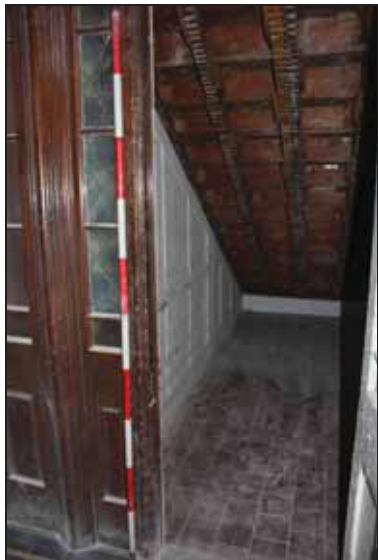
168

*Glazed and panelled door leading to space beneath the stairs, GF09, taken from the west*

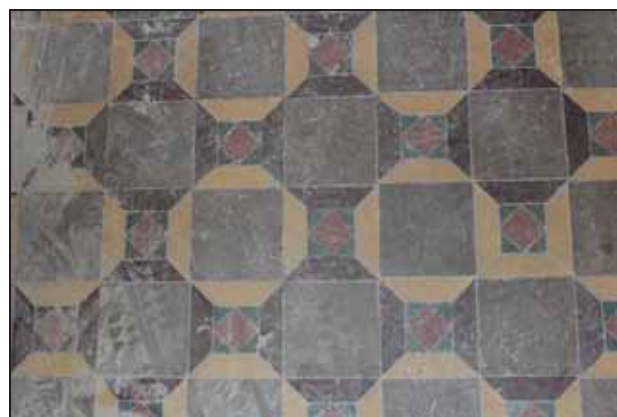
171

*Tiled floor, GF09, taken from the north-east*

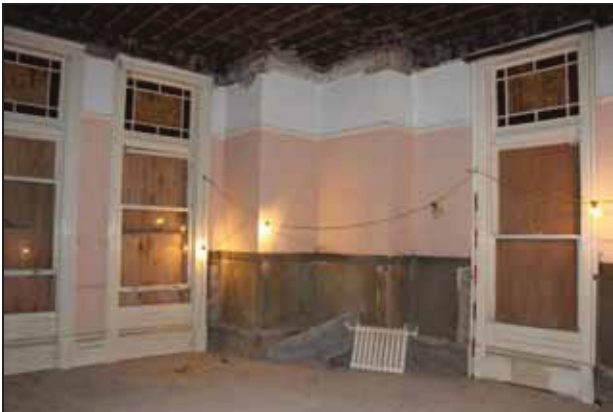
182

*Double sashes with overlights of coloured glass, GF04, taken from the north-west*

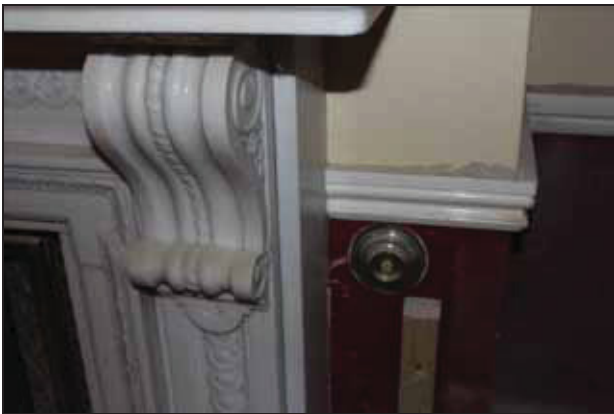
194

*Fireplace, GF07, taken from the north-west*
