ARCHAEOLOGICAL SOLUTIONS LTD

PEARSE HOUSE,  
PARSONAGE LANE, BISHOP'S STORTFORD,  
HERTFORDSHIRE,

HISTORIC BUILDING RECORDING  
AND MONITORING

Authors: Dr Lee Prosser PhD Lisa Smith BA Tansy Collins Bsc Kate Higgs MA (Oxon.)	
NGR: TL 50355 21665	Report No. 4500
District: East Hertfordshire	Site Code: AS1644
Approved: Claire Halpin	Project No. 5506
MIFA	Date: 30 January 2014
Signed:

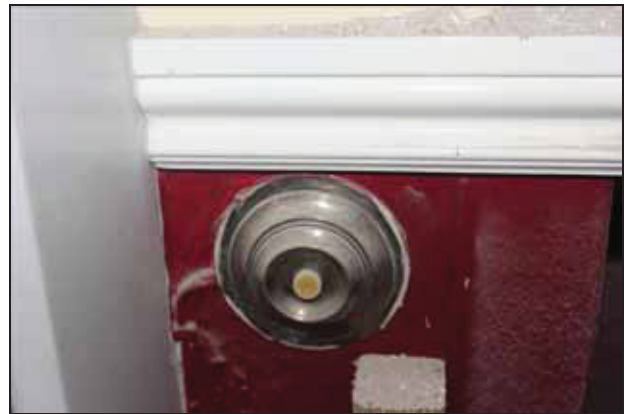
195

*Fireplace with servants bell adjacent, GF07, taken from the west*

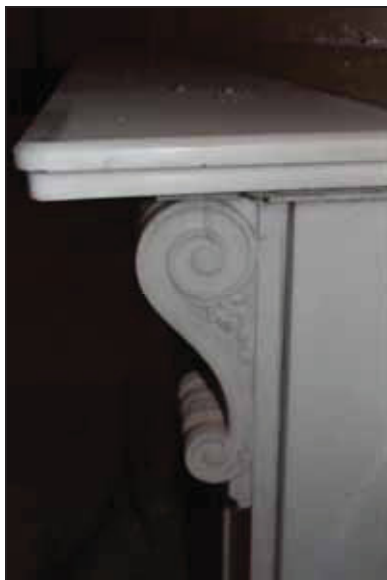
196

*Servants bell adjacent, GF07, taken from the west*

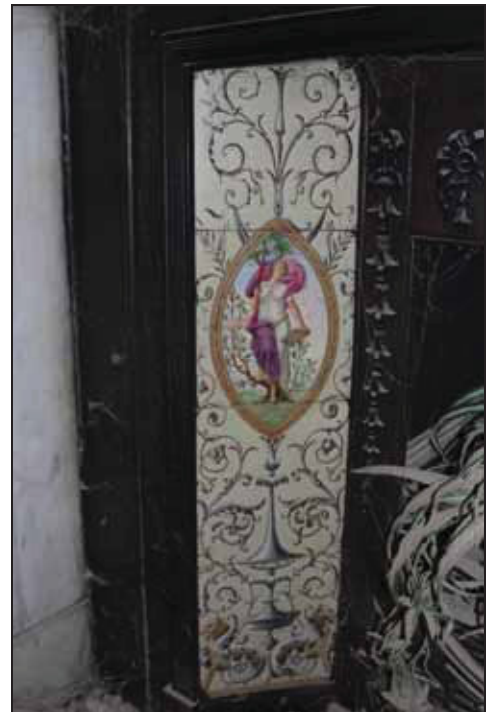
203

*Fireplace with decorative reveals, GF06, taken from the south-west*

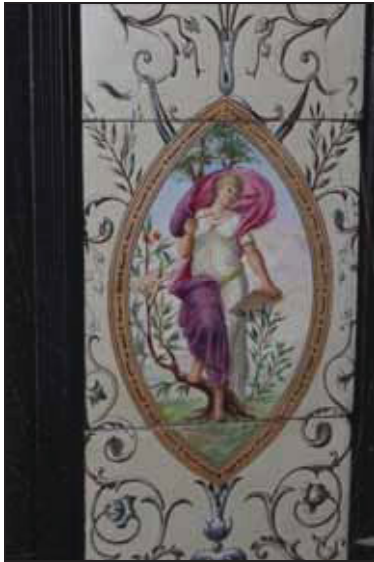
204

*Detail of tiled reveal, fireplace, GF06, taken from the south*

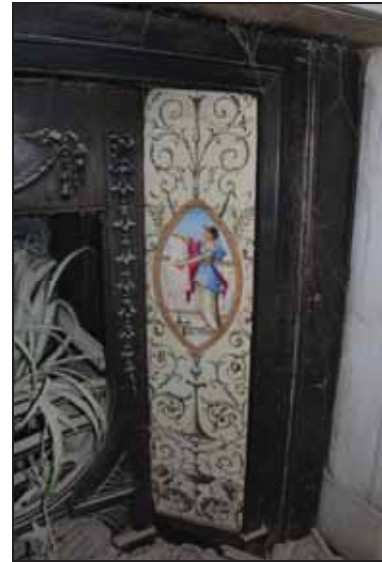
205

*Detail of decorative tiled reveal to fireplace, GF06, taken from the south*

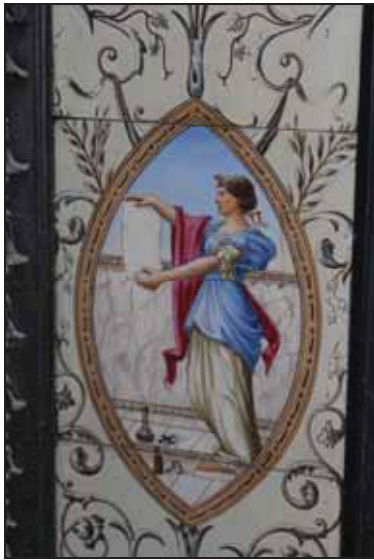
206

*Detail of decorative tiled reveal to fireplace, GF06, taken from the west*

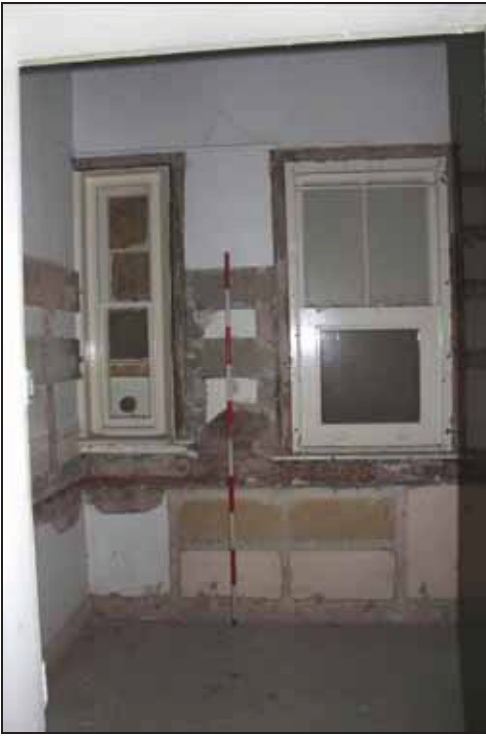
210

*GF14, taken from the west*

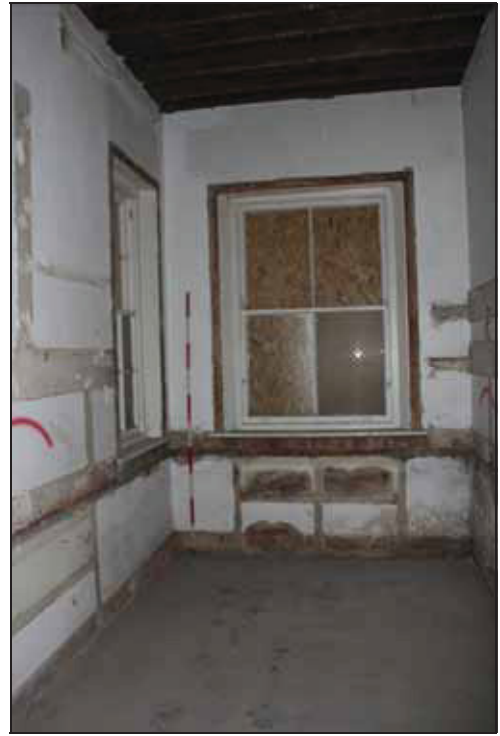
211

*GF15, taken from the north-west*

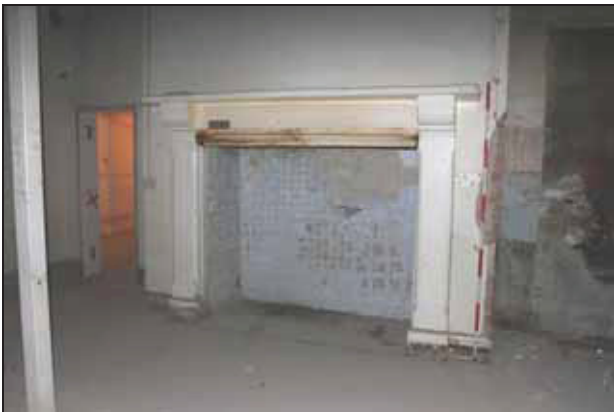
212

*GF13, taken from the south-east*

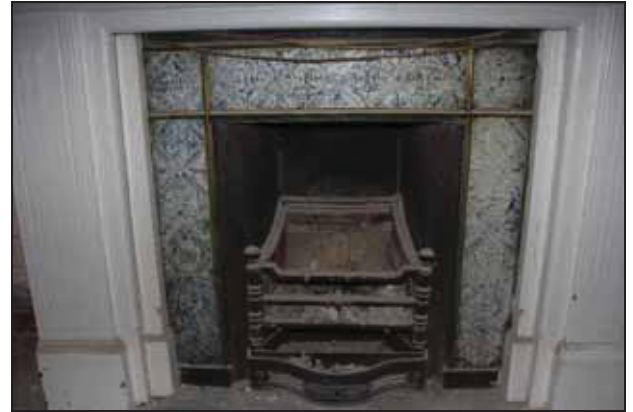
217

*Fireplace with ornate over-mantle, GF17, taken from the south-west*

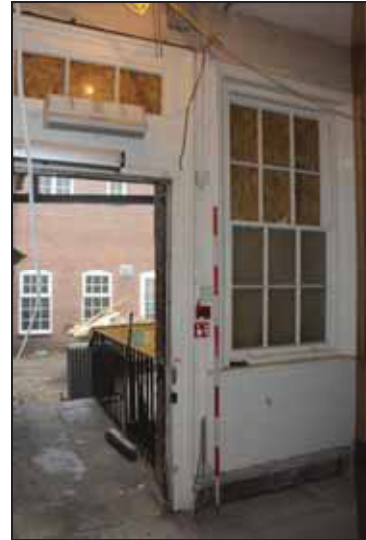
219

*GF17, taken from the east*

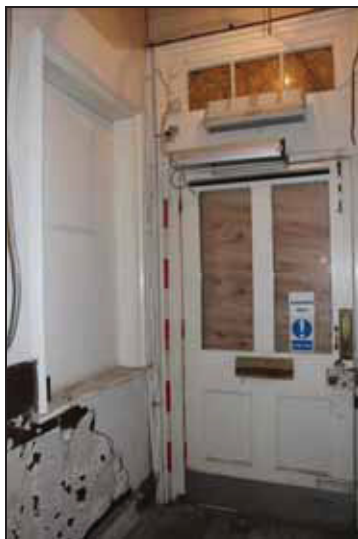
220

*Side entrance to service range, GF10, taken from the south-west*

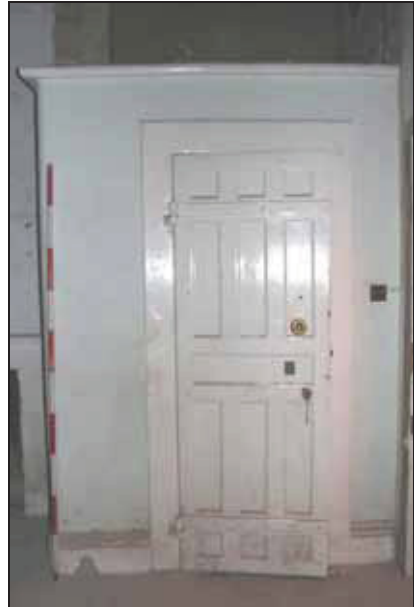
223

*GF16 with strong room, taken from the east*

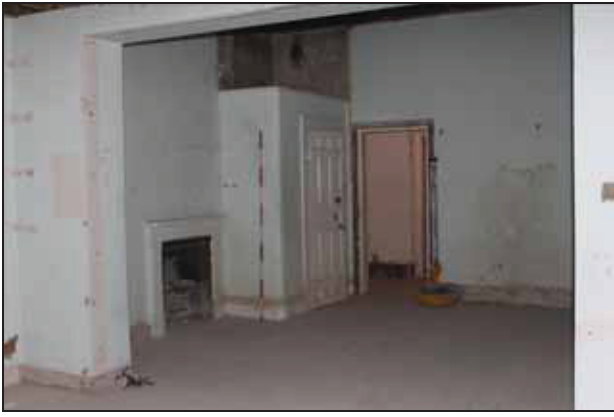
228

*GF16, taken from the west*

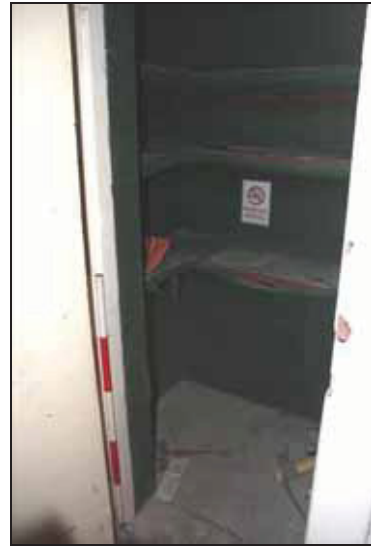
229

*GF16, taken from the east*

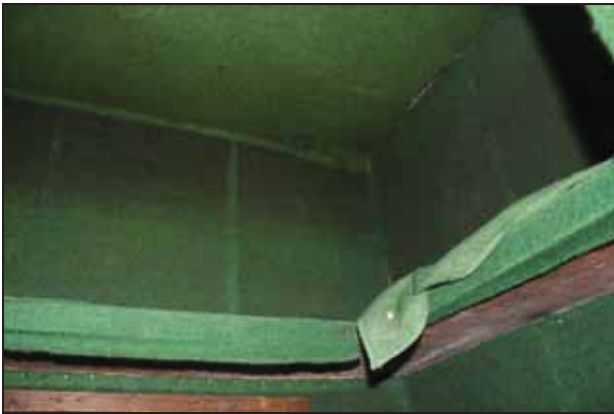
230

*Interior of the strong room, GF16, taken from the north*

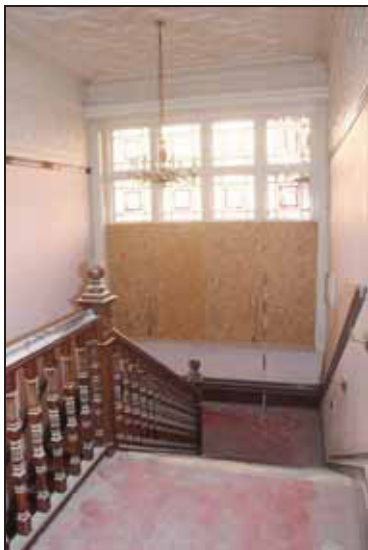
232

*Stair landing with decorative newel posts, taken from the south*

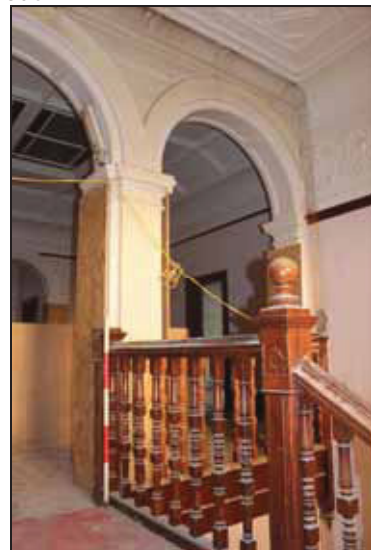
233

*Staircase from first floor level, FF01, taken from the north*

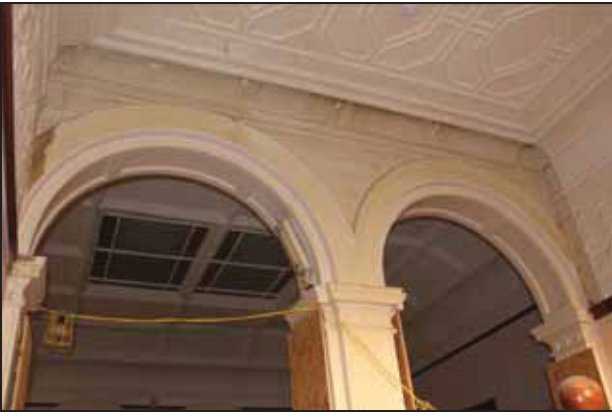
234

*Upper portions of the staircase with arched apertures leading through to central vestibule, FF01, taken from the west*

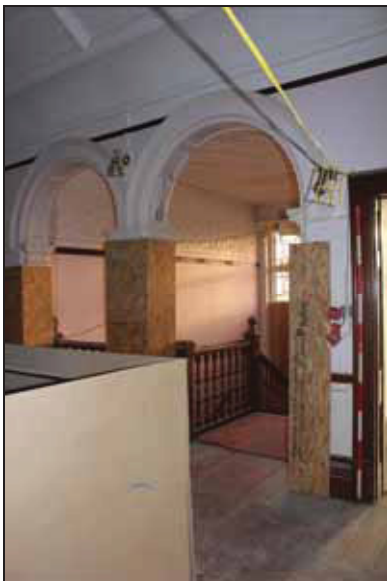
238

*Ceiling above stair well, FF01, taken from the north*

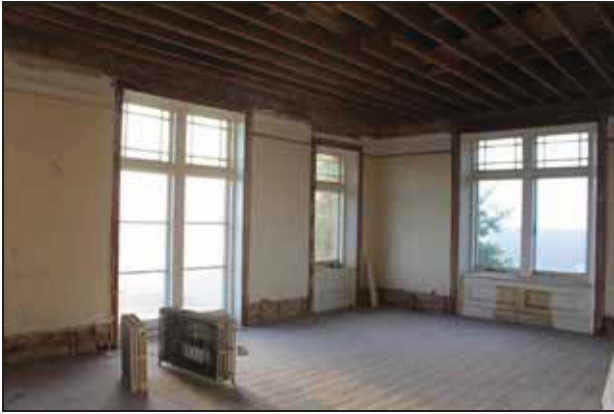
240

*FF03, taken from the west*

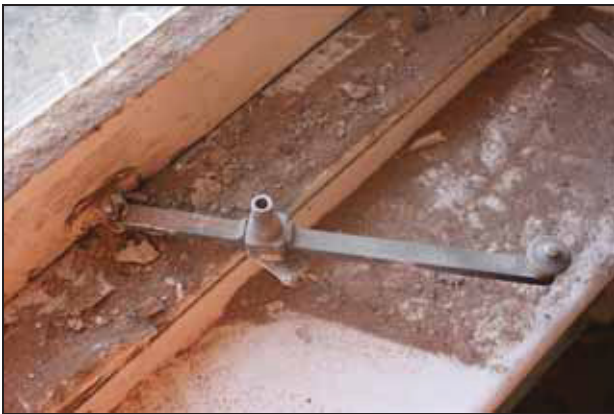
242

*Decorative window catch, FF03, taken from the south-east*

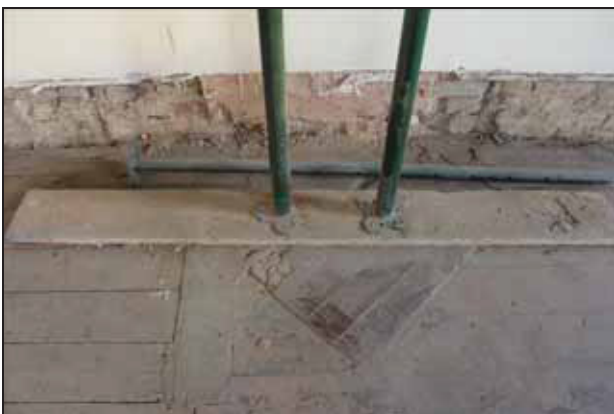
244

*Part of FF03 formerly divided and heated by a corner fireplace now removed, taken from the north-east*

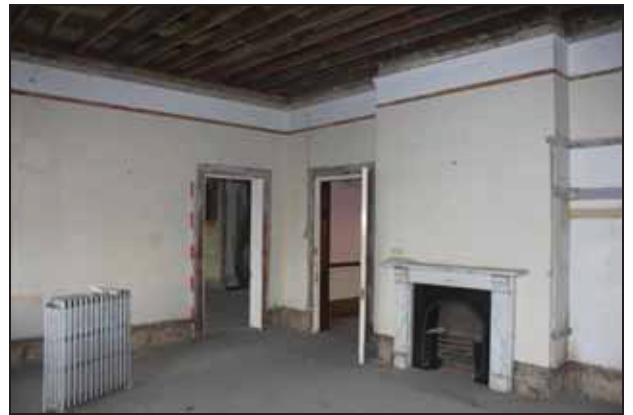
249

*Decorative catch, FF04, taken from the south-east*

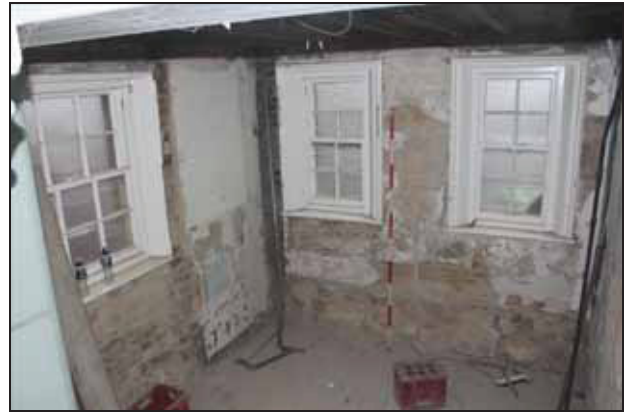
296

*Intermediate stair landing within the campanile, FF15, taken from the west*

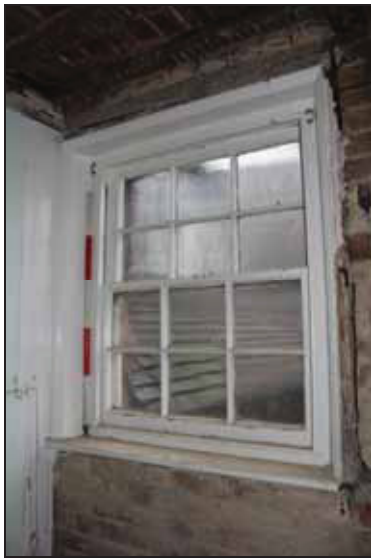
297

*Original sash window, intermediate stair landing within the campanile, FF15, taken from the south*

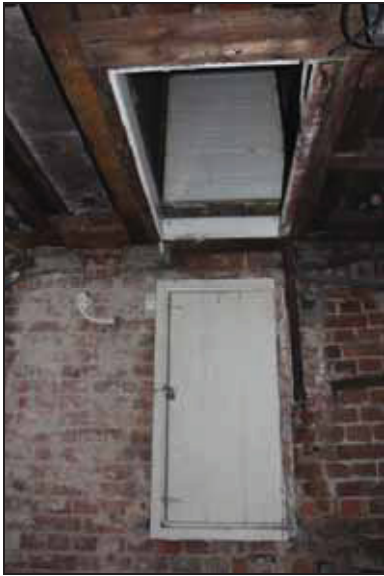
303

*Small door to exterior with loft hatch above for access to water tanks, TF01, taken from the north-east*

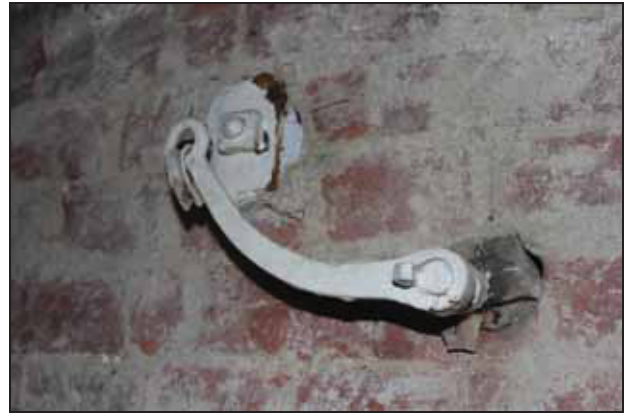
304

5.112 As noted above, the back stair rises in a final flight to a small chamber occupying the top floor of the campanile. Here, a small hatch in the south wall provides external access to a bell with internal iron handle and pulley (Plate 28). The space is simple, lit on the east by three narrow four-over-four sashes. The ceiling space is occupied by water tanks supported on I-girders resting on stone corbels. Above, the roof is simple with a softwood umbrella-like structure rising from a tie-beam on a pair of struts.

*Internal bell pull, TF01, taken from the north*

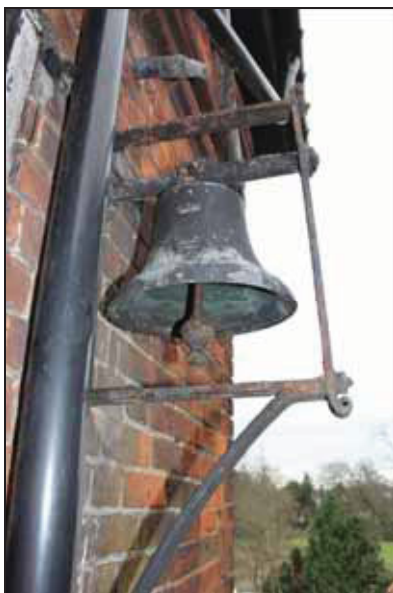
305

*Bell on the exterior of the campanile accessed from the small door within TF01, taken from the north-west*

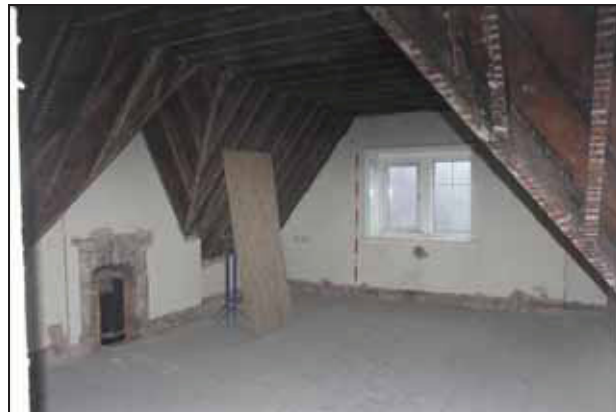
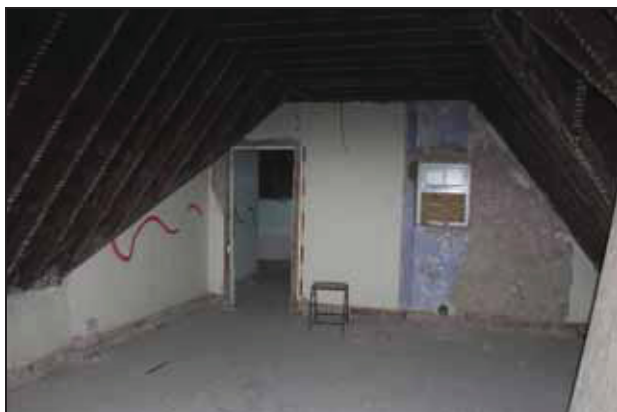
5.105 SF04 occupies the gable end return to the main frontage though with few features surviving (Plate 26). A gable window on the east has been replaced with a casement window. The fireplace has been removed. A small window has been inserted to the north of the door on the east.

*SF04, taken from the west*

*SF04, taken from the east*

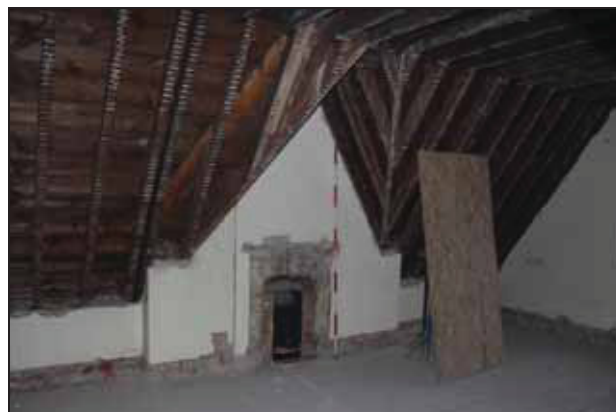
310

*Fireplace, SF04, taken from the south-west*

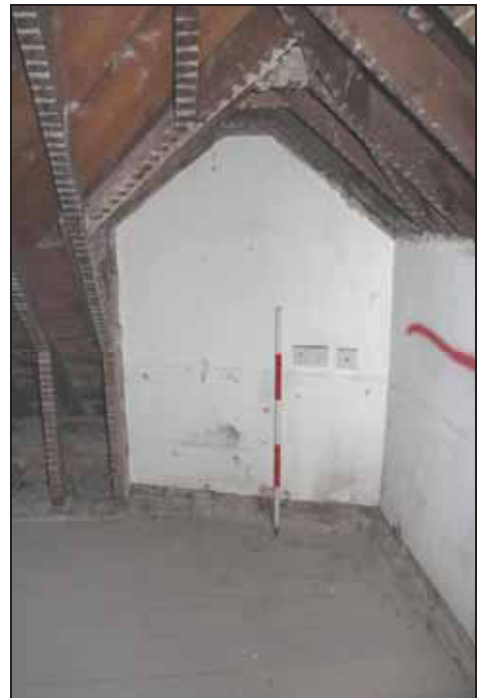
318

Blocked corner fireplace, SF07, taken from the south-west

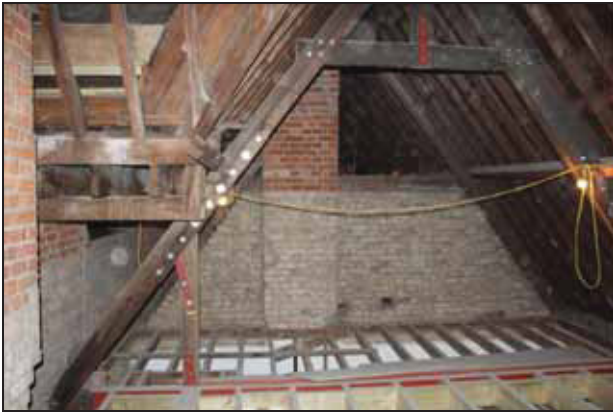
332

*Timber hanger with Baltic mark, roof space above north gable, SF09, taken from the north*

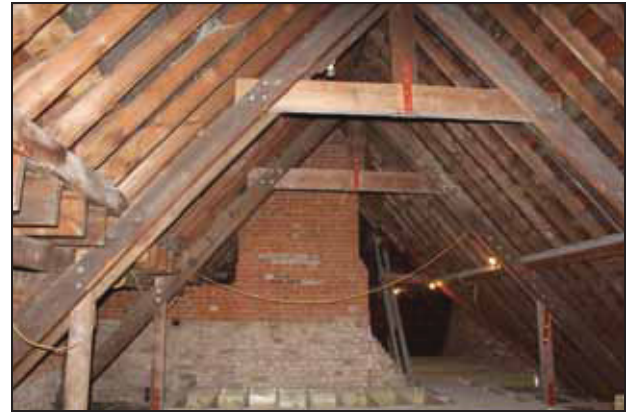
333

*Chimney stack within roof space above western extents of the main house, SF09, taken from the north-west*

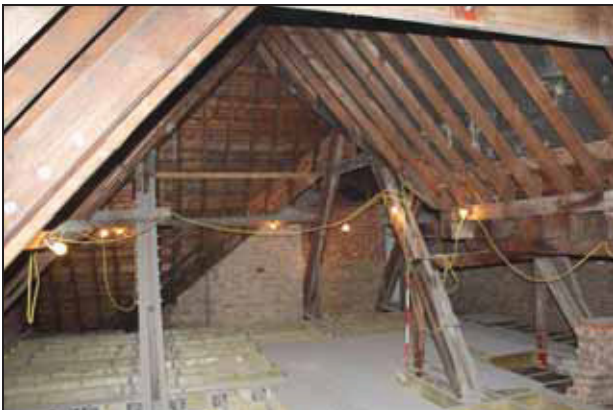
334

*Chimney stack within roof space above rear area of the main house, SF09, taken from the north-east*

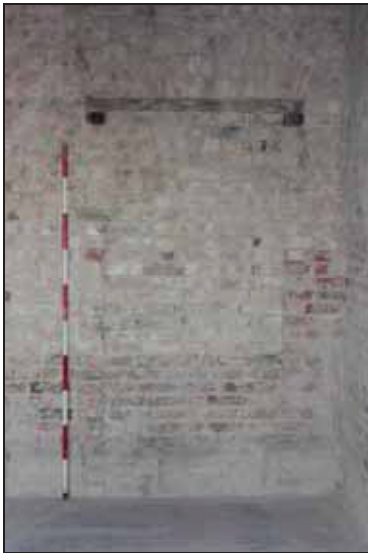
344

*Chimney stack stripped back with removal of surround and grate, FF06, taken from the south-west*

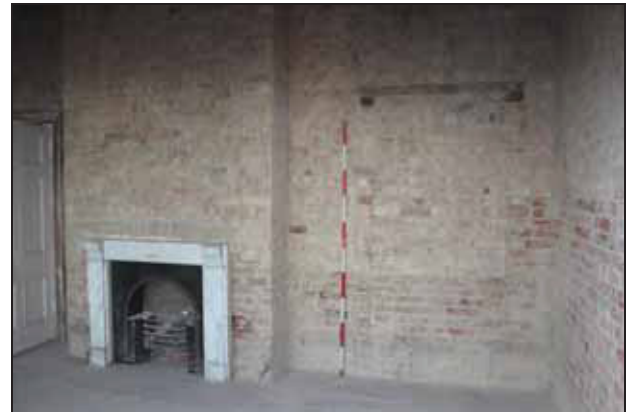
345

*Blocked doorway, FF04, taken from the north-west*

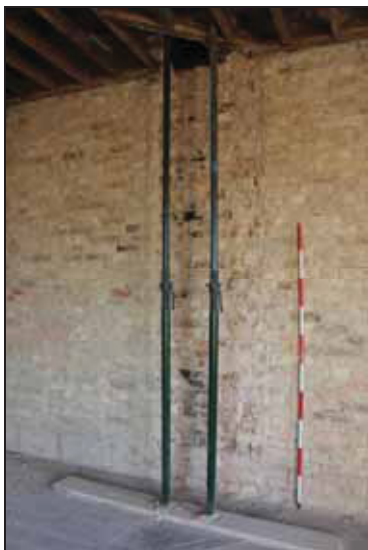
346

*Blocked doorway, FF04, taken from the west*

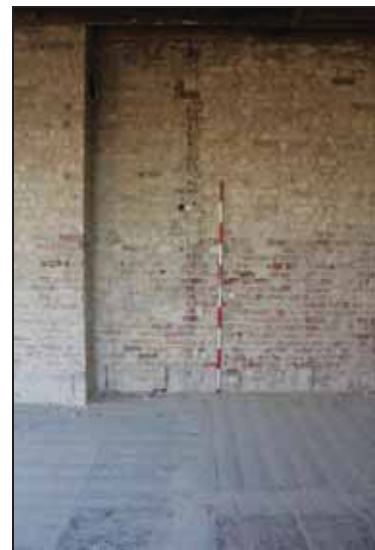
347

*Scarring within the brickwork for former corner chimney stack, FF03, taken from the north-west*

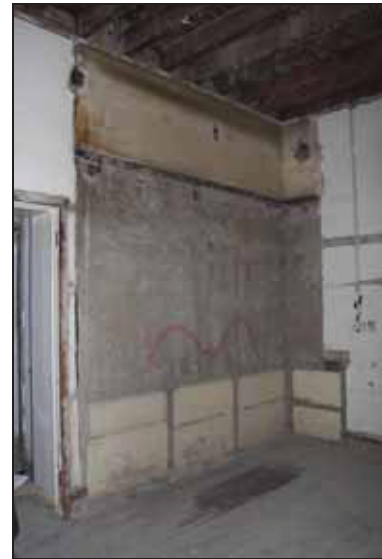
363

*Position of the original range and hood, GF12, taken from the north-east*
