**THE RED HOUSE
84, HIGH STREET, BUNTINGFORD
HERTFORDSHIRE**

HISTORIC BUILDING MONITORING AND RECORDING

Authors: Dr Lee Prosser PhD Lisa Smith BA Kathren Henry	
NGR: TL 36119 29765	Report No. 4377
District: East Herts	Site Code: n/a
Approved: Claire Halpin	Project No. 4586
MIFA	Date: 24 July 2013
Signed:

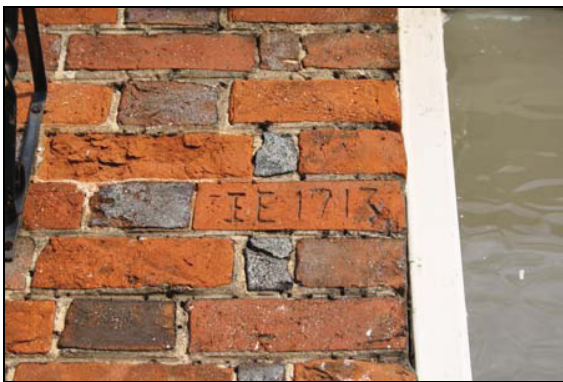
3

Dated brick with initials possibly 'I E 1713' to the left of the door, south elevation, taken from the south-east

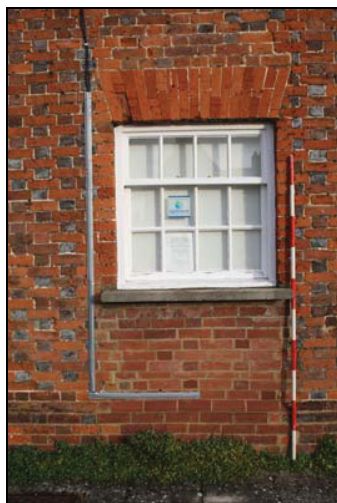
5

Window with disturbed brickwork below, south elevation, taken from the south-east

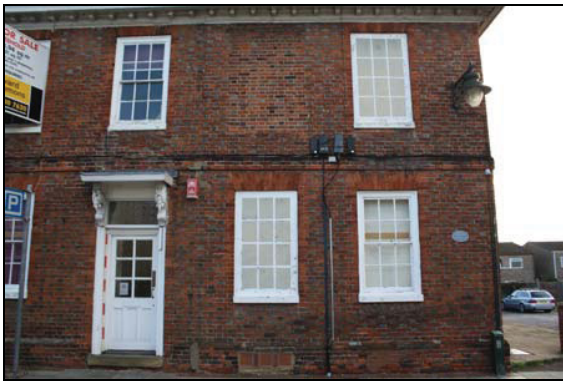
9

West elevation with blocked window at first floor, taken from the south-west

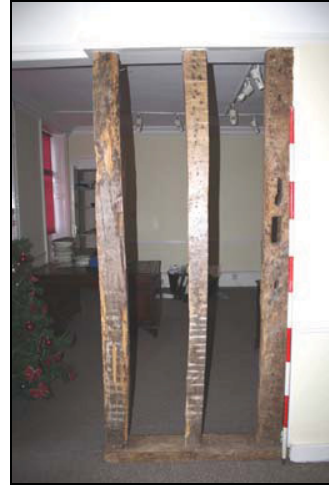
14

Studwork partition with re-used members, GF01, taken from the south-east

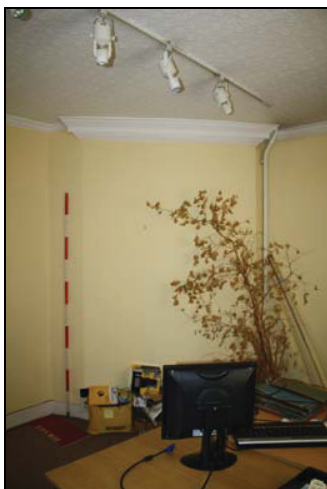
17

4.21 The room preserves its original box-cornice, with slight elaboration of the mouldings above the position of the original fireplace, which was set in a canted, internal corner stack (Plate 13). The listing of 1984 describes a good fireplace, but this is no longer present. The exposure of the chimney stack revealed sections of panelling and walls plastered on either side. The western sash window is a 19th century example, but set in splayed reveals with surviving 18th century shutters, until recently fixed open, but latterly eased to reveal the locking bar to the rear. The south window, noted above is modern and of no interest and has since been blocked.

Blocked canted corner fireplace, GF03, taken from the south-west

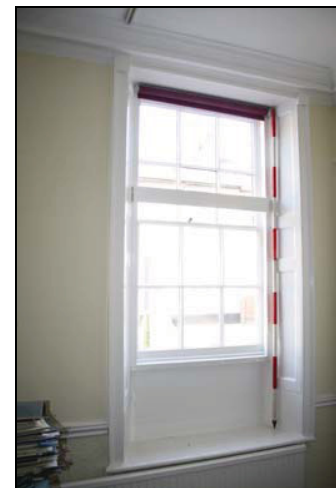
24

4.18 Two six-over-six sash windows on the west are not original though probably late 18th century replacements with a glazing-bar profile characteristic of the 1790s; the lower sash on the east is a modern replacement. They are set in splayed reveals with shutters which were painted

Sash window with splayed reveals, GF02, taken from the east

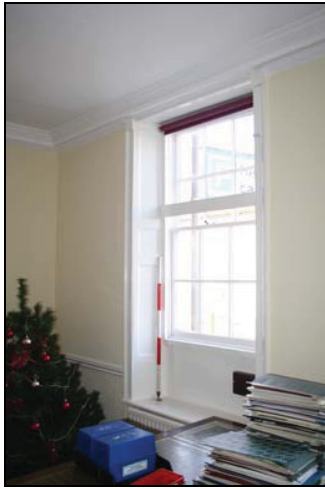
25

Sash window with splayed reveals, GF02, taken from the north

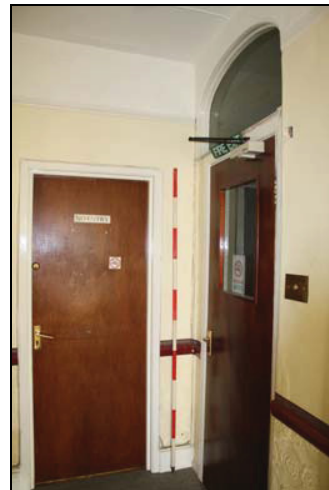
27

Corridor leading to side entrance, GF04, taken from the south-east

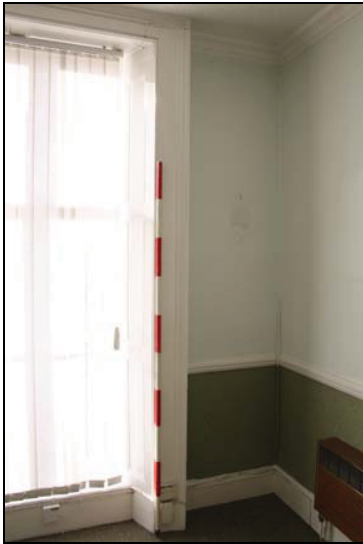
32

Large sash window, GF05, taken from the north

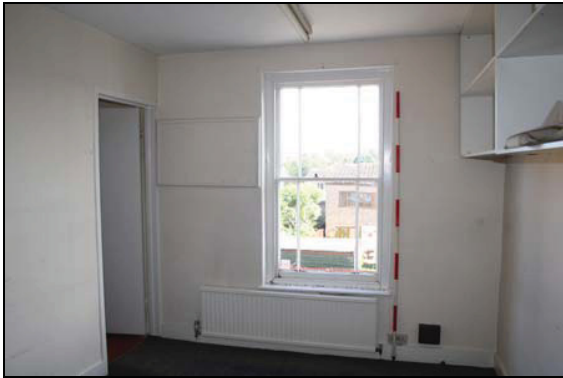
48

Original architrave, FF04, taken from the west

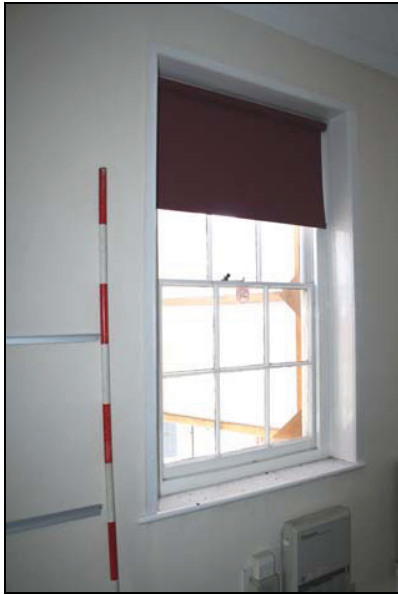
54

Sash windows on the main façade, FF02, taken from the north-east

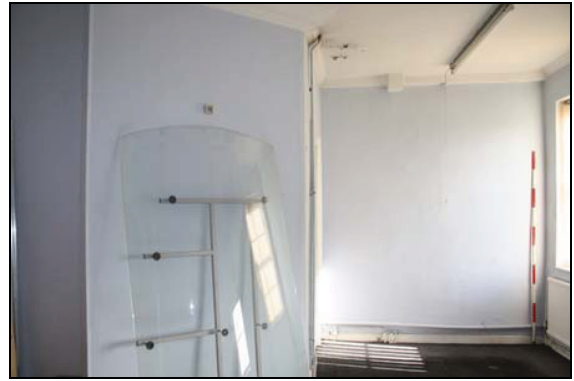
55

Sash window on the main façade, FF02, taken from the south-east

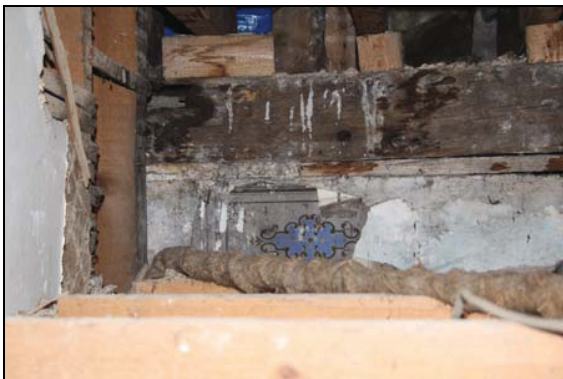
58

Timber-framing of the adjoining property seen in the roof space above FF08, taken from the south-east

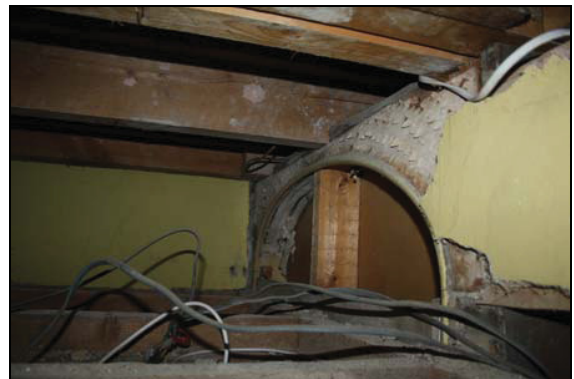
59

19th century wall paper and plasterwork seen in the roof space above FF08, taken from the south-east

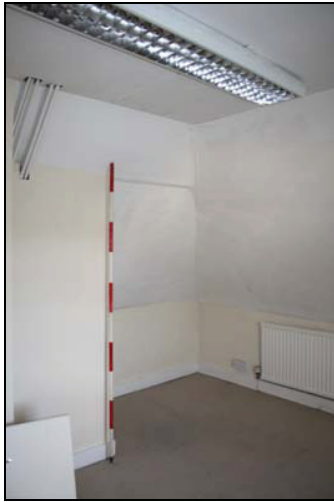
66

Boxed-in chimney stack, SF03, taken from the west

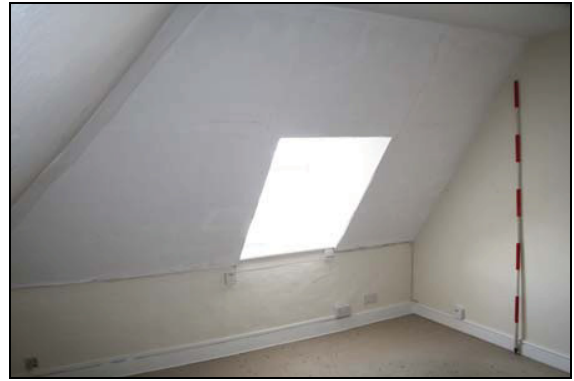
67

SF03, taken from the west

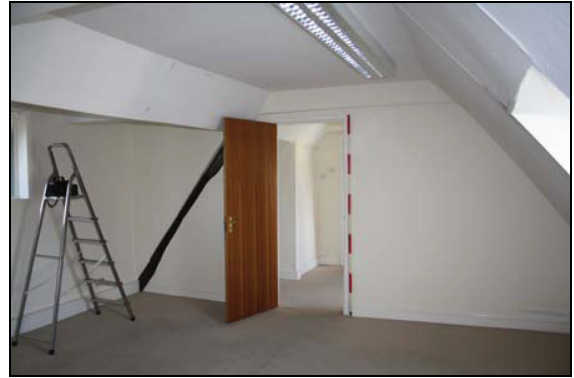
69

Exposed principal rafter, SF02, taken from the south-west

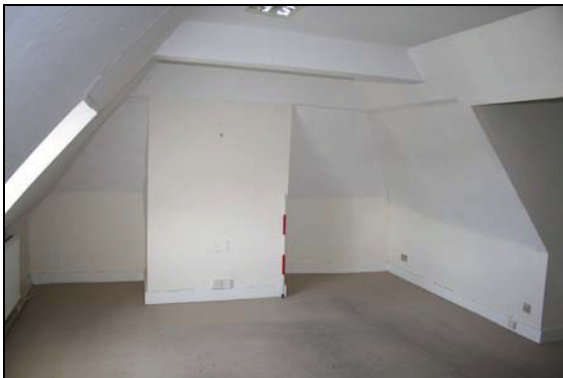
70

Exposed principal rafter, SF02, taken from the north-west

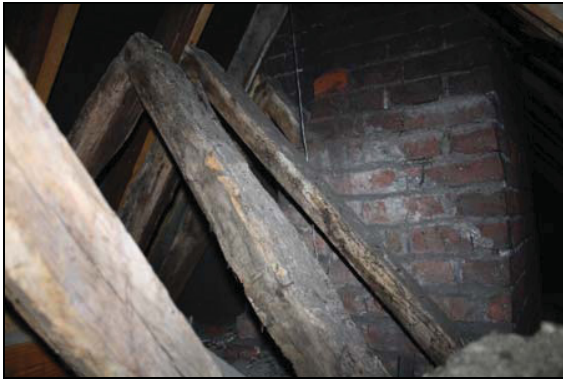
72

Rafter couples rising above collar level, taken from the north-west

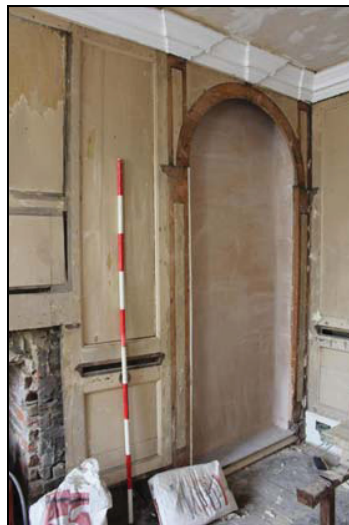
80

18th Century wall panelling surrounding fireplace, northern wall, GF02, taken from the south-west

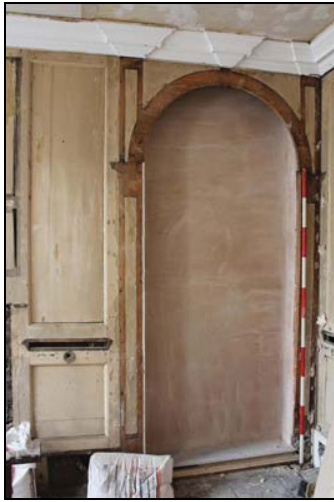
81

Arched panelled aperture, northern wall of GF02, taken from the south-west

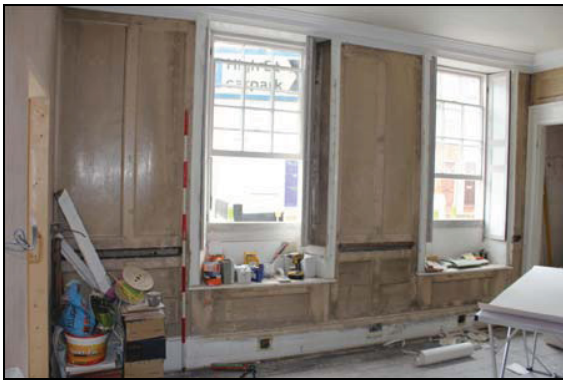
83

18th Century wall panelling, eastern wall, GF02, taken from the west

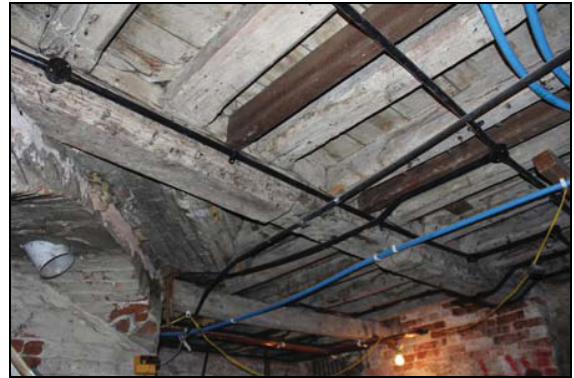
101

Basement with central chimney block, BF01, taken from the north

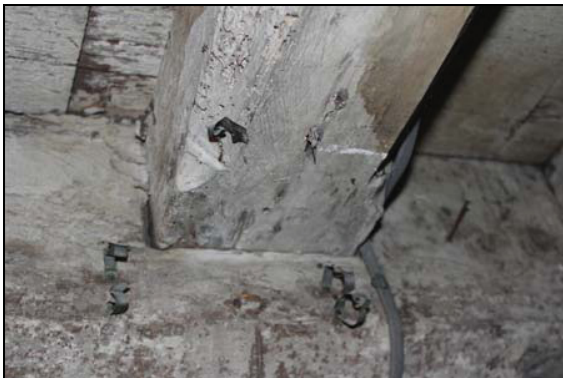
102

Central chimney block with supporting strainer arch, BF01, taken from the south

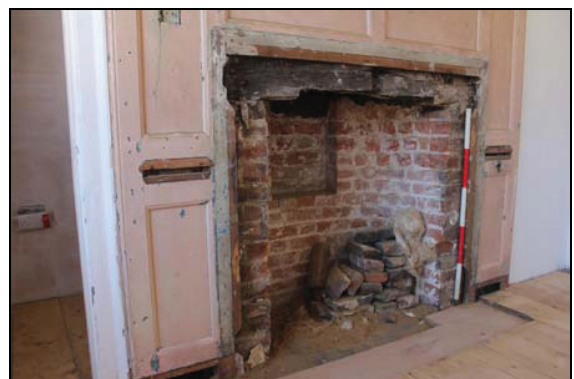
110

Exposed fireplace and surrounding panelling, FF02, taken from the south-east

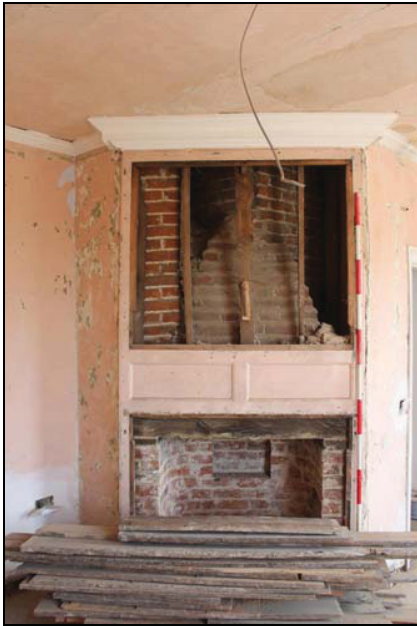
111

Exposed fireplace and surrounding panelling, FF02, taken from the south

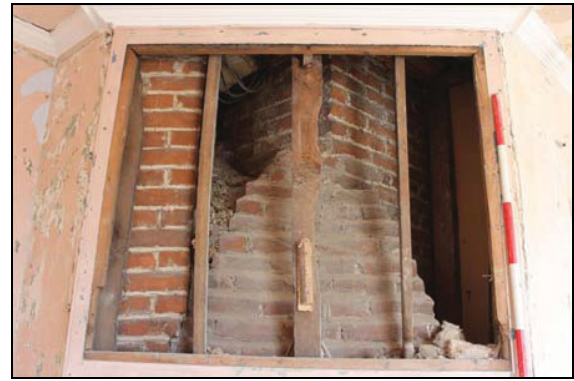
112

Panelling and exposed chimney construction, FF03, taken from the south-west

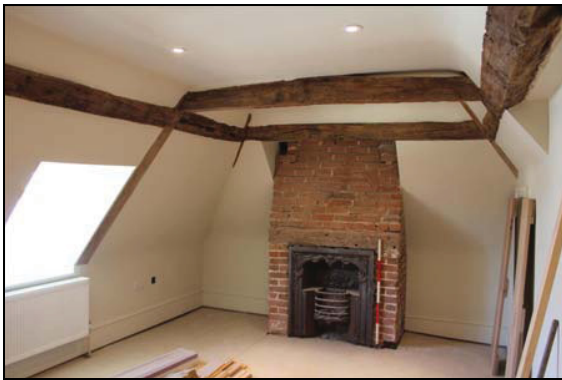
113

Exposed chimney construction, FF03, taken from the south-west

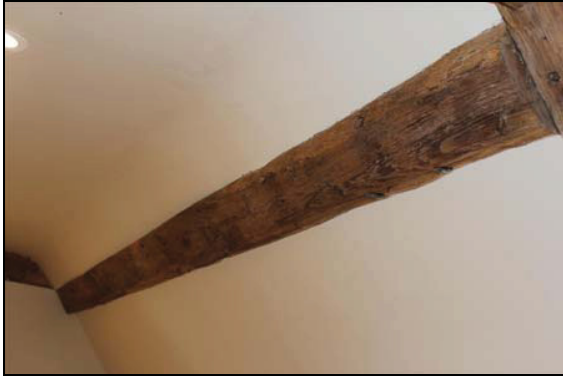
117

Purlin, re-used medieval member, SF04, taken from the north-east

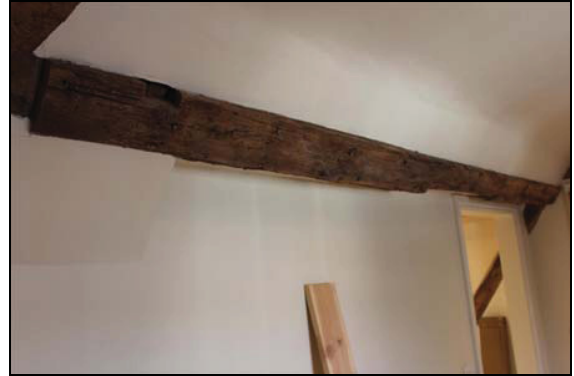
118

Western purlin with regular arrangement of pegs for common-rafters above and below, SF04, taken from the north

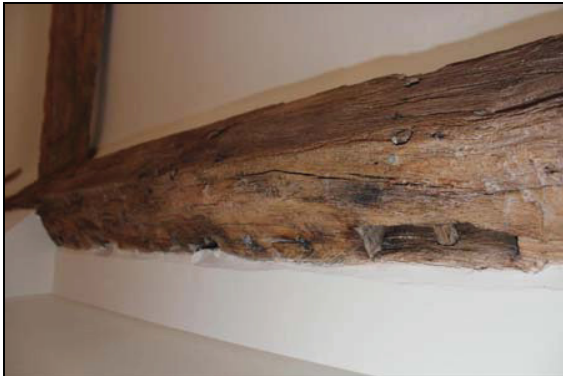
119

Eastern purlin with regular arrangement of pegs for common-rafters above and below, SF04, taken from the north-west

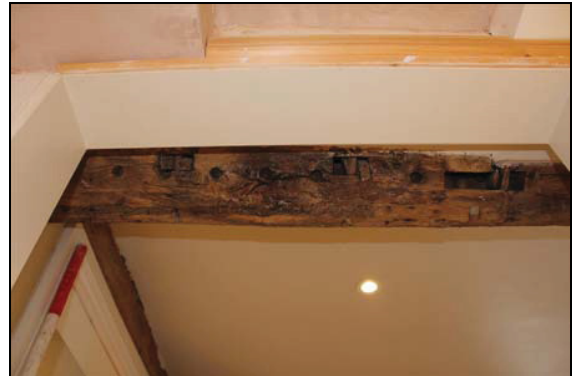
120

Redundant mortices to the eastern purlin, SF04, taken from the south

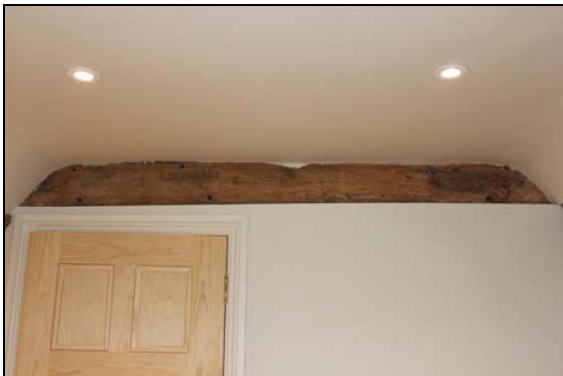
121

Redundant mortices to the eastern purlin, SF04, taken from the north-east

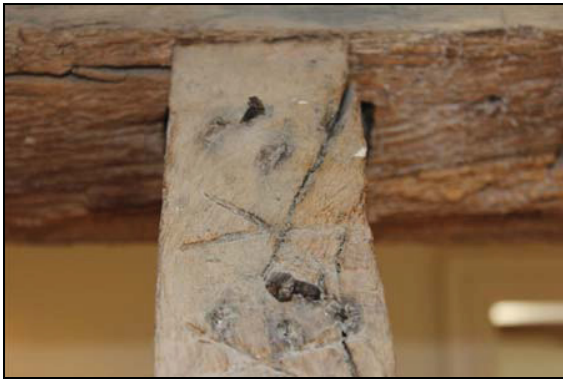
123

Assembly mark 'XXII' to purlin at junction with common-rafter now removed, SF02, taken from the north-east

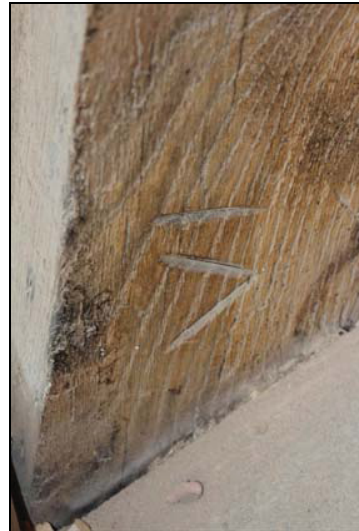
124

Assembly mark 'XX' to common-rafter, SF02, taken from the south-east

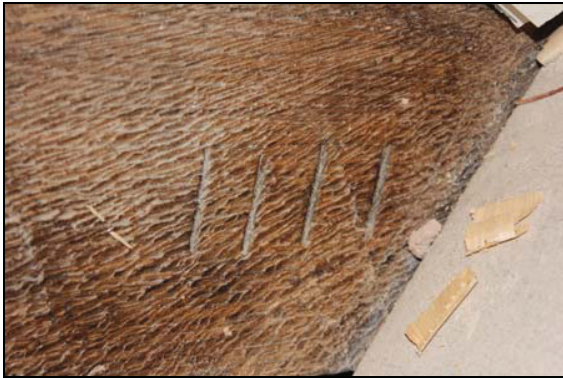
125

Assembly mark 'VI' to common-rafter, SF02, taken from the north-west

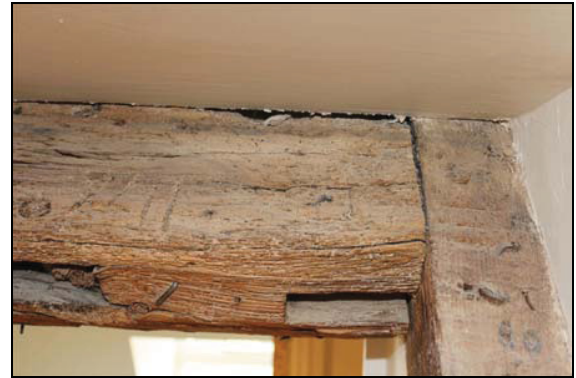
126

Assembly mark 'IIII' to common-rafter, SF02, taken from the south-west

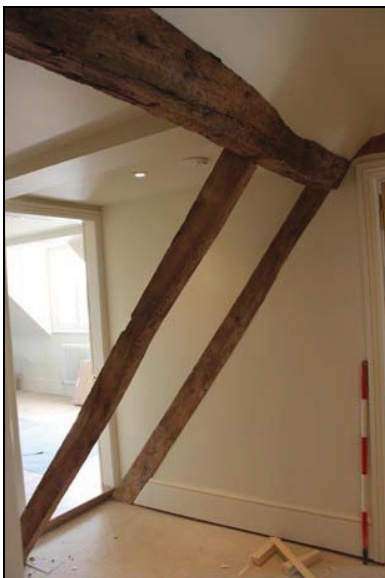
127

Assembly marks to the purlin and common-rafter, SF02, taken from the east

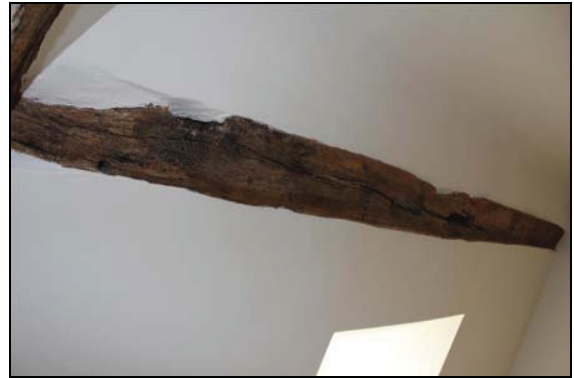
132

Eastern purlin with peg holes for rafters above and below, SF03, taken from the south

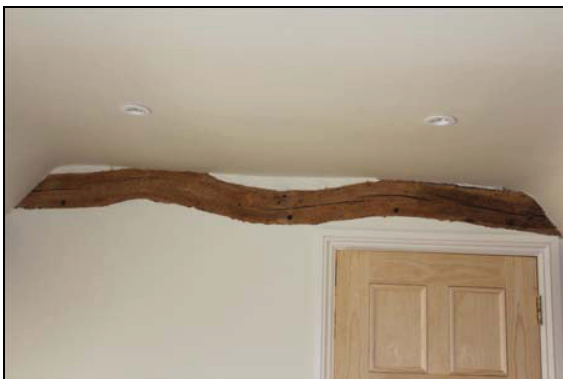
133

Western purlin with peg holes for rafters above and below, SF03, taken from the south-east
