DANE FARMHOUSE, BOWER HEATH LANE,  
HARPENDEN, HERTFORDSHIRE

HISTORIC BUILDING MONITORING AND RECORDING

Author:	Lee Prosser PhD Lisa Smith BA Tansy Collins MSt Kathren Henry	
NGR: TL 14846 17321	Report No: 4973	
District: St Albans	Site Code: AS1791	
Approved: Claire Halpin	Project No: 4240	
Signed:	Date: 26 <sup>th</sup> October 2015

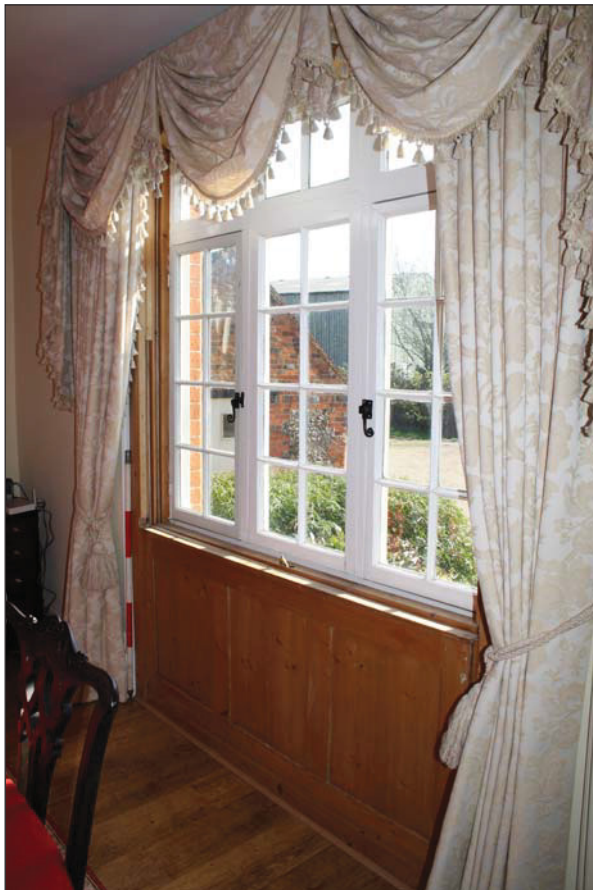
4.14 Much of the window appears to be original, with slender glazing bars typical of the mid-19<sup>th</sup> century style, though the left-hand casement has been renewed and all the window-furniture is modern. Below, two, three-panel vertical sliding shutters survive in good working order behind an apron in the same style (Plate 4). All the elements have been stripped back to the pine but were almost certainly originally painted.

Plate 4 Three-light casement window with shutters, GF02, taken from the north-west (DP 27)

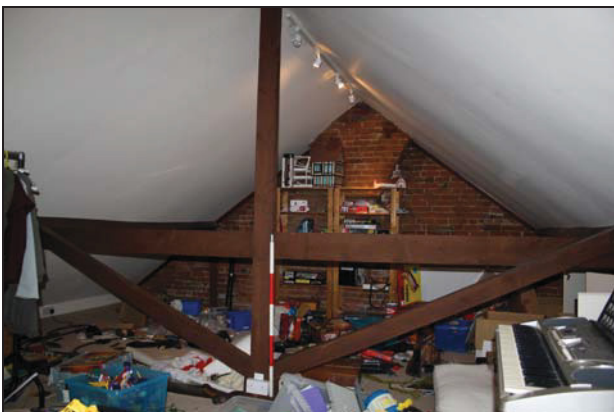
40

*Internal chimney at eastern gable end, attic, taken from the west*

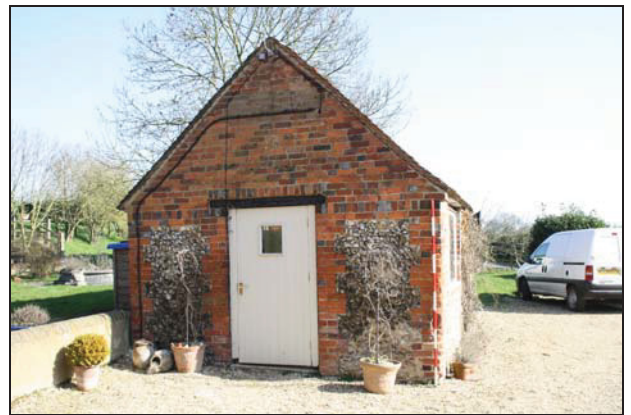
45

*Outbuilding, south and west elevation, taken from the south-west*

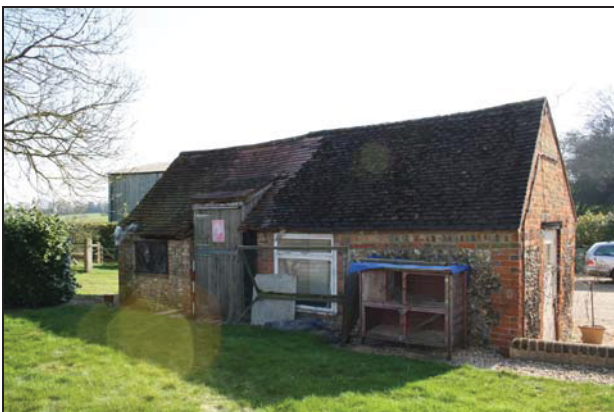
46

*Outbuilding, west elevation, taken from the west*

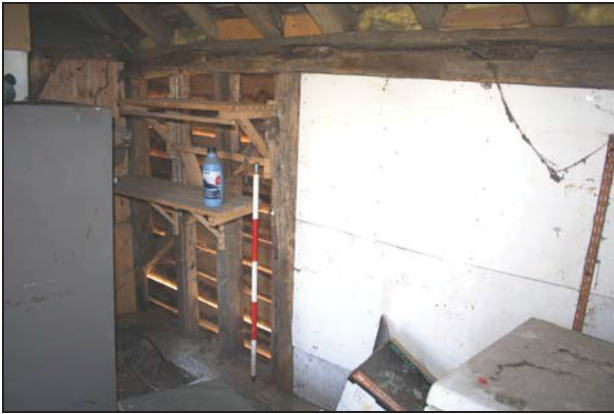
48

*Outbuilding, original external wall of brick and flint element and end truss of timber framed section, taken from the east*

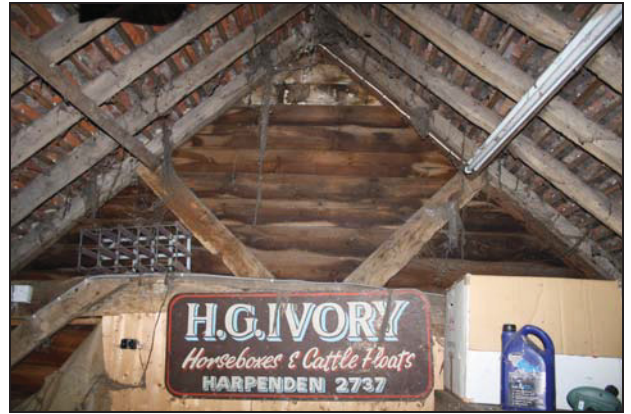
49

*Outbuilding, south elevation, timber framing, taken from the north-west*

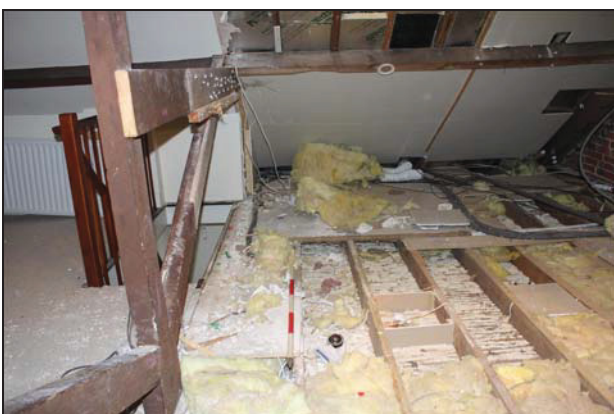
52

5.4 Monitoring conducted during the loft conversion saw the exposure of the floor joists within the roof space, as well as a number of rafters. Little additional information regarding the history of the building was exposed, and the fabric was found to be entirely consistent with the other elements of the roof visible during the initial survey. Slender softwood rafters were exposed that rise over the purlins of the king-post roof structure and are all being retained as part of the conversion. The floor structure is similarly of slender thin-section softwood joists, some of which appear replaced. No assembly markings, graffiti, or trade marks were found on any timbers.

*Detail of the floor joists in the roof space following the removal of modern boarding, taken from the south-west*

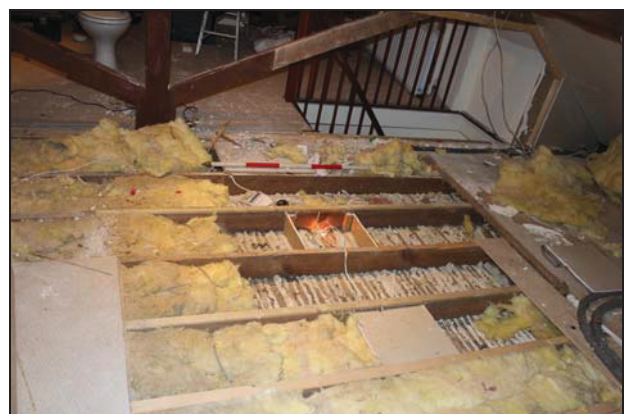
53

*View of the floor joists in the roof space following removal of the modern enclosed closet, taken from the south*

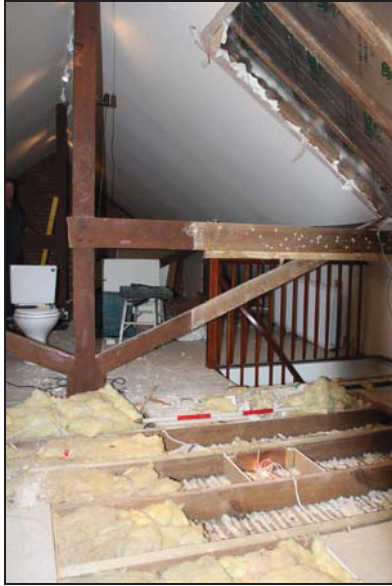
54

*View of the floor joists in the roof space following removal of the modern enclosed closet, taken from the north*

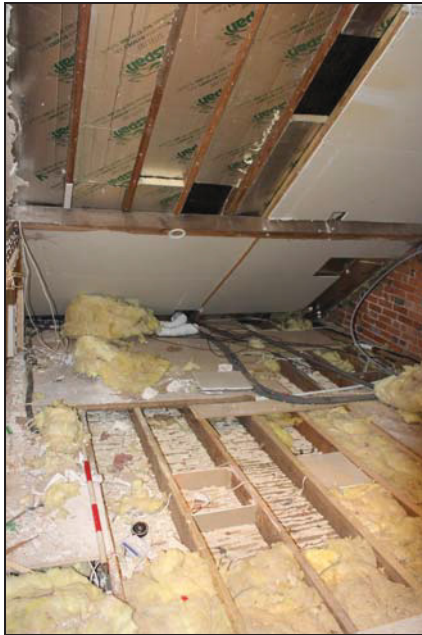
56

*View of floor joists in the north-east corner of the roof space following removal of the modern enclosed closet, taken from the south*

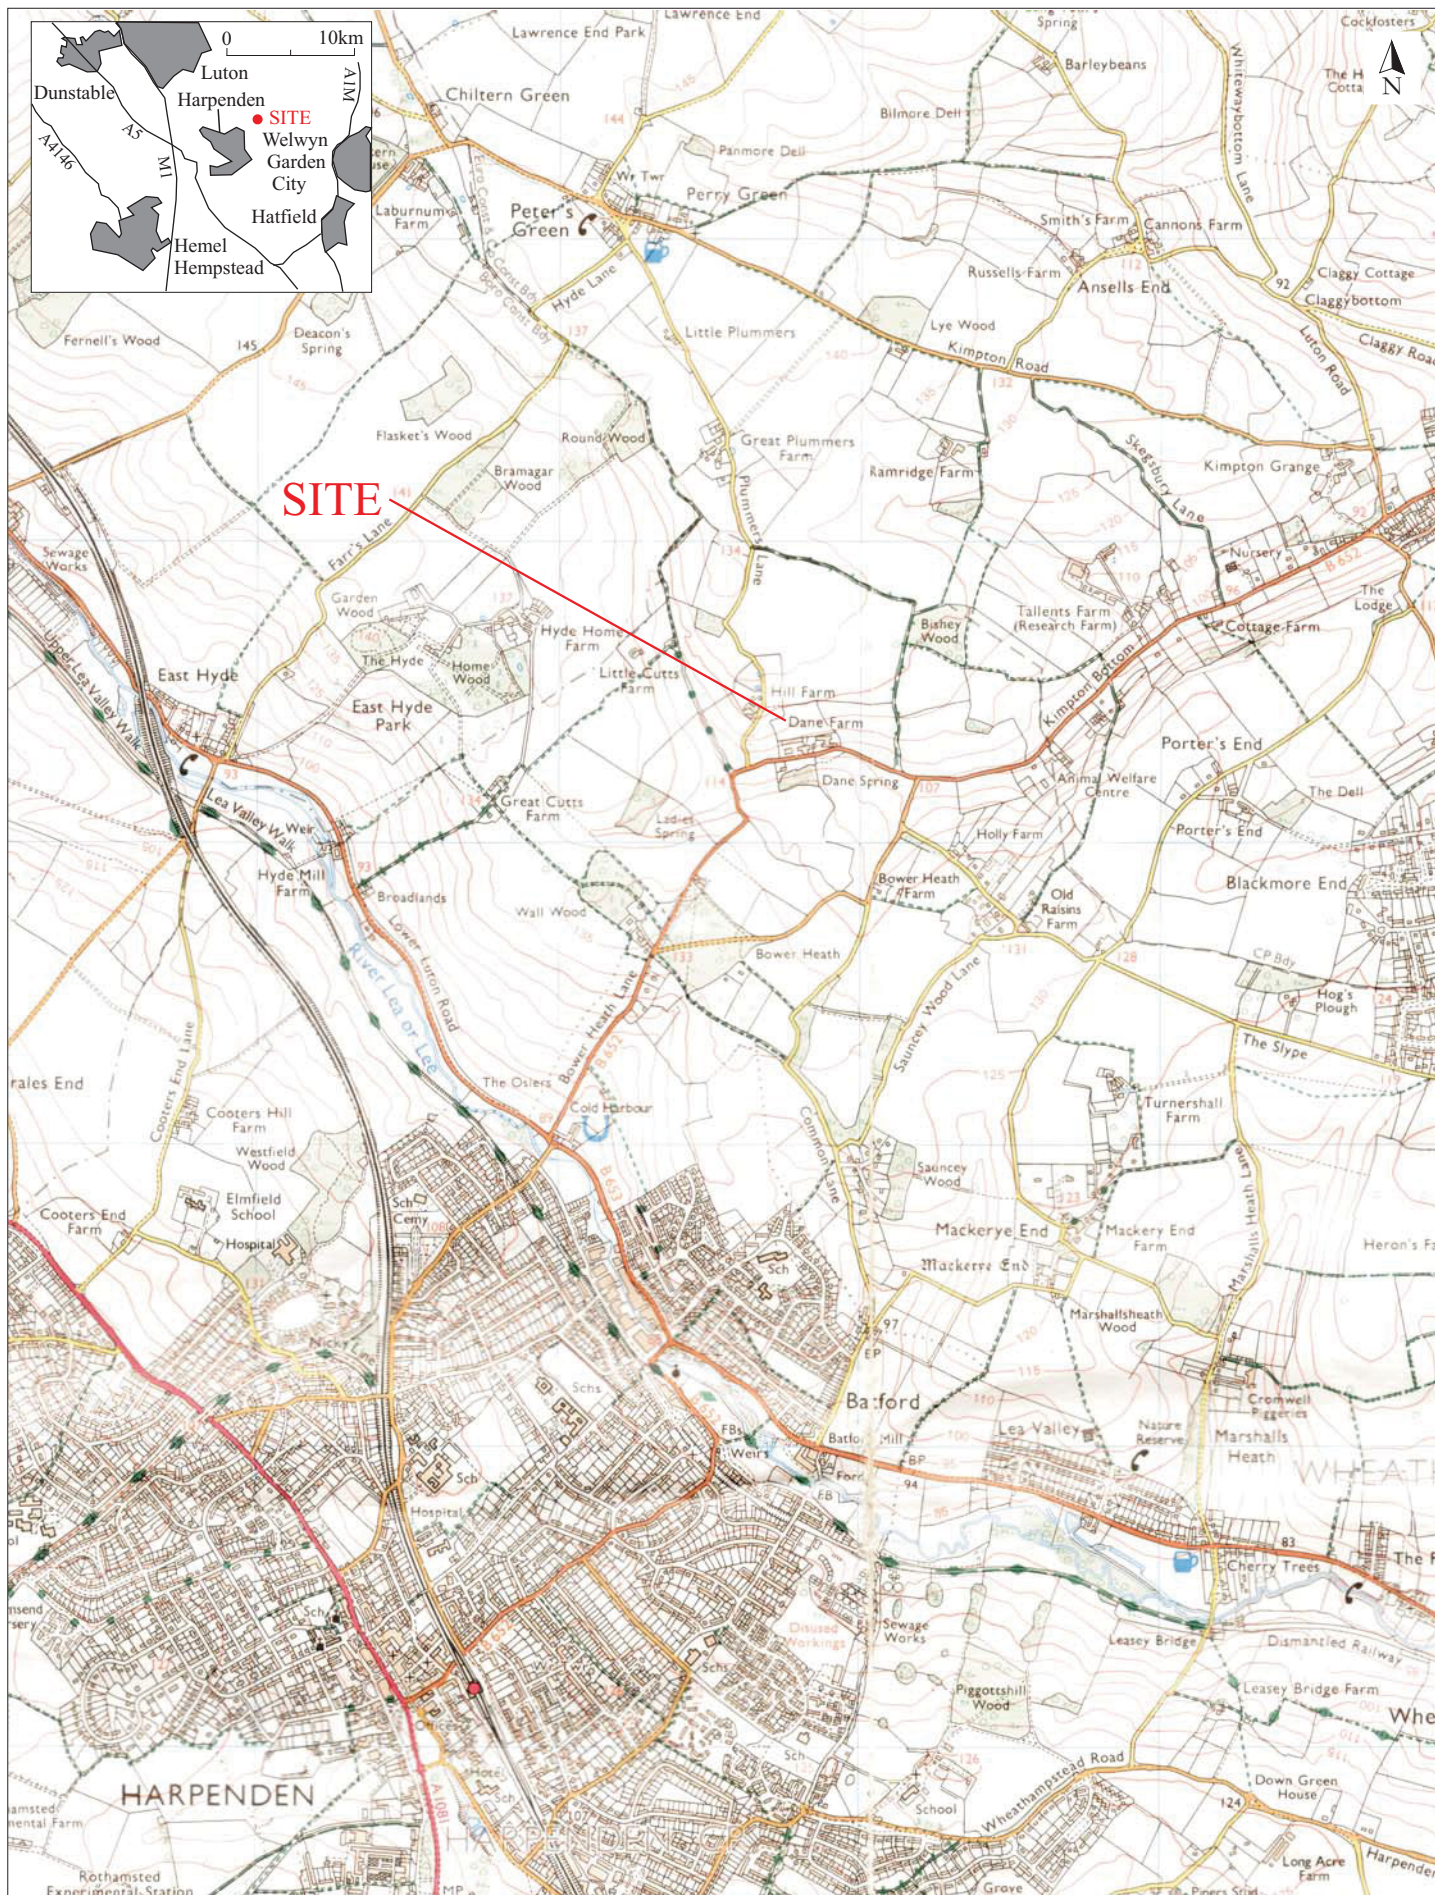
57

*View of the floor joists, common rafters and purlin in the roof space following removal of the modern enclosed closet, taken from the south*
