HISTORIC BUILDING RECORDING AND BUILDING
MONITORING & RECORDING

Authors: Tansy Collins MSt Lauren Wilson MA PCIfA	
NGR: TL 3359 2202	Report No: 5084
District: East Hertfordshire	Site Code: AS1817
Approved: Claire Halpin MfA	Project No: 6561
Signed:	Date: 8 th April 2016

ORCHARD COTTAGE, GREEN END, DANE END, WARE, HERTFORDSHIRE, SG12 0NS

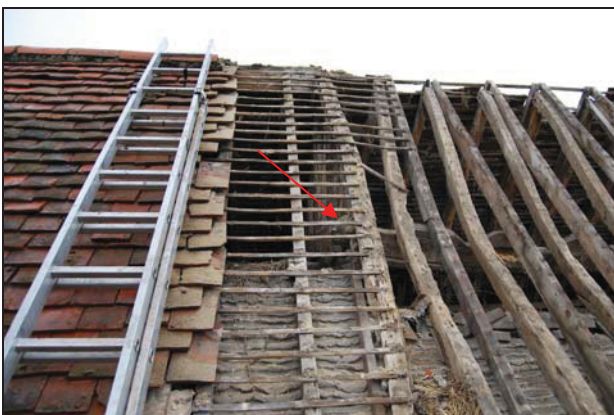
DP 5

View of the roof structure following removal of the tiles. Note the weathered purlin end of the historic core (indicated).

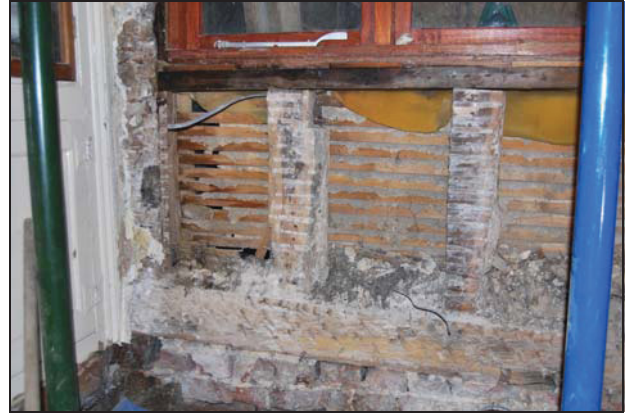
DP 12

South-west side of Room GF01 showing sole-plate and truncated studs below the modern window

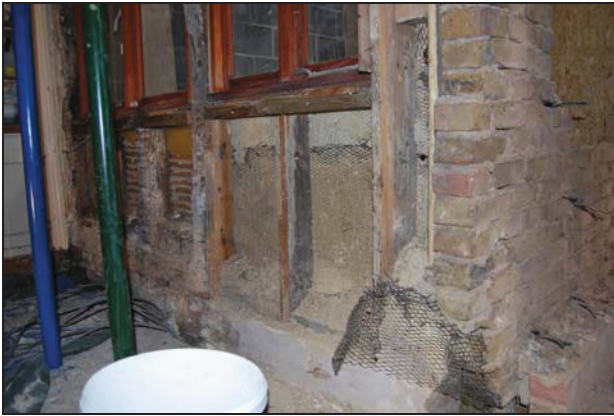
DP 13

South-west side of Room GF01 showing sole-plate and truncated studs with modern fabric elsewhere.

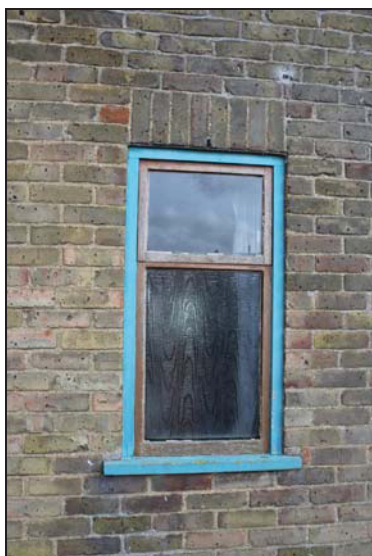
DP 11

Detail of the replacement casement on the north-west side of Unit 3, taken from the north-west

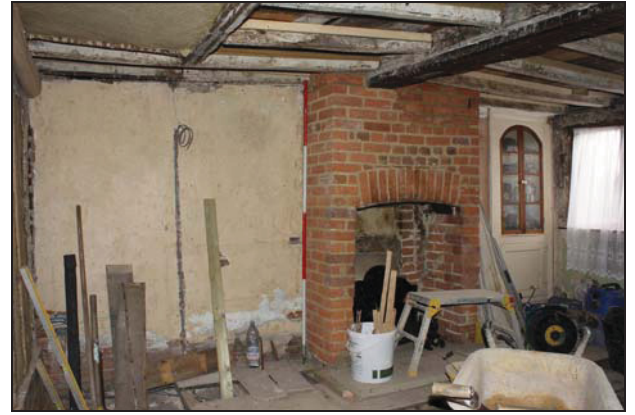
DP 20
Room GF01 in the historic core of the cottage (main range), taken from the north

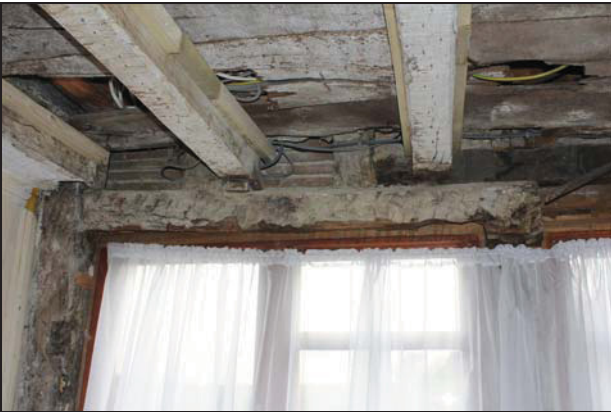
DP 29
South-west side of Room GF01 (main range) showing truncated mid-rail, taken from the north-east

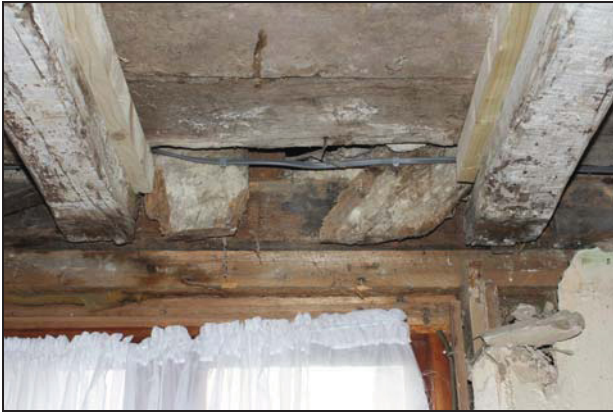
DP 31

South-west side of Room GF01 (main range) showing joists with upper stud and brace positioned to meet the mid-rail that is now truncated, taken from the north-east
