KITCHENER'S MEADS, 59 FISHPOOL STREET
ST ALBANS, HERTFORDSHIRE

HISTORIC BUILDING MONITORING AND
RECORDING

Author:	Tansy Collins BSc Lee Prosser PhD Kathren Henry	
NGR: TL 14141 07165	Report No: 5011	
District: St Albans	Site Code: FPS15	
Approved: Claire Halpin	Project No: 6100	
Signed:	Date: 11 th December 2015

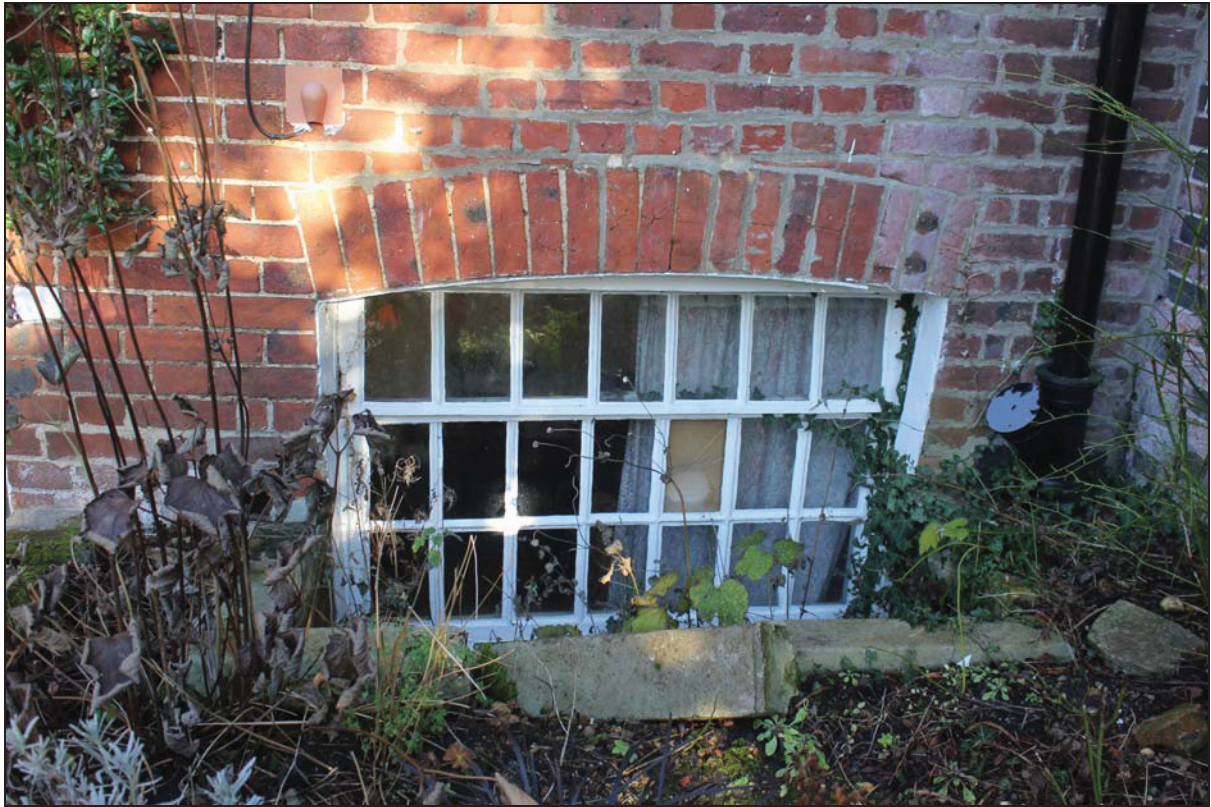
Plate 3 East window at basement level on the south elevation, taken from the south (DP 8)

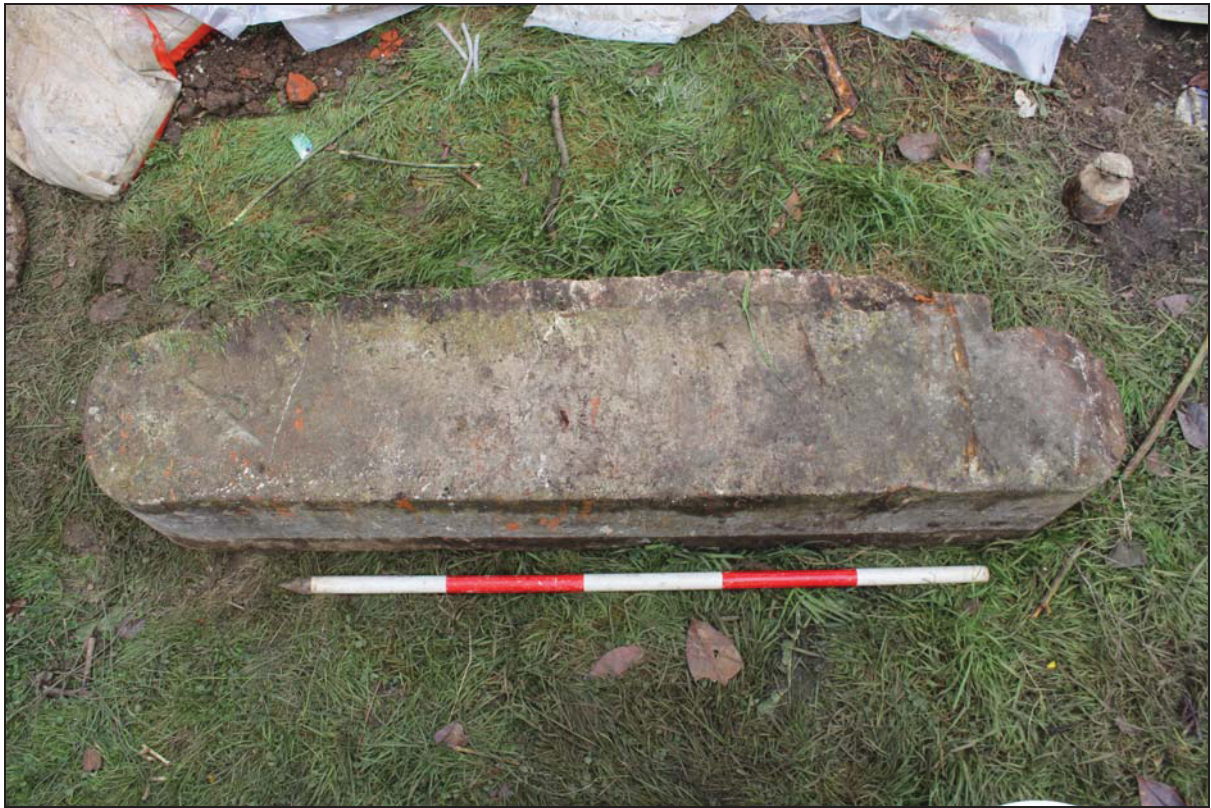
Plate 5 Shaped lower step retrieved from the external steps (DP 115)

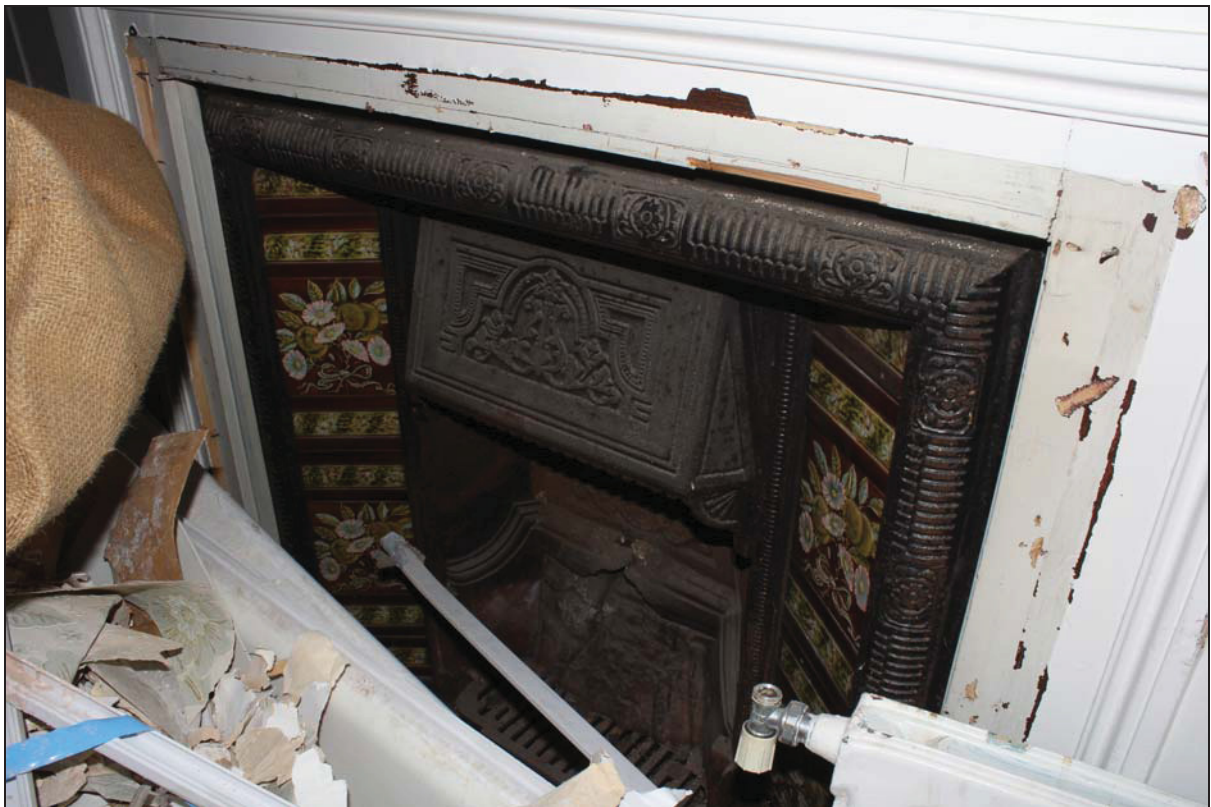
Plate 10 Decorative fireplace in Room GF02, taken from the north-west (DP 106)

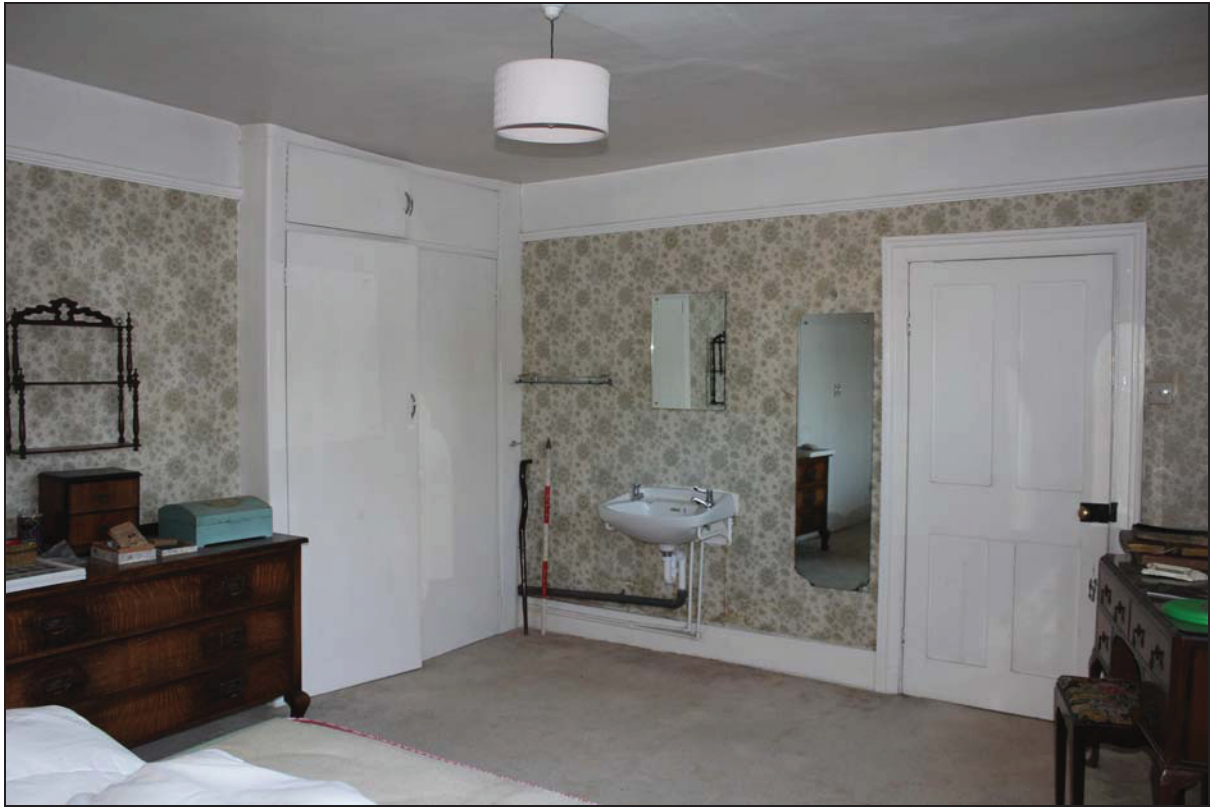
4.25 The principal bedroom to the east (FF02) replicates the layout of the reception room below. It has a high plain skirting board of no interest and a moulded picture rail. The ceiling is irregular, reflecting the presence of early lath and plaster. The door from the landing is a late 18th / early 19th century four-panel door, while the tripartite sash window on the north survives within a moulded box surround, though the lower central sash appears to have been replaced. A fireplace on the north is blocked and to either side are 1960s full-height fitted cupboards (Plate 15), the cupboards removed during the planned works. The floorboards were exposed and some good examples survive being an average of 8¾" (222mm) wide though there has been some replacement in modern fabric. The floorboards have been lifted in the area of the bridging joist and reveals

Plate 15 West side of Room FF02, taken from the east (DP 24)

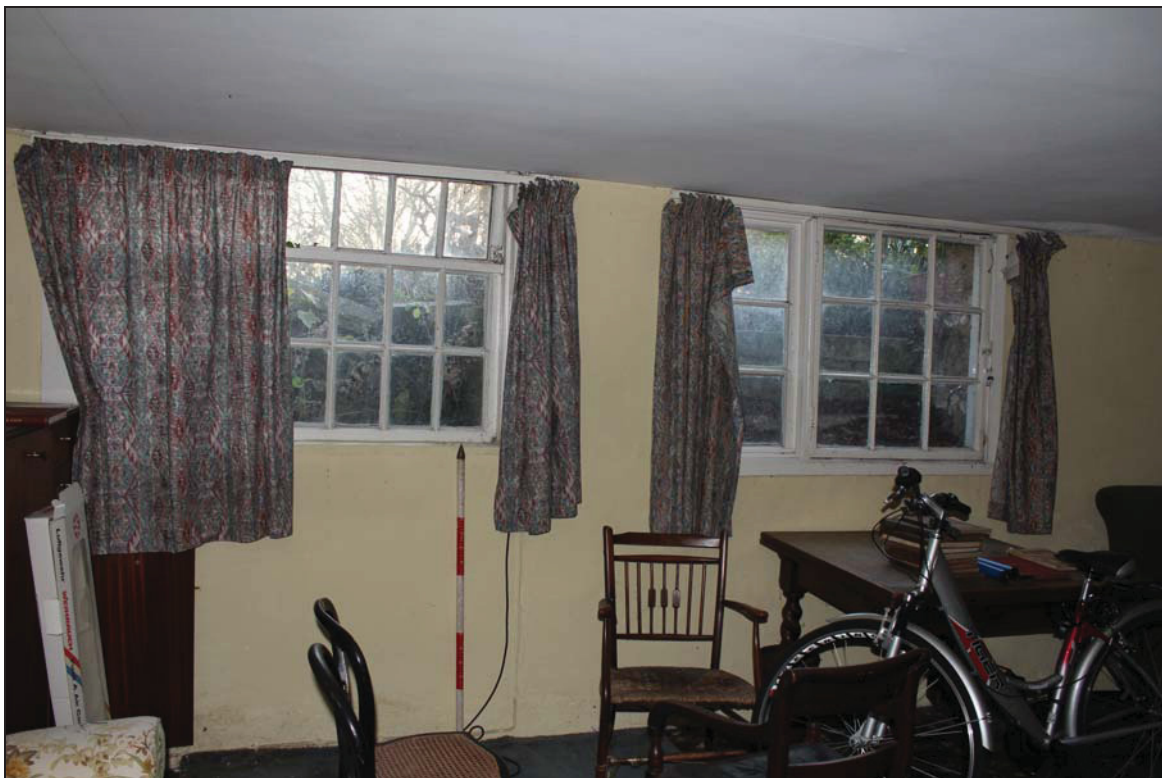
4.31 To the east, Room BF01 is entered through a 20th century boarded door. The room has plain plastered walls and a low modern plastered ceiling. The chimney breast projects on the north side with a formerly functioning fireplace, perhaps suggesting a domestic function such as a housekeeper's room. The windows to the garden are as described above, that to the east original to the range, while that to the west is late 19th or early 20th century in date (Plate 20).

Plate 20 South side of Room BF01, taken from the north (DP 59)

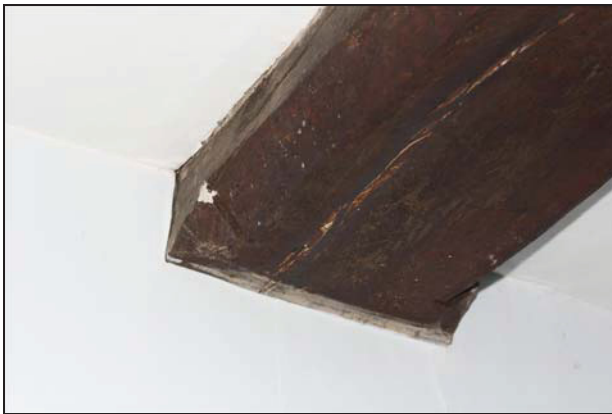
DP 38

Room GF02 showing exposed medieval bridging joist, taken from the south-east

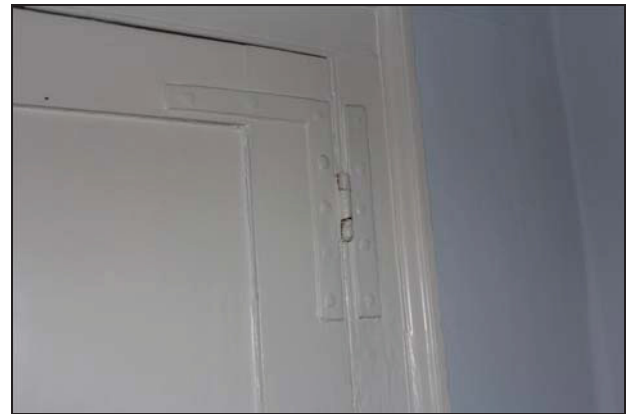
DP 39

Chamfer stops at the end of the bridging joist in Room GF02, taken from the north-west

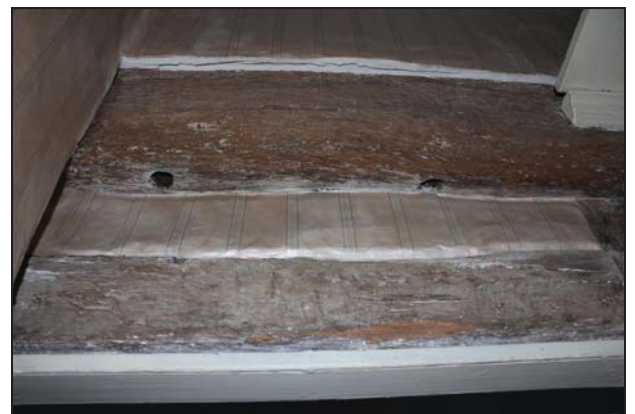
DP 41

Timber-framing of the rear wall of the historic core seen within the cupboard in Room GF02, taken from the south-west

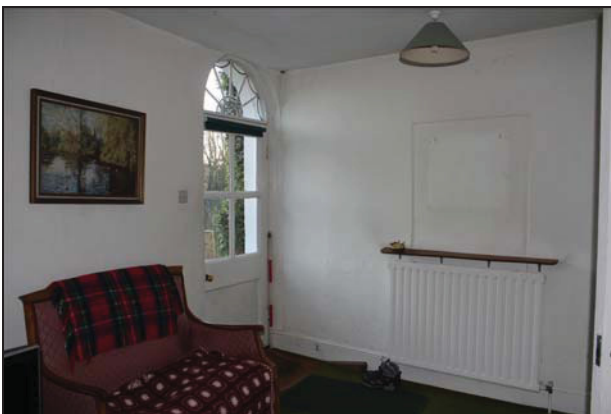
DP 46

South side of Room GF03 showing former kitchen fireplace, taken from the north-west

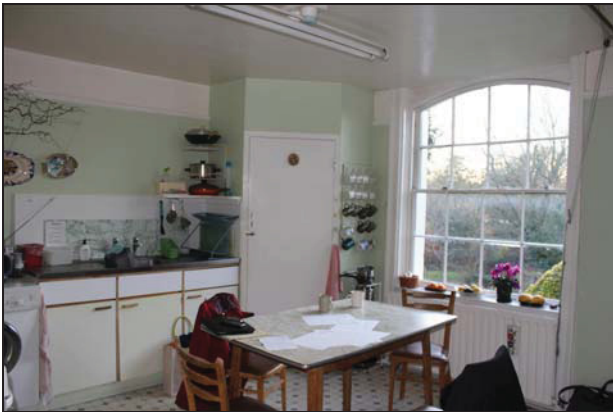
DP 50
North side of Room GF04 with modern door and
partition on the left, taken from the south-east

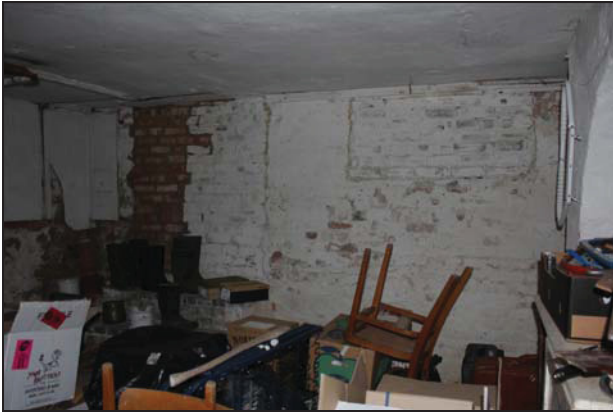
DP 67

West wall of Room BF02, taken from the east

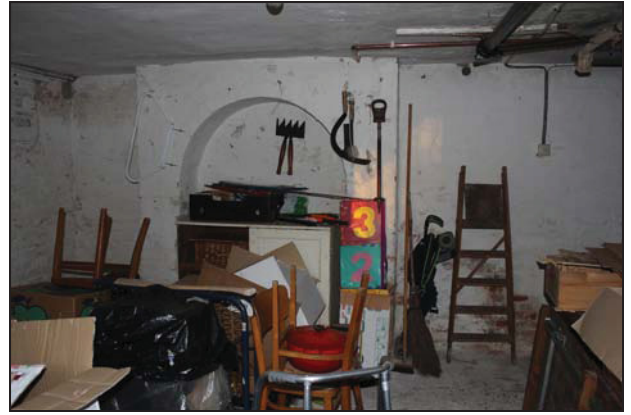
DP 68

North side of Room BF02 showing the strainer arch for the chimney stack above, taken from the south

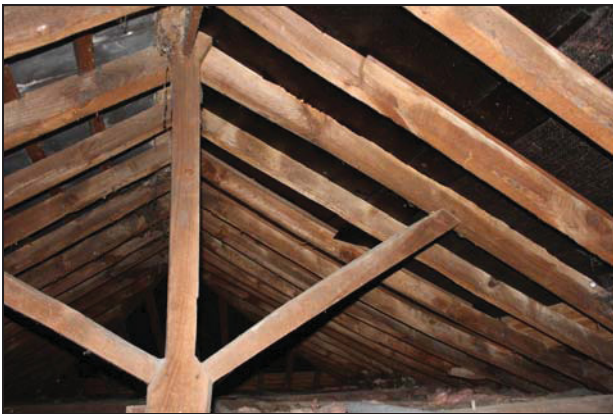
DP 69

4.38 The roof over the rear range was viewed through a hatch in Room FF05 and was found to be entirely consistent with a late 18th / early 19th century date. It utilises a king-post construction of fairly slender softwood members, all pegged, with the king-post shouldered at the base and with splayed head. There are no purlins to provide longitudinal reinforcement and instead raking struts are pegged to the principal rafters, which in turn are pegged to the head of the king-post. Common rafters rise to a ridgeboard, which is housed in the head of the king-post.

King-post roof structure over the rear, south range, taken from the east

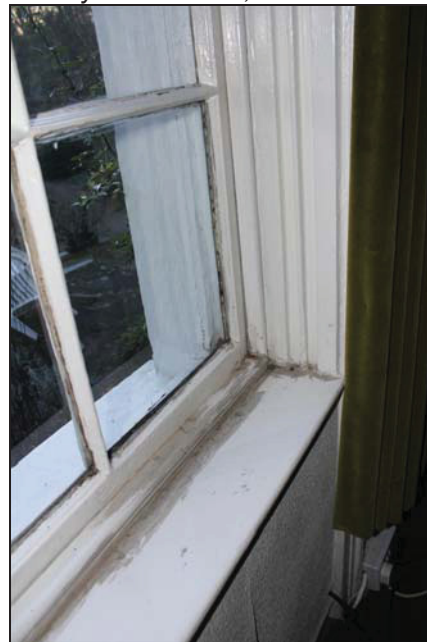
DP 70

Detail of the window on the south side of Room GF04 showing recesses to hold vertically sliding shutters that may survive within the window apron, taken from the east

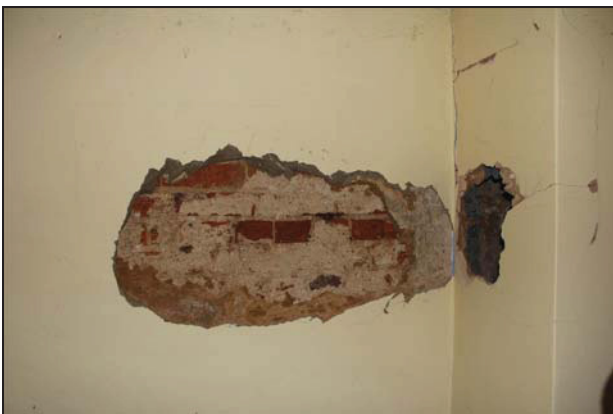
DP 71

4.32 In the south-west corner, a small area of plasterwork was removed to determine the nature of the underlying fabric and establish whether there was an original opening into the garden from this space. Three layers of plaster/render were encountered, the most recent being hard cement render. Below this, a sand and cement layer overlies the earliest fabric which comprises a lime plaster with a fairly high number of chalk inclusions (Plate 21). The underlying brickwork is all of the same date indicating there was no doorway in this position. To the west a pier was also investigated and found to be of modern blockwork construction enclosing a waste pipe of no interest.

South side of Room BF01 following the removal of layers of plasterwork exposing the brickwork below, taken from the north

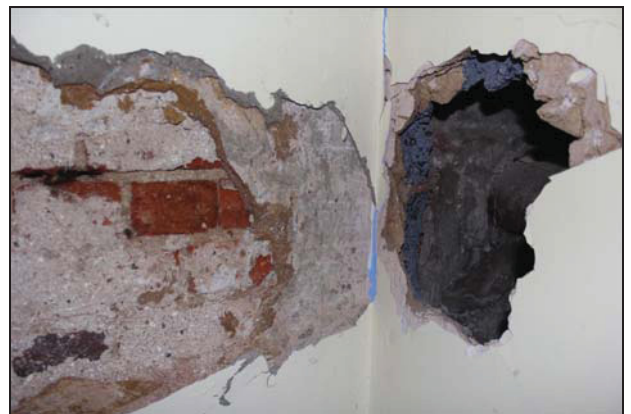
DP 72

Detail showing the south-west corner of Room BF01 showing brickwork on the left and block work of the attached pier to the right, taken from the north

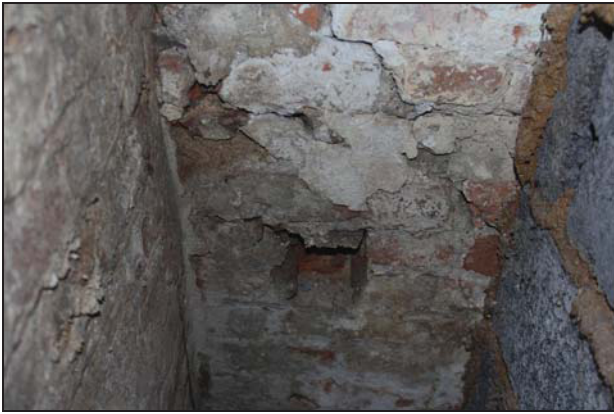
DP 73

View within the block work pier in the south-west corner of BF01 showing brickwork of the outer wall and internal wall, taken from the east

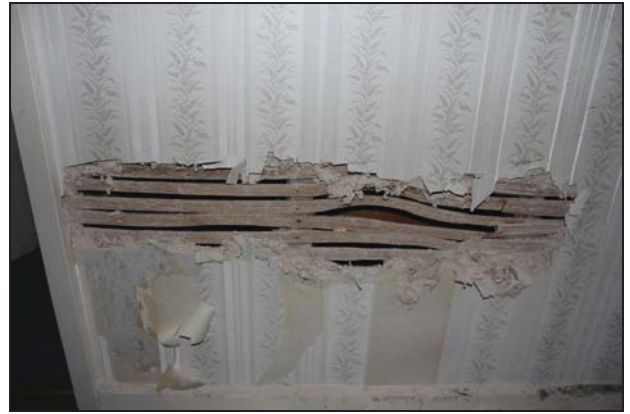
DP 74

Small intervention made on the west side of Room FF01 exposing slender studwork partition with lath and plaster over, taken from the east

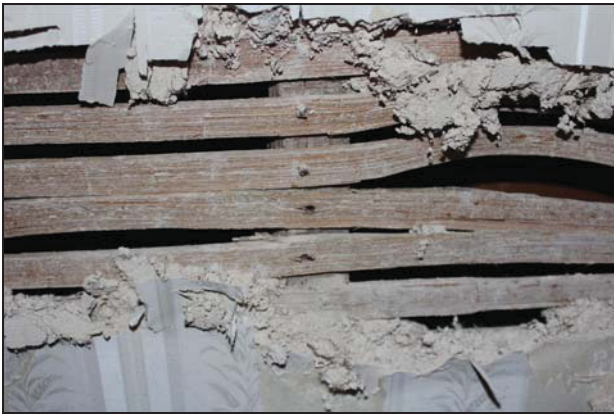
DP 75

Detail showing the nailed laths in the small intervention on the west side of Room FF01, taken from the east

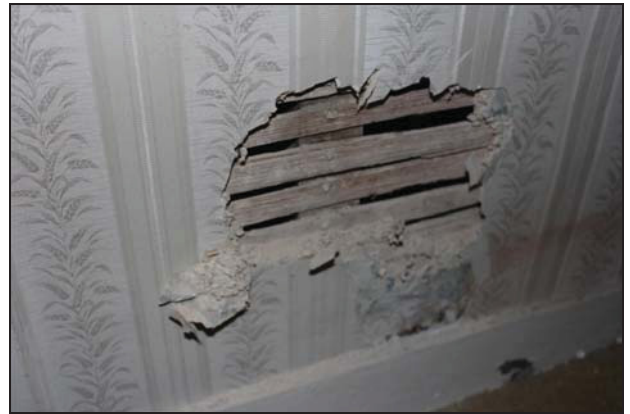
DP 76

Small intervention made on the south side of Room FF01 exposing slender studwork partition with lath and plaster over, taken from the north

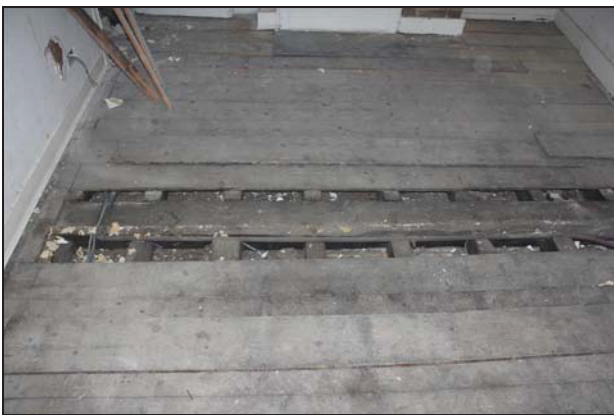
DP 77

View of floor joisting in Room FF03 after temporary lifting of the floorboards, taken from the north

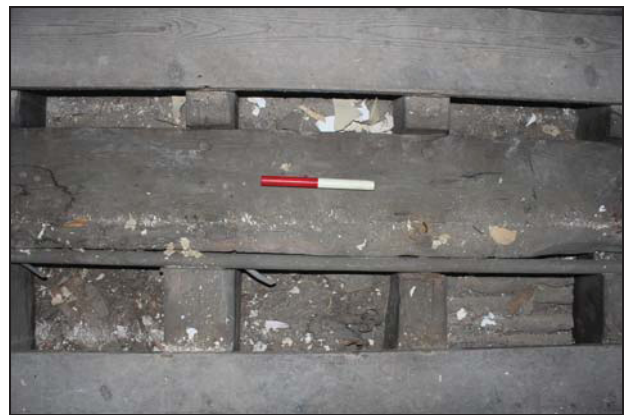
DP 78

Detail of the pegged floor joisting in Room FF03, taken from the north

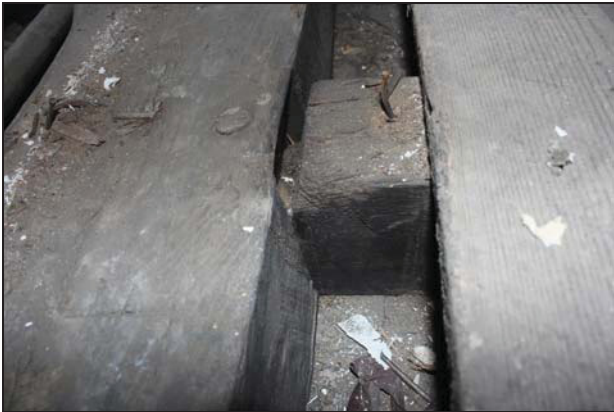
DP 79

Detail of the pegged common joisting showing joint with a diminished haunch in Room FF03, taken from the west

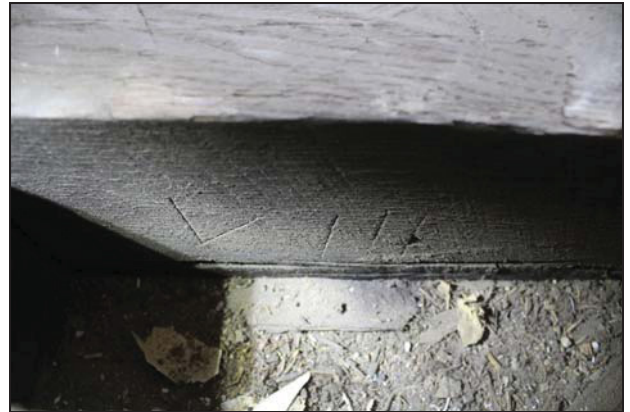
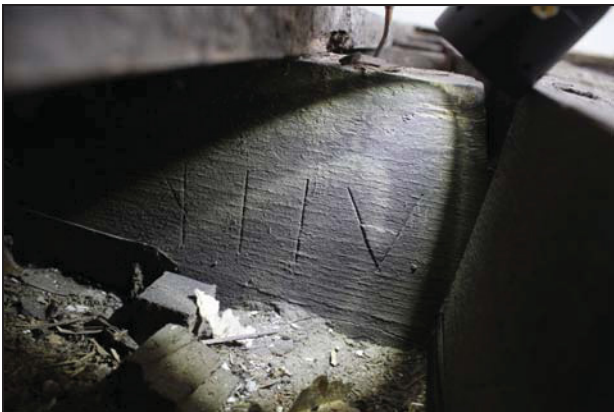
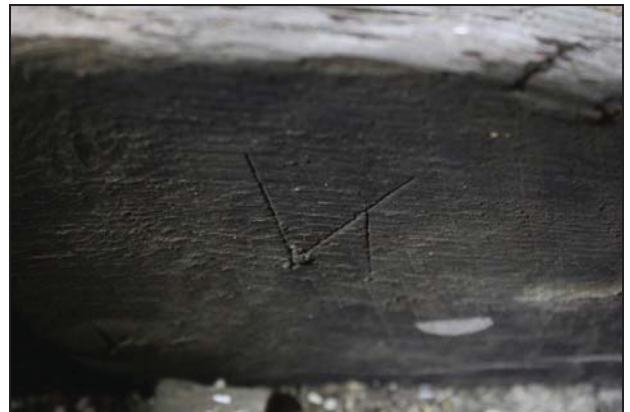
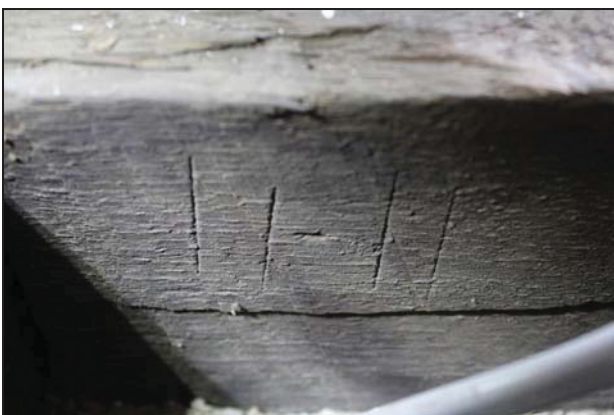
Detail showing scratched assembly mark on a common joist in Room FF03

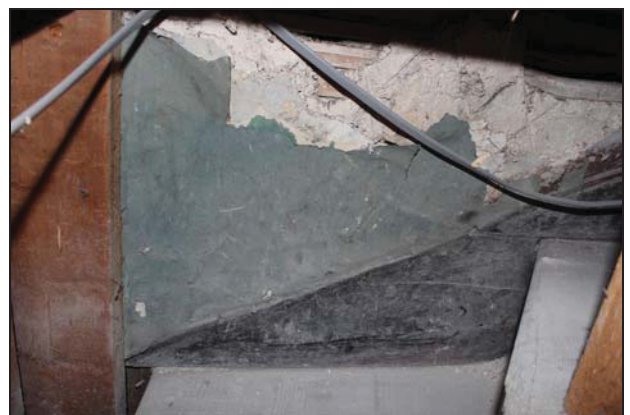
DP 84

View of staircase string of the entombed staircase below the landing FF01, taken from the west

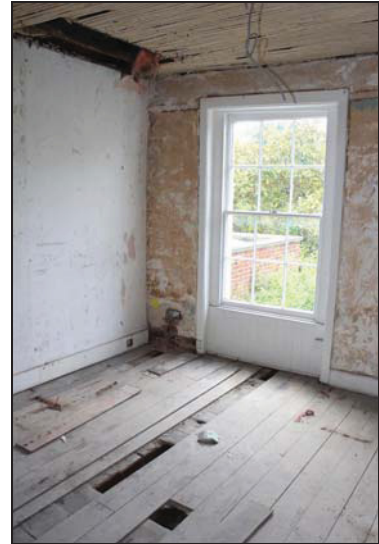
*DP 88
View of Room FF04 during the planned works,
taken from the north*

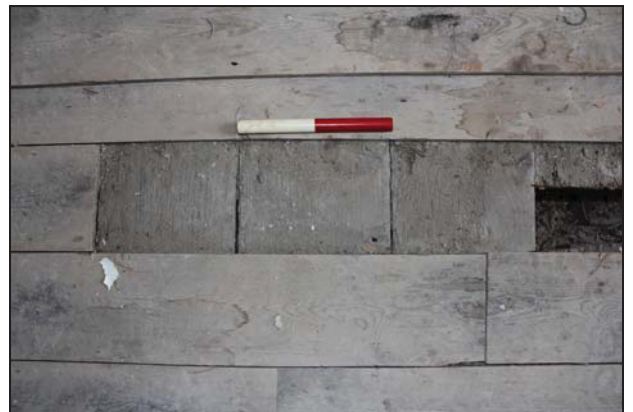
*DP 90
Detail of the original floorboards below modern
boarding in Room FF04, taken from the west*

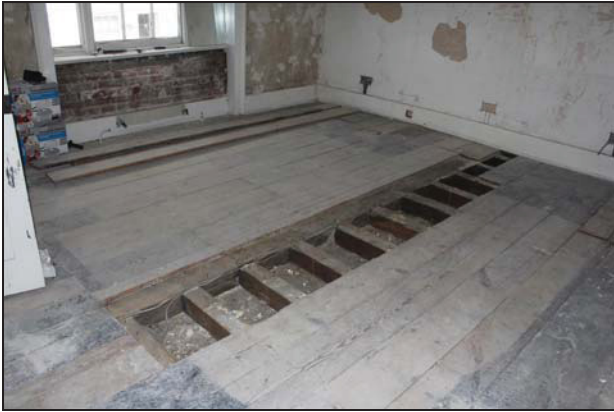
DP 91

View of Room FF02 during the planned works showing early floor joisting below the floorboards, taken from the south-west

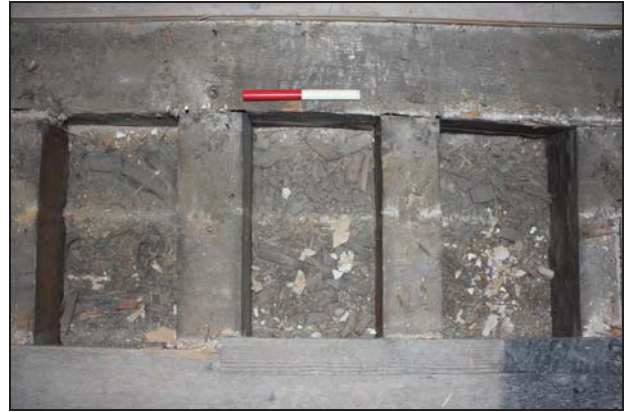
DP 92

Detail of the pegged floor joisting in Room FF02, taken from the south

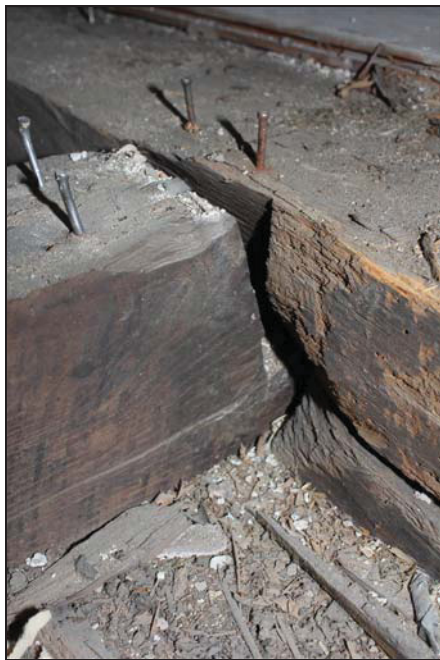
DP 93

squared hewn bridging joist with robust common joists extending north-south which have both hewn and pit-sawn faces. The commons measure 4½" x 4½" (114mm) and have a diminished haunch where tenoned into the bridging joist (Plate 16). No assembly marks are visible. The east wall has been re-plastered in modern fabric, though the other walls are of historic brickwork. Of note is the north-west corner where the later internal partition butts up against the pre-existing plastered wall on the north. The ceiling is plastered with some patching and repair visible.

Detail of the common joisting showing joint with a diminished haunch in Room FF02, taken from the south-east

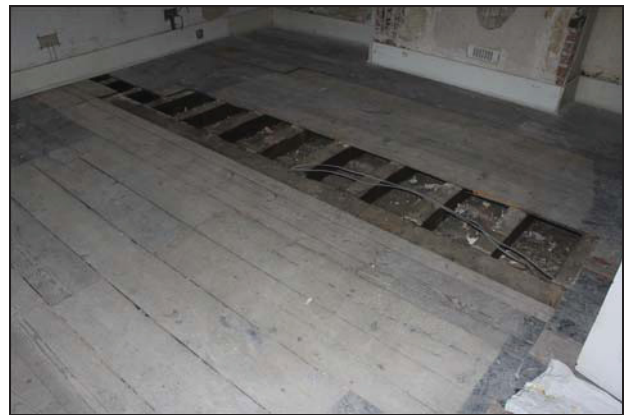
DP 94

View of Room FF02 during the planned works showing early floor joisting below the floorboards, taken from the north-west

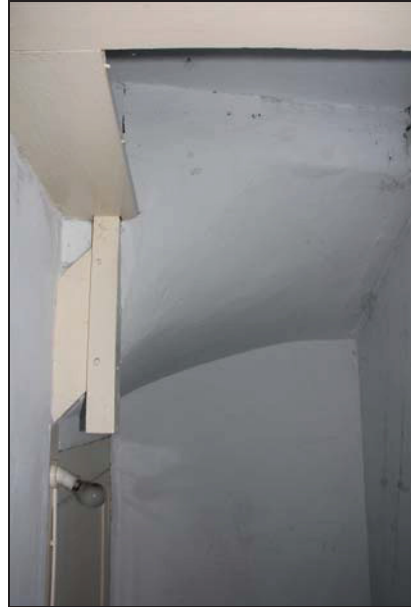
DP 103

Detail in the north-west corner of Room FF02 during the planned works showing internal partitions abutting the plasterwork of the north wall, taken from the south-east

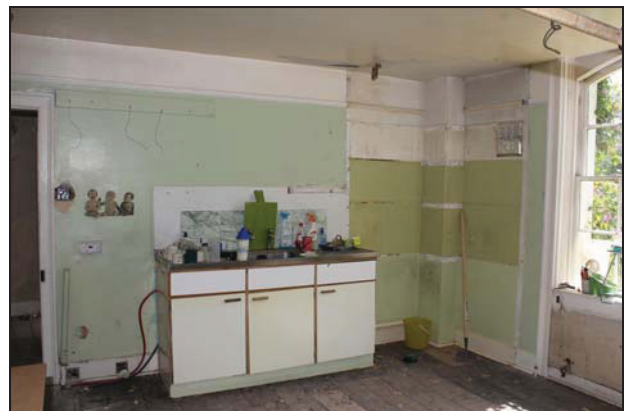
DP 107

North side of Room GF06 during the planned works, taken from the south

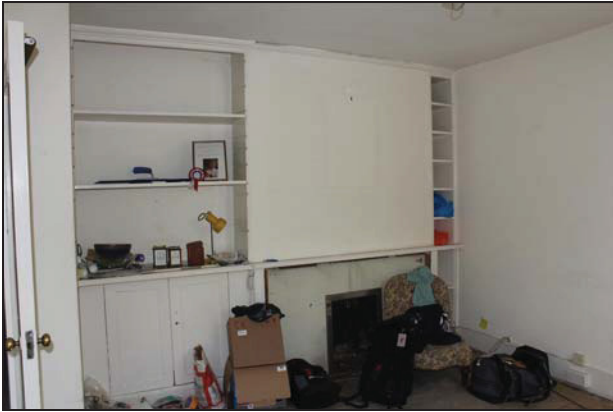
DP 108

West side of Room GF06 during the planned works after the removal of modern fixtures and fittings, taken from the west

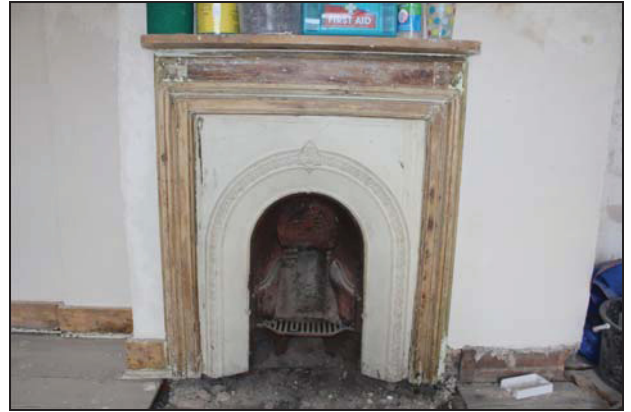
DP 109

North side of Room GF04 during the planned works, taken from the south

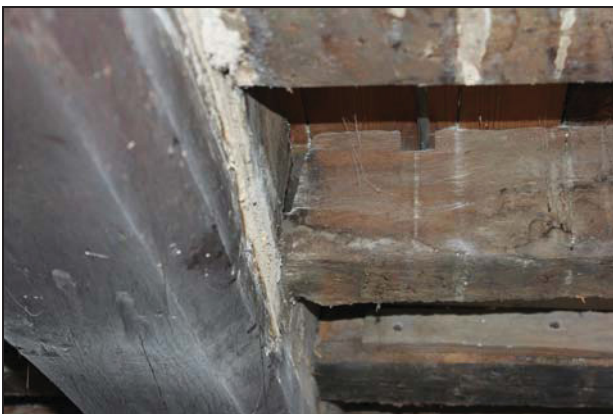
DP 112

View formerly boxed in structural timber on landing FF01, taken from the south

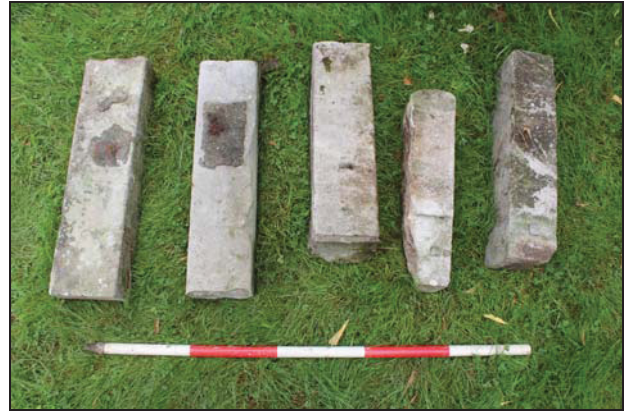
DP 115

Shaped lower step retrieved from the external steps

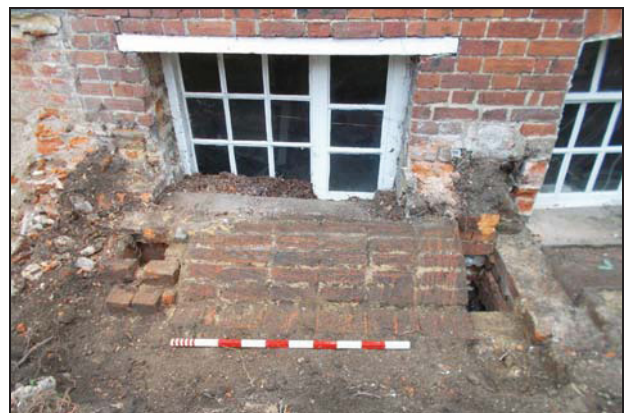
DP 119

View of the south side of the building (east end) showing original brick retaining structure keeping the fabric of the terrace away from the house, taken from the south

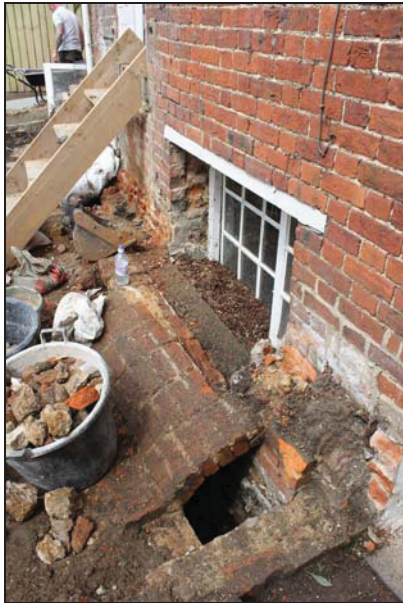
DP 120

View of the south side of the building (centre) showing original brick retaining structure and early 20th century window inserted above the original fabric, taken from the south

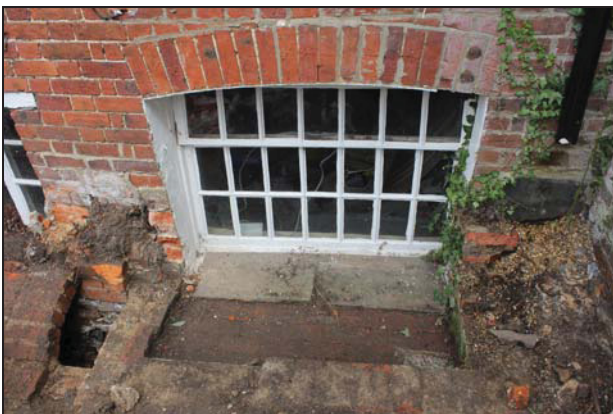
DP 122

View of the interior of the brick retaining arch on the south side of the building (centre), taken from the east

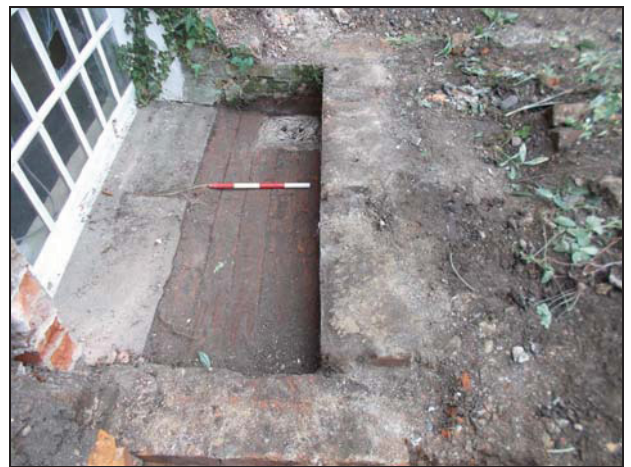
DP 123

View of the south side of the building (east end) showing original brick structure and original window above, taken from the south

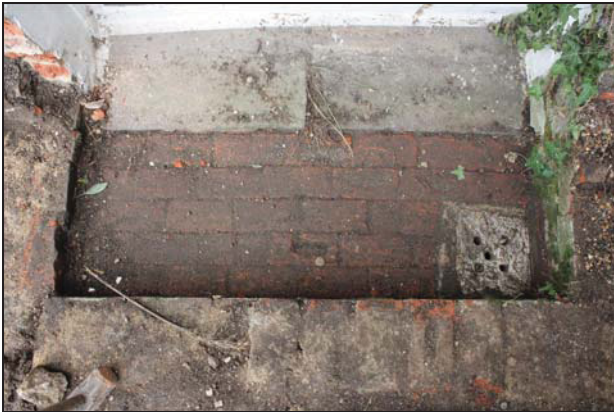
DP 124

View of the south side of the building (east end) showing original brick structure and with stone drain, taken from the west

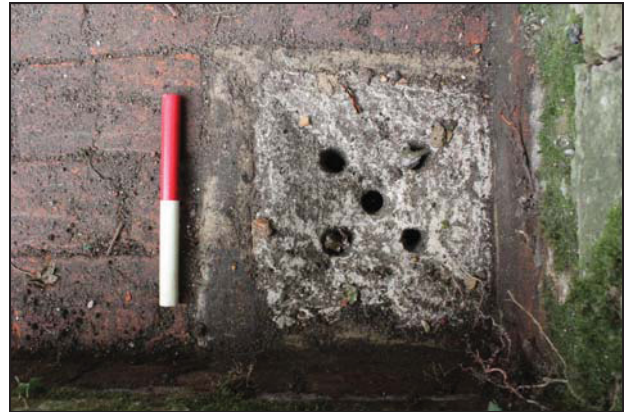
DP 125

View of the south side of the building (east end) showing original brick structure and with stone drain, taken from the south
