ARCHAEOLOGICAL SOLUTIONS LTD

**15 FISHPOOL STREET, ST ALBANS,
HERTFORDSHIRE, AL3 4RS**

HISTORIC BUILDING RECORDING & MONITORING

Authors:	Lauren Wilson MA PCIfA Lee Prosser PhD Tansy Collins (Photography) Kathren Henry (Graphics)	
NGR: TL 1426 0716		Report No: 5396
District: St Albans City and District		Site Code: AS1891
Approved: Claire Halpin MCIIfA		Project No: 6764
		Date: 4 July 2017

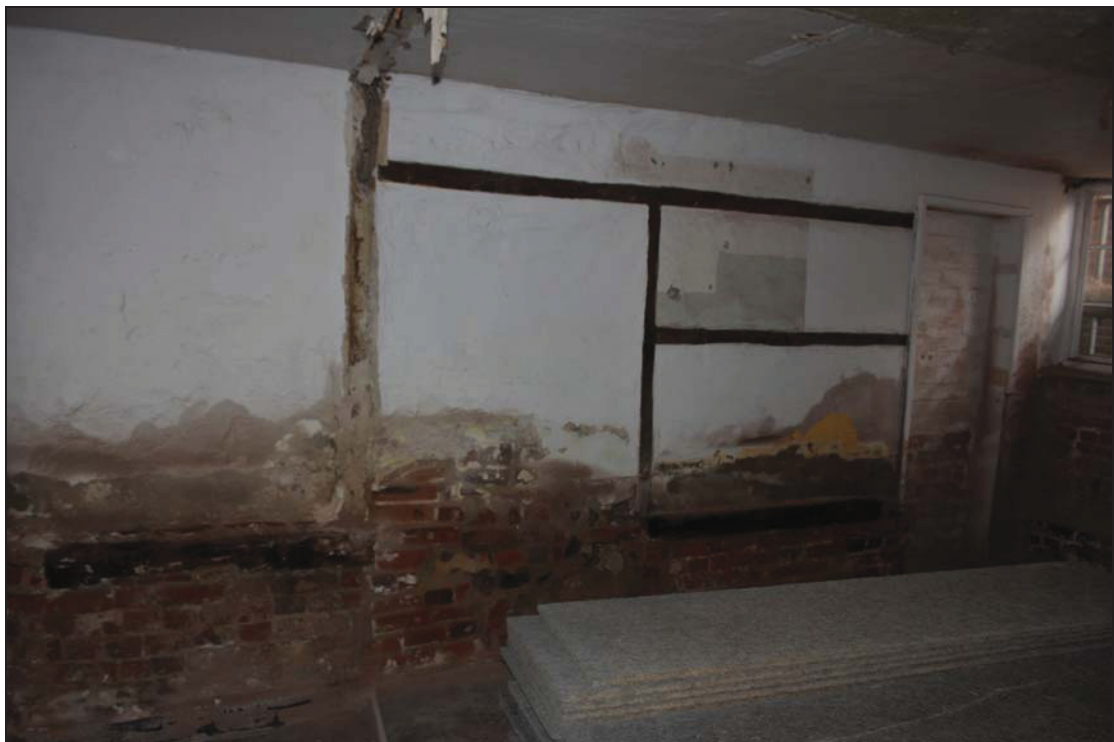
Plate 22 View of GF05, taken from the north-east (DP 316)

5.29 An asymmetrical room was latterly used as a second kitchen but few features of note were visible, except for a robust stud in the north-east corner and the rear of the stack from GF02. There are some slender timber bearers on the north wall (Plate 22).

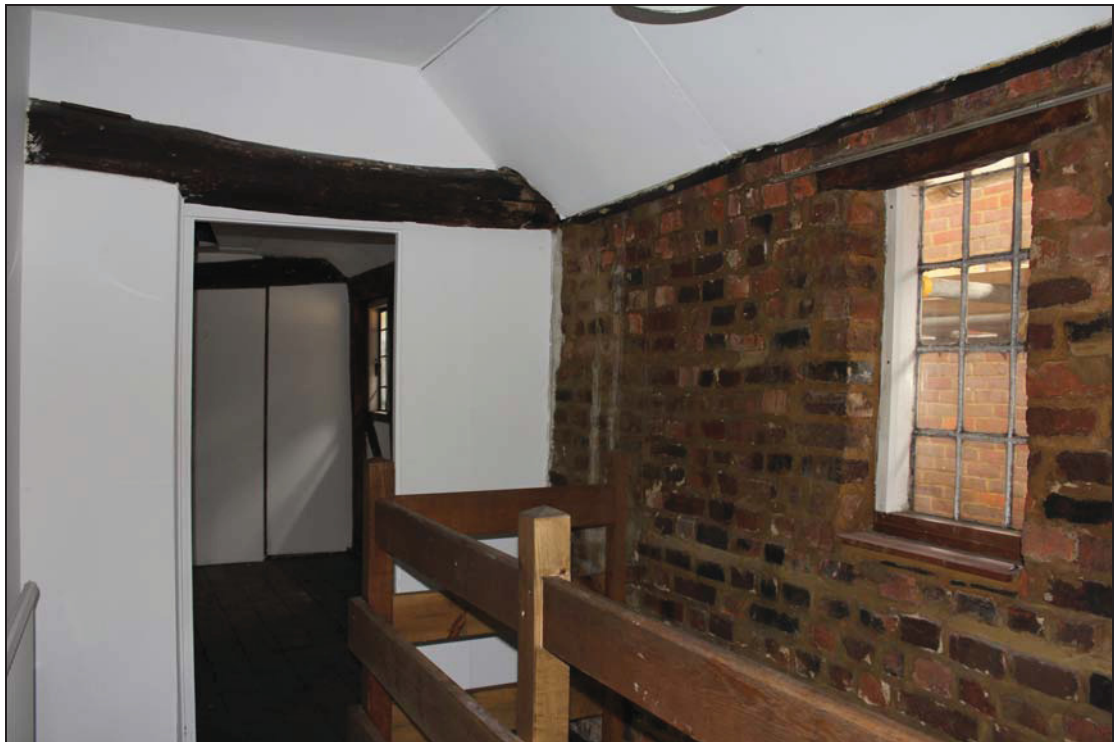
5.53 The stair in Bay 1 is modern and rises to a landing on the west where the outer wall has new brickwork and a 20th century fixed window, formerly a casement (Plate 44). On the first floor the internal partitions are all modern. The south part of the corridor marks a transition seen on the exterior between brick and timber. Some timber is visible internally including studs, a wall-plate, a principal post and braces, together with a simple iron-framed casement of some age set in a modern frame.

Plate 44 View of FF08, taken from the north (DP 178)

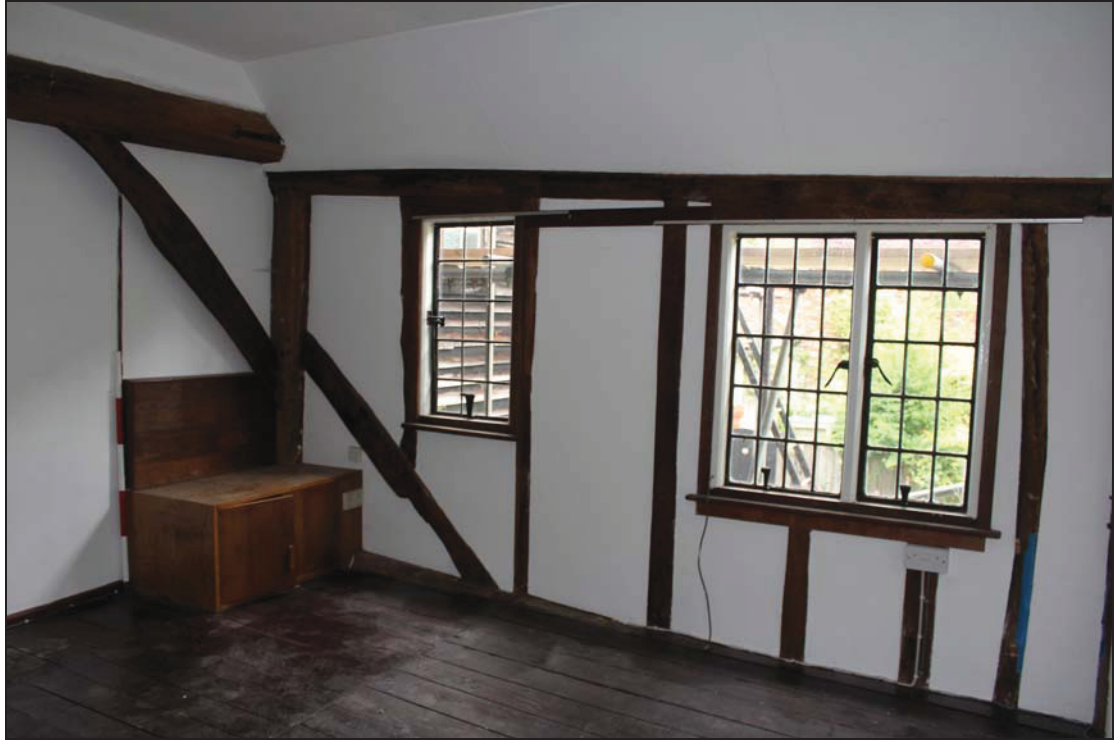
5.54 The north room is accessed via a pastiche Arts and Crafts-style door with heavy hinges. Timber-framing includes bracing to the tie-beam and multiple studs on the east wall (Plate 45), some pierced by modern casements.

Plate 45 View of FF09, taken from the south-west (DP 179)

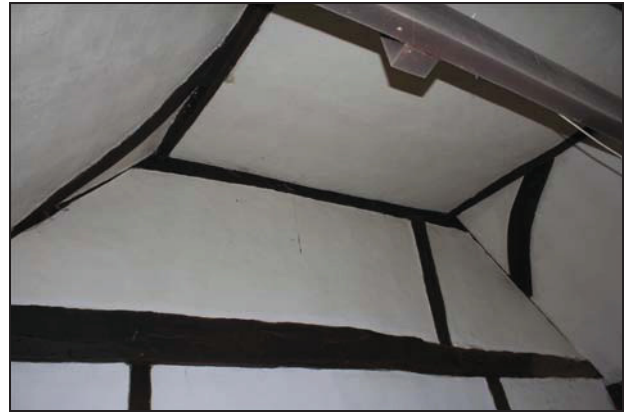
DP 145

Interior of FF04, taken from the north-west.

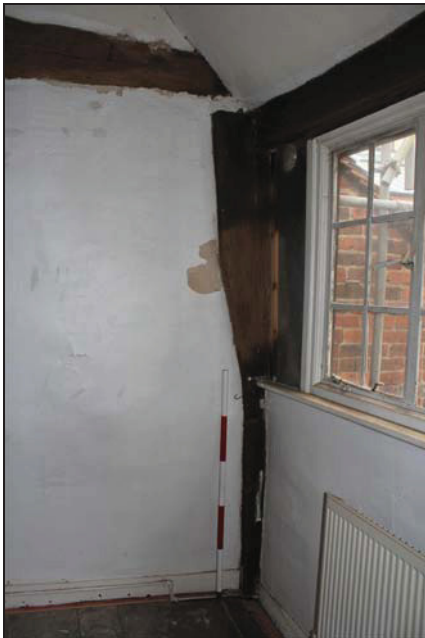
DP 146

Timber-frame in FF04, taken from the north-west.

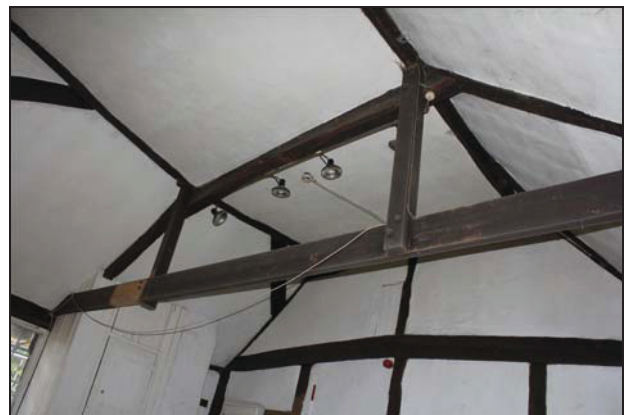
DP 149

Interior of FF04, taken from the north-east.

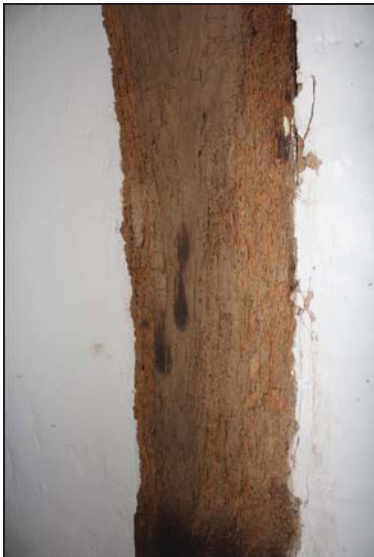
DP 152

Taper mark on a post in FF04, taken from the east.

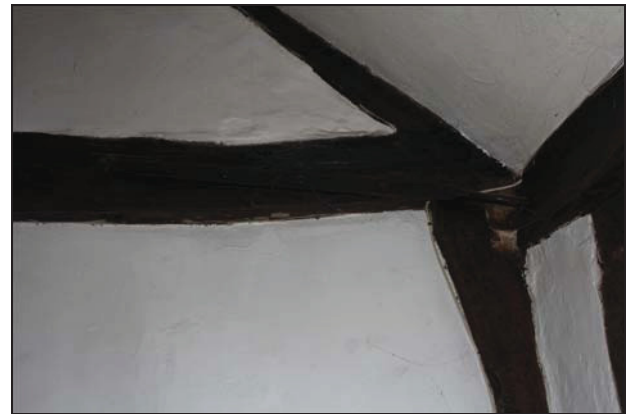
DP 153

Taper marks on studs in FF04, taken from the west.

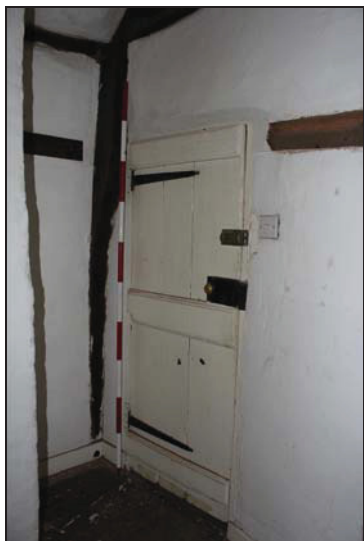
DP 154

Timber-frame in FF04, taken from the east.

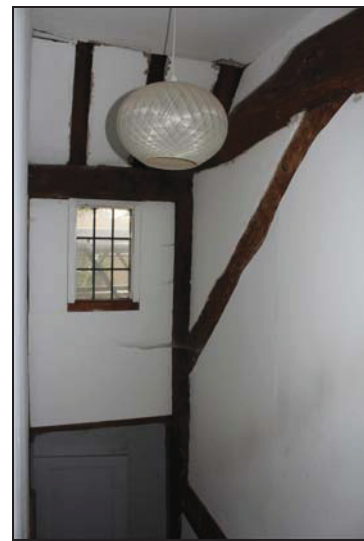
DP 155

Door to FF01 from FF04, taken from the north-east.

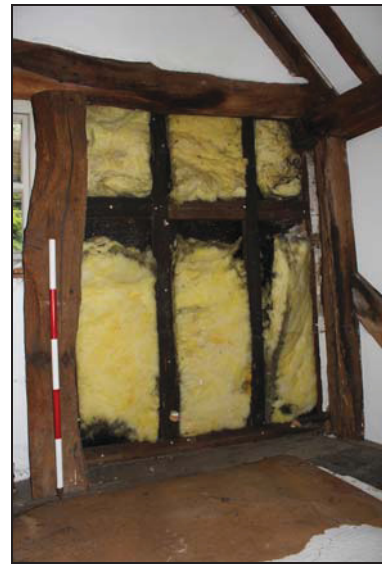
DP 157

View of FF15, taken from the east.

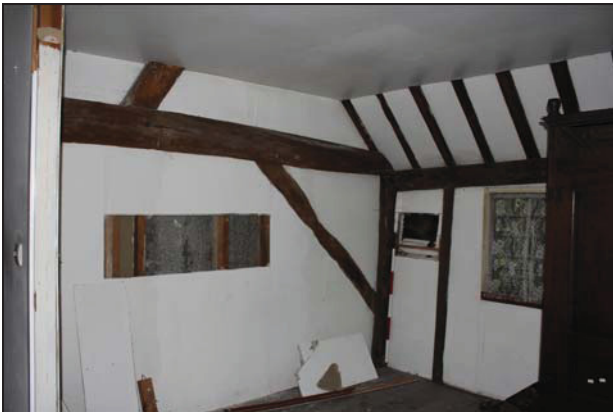
DP 158

Timber-framing in FF15, taken from the north.

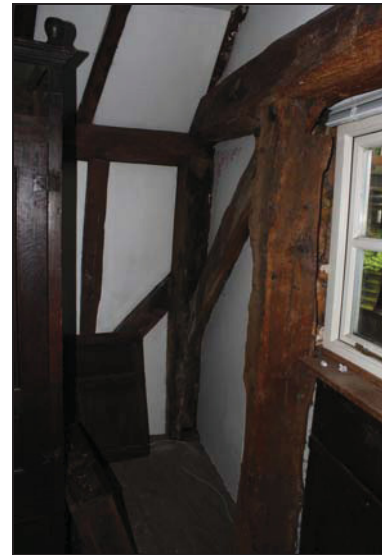
DP 159

View of FF15, taken from the south-west.

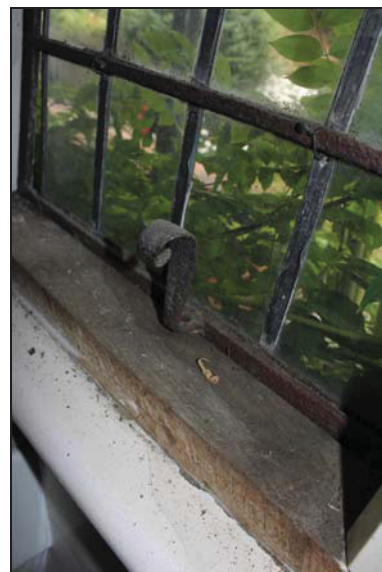
DP 161

Window in FF11, taken from the east.

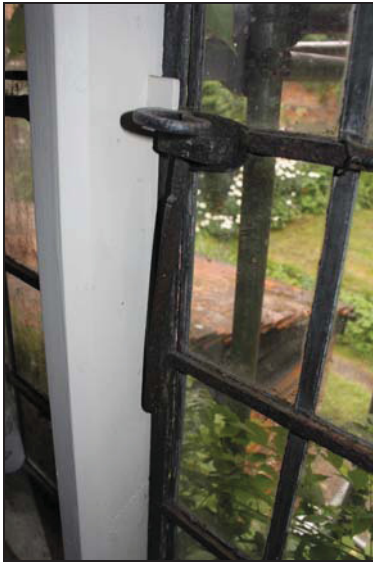
DP 162

Handle on the window in FF11, taken from the east.

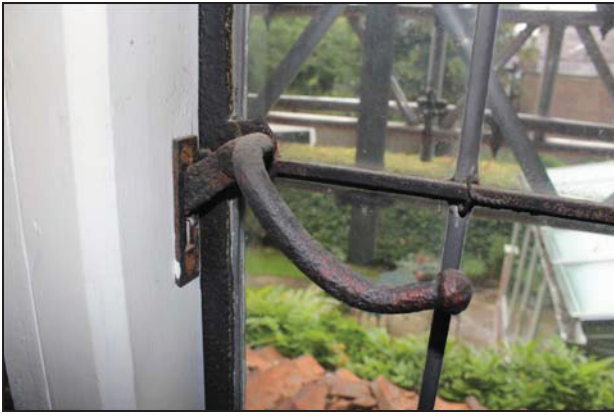
DP 168

Window handle in FF11, taken from the east.

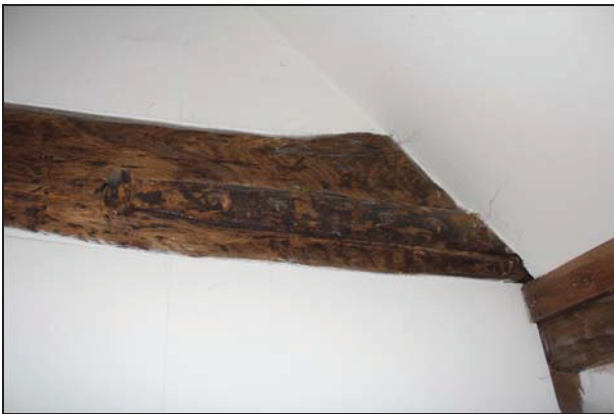
DP 172

View of FF13, taken from the west.

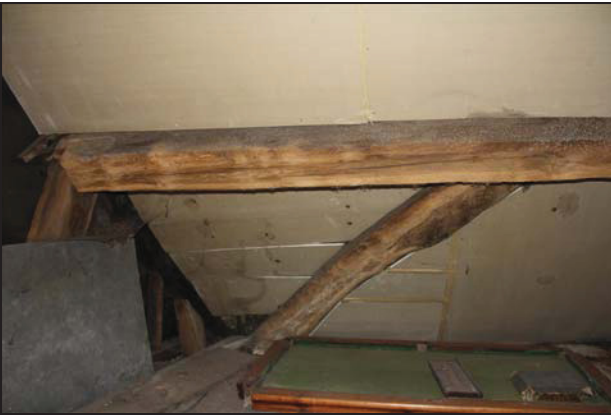
DP 174

Roof structure over the rear range, taken from the north.

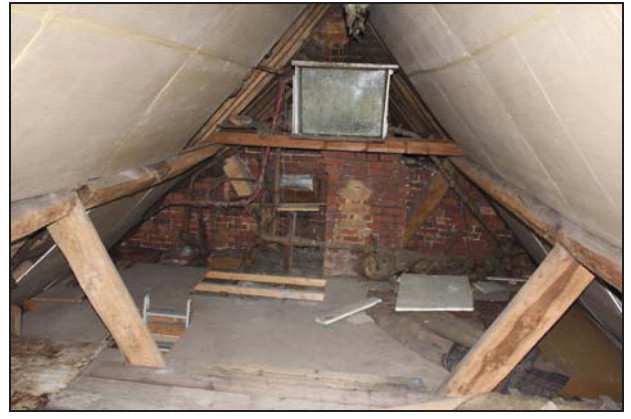
DP 175

Roof structure over the rear range, taken from the east.

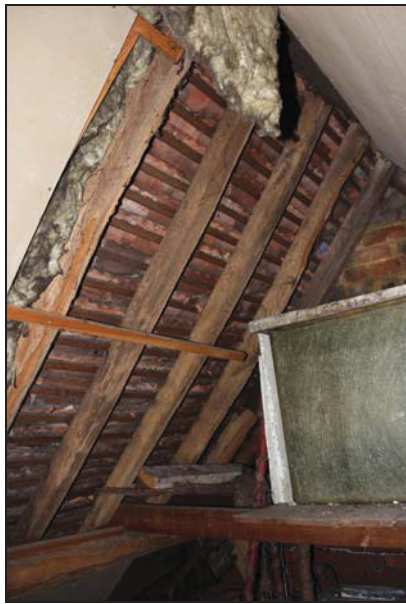
DP 176

Roof structure over the rear range, taken from the south.

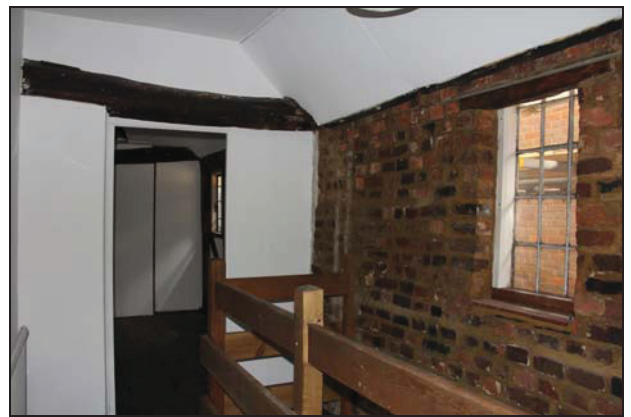
DP 177

Roof structure over the rear range, taken from the south-east.

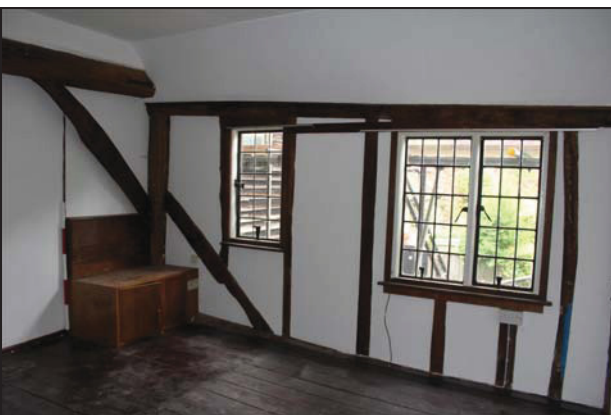
DP 178

View of FF08, taken from the north.

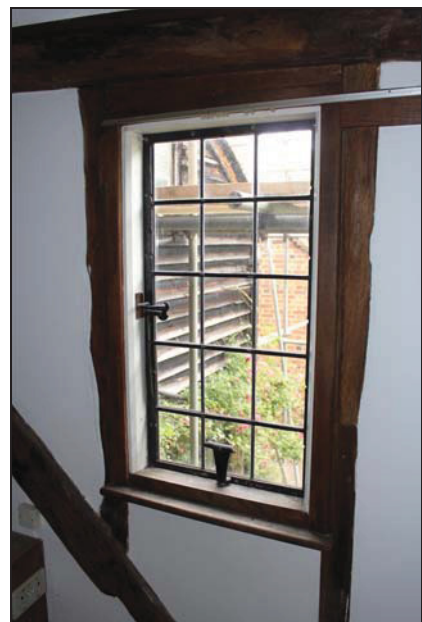
DP 179

View of FF09, taken from the south-west.

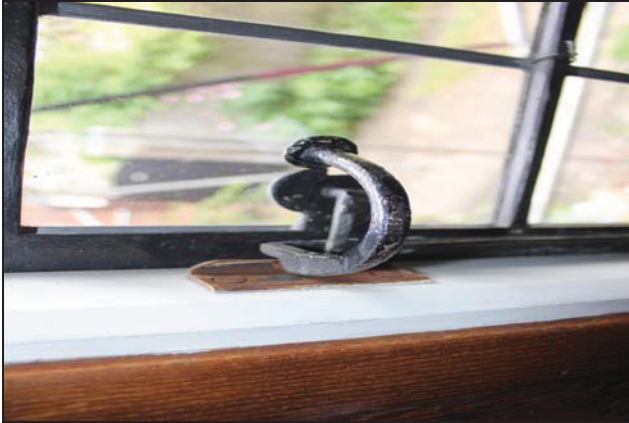
DP 180

Window in FF09, taken from the south-west.

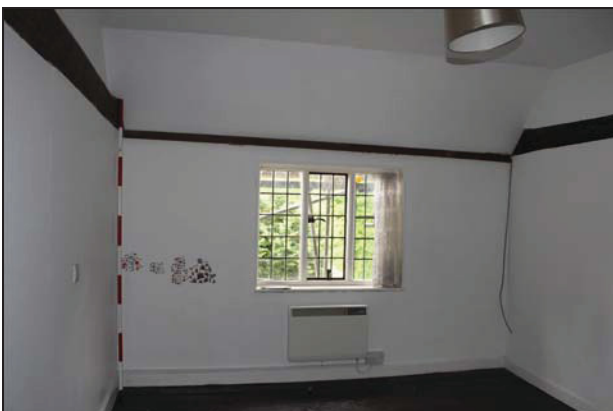
DP 184

View of FF10, taken from the south-west.

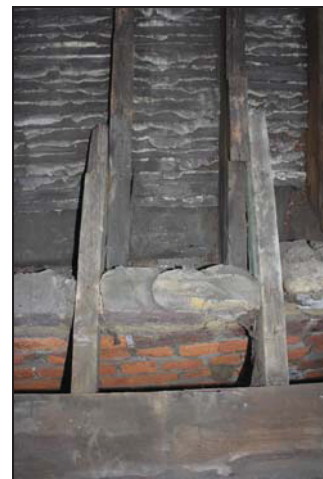
DP 194

Collapsed ceiling in the rear range, taken from the south.

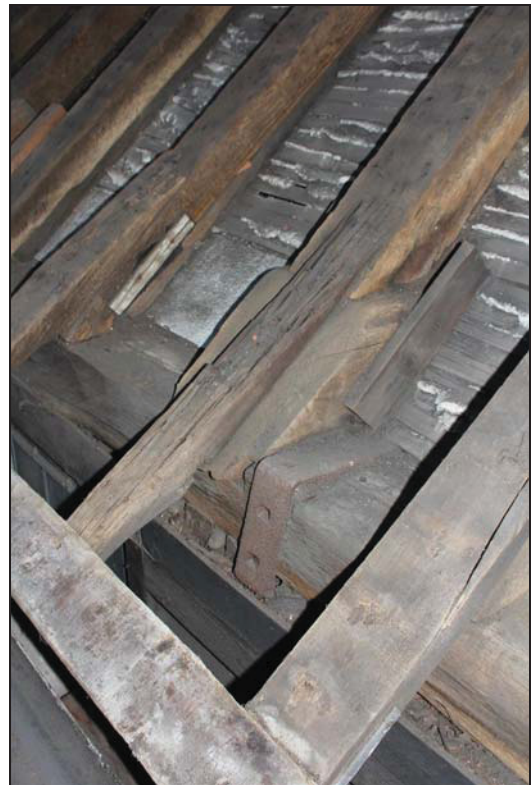
DP 200

truncated below purlin level and replaced with ephemeral timbers (Plate 55). On the west side of the bay the wall-plate has a face-halved and bladed scarf joint to the north. The east side has had all its rafter feet removed.

Plate 55 Roof structure over the rear range showing replacement rafters below the chimney stack, taken from the north-west (DP 200)

Roof structure over the rear range, taken from the north-west.

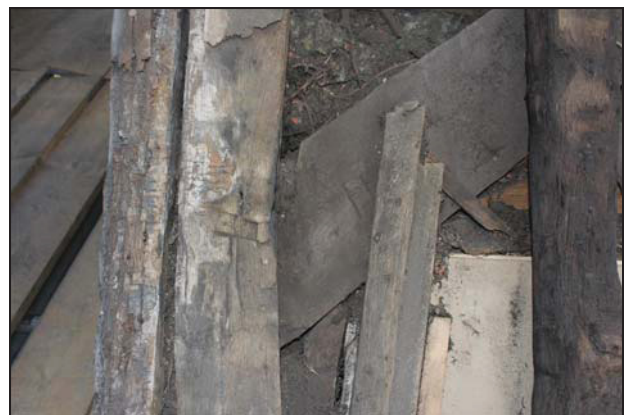
DP 212

5.65 Other points of note include the presence of charred rafters distributed throughout the roof structure. This may be assumed to be the result of the fire noted in the history above and indeed there are a higher number of affected timbers at the north end. However, the burning only affects discrete members and so suggests these timbers are reused in this building. A good example of this can be seen at the north end where the principal rafter is charred but the raking strut and peg used to secure this to the rafter is clean (Plate 53), but furthermore

Charring visible on the underside of rafter couples in bay 5 in the rear range, taken from the north-east.

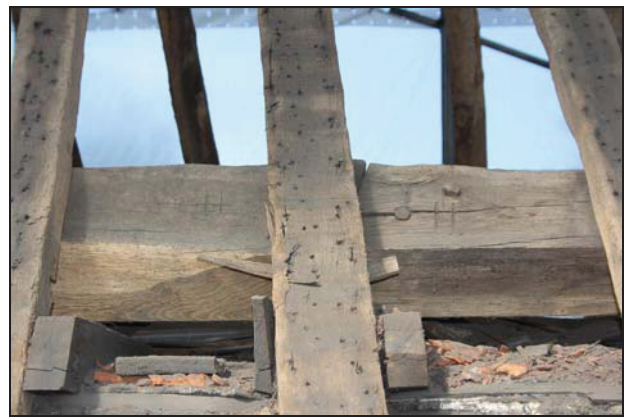
DP 216

Now blocked window aperture in bay 3 of the rear range, taken from the south-east.

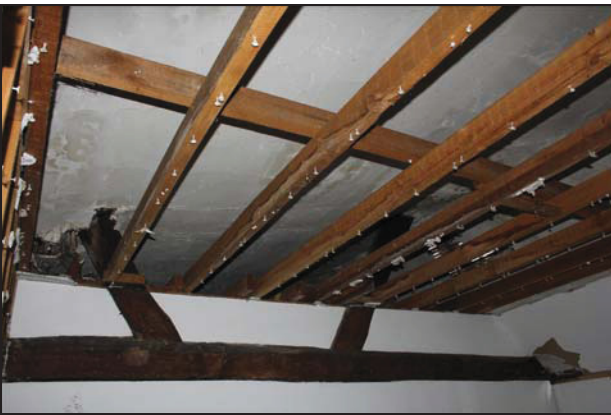
DP 226

Plate 53 Evidence of smoke-blackening and rafter replacement in the roof of the rear range, taken from the south-east (DP 226)

Evidence of smoke-blackening and rafter replacement in the roof of the rear range, taken from the south-east.

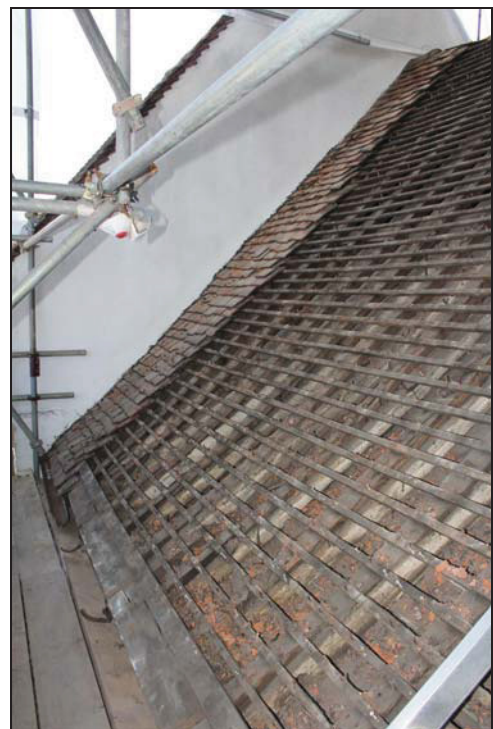
DP 229

Rafter holes in the rafters of the east front roof, taken from the north-west.
