**LOWER FARM, BURY GREEN, LITTLE HADHAM,
WARE, HERTFORDSHIRE SG11 2EY**

**HISTORIC BUILDING RECORDING AND
ARCHAEOLOGICAL MONITORING & RECORDING**

Authors: Tansy Collins MSt Lauren Wilson MA (Background Research) Kathren Henry	
NGR: TL 4522 2096	Report No: 5534
District: East Hertfordshire	Site Code: AS 1910
Approved: Claire Halpin MIfA	Project No: 7300
	Date: 7 February 2018

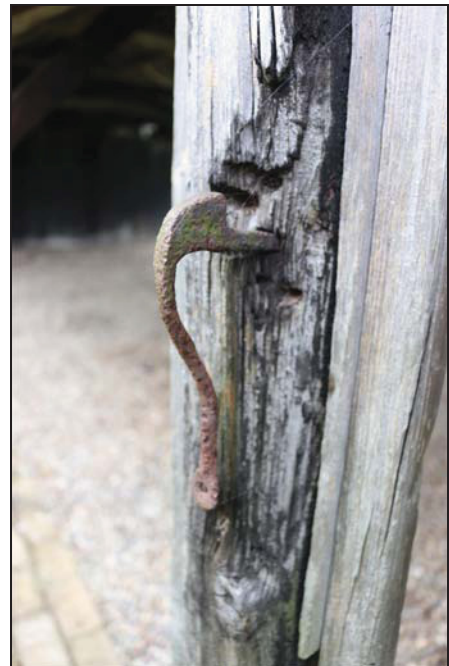
DP 10

Door fastener marking the position of a former doorway on the south-east side of Unit 2, taken from the north-east

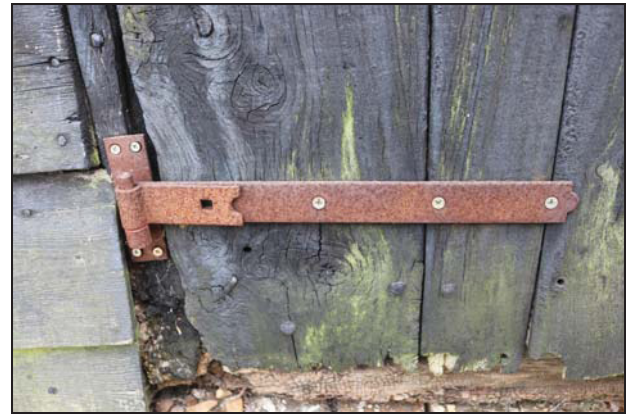
DP 22
Detail of the doorway on the north-west elevation (Unit 4) showing later iron hinge, taken from the north-west

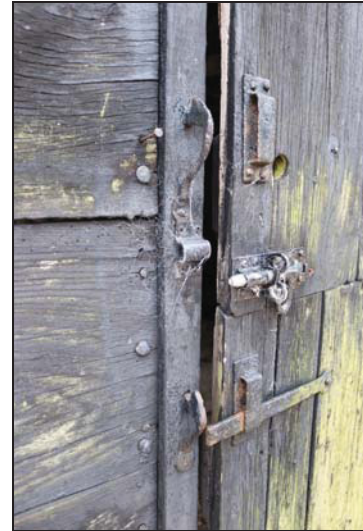
DP 26

Detail of the doorway on the north-west elevation of Unit 5 showing pair of early fasteners for the formerly split door, taken from the north-west

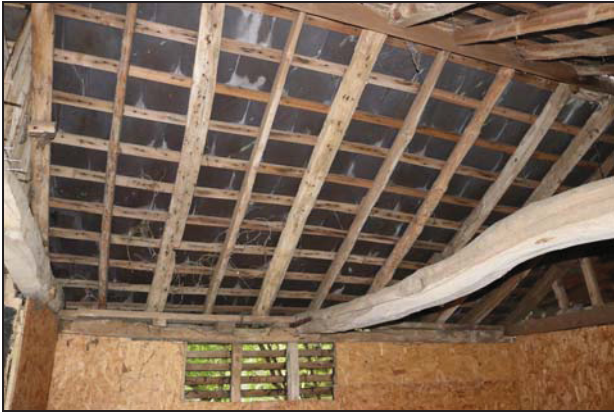
DP 37

North-west roof pitch of Unit 1, taken from the south-east

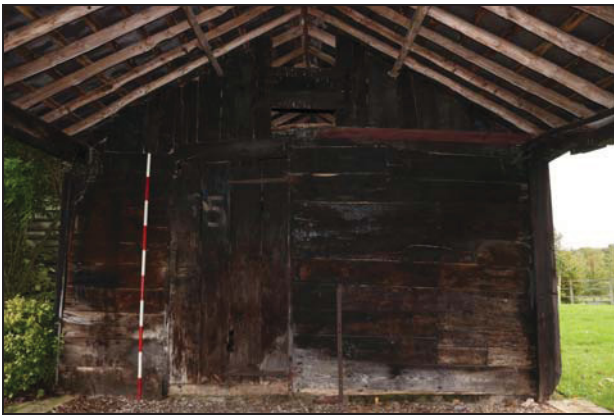
DP 39

Horizontally boarded partition between Units 2 and 1, taken from the south-west

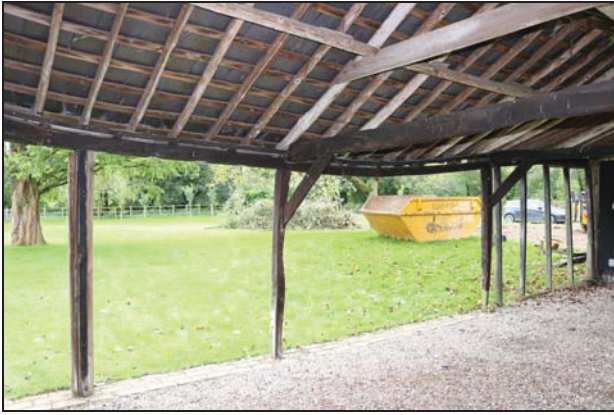
DP 49

Open-fronted bays to the south-east of Unit 2 which were formerly infilled with studwork, taken from the north

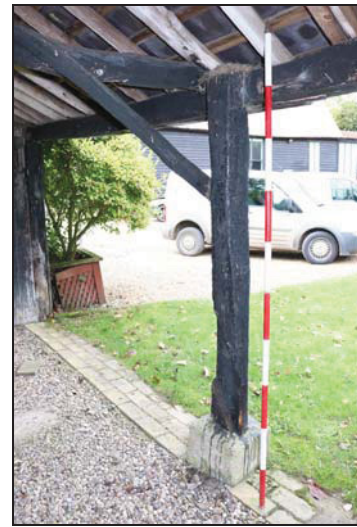
DP 52

Reused medieval timber forming the north-west bay post of the southern truss (Unit 2), taken from the north-east

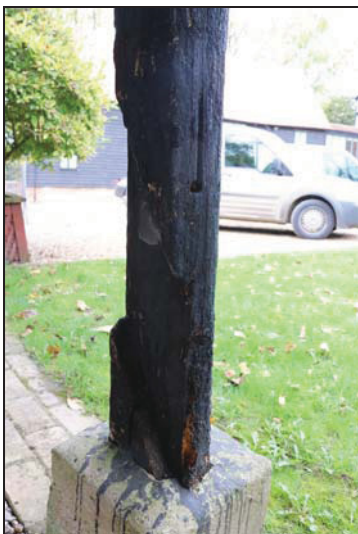
DP 53

Detail of the reused medieval timber forming the north-west bay post of the southern truss (Unit 2) showing mortice for a tension brace and wattle notch, taken from the east

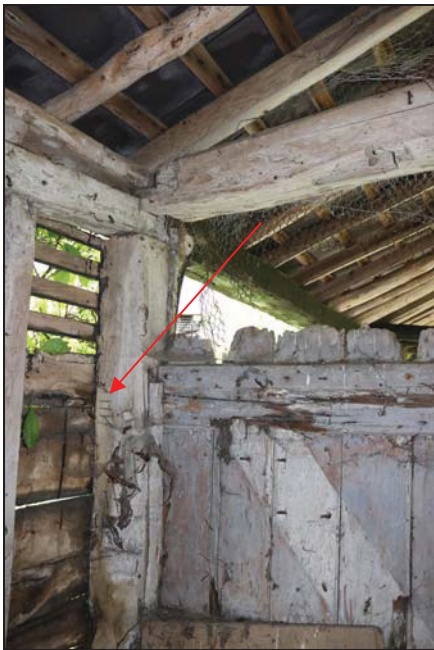
DP 63

Detail of the north-west end of the truss between Units 3 and 2 showing mortises for the pegged inner brace and assembly mark (indicated), taken from the south-east

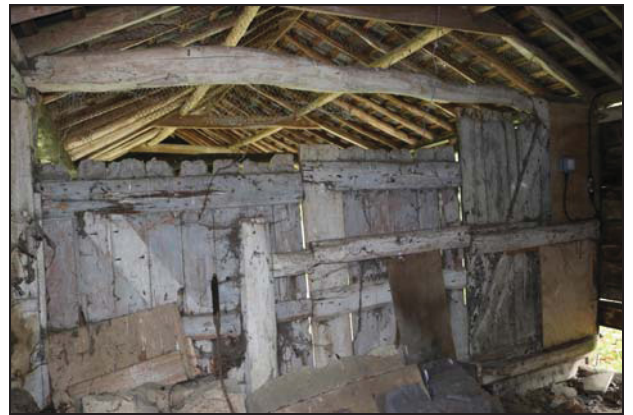
DP 64

Partition between Units 3 and 2 showing accretive nature of the partition, taken from the south-west

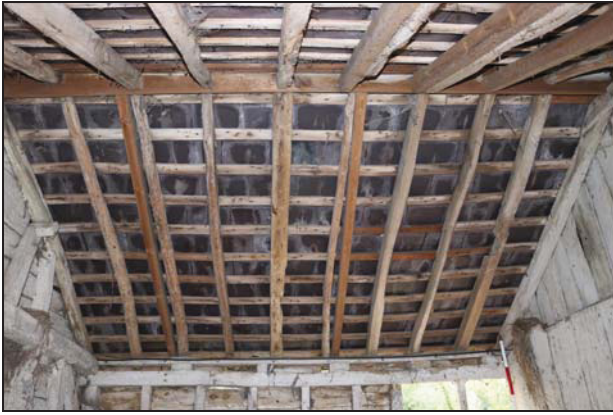
DP 66

South-east side of Unit 4 showing regular primary-braced studwork, taken from the north-west

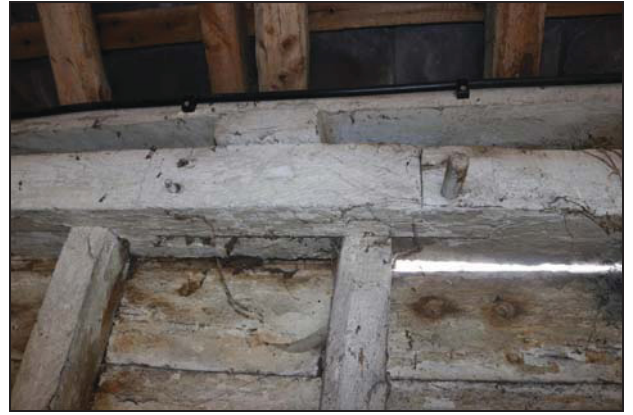
DP 67

South-east side of Unit 4 showing roof pitch including a mix of reused and later rafters, taken from the north-west

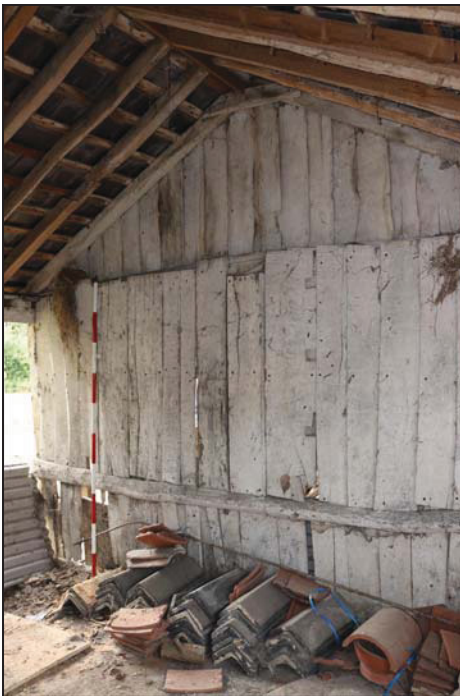
DP 68

Scarf joint in the south-east wall-plate of Unit 4, taken from the north-west

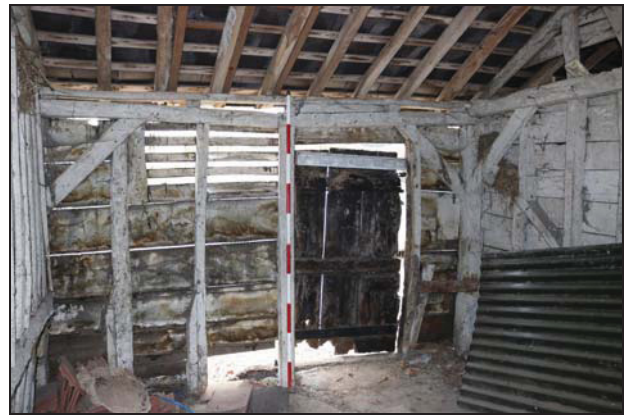
DP 69

South-west wall of Unit 4 showing robust vertical boarding to the adjoining unit, taken from the north

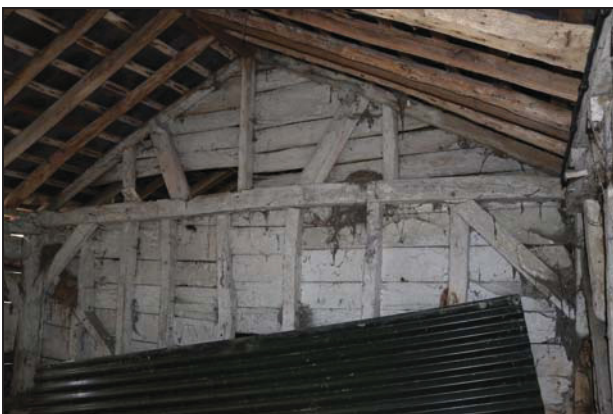
DP 70

North-west side of Unit 4 showing lateral braces with infill studwork and door and ventilation aperture, taken from the south-east

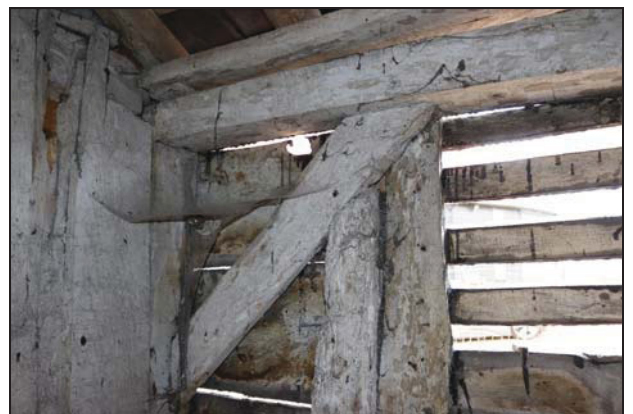
DP 71

North-east side of Unit 4 showing studwork with horizontal boarding to the rear, taken from the south

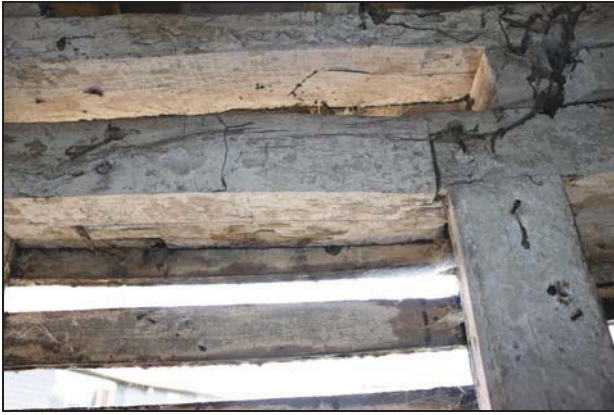
DP 72

Detail of the north-west wall of Unit 4 showing pegged lateral brace, taken from the south-east

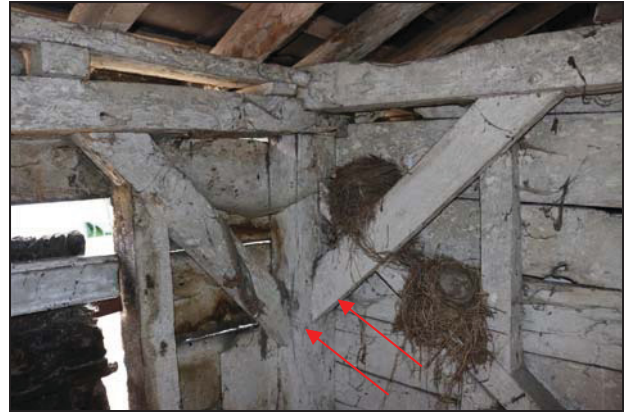
DP 73

Scarf joint in the north-west wall-plate of Unit 4, taken from the east

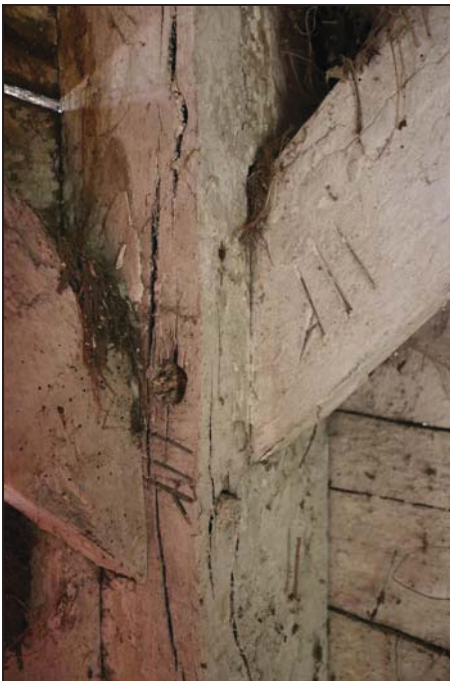
DP 74

North-west corner of Unit 4 showing lateral brace and inner brace to the truss with assembly marks (indicated), taken from the south

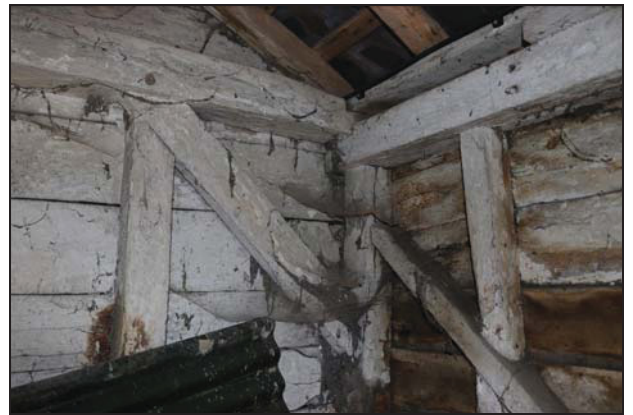
DP 75

Detail of the north-west corner of Unit 4 showing assembly marks, taken from the south

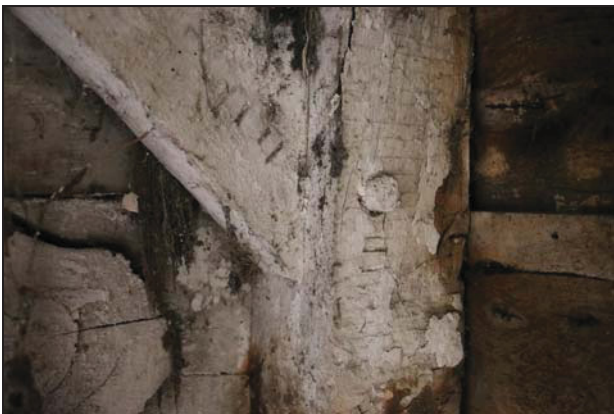
DP 76

North-east corner of Unit 4 showing inner brace to the truss and adjoining primary-brace, taken from the south-west

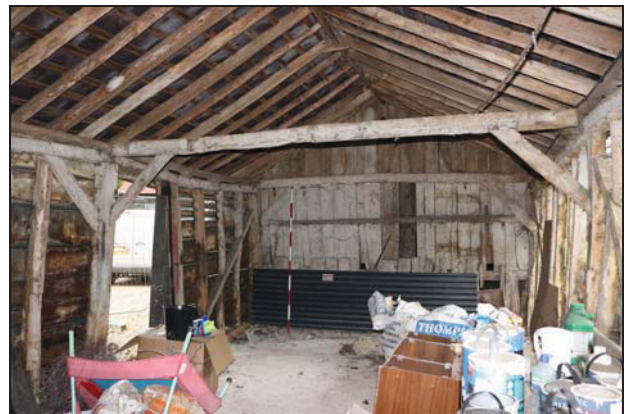
DP 77

North-east corner of Unit 4 showing pegged inner brace with assembly marks, taken from the south

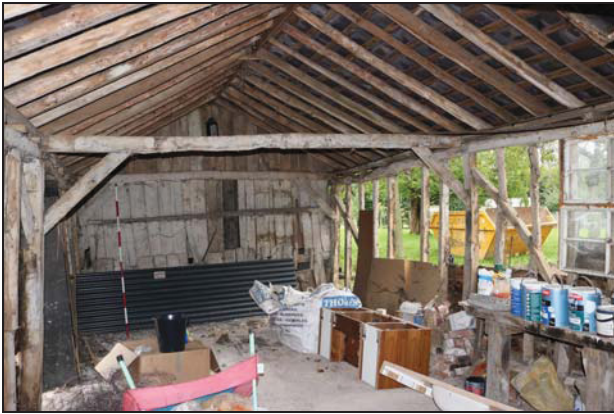
DP 78

Interior of Unit 5, taken from the south-west

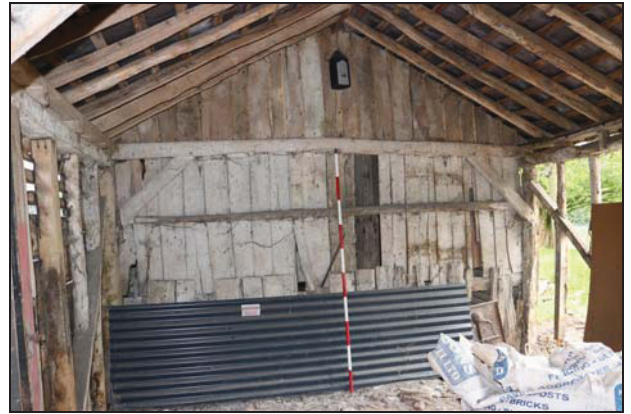
DP 79

Interior of Unit 5 showing primary-braced framing on the right with the external weatherboarding removed, taken from the south-west

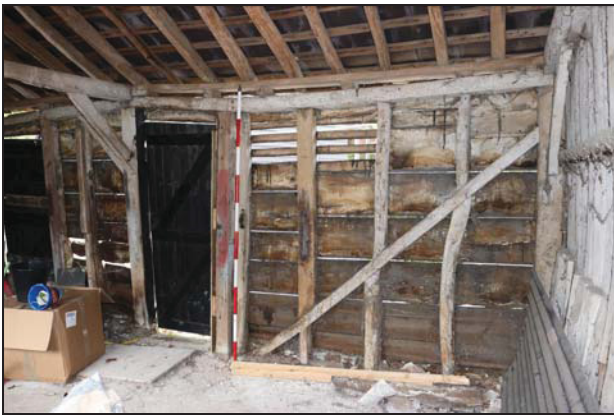
DP 80

North-east end of Unit 5 showing truss with robust vertical boarding to the rear, taken from the south-west

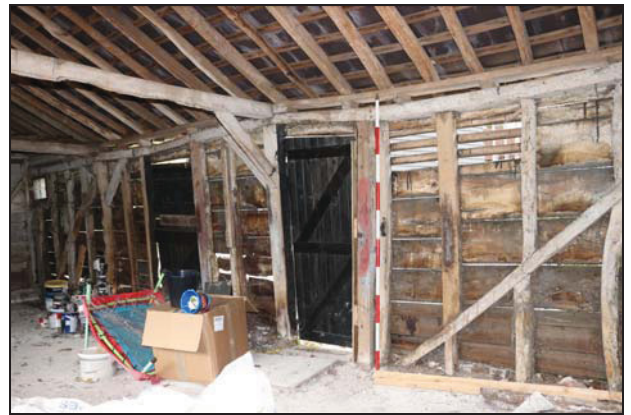
DP 81

North-west wall of Unit 5 (north-east bay), taken from the south-east

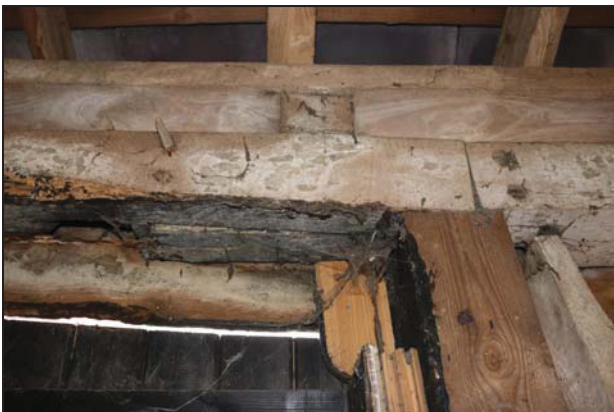
DP 82

North-west wall of Unit 5, taken from the east

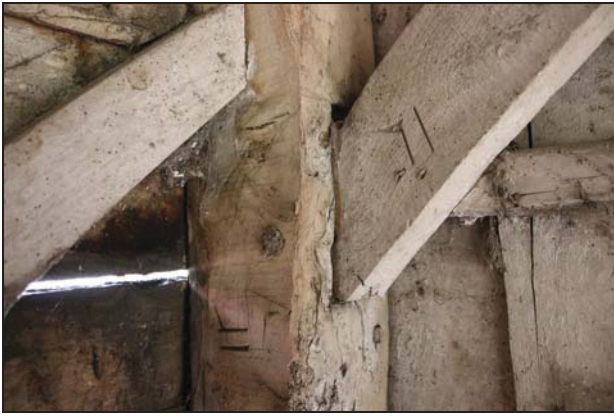
DP 84

North-west corner of Unit 5 (north-east bay) showing inner brace to the truss and adjoining primary-brace, taken from the south

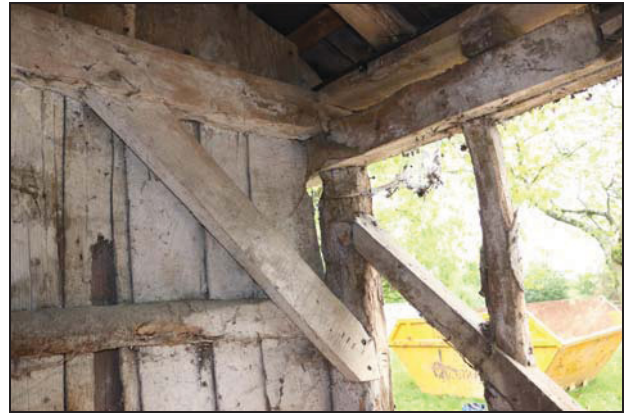
DP 85

North-west corner of Unit 5 (north-east bay) showing inner brace and post with assembly marks, taken from the south

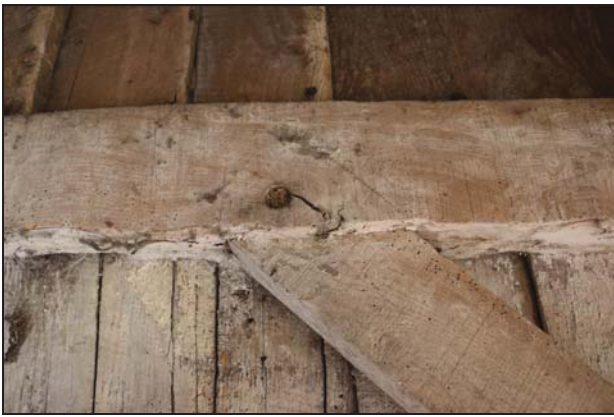
DP 86

North-east corner of Unit 5 (north-east bay) showing inner brace and post with assembly marks, taken from the south-west

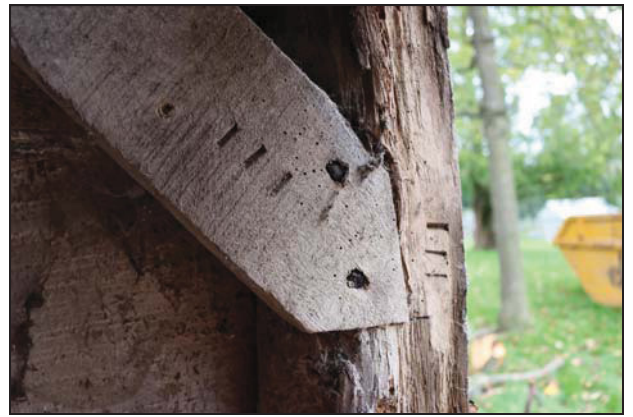
DP 87

North-east corner of Unit 5 (north-east bay) showing inner brace pegged at the head, taken from the south-west

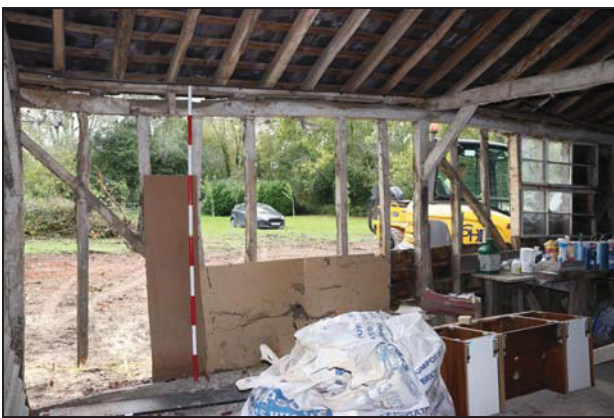
DP 88

North-east corner of Unit 5 (north-east bay) showing inner brace nailed at the base to the post, taken from the south-west

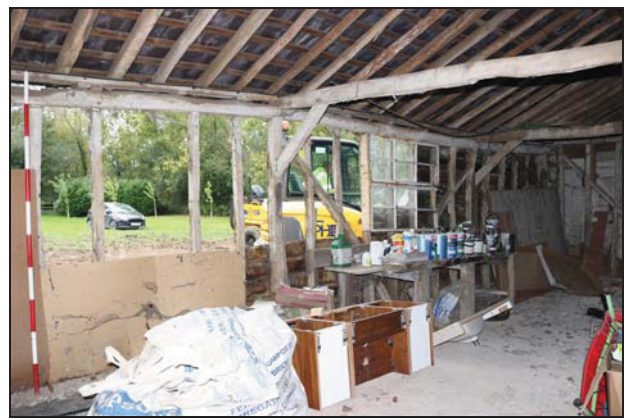
DP 89

South-east wall of Unit 5 (north-east bay), taken from the north-west

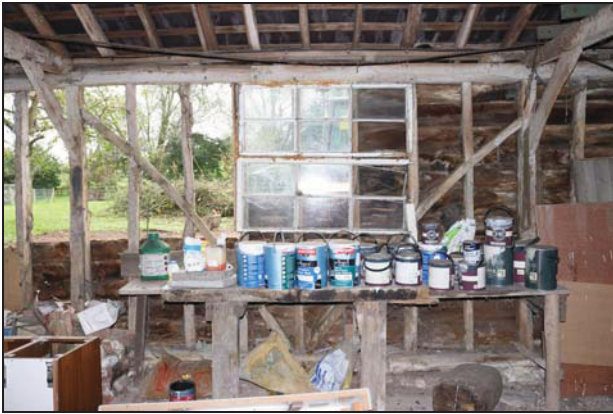
DP 90

South-east wall of Unit 5, taken from the north

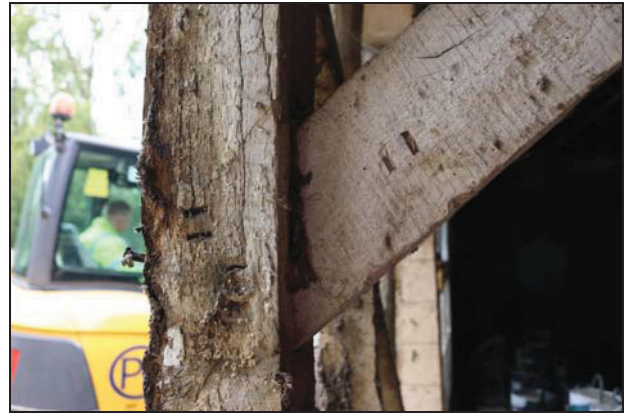
DP 91

South-east wall of Unit 5 (central bay), taken from the north-west

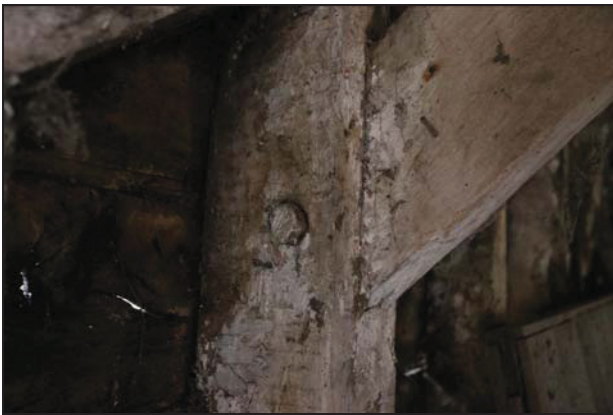
DP 92

South-east end of the truss between the north-east and central bay (Unit 5) showing pegged inner brace and post with assembly marks, taken from the north

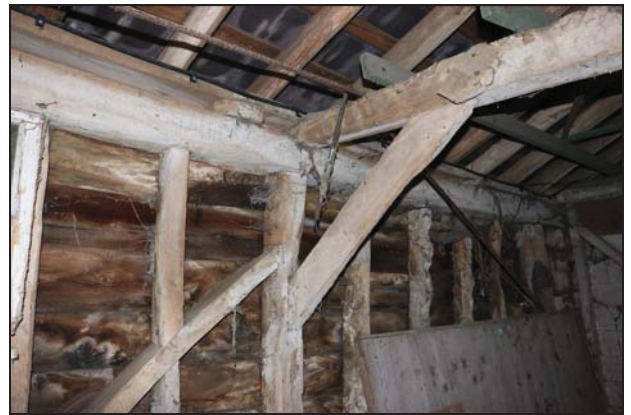
DP 93

South-east end of the truss between the central and south-west bay (Unit 5) showing pegged inner brace and post with assembly marks, taken from the north

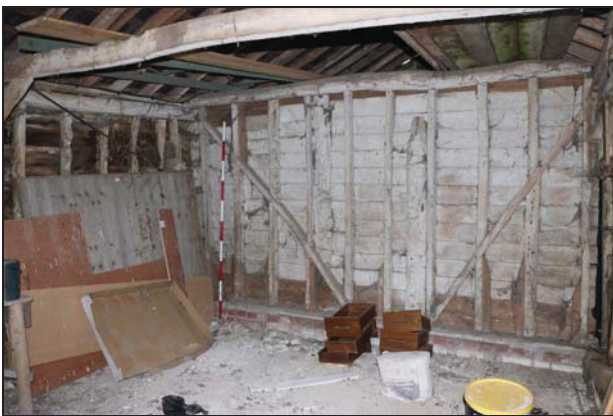
DP 94

South-east corner of Unit 5 (central bay) showing inner brace to the truss and adjoining primary-brace, taken from the north

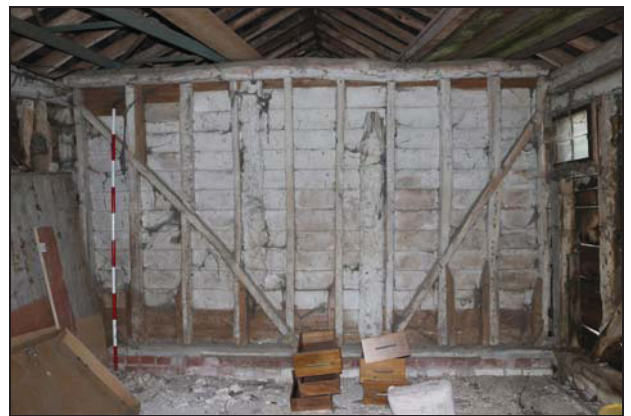
DP 95

South-west bay of Unit 5, taken from the north

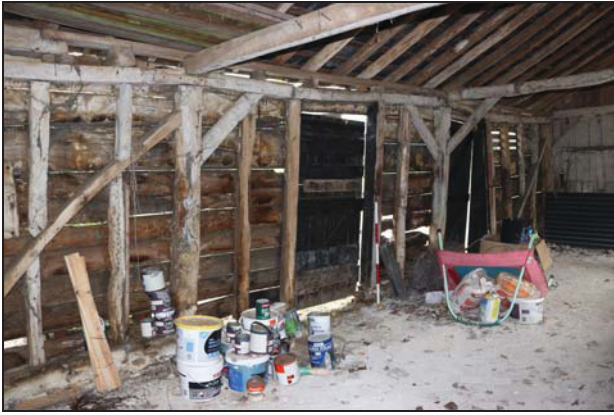
DP 96

Primary-braced studwork at the south-west end of Unit 5, taken from the north

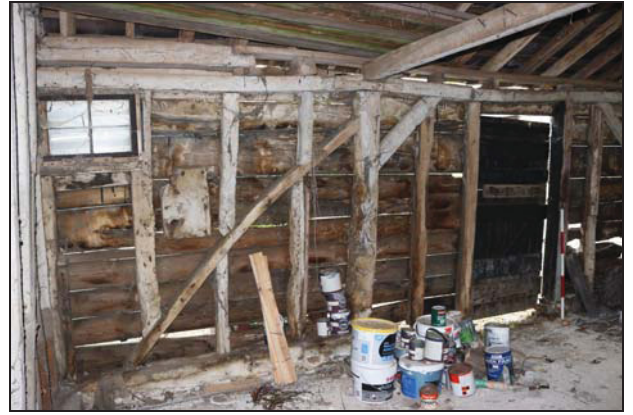
DP 97

North-west wall of Unit 5, taken from the south

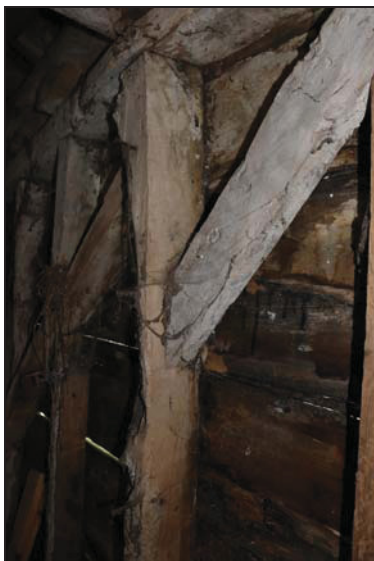
DP 100

South-west bay post of the central bay (Unit 5) with varying timber-framing to either side, taken from the south
