**BARNS AT DANE END HOUSE, CONDUIT LANE,
GREAT HORMEAD, BUNTINGFORD,
HERTFORDSHIRE**

HISTORIC BUILDING RECORDING

Level 3

Authors: Lauren Wilson MA PCIfA Kath Henry (Graphics)	
NGR: TL 40520 30120	Report No: 5372
District: East Herts	Site Code: AS 1883
Approved: Claire Halpin MCIfA	Project No: 6858
	Date: 5 May 2017

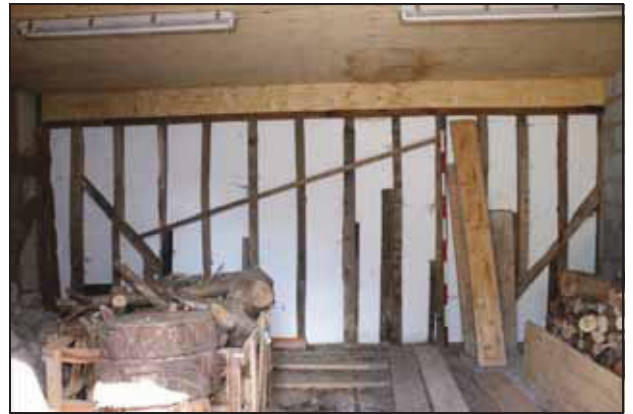
DP 16

5.27 To the north the structural wall-plate of the outbuildings has been tenoned into the principal post of the main barn but is machine-sawn and is replaced (Plate 18). The original form survives in outline on the north, where thirteen slender studs rise from the concrete floor and are simply mortised and tenoned into the wall-plate, some have been additionally supported with nailed-on supports. Two primary braces descend from the two outer studs and are pegged. A single splayed and tabled scarf joint with under-squinted abutment and missing face peg is visible to the west, but is again anachronistic in this context.

North wall of the west room of Barn 2's outbuildings, taken from the south.

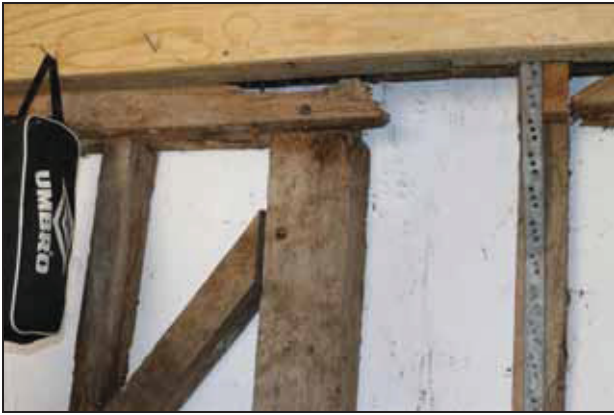
DP 21

Gap in the wall-plate along the north wall of the east room of Barn 2's outbuildings, taken from the south.

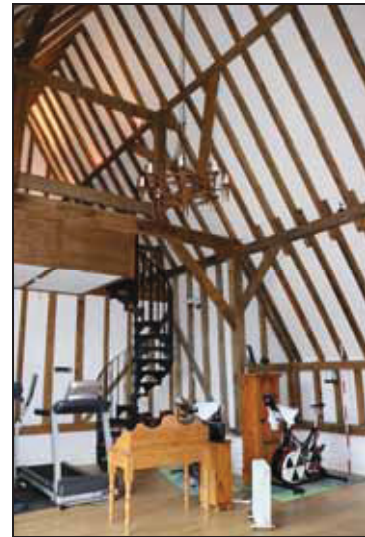
DP 27

Truss 2 in Barn 1, taken from the south.

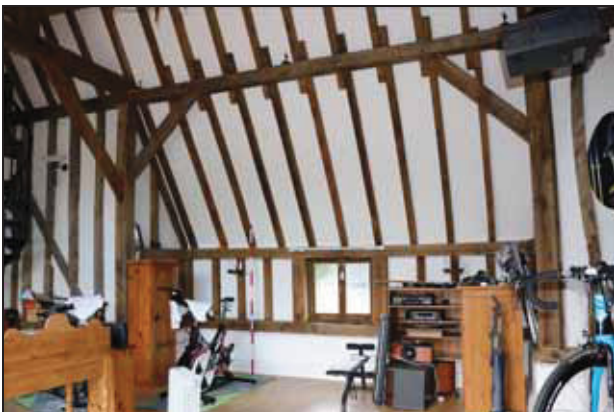
DP 28

Truss 2 in Barn 1, taken from the south-west.

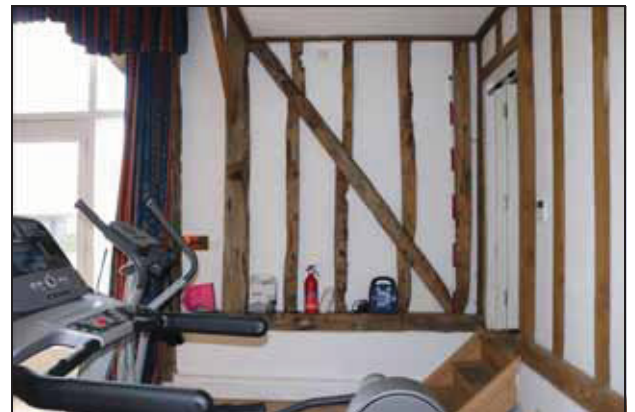
DP 29

Outshut on the south-east side of bay 2 in Barn 1, taken from the west.

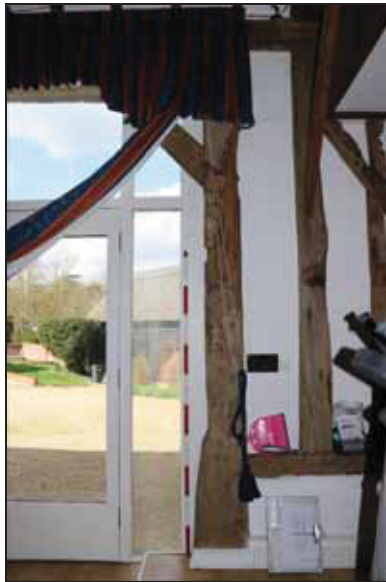
DP 30

North-west side of bay 3 in Barn 1, taken from the south-east.

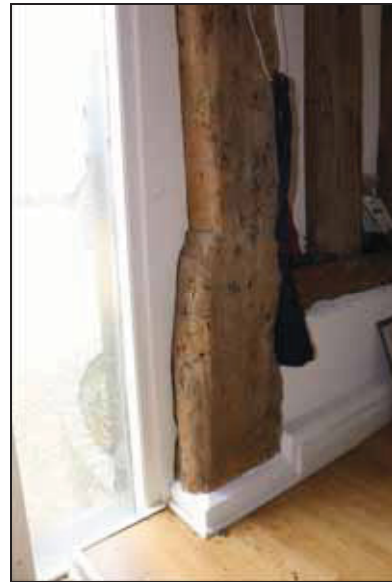
DP 31

North-west side of bay 2 in Barn 1, taken from the south-east.

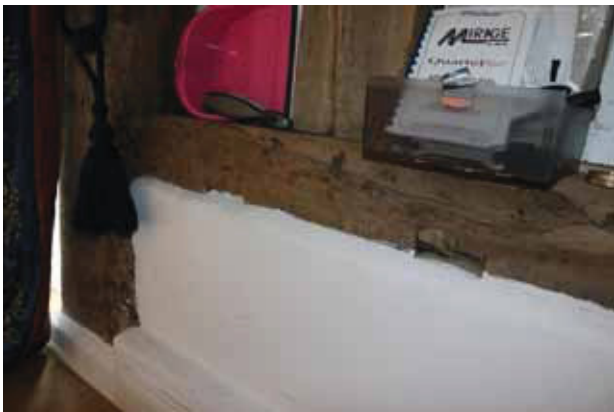
DP 32

Jowled principal post positioned upside down on the north-west side of bay 2 in Barn 1, taken from the south-east.

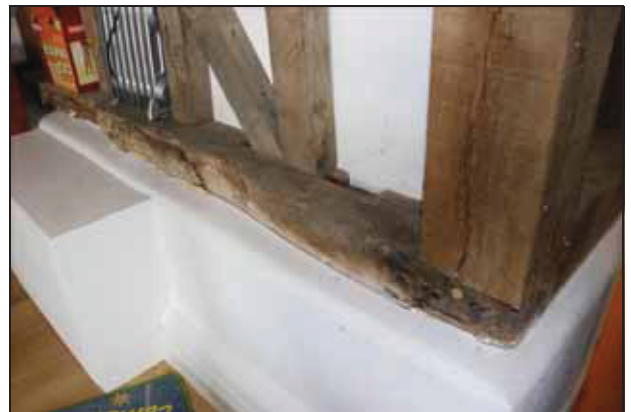
DP 33

Notches in the sole-plate on the north-west side of bay 3, taken from the east.

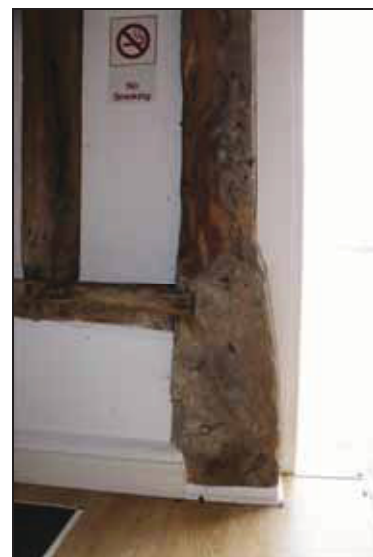
DP 35

North-west side of bay 1 in Barn 1, taken from the north-east.

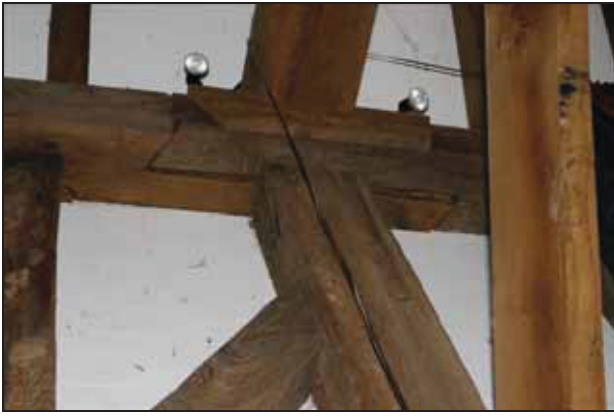
DP 36

Jowled principal post positioned upside down on the north-west side of bay 2 in Barn 1, taken from the south-east.

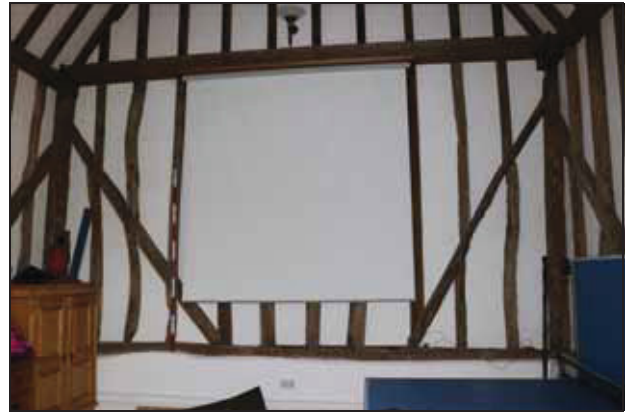
DP 37

5.10 The wall-framing is of fairly regular construction with a standard nine studs to each bay and straight primary braces (Plate 7). The wall-plates have face-halved under-squinted scarf joints at the bay divisions each with a nailed-on plate to its edge (Plate 8). The original pattern of pegging is not entirely clear because the recent rebuilding has pegged every replacement, however where the original

Scarf joint in the wall-plate at the bay divisions in Barn 1, taken from the south-east.

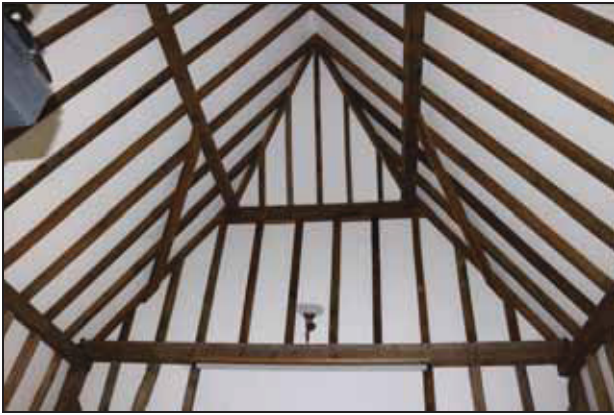
DP 38

South-west end of Barn 1, taken from the north-east.

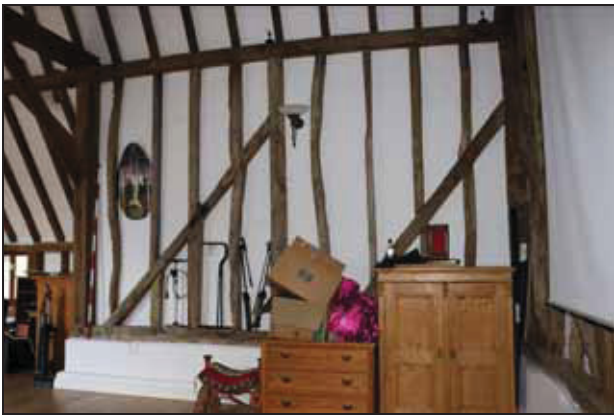
DP 40

Studwork and sole-plate at the south-west end of Barn 1, taken from the north-east.

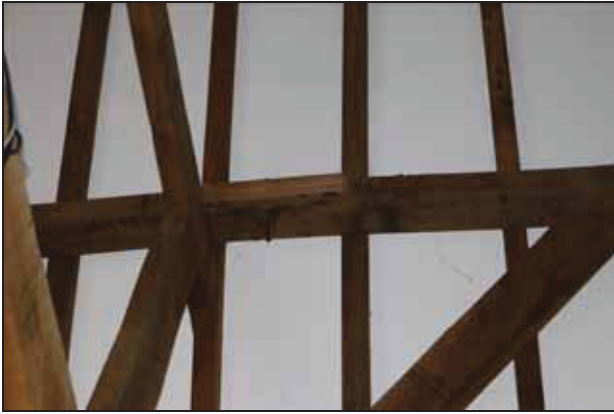
DP 42

Truss form in Barn 1, taken from the south-west.

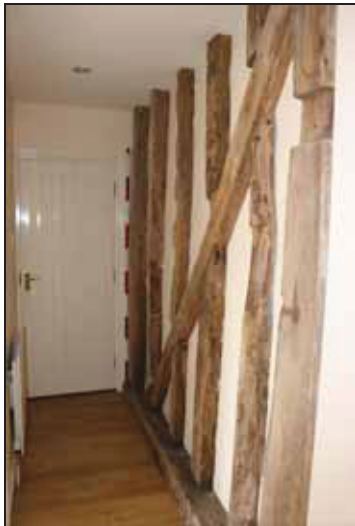
DP 44

North-west side of bay 3 in Barn 1, taken from the south.

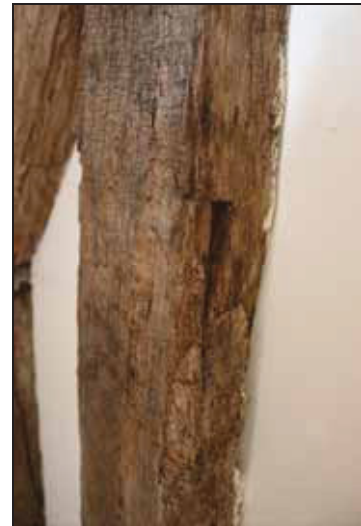
DP 45

North-west side of bay 3 in Barn 1, taken from the north-east.

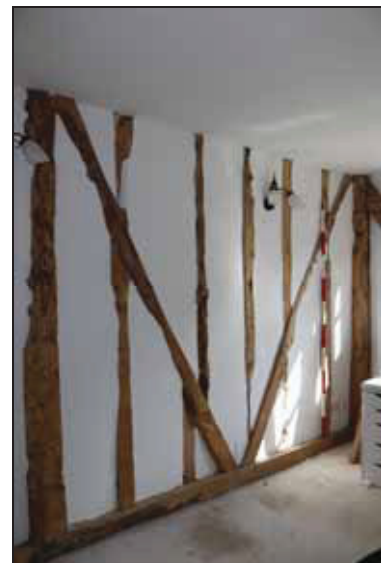
DP 47

Subdivided bay 3 in Barn 1, taken from the south-east.

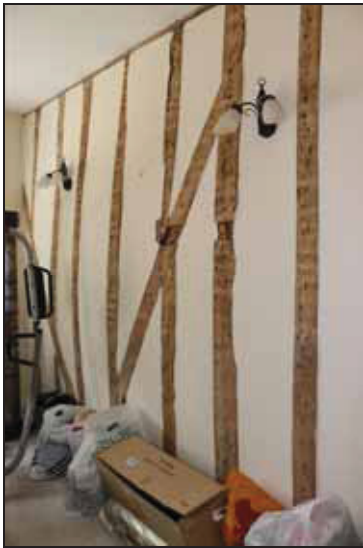
DP 48

North-east end of bay 3 in Barn 1, taken from the south-west.

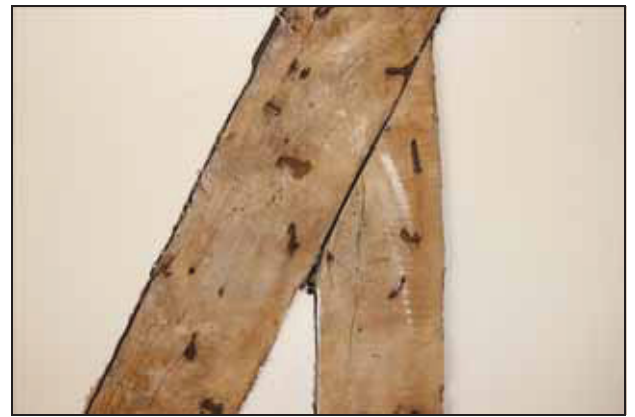
DP 49

Original outer wall of Barn 1, taken from the north-west.

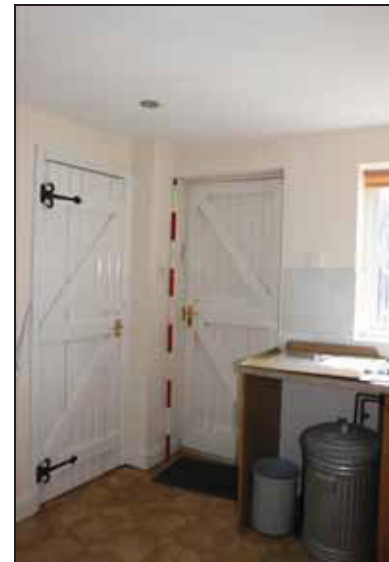
DP 51

North extension to Barn 1, taken from the north-west.

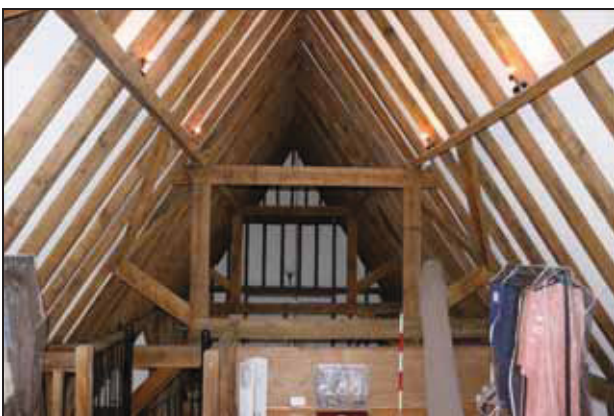
DP 52

North-west extension to Barn 1, taken from the north-west.

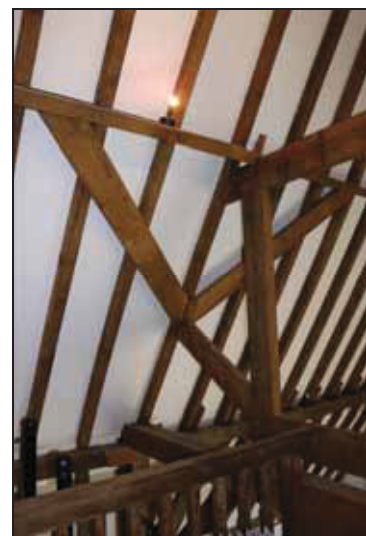
DP 53

Roof structure in Barn 1, taken from the north-east.

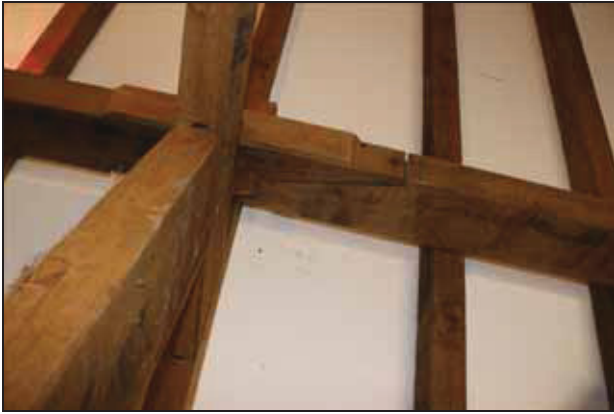
DP 54

Roof structure in Barn 1, taken from the north-west.

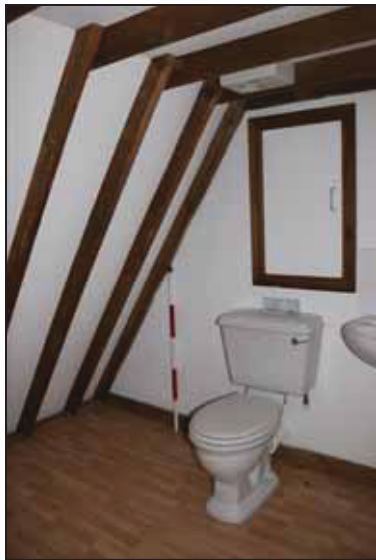
DP 56

Mezzanine level in bay 3 of Barn 1, taken from the south-west.

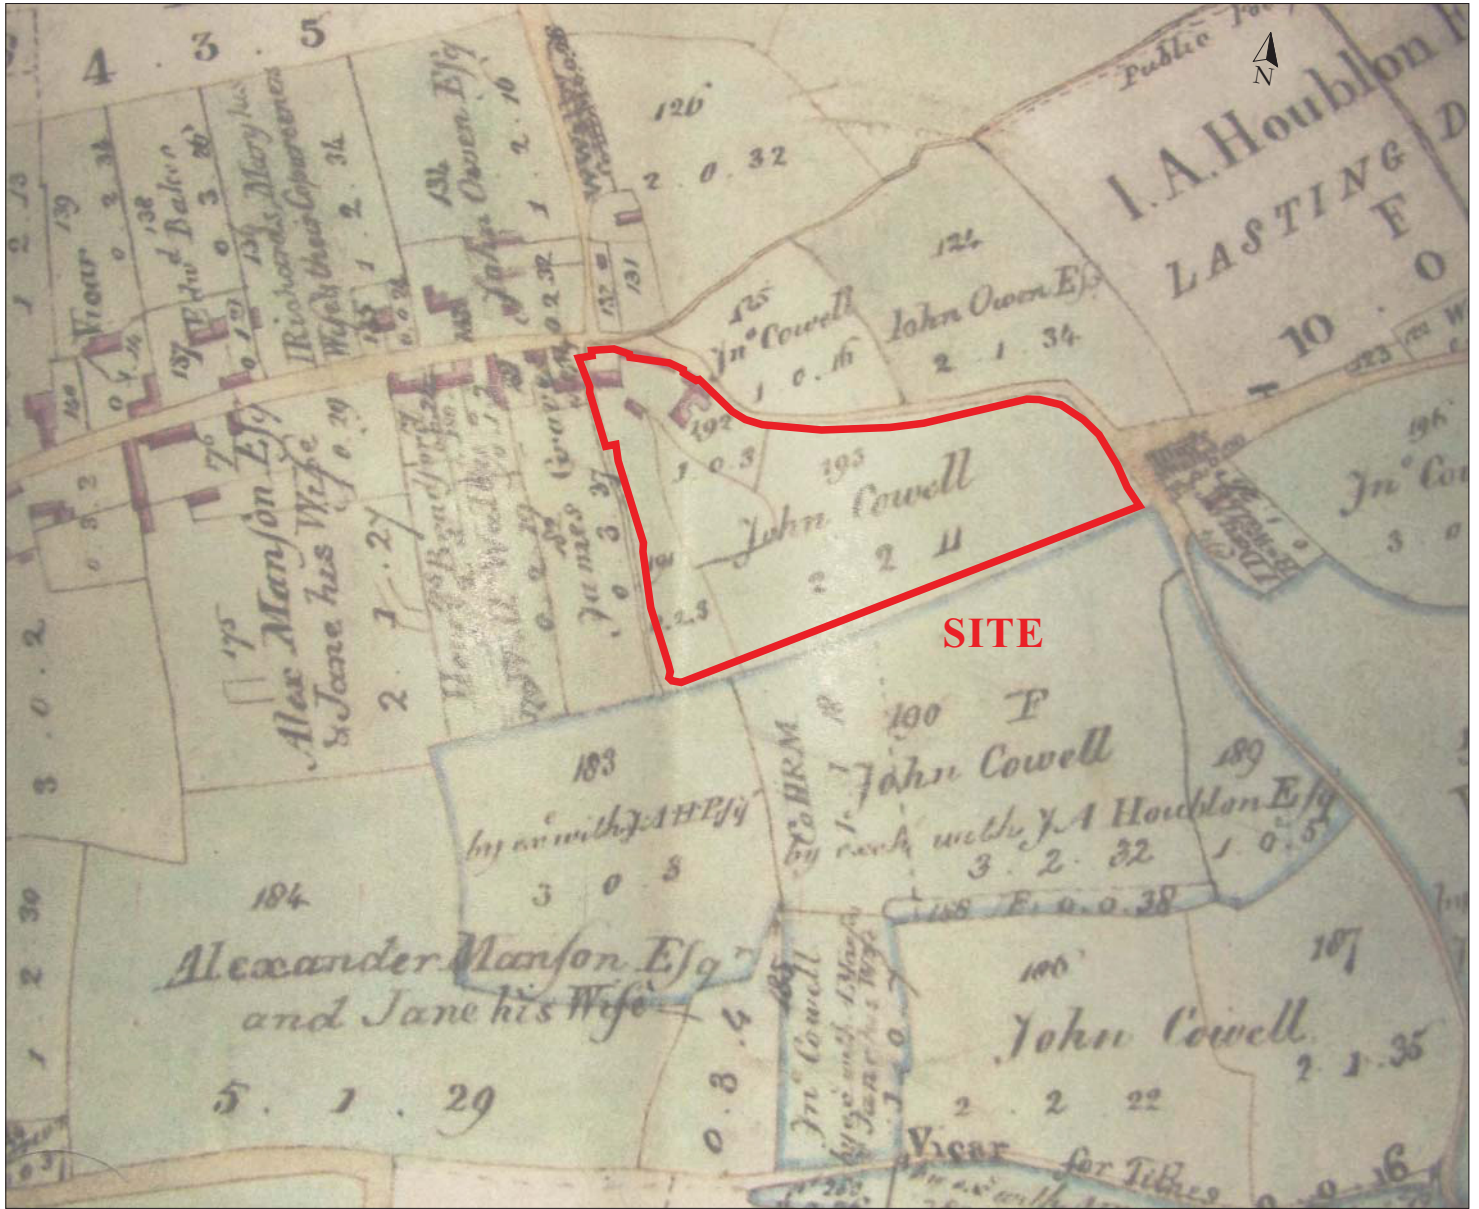
Archaeological Solutions Ltd
Fig. 3 Enclosure map, 1823
Not to scale
Barn at Dane End House, Great Hormead, Herts (P6858)

4.2.6 The first cartographic source of 1823 shows the original house in the position of the new modern garage, comprising a rectangular structure, orientated east-west near the western property boundary (Fig. 3). A small rectangular structure, presumably the third, now demolished, barn lies to the south-east. Barn 1 is visible to the east of this with two projecting ranges at the north and south ends. The site is labeled as owned by John Cowell, as are many of the surrounding fields.
