AMWELL END, DOWN GREEN LANE,  
WHEATHAMPSTEAD, HERTFORDSHIRE  
HISTORIC BUILDING MONITORING AND RECORDING

Authors:	Tansy Collins BSc Kathren Henry	
NGR: TL 16762 13340	Report No. 4951	
District: St Albans	Site Code: n/a	
Approved: C. Halpin MCIFA	Project No. 5679	
Signed:	Date: 28 September 2015

## HISTORIC BUILDING MONITORING AND RECORDING

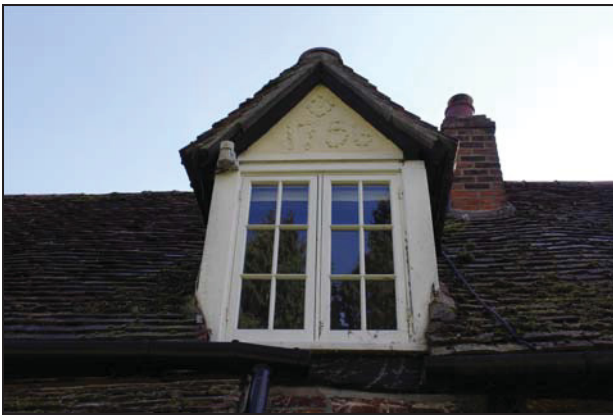
3

*Dormer window on the west side of Range 1 showing date of 1756, taken from the west*

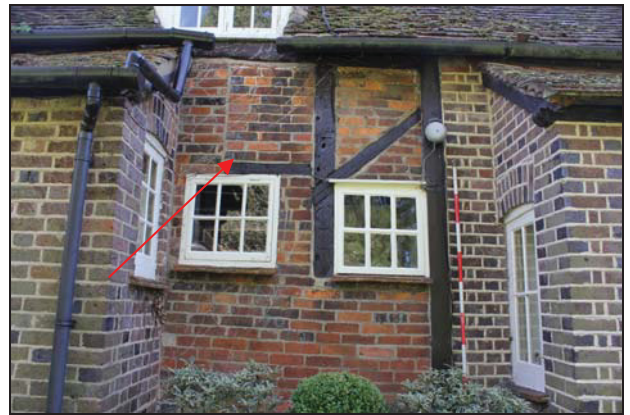
4

*Section of the west elevation (Range 1) showing timber-framing infilled with brick and position of possible early window (indicated), taken from the west*

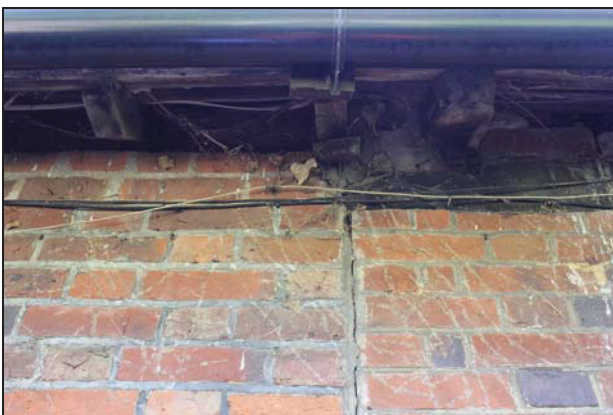
5

*West elevation between Ranges 1 and 4 showing straight joint in the brickwork, taken from the west*

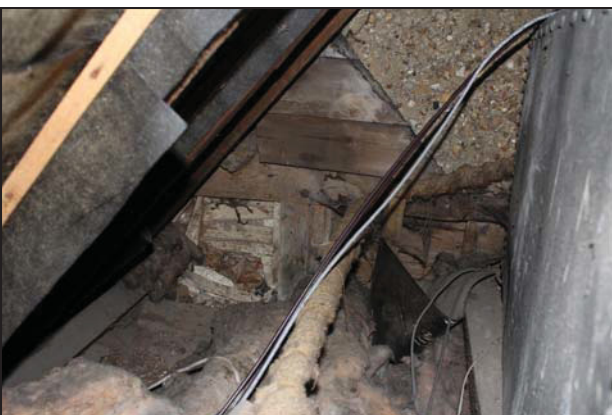
11

*Roof space of the south gable end of Range 1 showing exposed timber framing, taken from the south*

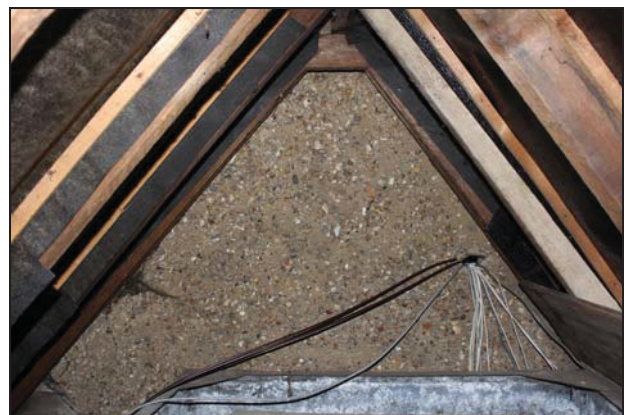
12

*Roof space of the south gable end of Range 1 showing pebble-dashing, taken from the south*

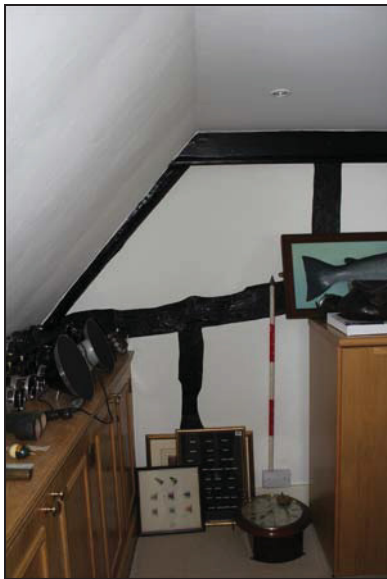
21

View of the timber-framing of the south end of Range 1 visible within Room FF08 (Range 2), taken from the south

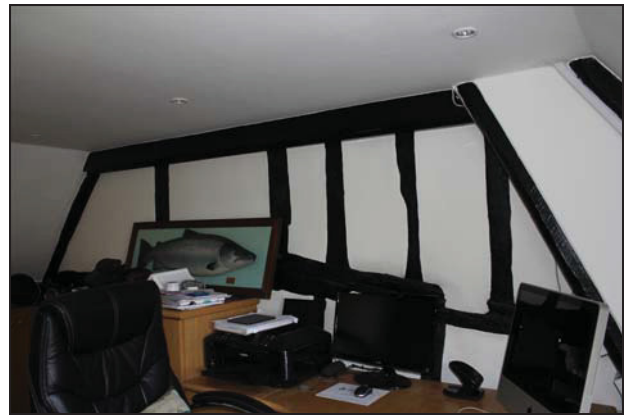
22

View of the timber-framing of the south end of Range 1 visible within Room FF08 (Range 2), taken from the south-east

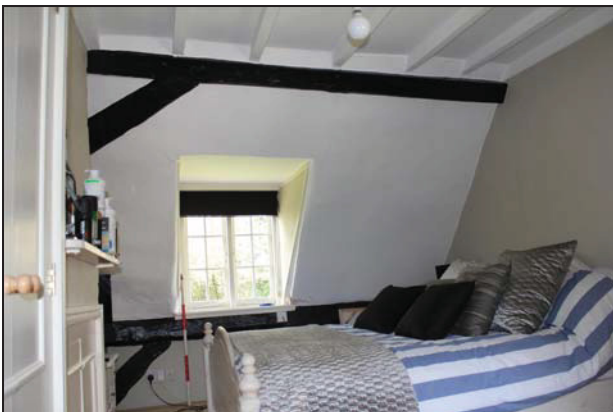
23

West side of Room FF07 (Range 1) showing exposed timber elements including a wind brace, taken from the east

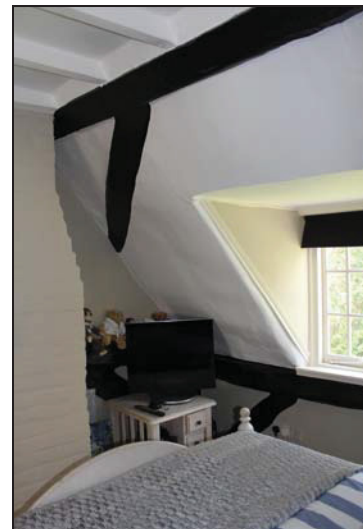
24

West side of Room FF07 (Range 1) showing exposed timber elements including a wind brace, taken from the north-east

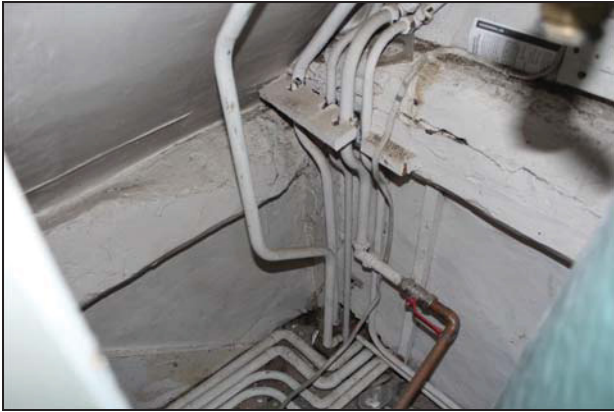
25

*Cupboard in the south-east corner of Room FF07 (Range 1) showing timber-framing including a corner post with tie-beam and wall-plate and section of brace visible on the left, taken from the north-west*

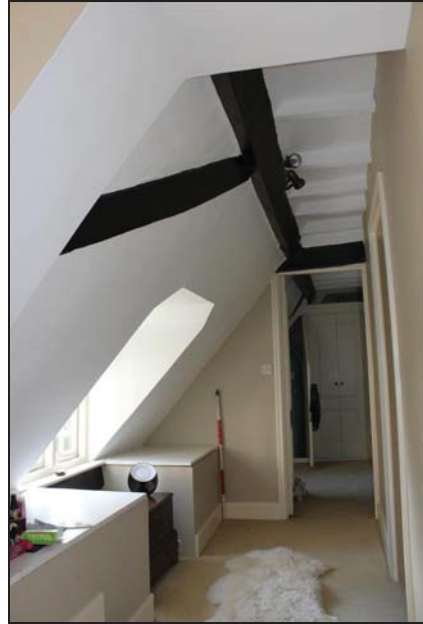
26

*Corridor FF05 on the east side of Range 1 showing exposed roof timbers including a wind brace, taken from the north*

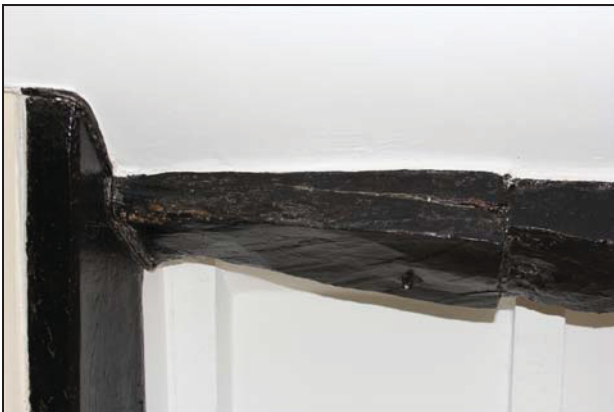
27

*Crude scarf joint in the purlin on the east side of Range 1 (FF05), taken from the west*

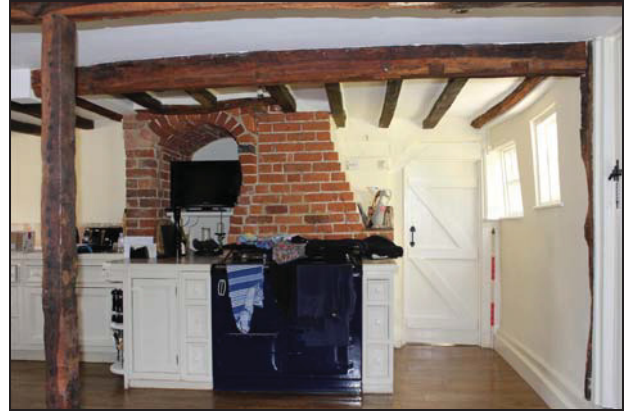
38

*South side of Room GF04 (Range 1) showing exposed brick chimney stack, taken from the north*

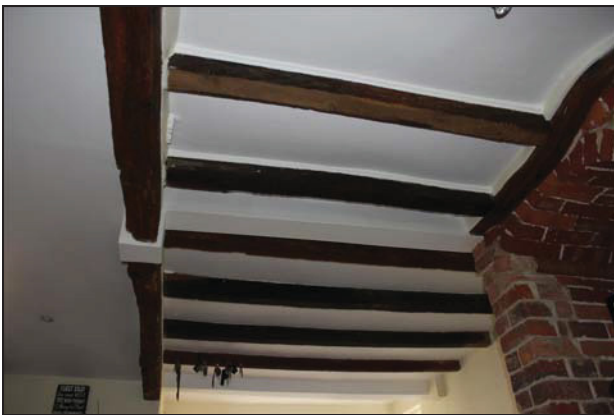
44

*Binding joist between Rooms GF03 and 04 showing redundant mortices for staves and studs (Range 1), taken from the east*

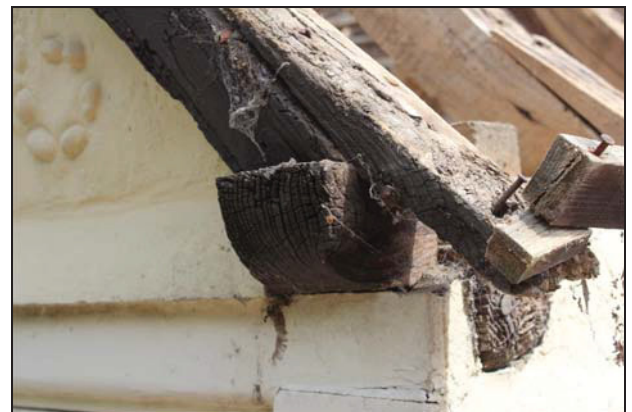
59

*Detail of the dormer window (Range 1: Bay 2, west side) showing gable with modern cement render infill, taken from the west*

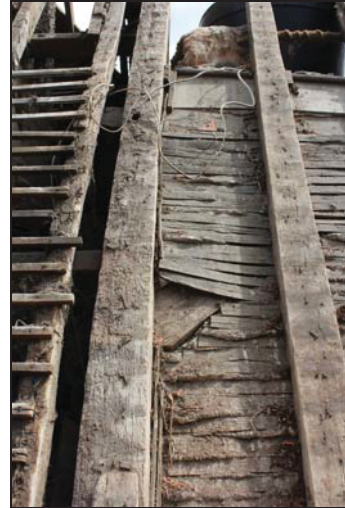
67

*West roof pitch of Range 1 (Bay 1: south end) showing principal rafter with pegged collar and weathered projecting purlin end, taken from the west*

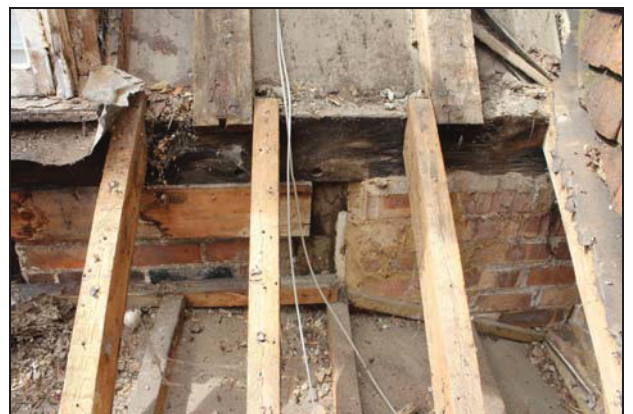
77

Plate 8 East roof pitch of the historic core (Bay 1: north end) showing wind brace with lath and plaster above and replacement boarding below, taken from the east (DP 77)

*East roof pitch of Range 1 (Bay 1: north end) showing wind brace with lath and plaster above and replacement boarding below, taken from the east*

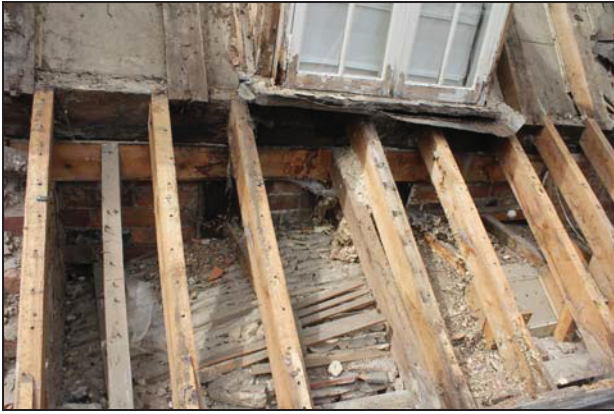
78

*East side of Range 1 (Bay 1: north end) showing wall-plate with surviving stud and adjacent peg-holes for a tension brace, taken from the east*

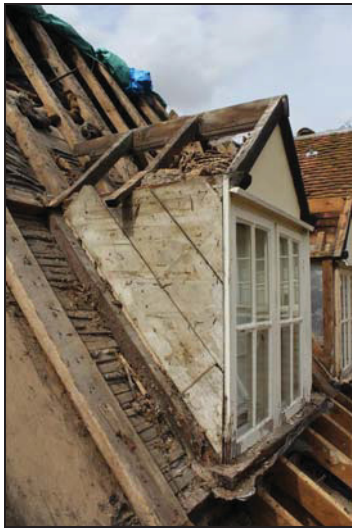
80

*Dormer window (Range 1: Bay 1, east side), taken from the south-east*

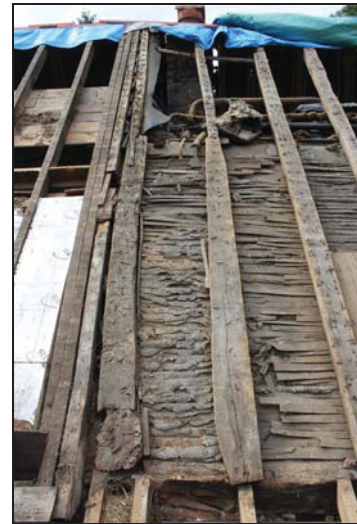
81

*Dormer window (Range 1: Bay 2, east side), taken from the south*

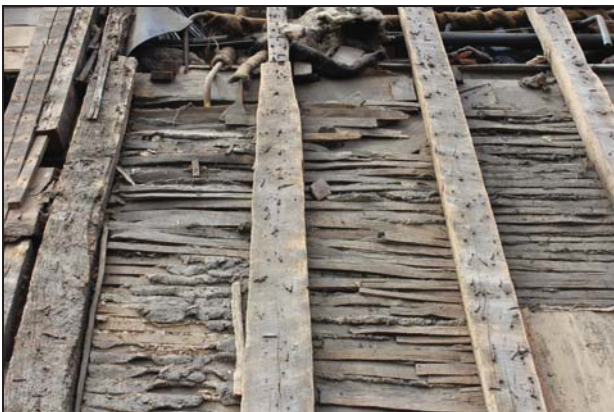
82

*East roof pitch at the junction between Ranges 1 and 2, taken from the east*

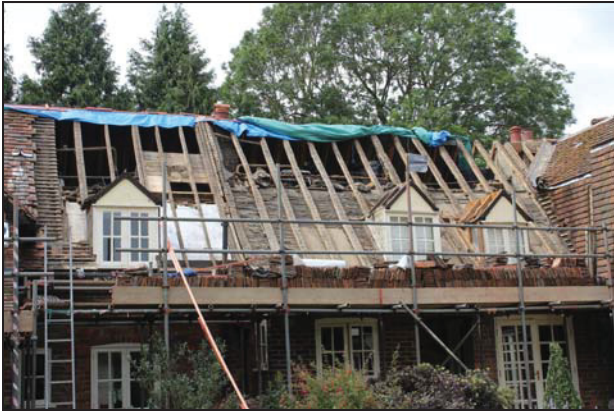
84

*View of the east side of Ranges 1 and 2 during removal of the roof cladding, taken from the east*

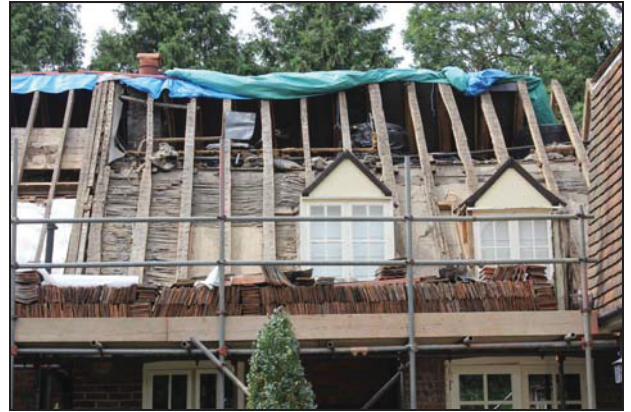
85

*View of the east side of Ranges 1 and 2 during removal of the roof cladding, taken from the east*

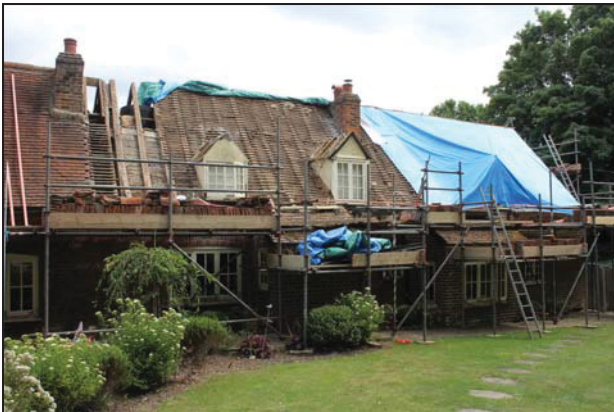
86

*View of the east roof pitch of Range 1, taken from the east*

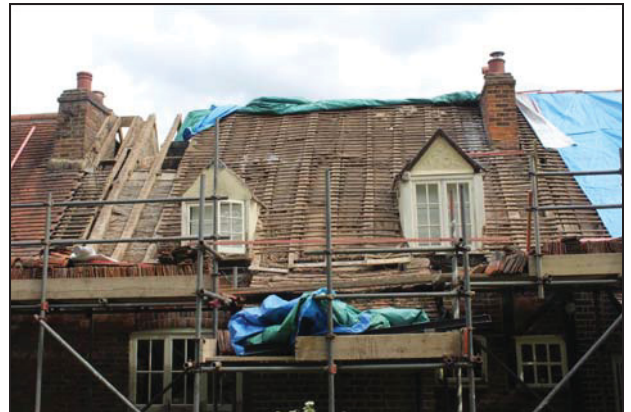
87

*View of the west side of Ranges 1 and 2 during removal of the roof cladding, taken from the west*

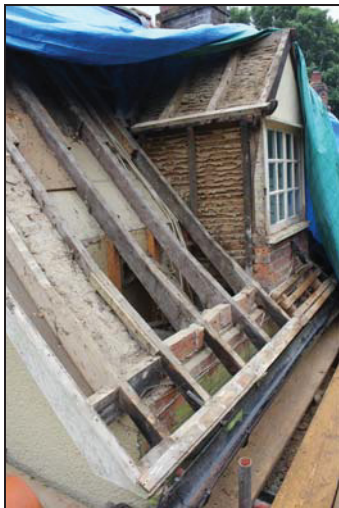
88

*View of the west roof pitch of Range 1, taken from the west*

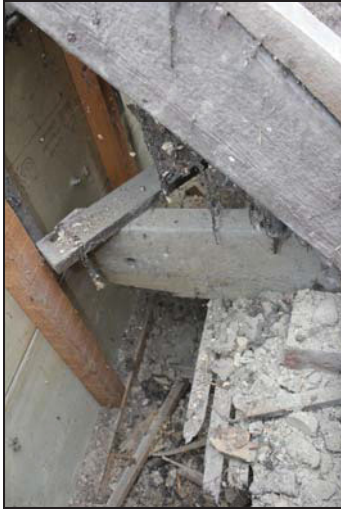
90

*Detail of the west roof pitch of Range 4 showing alterations of the roof structure, taken from the west*

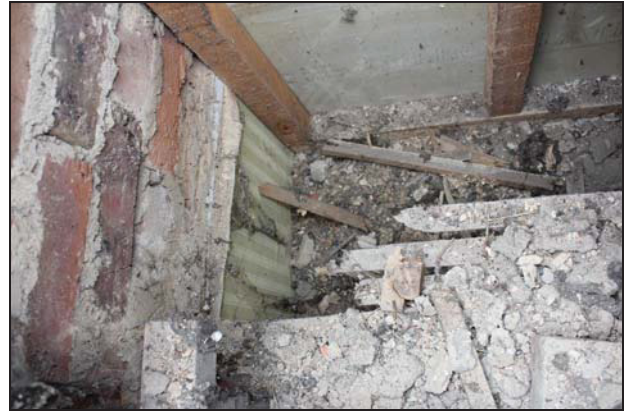
91

*Detail of the west roof pitch Range 4 showing truncated tie-beam, taken from the north*

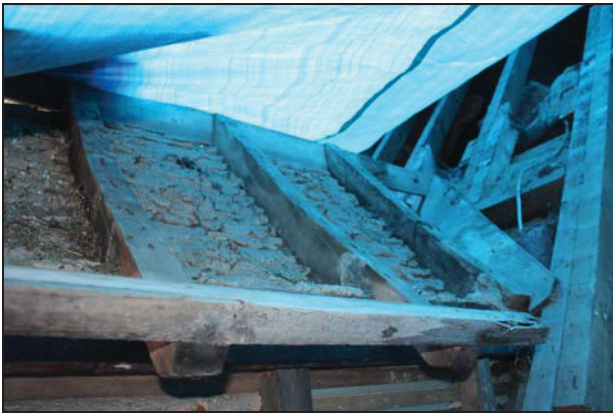
92

*Detail of the west side of the roof over Range 4 showing wallpaper entombed by the later remodelling of the range, taken from the west*

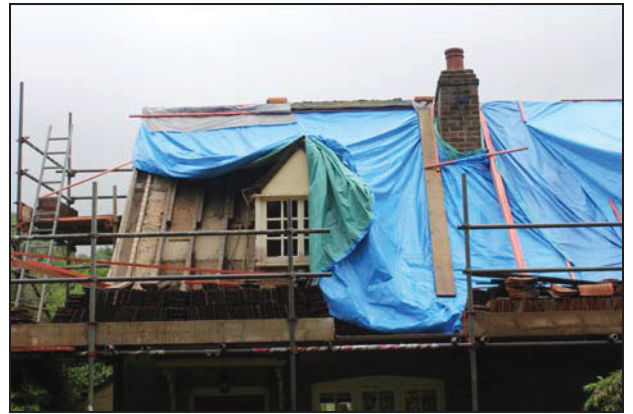
93

*Detail of the dormer window (Range 4: west side) showing rafter couples to a ridgeboard, taken from the south-west*

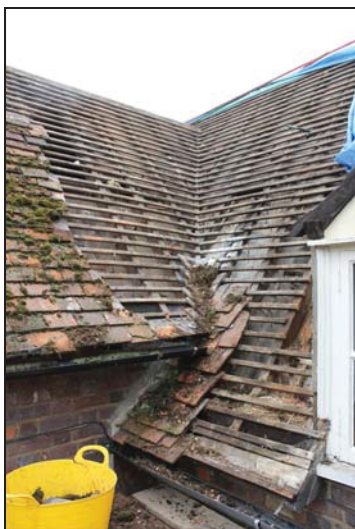
94

*Detail of the west roof pitch of Range 4 showing alterations to the roof structure, taken from the west*

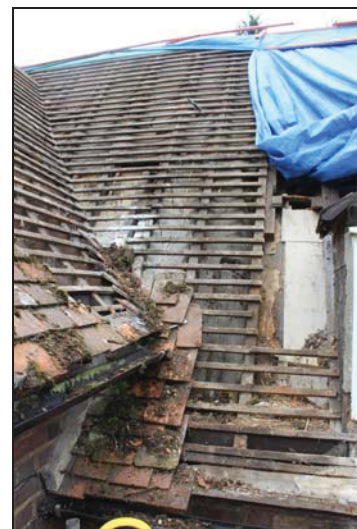
95

*East roof pitch of Ranges 2 and 3, taken from the south-east*
