CENTRAL MALTING, NEW ROAD, WARE,  
HERTFORDSHIRE

HISTORIC BUILDING APPRAISAL

Authors: Matthew Williams MA MSc Lee Prosser BA PhD	
NGR: TL 3603 1433	Report No. 3149
Parish: Ware	Site Code: AS 1163
Approved: Claire Halpin MIFA	Project No. 3260
Signed:	Date: September 2008

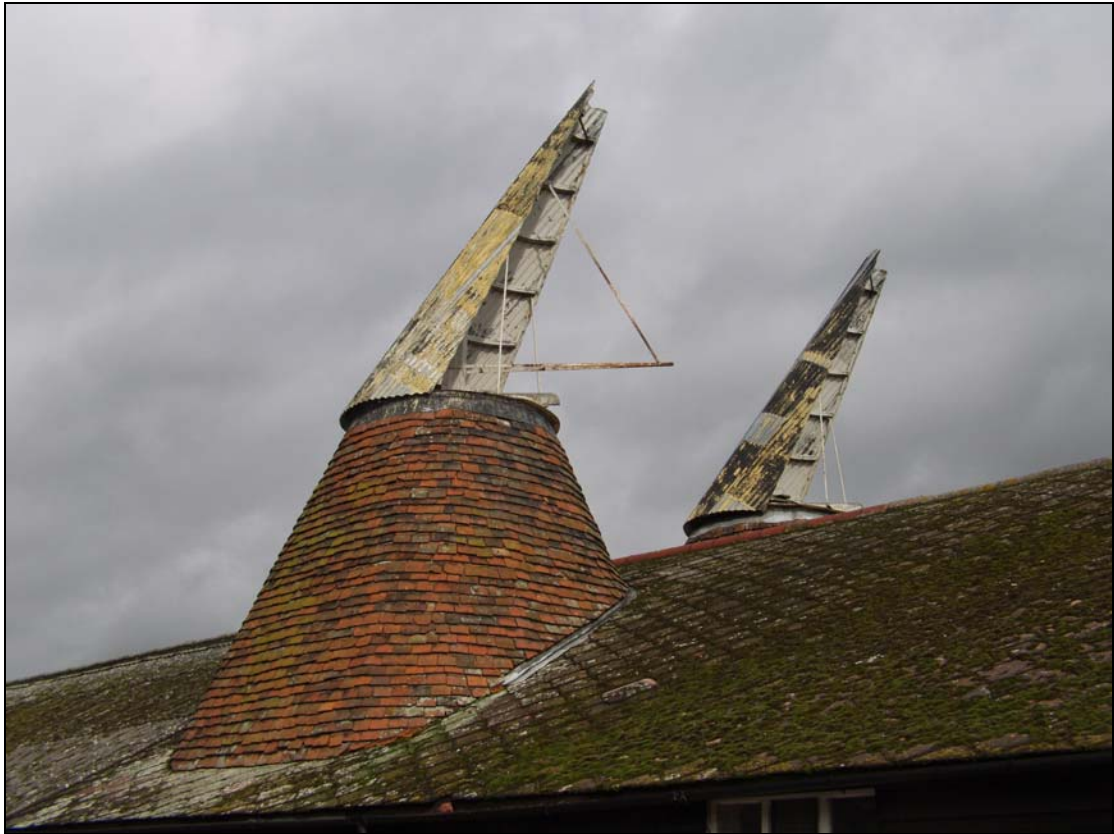
3 Two roof cowls taken from the south-east (24)

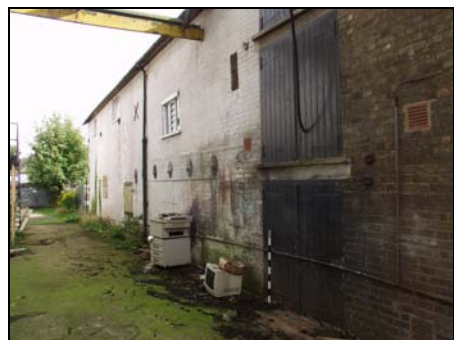
35

*Loading doors and iron tie plates to north elevation, taken from the north-east*

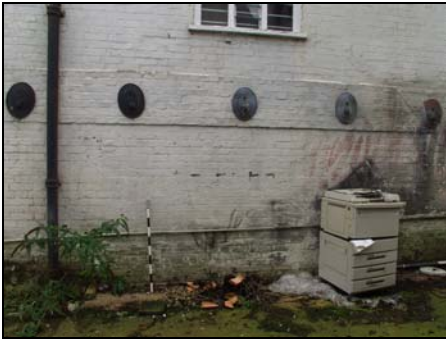
36

*Loading doors and iron tie plates to north elevation, taken from the north-east*

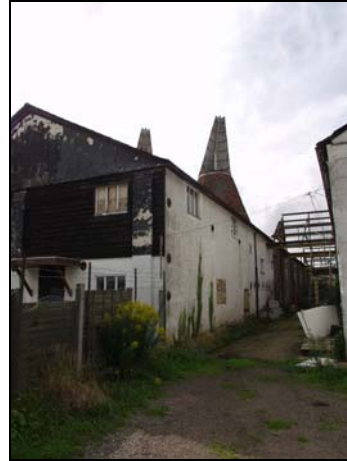
37

*Iron tie plates to north elevation, taken from the north*

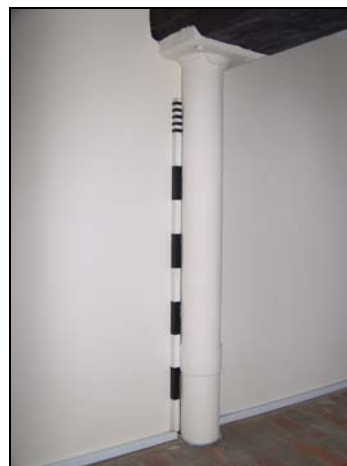
41

5.3.3 Among a few distinguishing features, two blocked shovelling apertures remain visible on the east wall which formerly gave access from the central floor into the adjacent kilns. It is also possible to discern the sawn-off stumps of many former cast iron stanchions in the floor which once supported the upper levels in two rows. Their spacing varies, but have been noted in Figure 3. A further surviving detail is a series of indentations in the wall at the south-west corner, caused by abrasion from the use of a vertical ladder formerly attached to the wall at this point (Plate 10). The space

*Detail of former position of ladder*

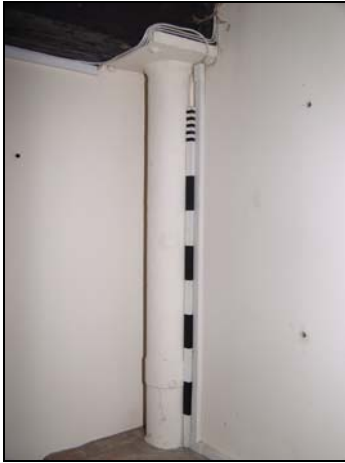
42

*Detail of surviving iron stanchion*

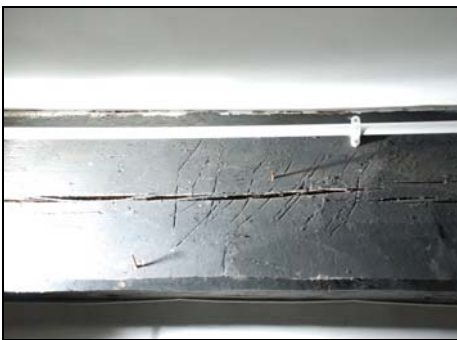
46

6.6 Elements of particular interest and historic value include the Baltic bracking marks, which are typically found on early 19<sup>th</sup> century industrial and agricultural buildings where good quality Baltic softwood was utilised, and the fairly low impact that conversion in the 1980s had to the overall integrity of the building. Though dilapidated, the three maltings also preserve much of their original external appearance in outline, complete with kiln cowls, and thus their value as a group is an important historic asset to the town.

*Detail of Baltic mark in store room*
