**THE BARN, OLD PARK FARM, PERRY GREEN, MUCH
HADHAM, HERTFORDSHIRE**

HISTORIC BUILDING RECORDING

Authors:	Tansy Collins BSc Lee Prosser PhD Matthew Williams MA MSc Charlotte Davies BA Kathren Henry	
NGR: TL 44299 16773	Report No: 3233	
District: East Hertfordshire	Site Code: AS 1182	
Approved: Claire Halpin	Project No: 3296	
Signed:	Date: December 2008

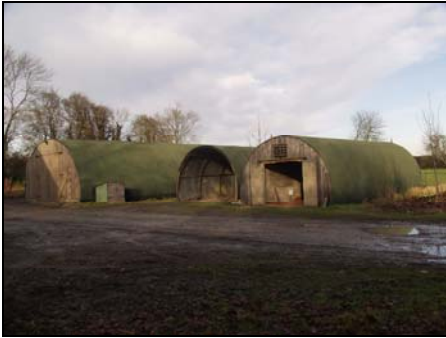
1

Exterior view of Buildings 2-4, taken from the south

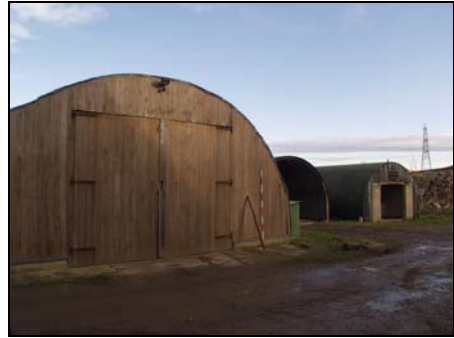
2

South-west elevation of Buildings 2-4, taken from the south-west

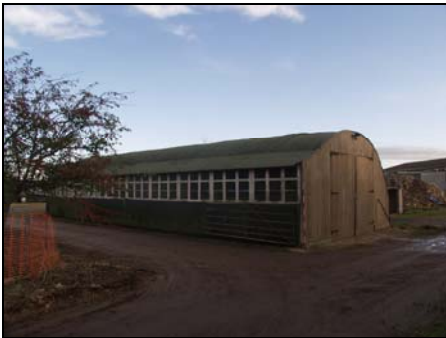
3

North-west and south-west elevations of Building 2, taken from the west

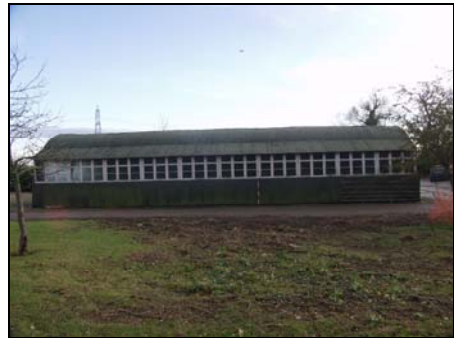
4

North-west elevation of Building 2, taken from the north-west

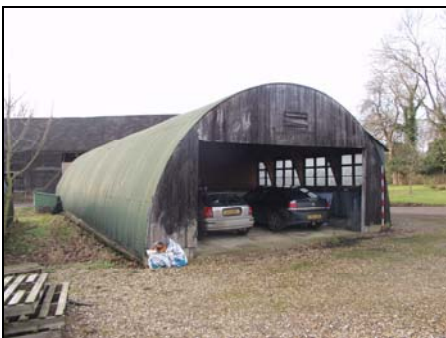
5

North-east elevation of Building 2, taken from the north-east

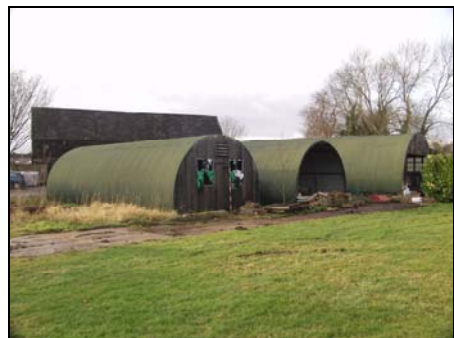
6

Exterior view of Buildings 2-4 with Building 1 visible to the rear, taken from the south-west

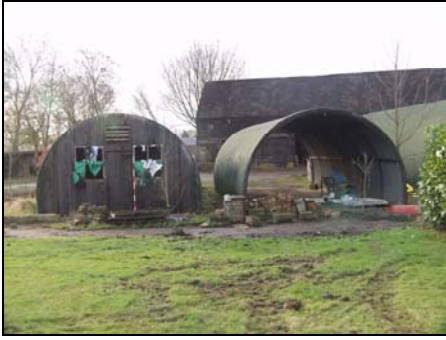
7

North-east elevation of Buildings 3 and 4, taken from the north-east

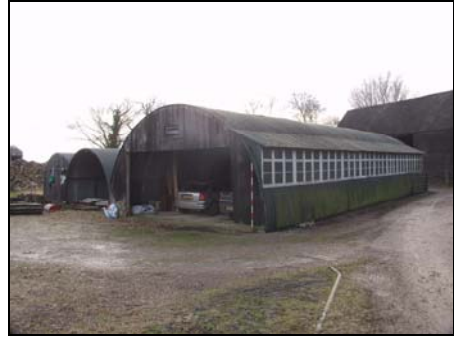
8

North-west and south-east of Building 2, taken from the north

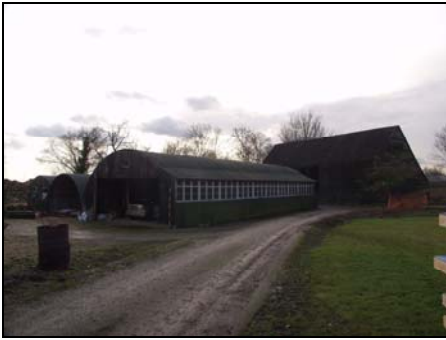
9

View of Building 2 with Building 1 (the barn) to the rear, taken from the north-east

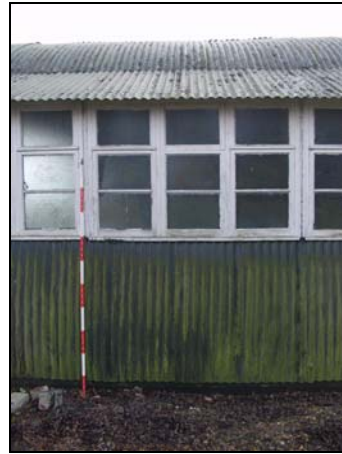
10

Detail of casement on the north-west wall of Building 2, taken from the north-west

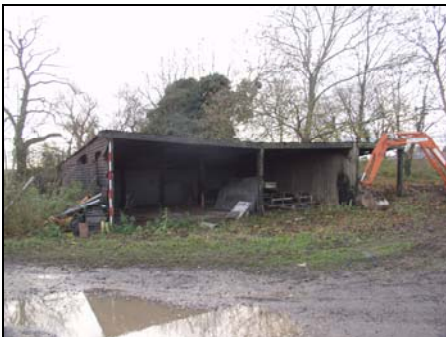
11

View of Building 5, taken from the north-east

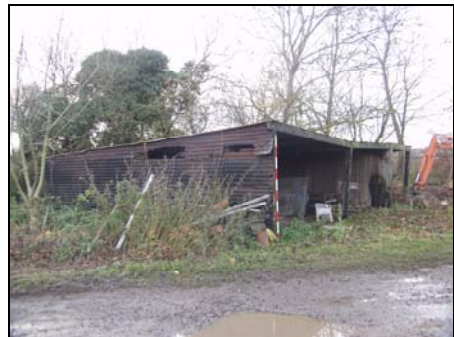
12

East and north wall of Building 5, taken from the north-east

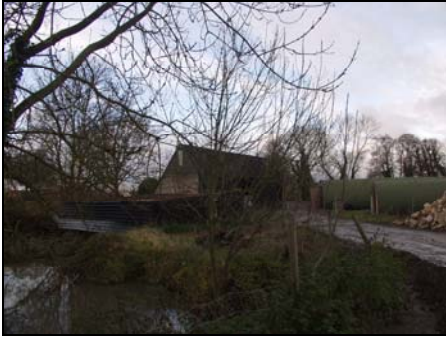
13

South side of Building 5 with Building 1 to the rear, taken from the south-east

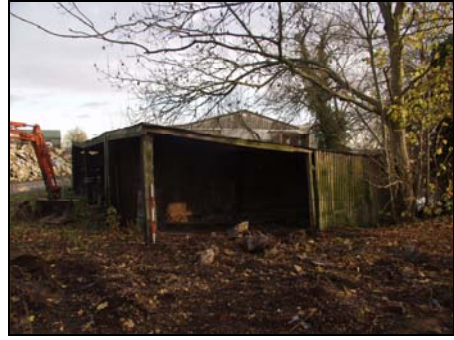
14

West side of Building 5, taken from the west

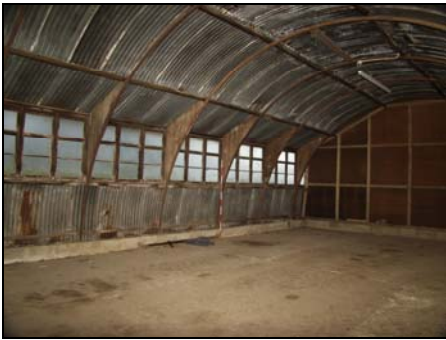
15

South-west area of Building 2, taken from the south

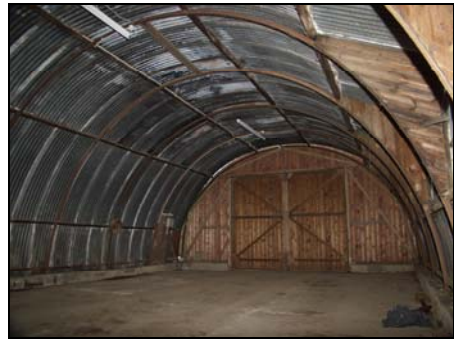
16

South-west area of Building 2, taken from the north-east

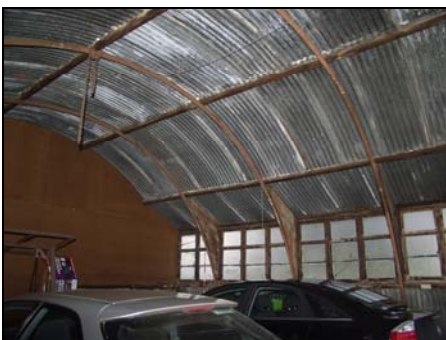
17

North-east area of Building 2, taken from the east

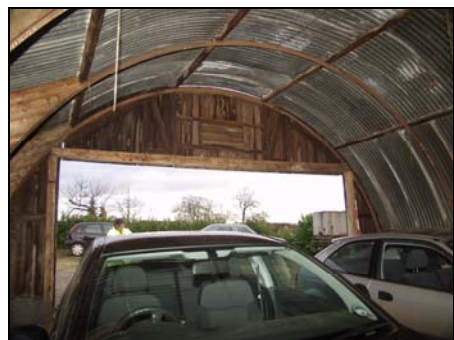
18

North-east area of Building 2, taken from the south-west

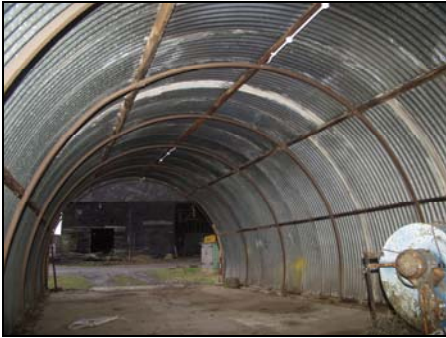
19

Interior of Building 3, taken from the north-east

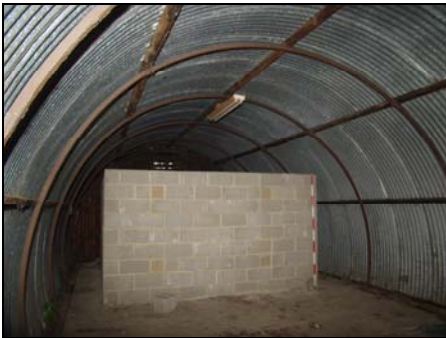
21

Interior of Building 3, taken from the north-east

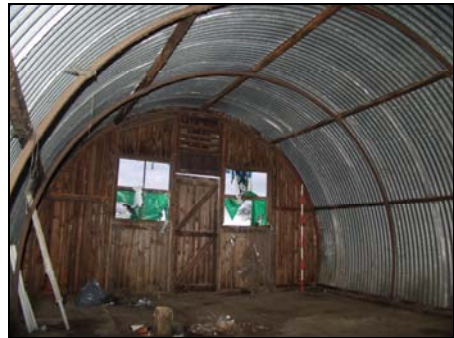
22

North-east of Building 3, taken from the south-west

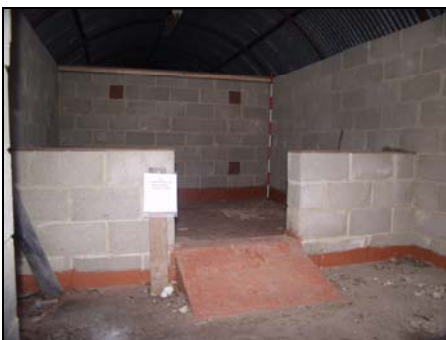
23

South-west area of Building 3, taken from the south-west

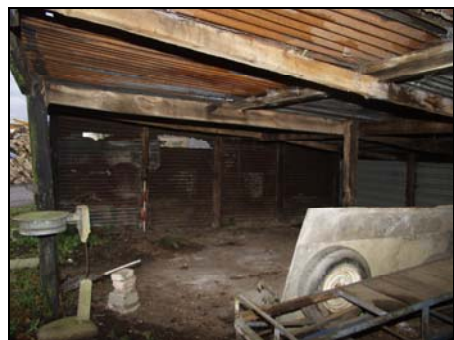
24

East side of Building 5, taken from the west

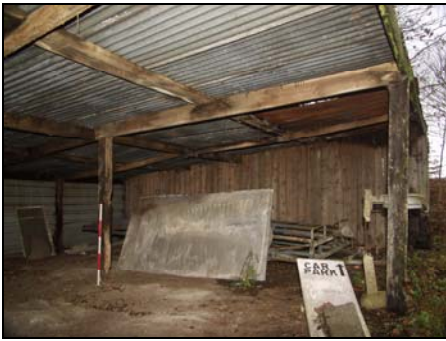
25

East side of Building 5, taken from the east

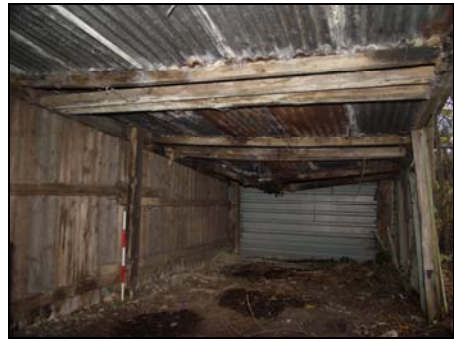
26

West side of Building 5, taken from the north

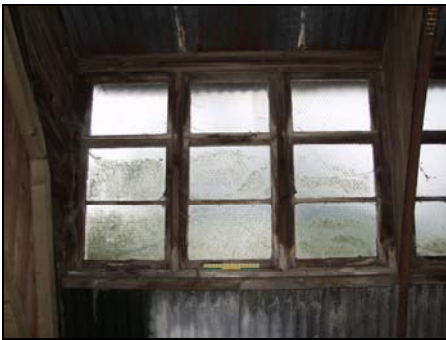
27

Detail of casement in Building 2, taken from the south-east

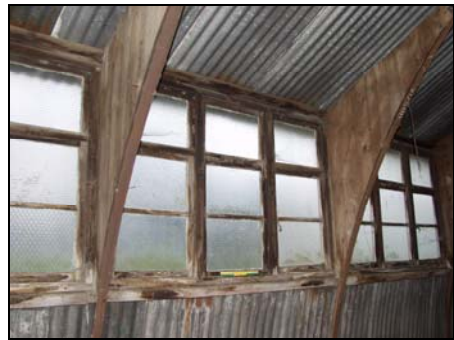
28

Detail of casement in Building 2, taken from the south

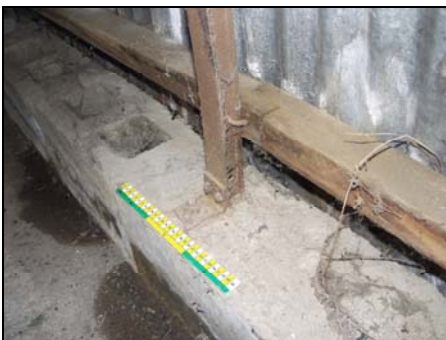
29

Construction detail of Building 2 at base of a truss, taken from the west

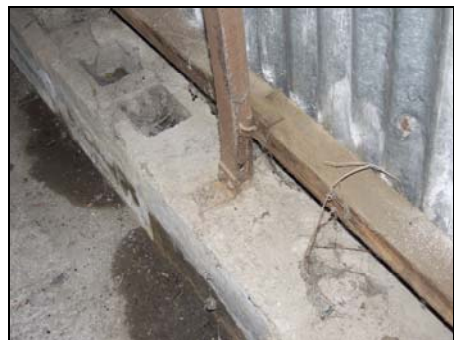
30

Construction detail of Building 2 at base of a truss, taken from the west

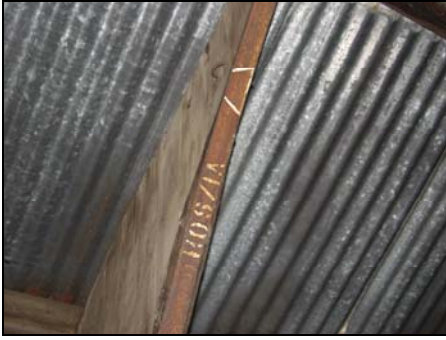
31

Detail of markings on metal trusses in Building 2, taken from the north

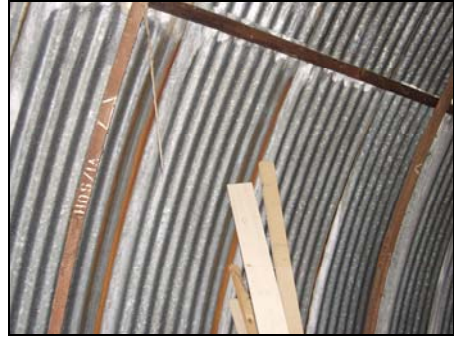
32

Detail of trusses within Building 2, taken from the north

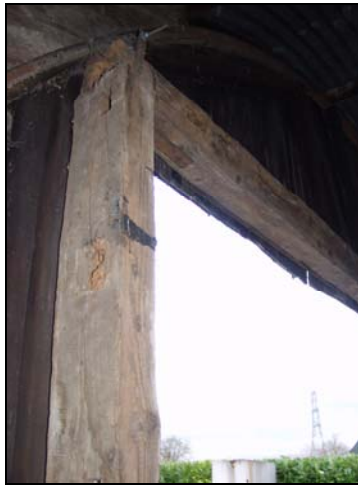
33

Detail of reused timber on the north-east side of Building 2, taken from the north-west

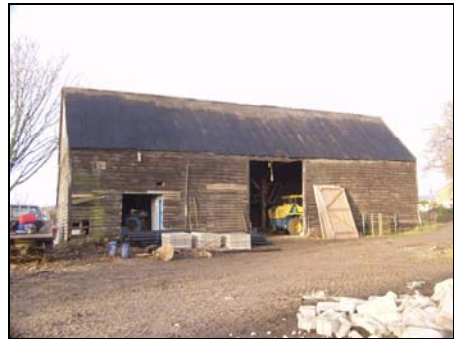
34

East elevation of Building 1, taken from the south-east

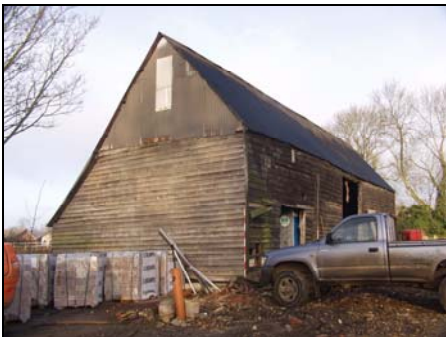
35

South and east elevation of Building 1, taken from the south-east

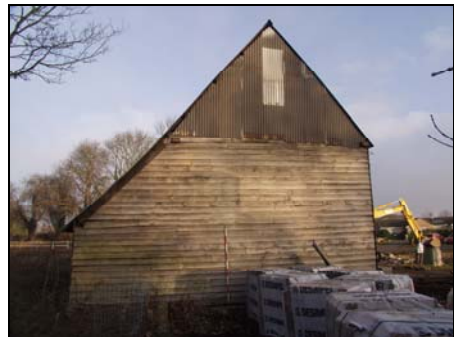
36

South elevation of Building 1, taken from the south

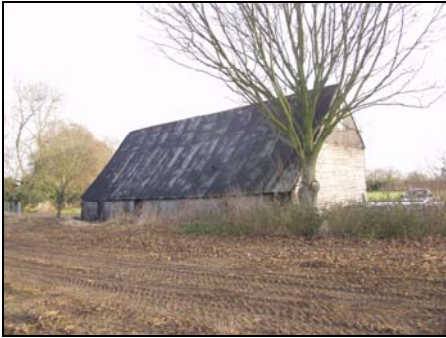
37

West and south elevation of Building 1, taken from the south-west

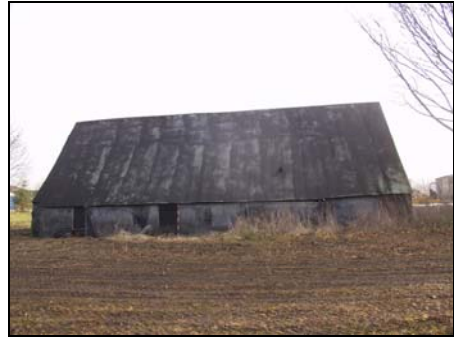
38

West elevation of Building 1, taken from the west

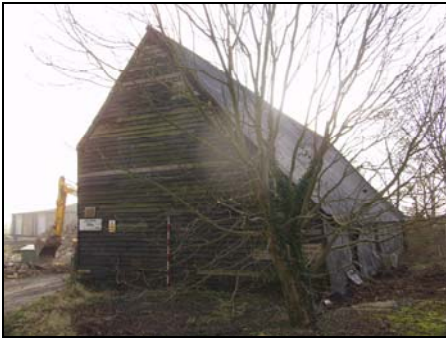
39

North elevation of Building 1, taken from the north
