**23 BALDOCK STREET,
WARE**

HISTORIC BUILDING APPRAISAL

Authors: Dr Lee Prosser BA PhD Tansy Collins Bsc	
NGR: TL 3558 1455	Report No. 3400
District: East Herts	Site Code: n/a
Approved: Claire Halpin	Project No. 3569
MIFA	Date: October
Signed:	2009

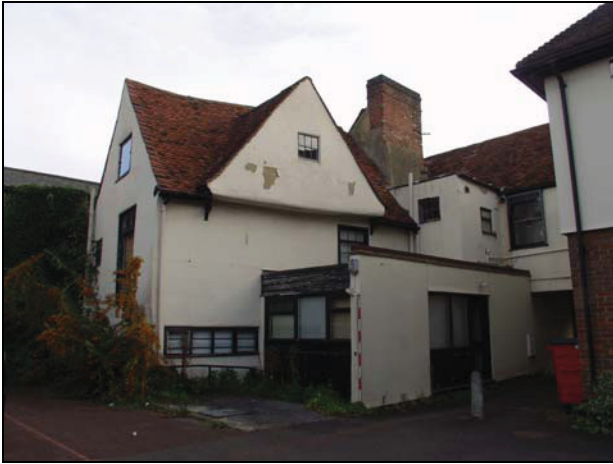
DP 1

View of the rear range with south gable and later extensions, taken from south-west

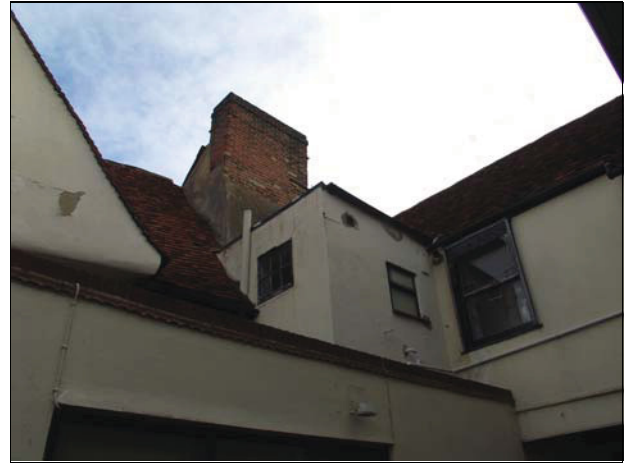
DP 2

View of the junction between the main and rear ranges showing flat roofed addition, taken from the south-west

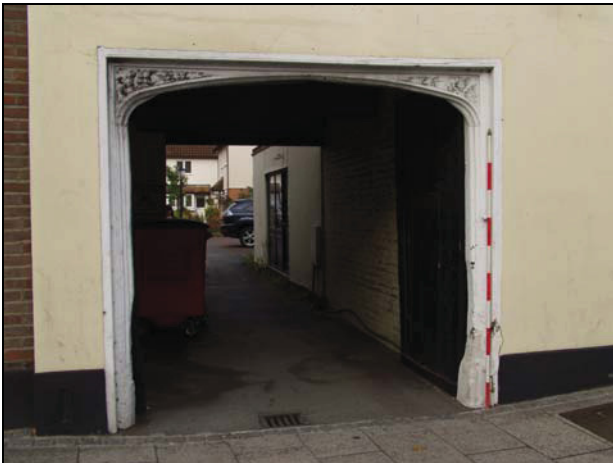
DP 3

View of the carriageway arch, taken from the east

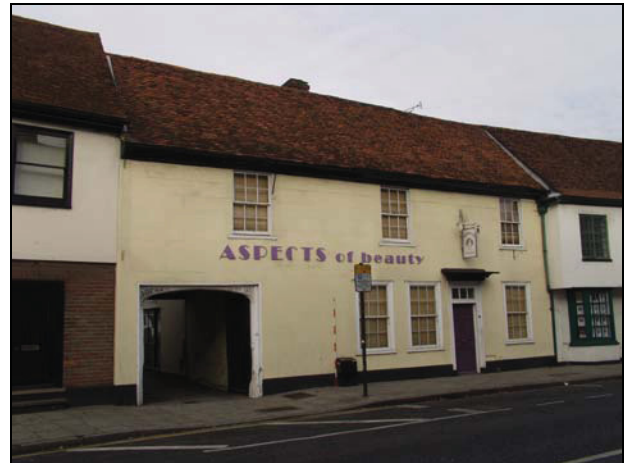
DP 4

East elevation of the building, taken from the south-east

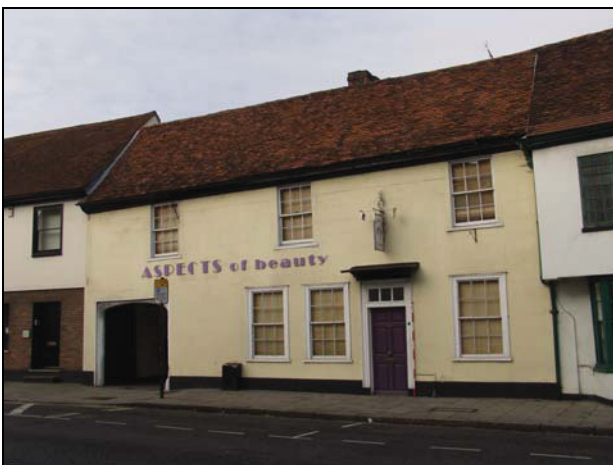
DP 5

East elevation of the building, taken from the east

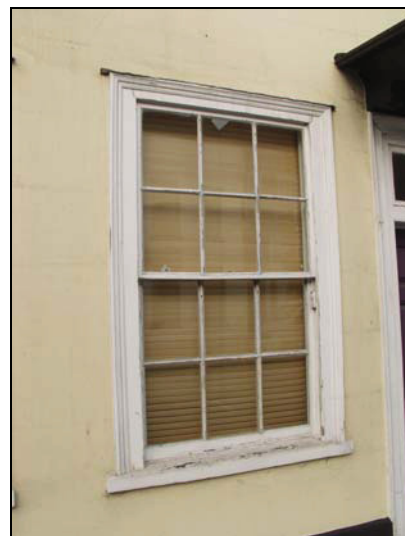
DP 6

Window on the ground floor of the east elevation, taken from the south-east

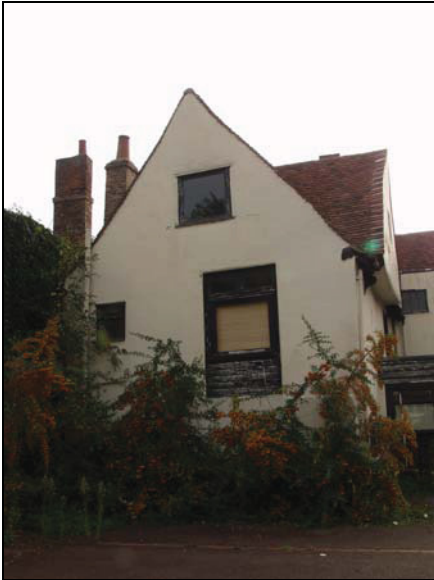
DP 7

West elevation of the rear range, taken from the west

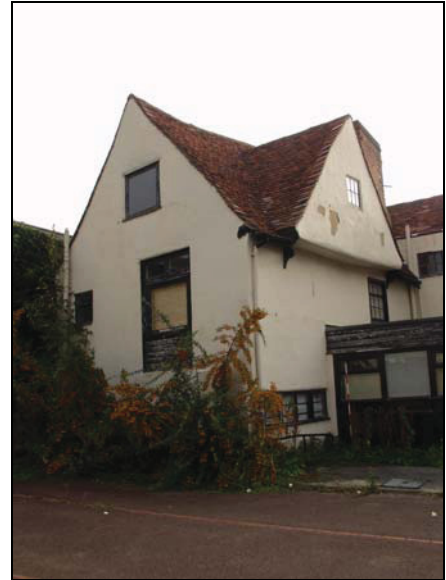
DP 8

West and south elevations of the rear range, taken from the south-west

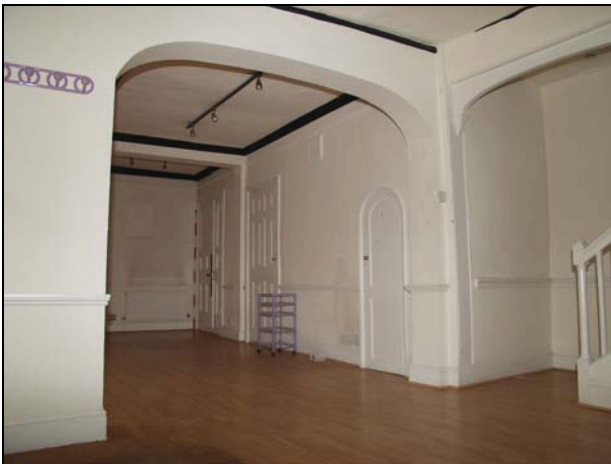
DP 9

Room 1, ground floor, taken from the north-east

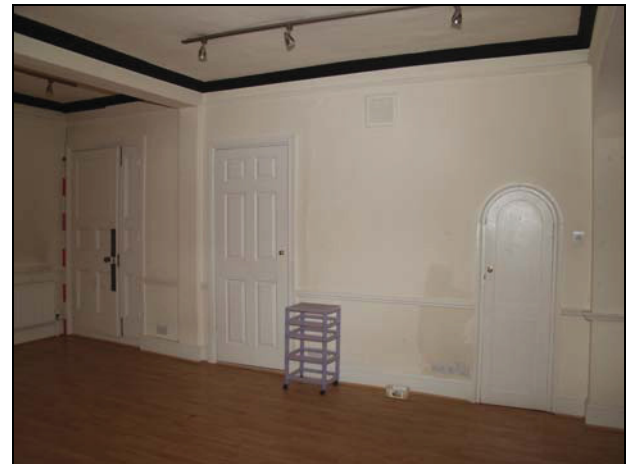
DP 10

West wall of Room 1 (south end), taken from the north-east

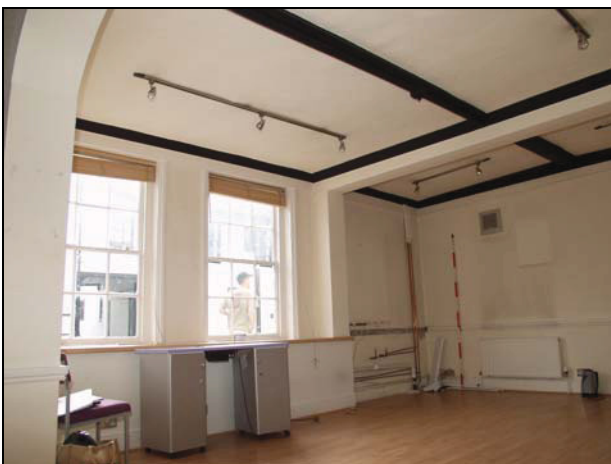
DP 11

East wall of Room 1 (south end), taken from the north-west

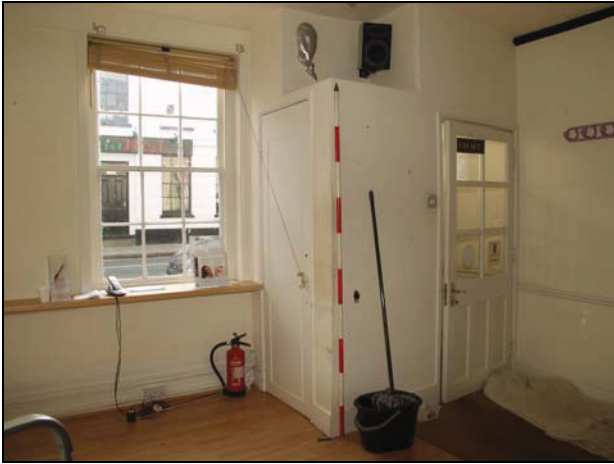
DP 13

Entrance to building in Room 1 showing internal porch, taken from the north-west

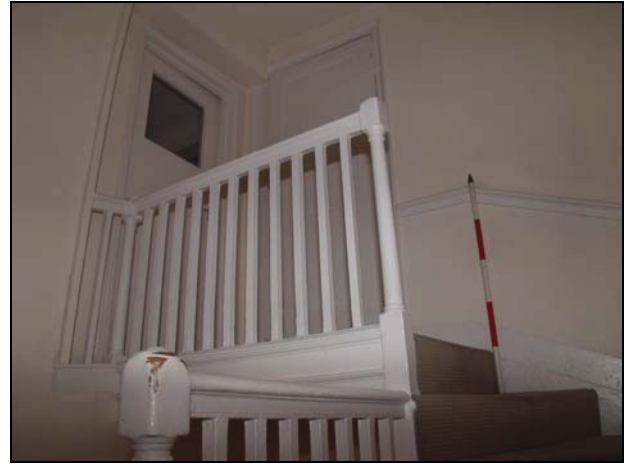
DP 14

View of the staircase at upper level, taken from the north-west

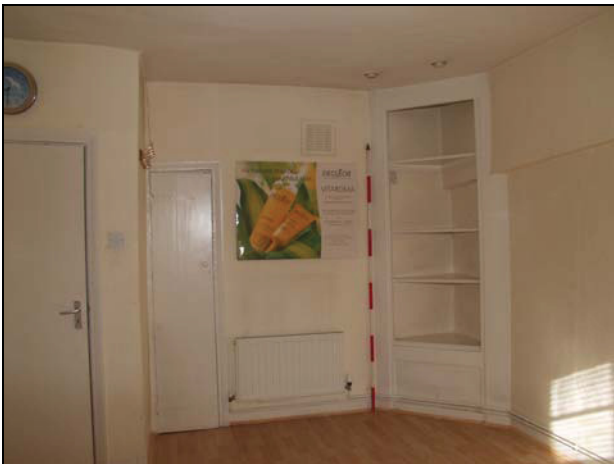
DP 15

West side of Room 6, first floor, taken from the east

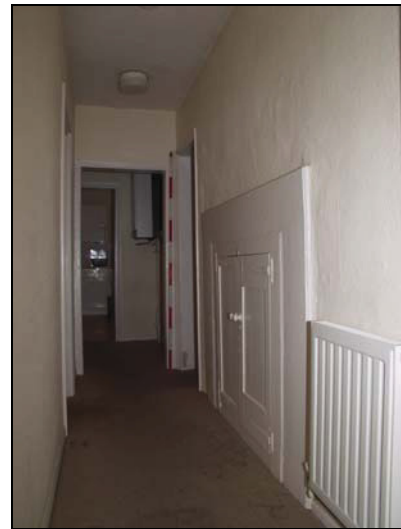
DP 16

Corridor in the first floor of the main range, taken from the north

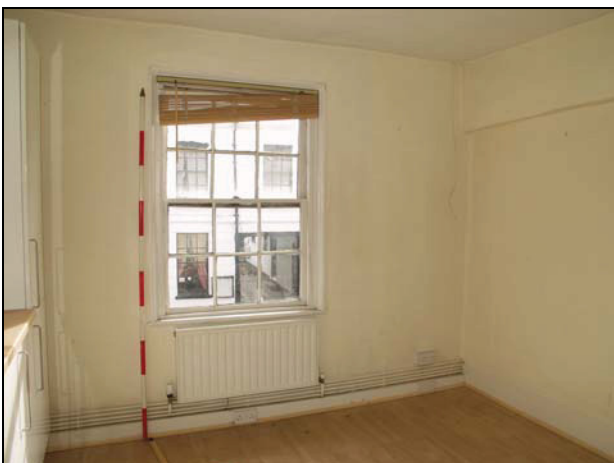
DP 17

4.2.23 The central room (Room 7) has been completely modernised but preserves the outline of a probable tie-beam on the south wall. The window on the east is a six-over-six sash of late 18th century date preserving most original crown glass and its moulded surround. As noted above, its original fireplace now isolated in the adjoining corridor.

East wall of Room 7, first floor, taken from the west

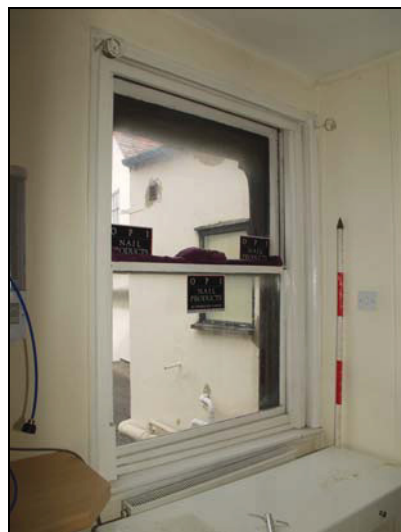
DP 18

Modified sash window in the kitchen of Room 8, first floor, taken from the south-east

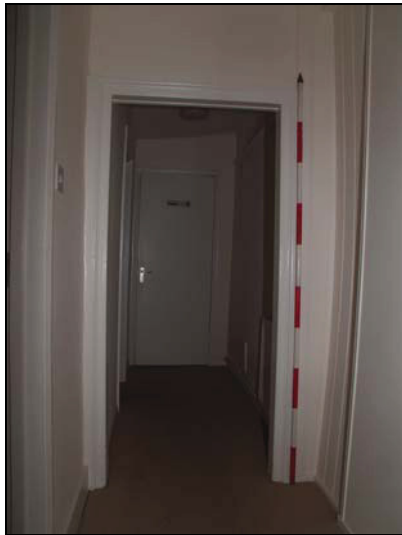
DP 19

Corridor on the first floor of the rear range, taken from the east

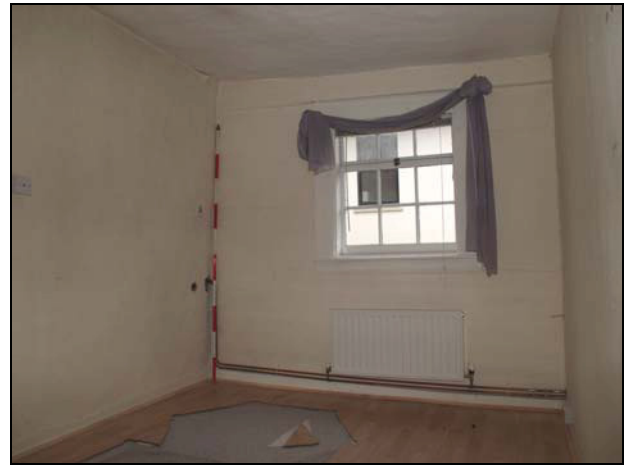
DP 20

South wall of Room 9, first floor, taken from the north-west

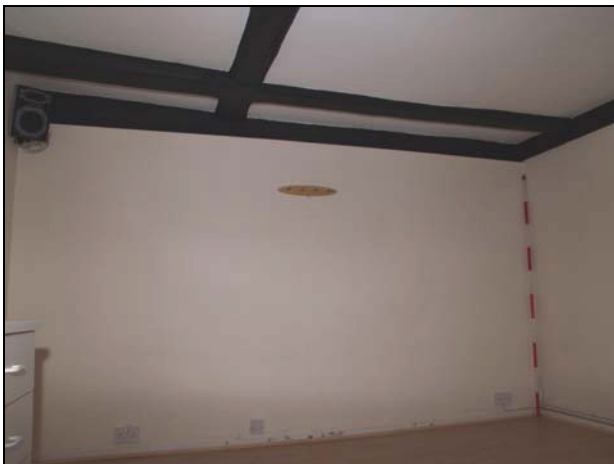
DP 21

East side of Room 10, first floor, taken from the west

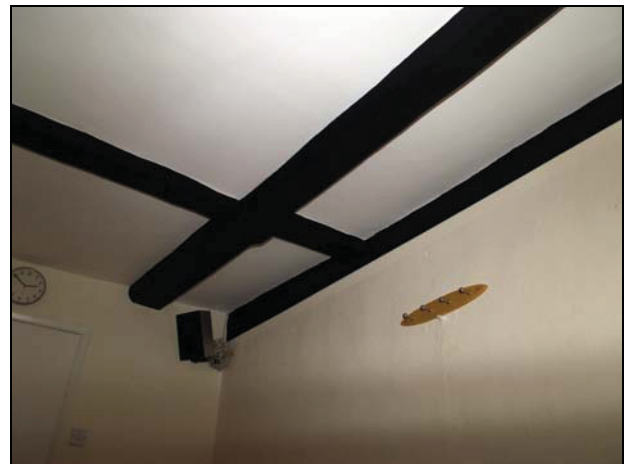
DP 22

Ceiling joists in Room 10, east side, taken from the south-west

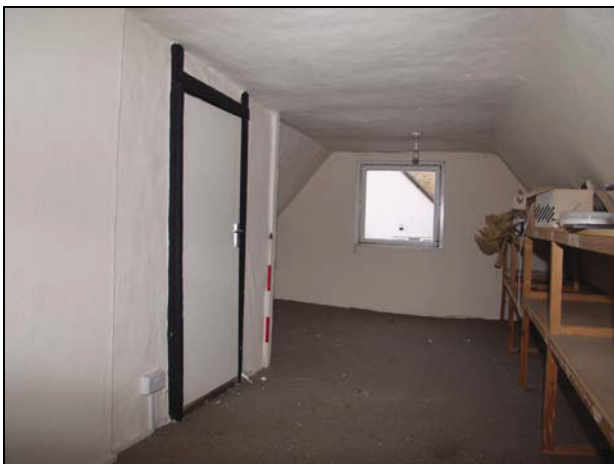
DP 23

Room 11, second floor of the rear range, taken from the east

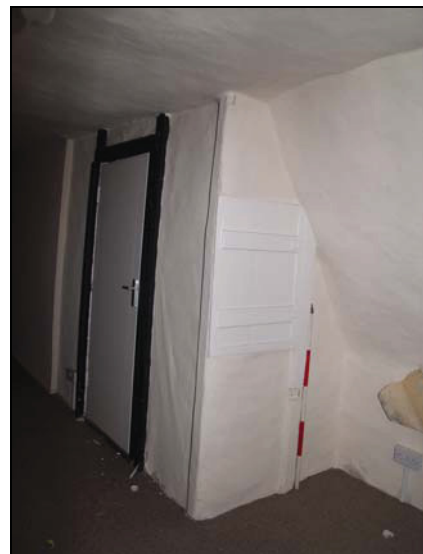
DP 24

Exterior of Room 12, second floor, on the south side of Room 11, taken from the north-west

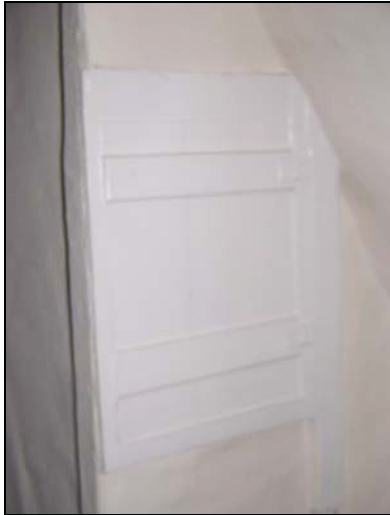
DP 25

External view of the hatch to Room 12, taken from the west

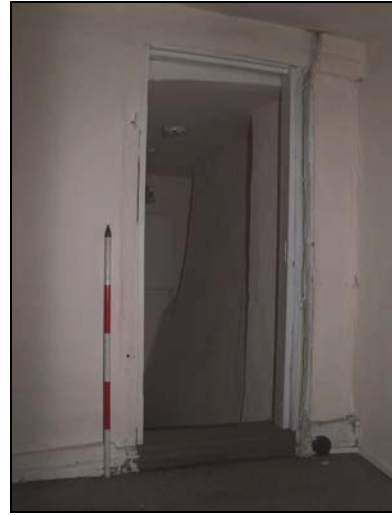
DP 26

Door of Room 11 showing redundant pintles, taken from the west

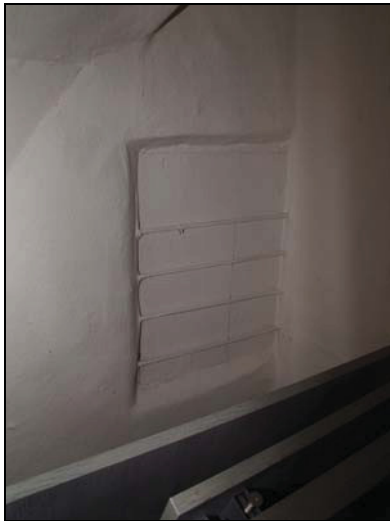
DP 27

Internal view of the hatch in Room 12, taken from the east

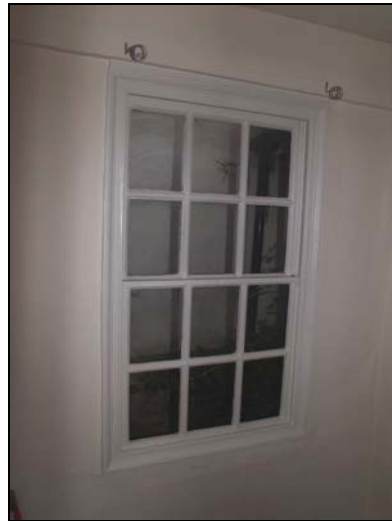
DP 28

Early 18th century window on the north side of the stair, taken from the south-west

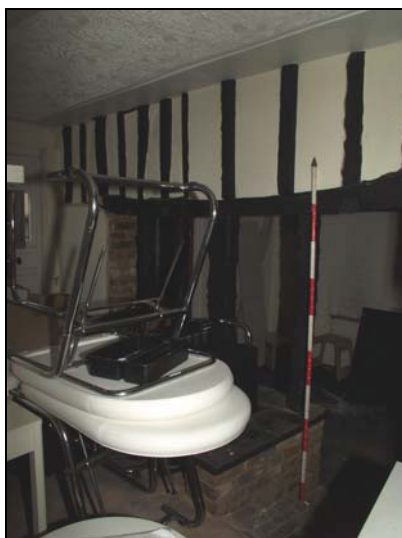
DP 29

North wall of Room 5, ground floor, taken from the south-east

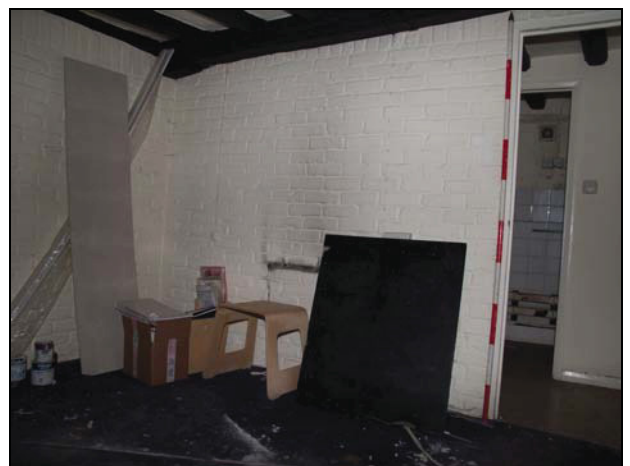
DP 30

North wall of Room 3, ground floor, taken from the south

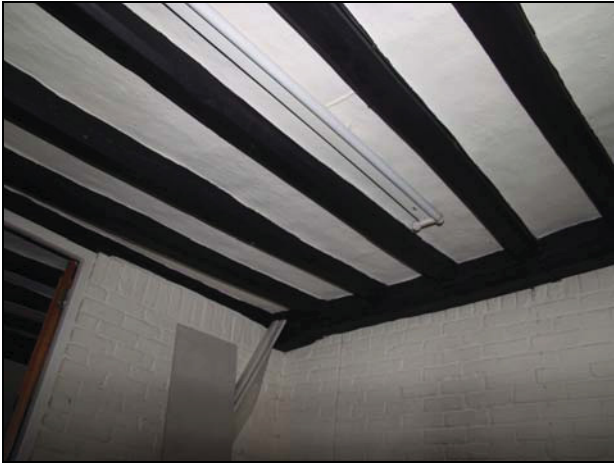
DP 31

View of ceiling joists in Room 3, taken from the south-east

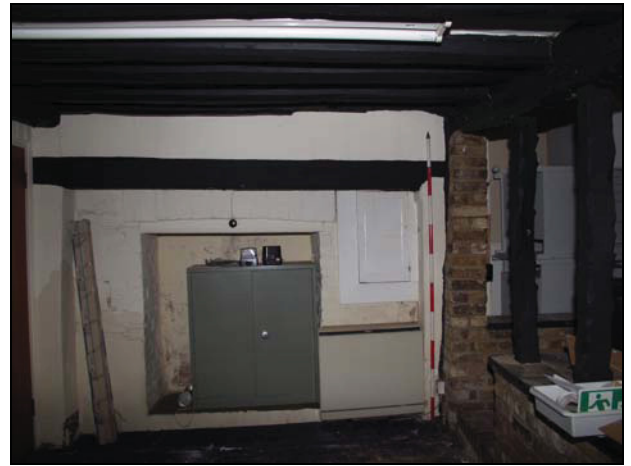
DP 34

East wall of Room 3 showing fireplace, taken from the west

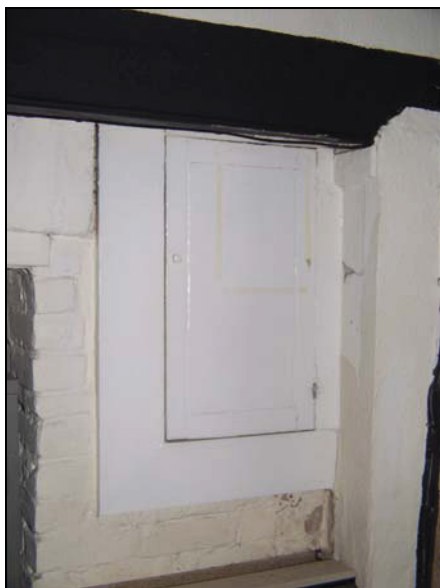
DP 35

Cupboard flanking the fireplace in Room 3, taken from the north-west

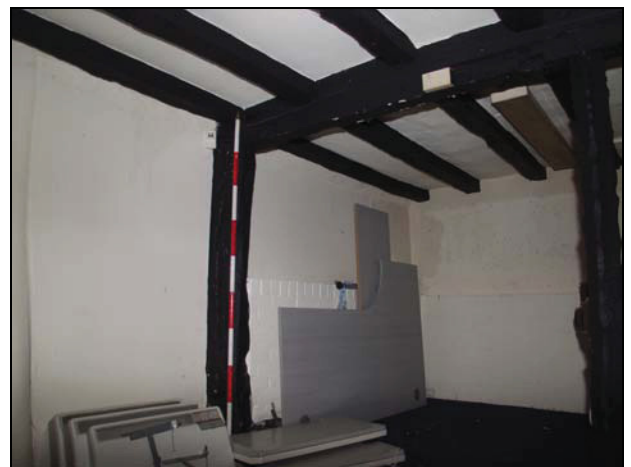
DP 36

View of Room 4, ground floor, taken from the north-east

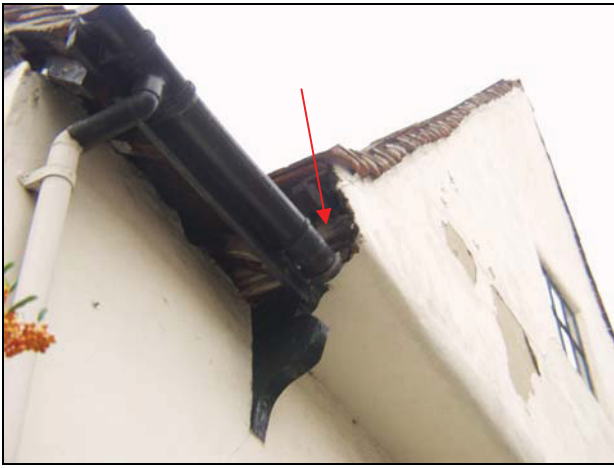
DP 37

View of the jettied south gable of the rear range with moulded bressummer, first floor, taken from the south-west

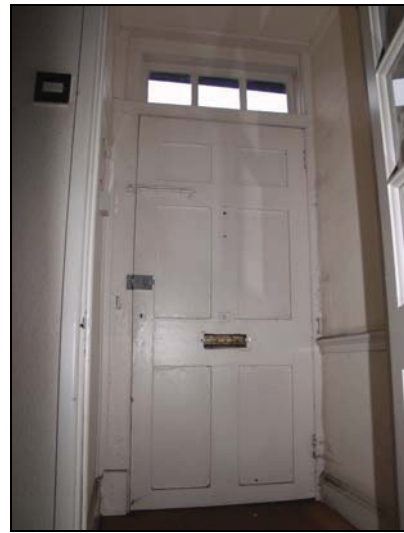
DP 38

4.2.5 The door lobby, as noted above, is of flimsy materials with a secondary inner door of no great age. The rear face of the front door has six plain recessed panels. A heavy staple on the jambs survives for a locking bar. The bolt is possibly 19th century. The overlight has robust glazing bars with an ovolo moulding and fillet typical of the early 18th century. Immediately adjoining the door to the south we may see a short section of original skirting board, dado rail and cornice moulding, but this disappears beneath later cosmetic treatment of the neighbouring fabric.

Internal face of the front door, taken from the west

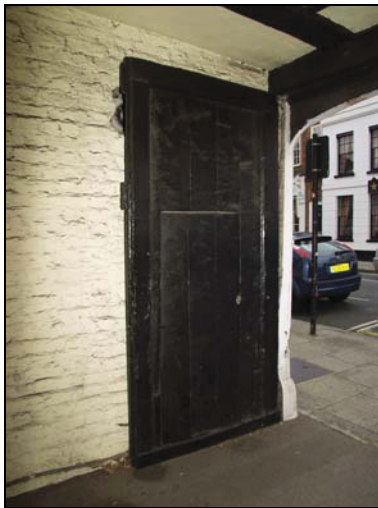
DP 39

North leaf of the carriage door, taken from the south-west

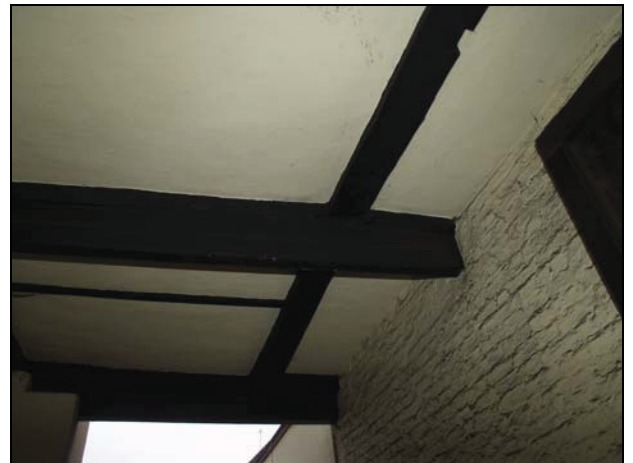
DP 40

Ceiling of the carriage, taken from the east

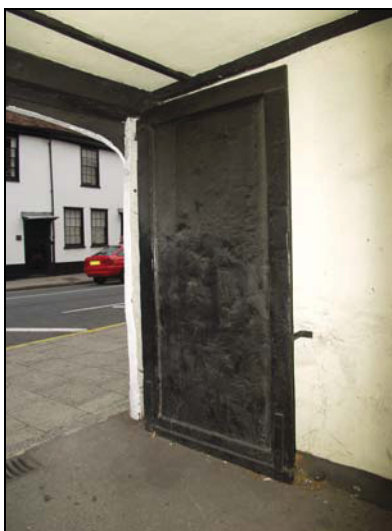
DP 41

South leaf of the carriage door, taken from the north-west

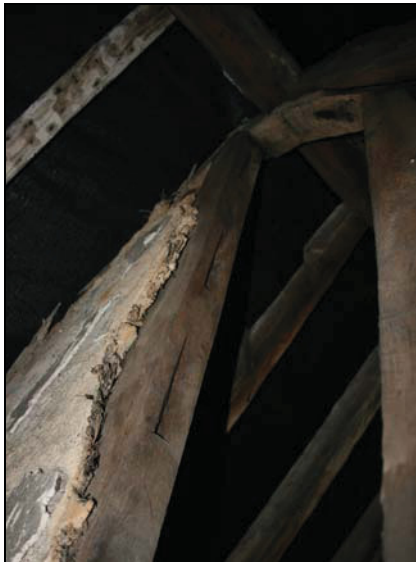
DP 42

4.2.35 Modification of the structure is clearly evident. The west pitch particularly appears to have been raised by repositioning the rafters, with each braced from the original purlin by a short section of timber (Plate 10). Other modification is also visible, though the full development of the roof lies outside the scope of the assessment. Occasional rafters appear to be weathered and some preserve notch-lap joints, which indicate reuse.

View of south gable in the roof space, main range, taken from the north

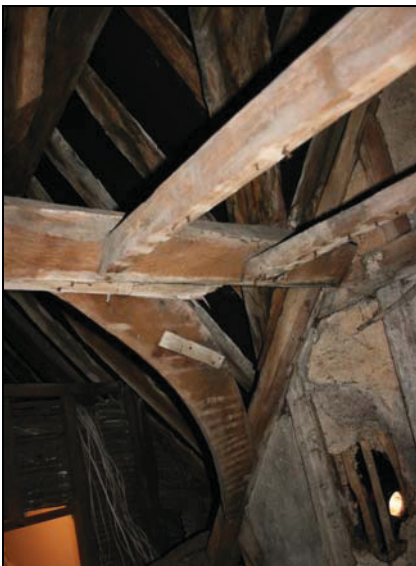
DP 44

Redundant mortice in a collar of the roof space, main range, taken from the south
