**BUILDINGS ON LAND OFF FOLLY ROAD,
GREAT WALDINGFIELD, SUFFOLK**

**An Archaeological Desk-Based Assessment and
Historic Building Recording**

Authors: Peter Thompson MA Lisa Smith BA	
NGR: TL 9080 4349	Report No: 3515
District: Babergh	Site Code: WFG 041
Approved: Claire Halpin	Project No: 3325
Signed:	Date: March 2010

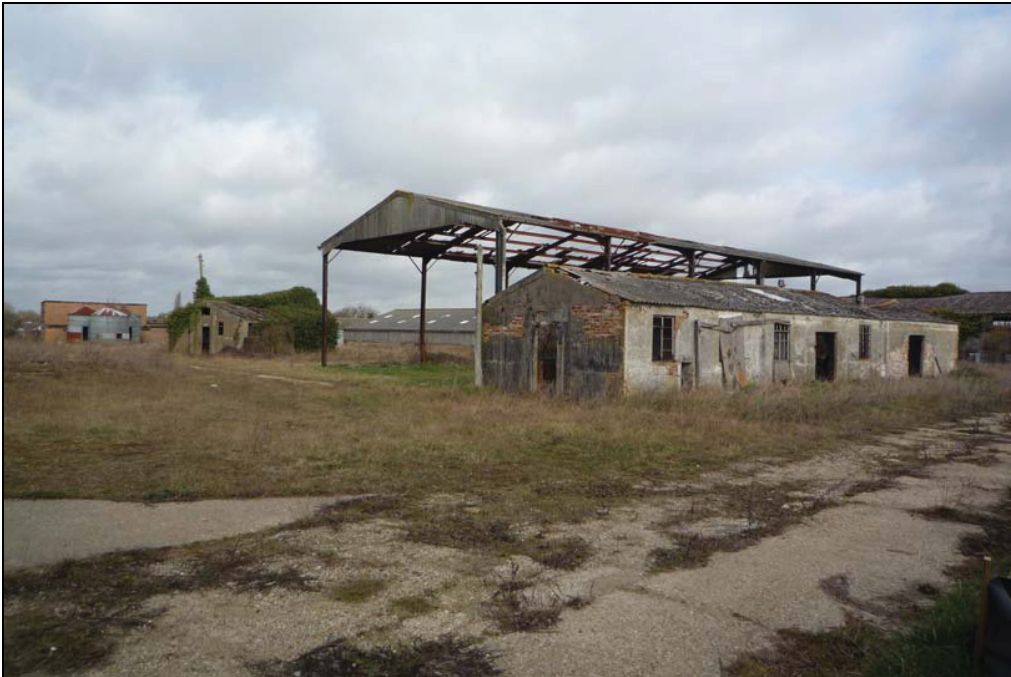
6.1 Today, four buildings are all that remain of RAF Sudbury's Communal Area 3. These lie within an area of un-kept scrub land interspersed with modern farm buildings loosely surrounding grassy courtyards and concrete slab drive ways, now in a poor state of repair (Plate 1). The site has been derelict for some time and neglect and decay has taken its toll on the buildings both old and new. The original World War II buildings have been heavily modified, completely transformed for agricultural purposes.

Plate 1 Buildings 1, 2, 4 and 8, taken from the south-east (DP 87)

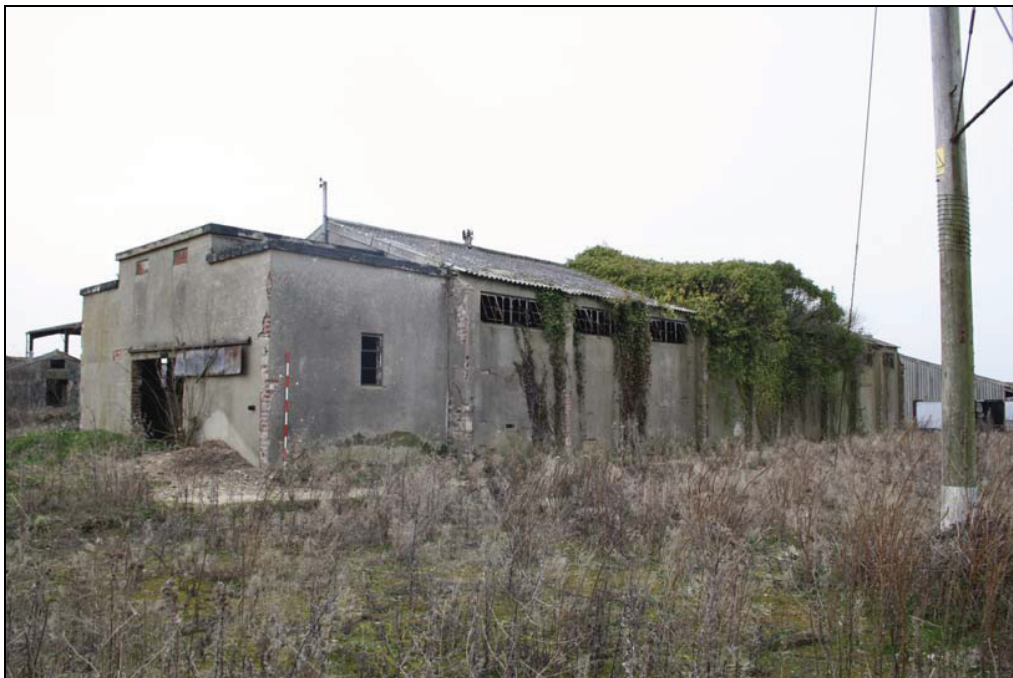
6.29 A large building located to the north-east of the site was originally used as a gymnasium and subsequently modified for agricultural purposes at a later date. A contemporary single story range extends along the south-west elevation and an additional flat roofed extension has been added to the south-eastern end of the building (Plate 6). A third building stood at the north-western end though now demolished.

Plate 6 The gymnasium and south-eastern extension, taken from the north-east (DP 35)

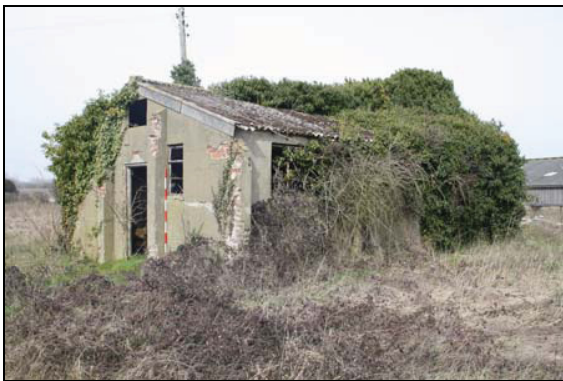
15

6.22 The building identified as the airmen's latrines is in extremely poor condition, being rapidly consumed by vegetation from the north (Plate 4). The building is brick-built and completely rendered with a shallow gabled roof clad in corrugated asbestos. The external elevations are divided into even bays by short narrow buttresses, also seen on each of the gable ends framing the central doorways.

The airmen's latrines, taken from the south-east

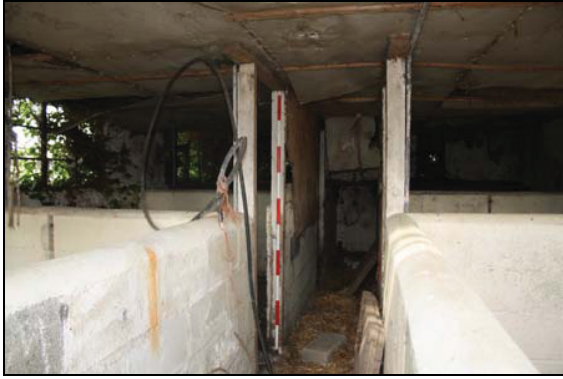
19

6.24 Internally the building has been completely altered to accommodate animal stalls inline with its later agricultural role and retains no evidence for its original function (Plate 5). Six stalls defined by four courses of modern white-washed block work flank a central concrete walkway leading to a blocked doorway in the northern gable end. The entrance to each stall is framed by timber uprights carrying lateral members providing additional support to a flimsy ceiling. A single small vertically boarded door remains *in situ* hung from the timber jamb by modern strap hinges. Others have been removed and now lie scattered throughout the building. Metal water drinking bowls attached to the dividing walls and glazed concrete feeding troughs feature in each of the stalls. The two northern most stalls are occupied by semi-circular metal framed pens clad in corrugated iron with sheet metal doors.

The airmen's latrines, interior, divided into animal pens taken from the south

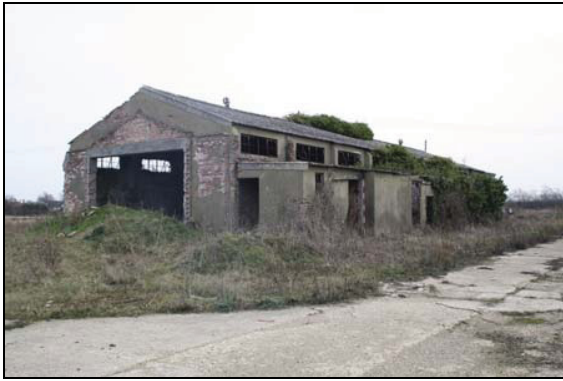
31

6.30 The main building is constructed of brick laid in a mixture of English and stretcher bond completely rendered over rising to a shallow asbestos covered gable roof. As with all the other buildings on site the building is in a poor state of repair partially taken over by vegetation. In places where the render has come away from the wall the brickwork beneath shows signs of decay (Plate 7).

The gymnasium and south-west range, taken from the south-west

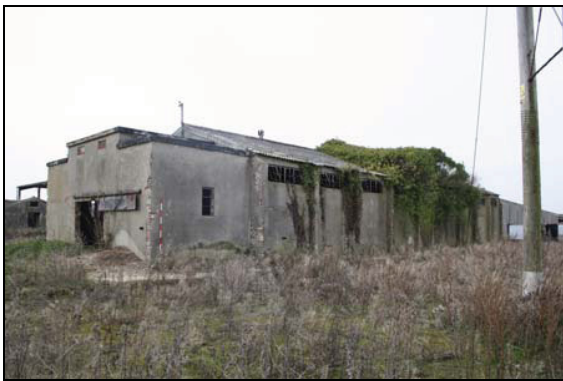
35

The gymnasium and south-eastern extension, taken from the north-east

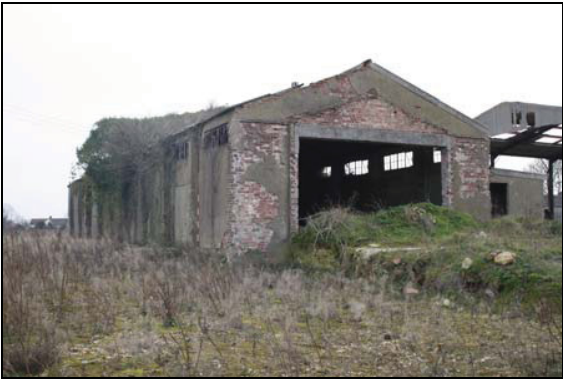
36

The gymnasium, taken from the north-west

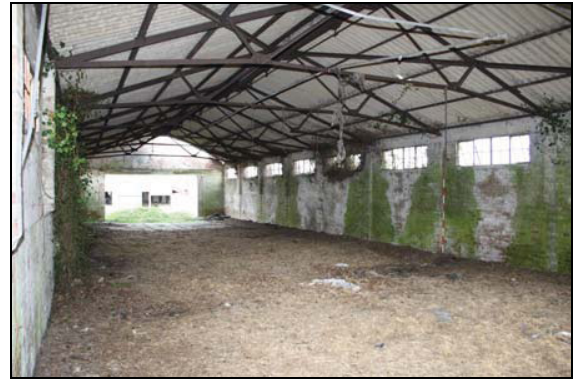
37

The gymnasium, taken from the north-west

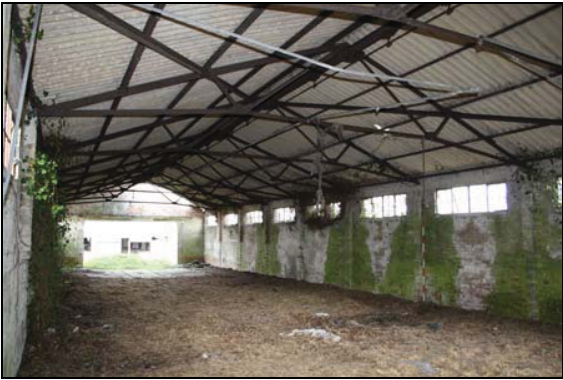
38

The gymnasium, interior, taken from the south-east

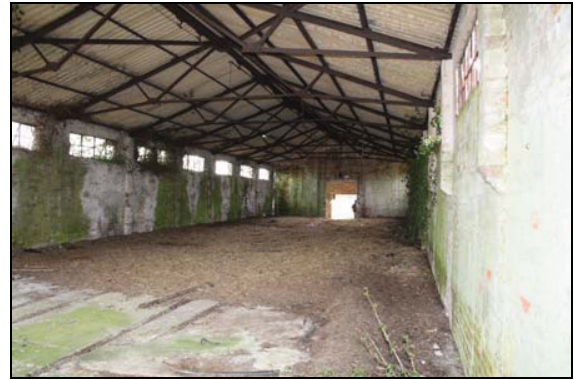
39

The gymnasium, interior, taken from the south-east

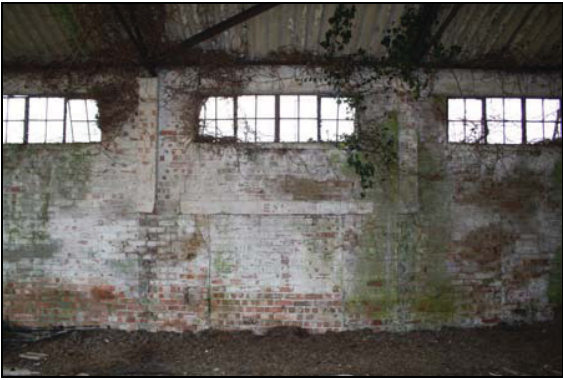
40

The gymnasium, interior, taken from the south-west

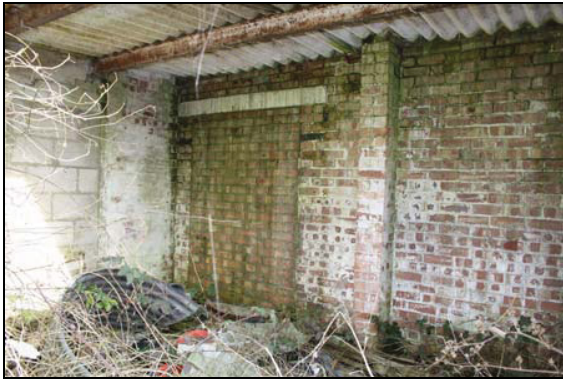
42

The gymnasium and south-west range, taken from the south-west

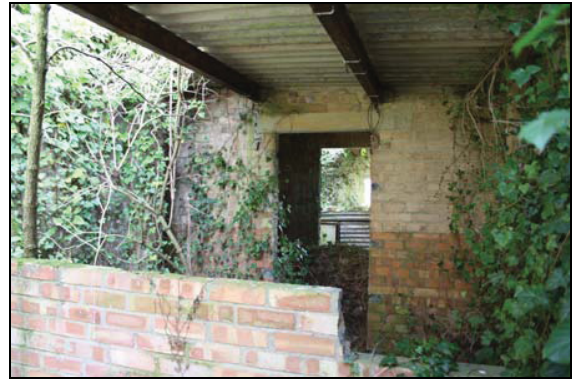
43

Blocked aperture leading from the south-west range to the gymnasium, taken from the south

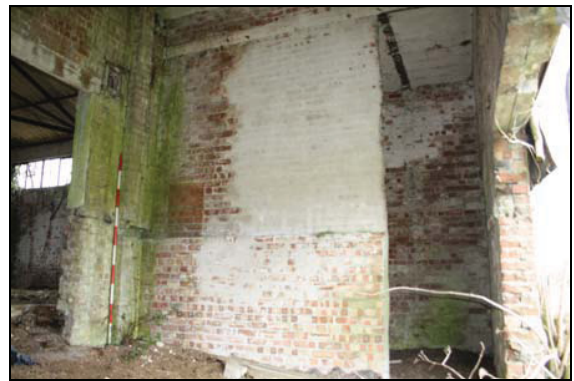
47

The gymnasium, interior, taken from north-west

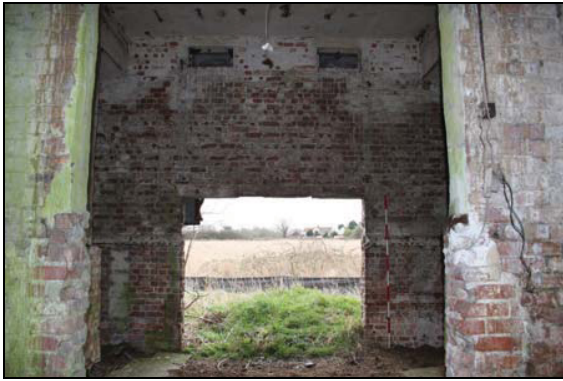
48

South-east extension, taken from the south-east

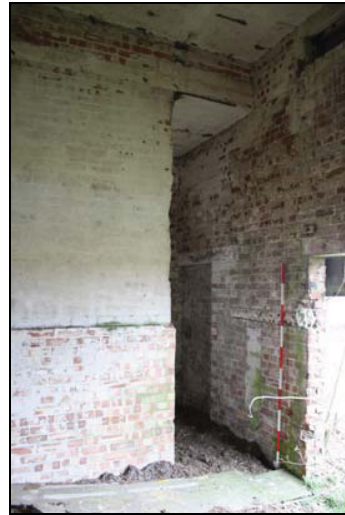
49

South-east extension, taken from the north-west

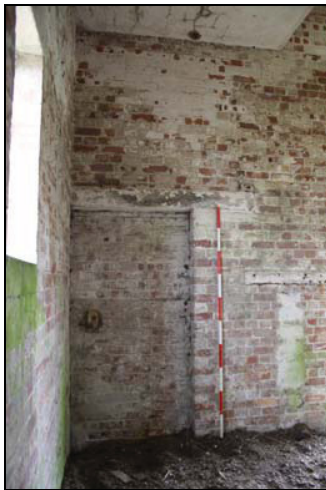
50

South-east extension, taken from the south-west

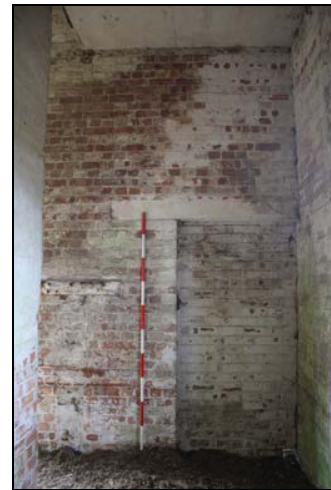
51

Block door way, south-east extension, northern unit, taken from the north-west

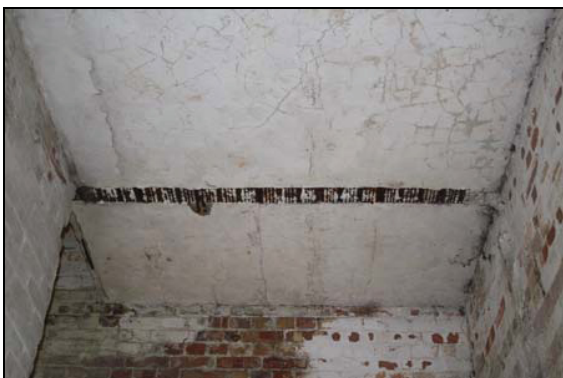
52

Block door way, south-east extension, southern unit, taken from the north-west

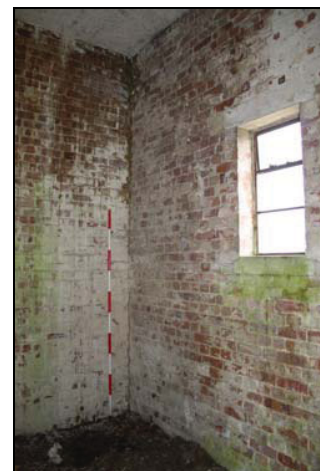
53

Evidence of a removed wall, south-east extension, southern unit, taken from the north-west

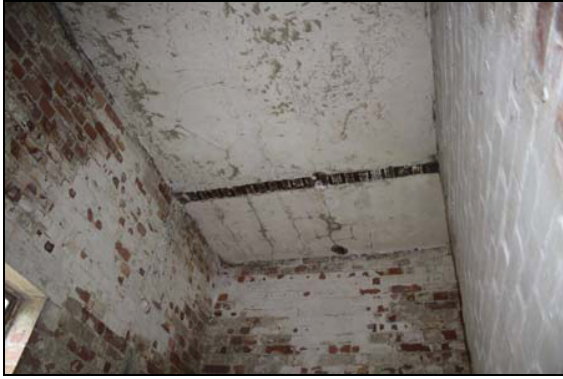
54

South-east extension, northern unit, taken from the south-east

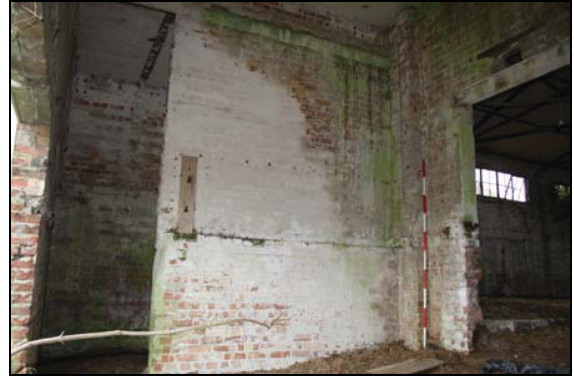
55

Evidence of a removed wall, south-east extension, northern unit, taken from the north-west

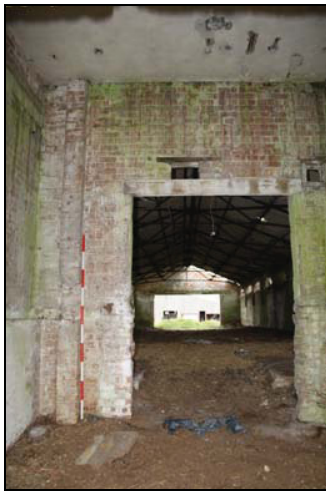
56

South-east extension, southern unit, taken from the south-east

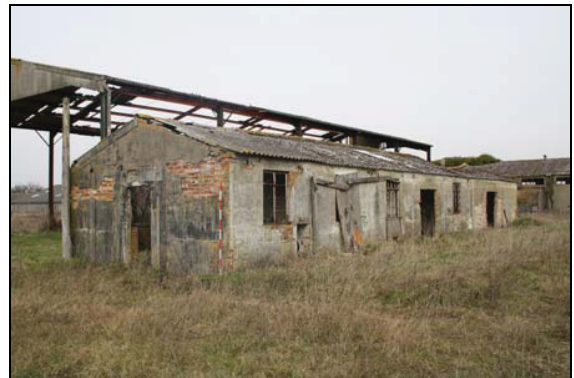
57

Entrance into gymnasium via south-east extension, taken from the south-east

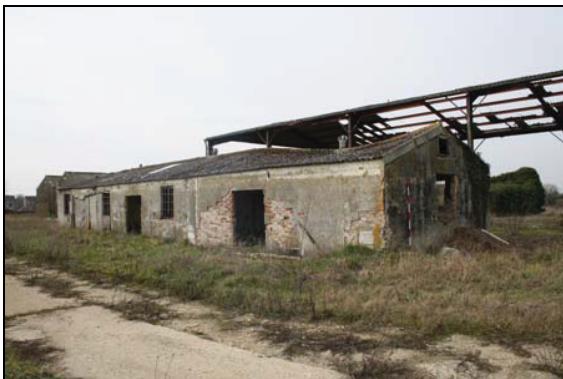
58

6.54 The south-eastern façade is pierced by numerous windows and doorways loosely defining the internal layout. The two units to the south are smaller with two larger to the north represented by large apertures crudely cut through the brickwork. The southern most unit has a three leaf metal casement window, the glass all removed with access given from a doorway in the south-western gable end. Unit Two is defined by a window boarded with modern plywood pieces crudely supported by planking nailed to the brickwork however it still preserves its metal framework. Two four light metal casement windows flank a central aperture with a large concrete lintel above indicating the original main entrance to the building through Unit 3. The fourth unit is for the most part blank pierced by a large wide doorway with a second to the north, which is blocked. The concrete lintels framing both doorways have high concentrations of pebbles throughout. Small apertures have been cut through the brickwork at lower level along the entire elevation to allow access for animals. The majority are now blocked.

The meat and ration store, taken from the south-east

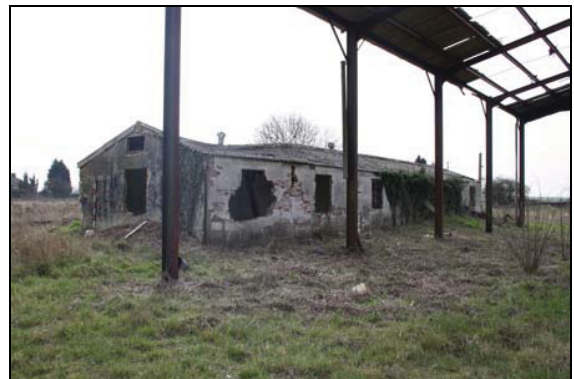
59

The meat and ration store, taken from the north-east

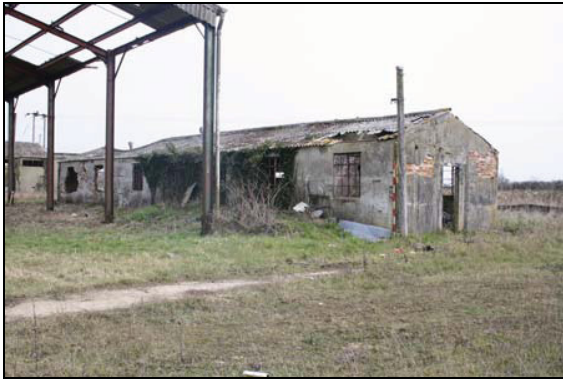
60

6.56 The north-western elevation is consumed by ivy growth however the original arrangement of windows is still evident consistent with that of the south-eastern elevation. In most cases the window furniture survives albeit in very poor condition.

The meat and ration store, taken from the north-west

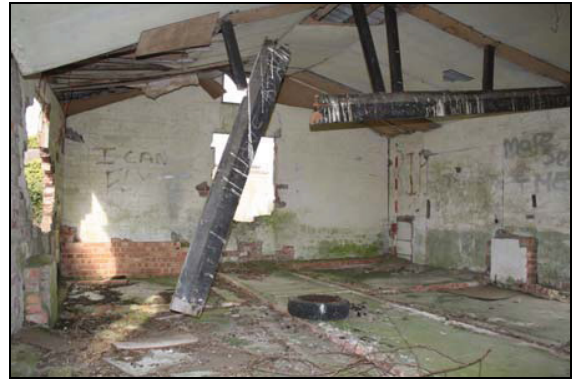
61

The meat and ration store, taken from the south-west

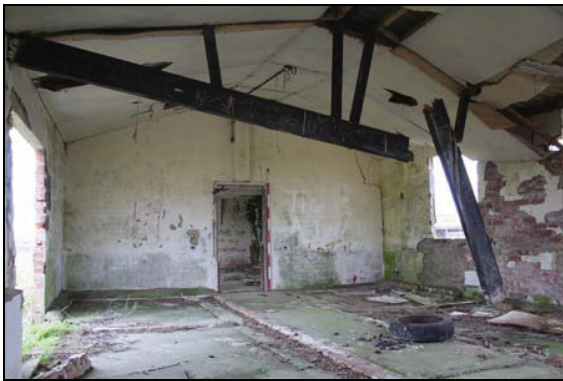
62

The meat and ration store, interior, bay 4, taken from the south-west

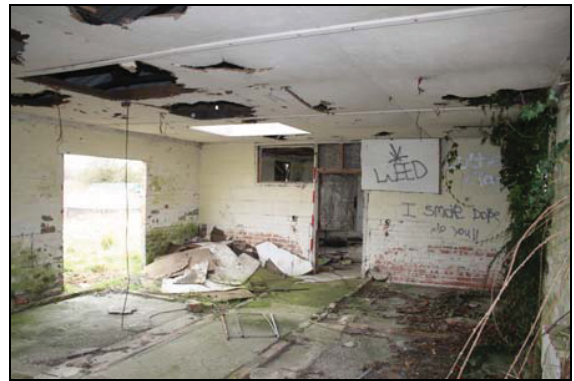
63

The meat and ration store, interior, bay 4, taken from the north-east

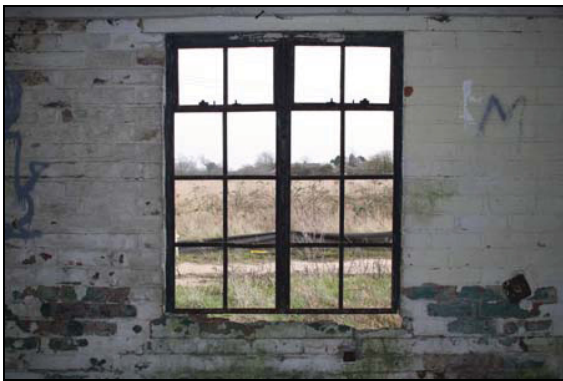
64

The meat and ration store, interior, bay 3, taken from the north-west.

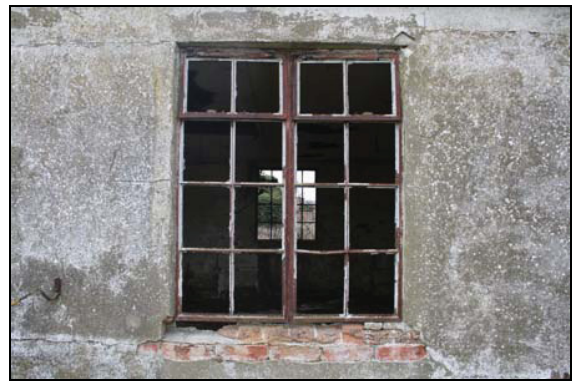
65

Metal framed window, the meat and ration store, interior, bay 3, taken from the south-west

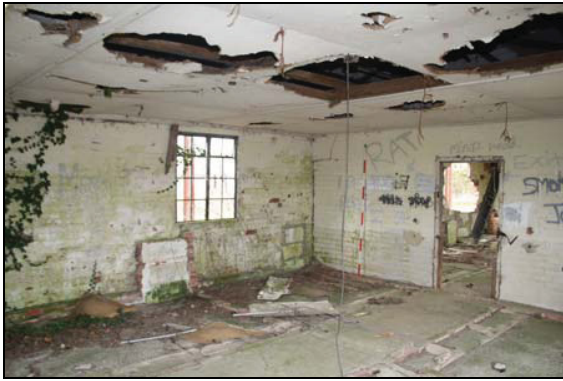
66

Metal framed window, the meat and ration store, exterior, bay 3, taken from the south-west

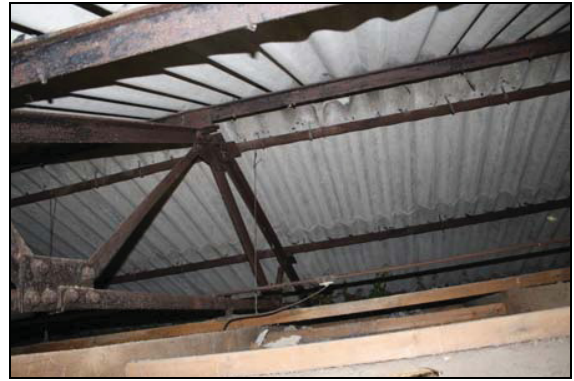
67

The meat and ration store, interior, bay 3, taken from the south-east

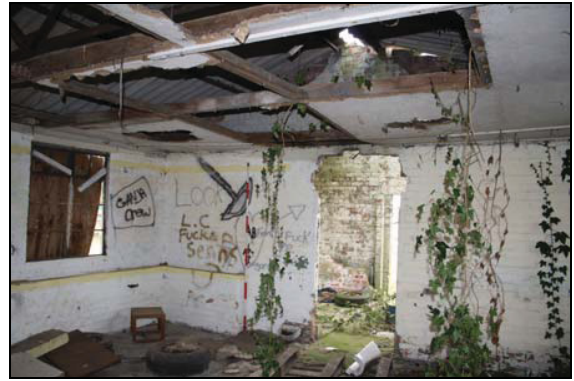
73

The meat and ration store, interior, bay 2, taken from the south-east

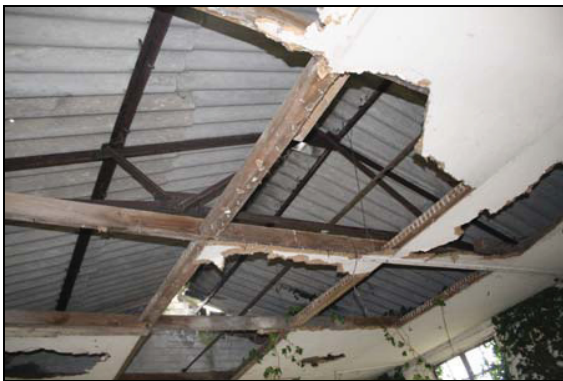
74

The meat and ration store, interior, bay 2, taken from the north-west

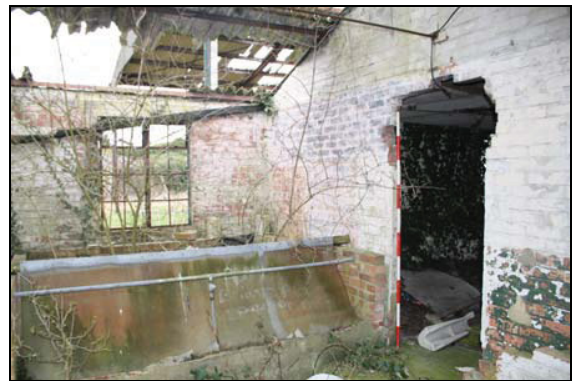
75

Roof structure, the meat and ration store, interior, bay 2, taken from the north-east

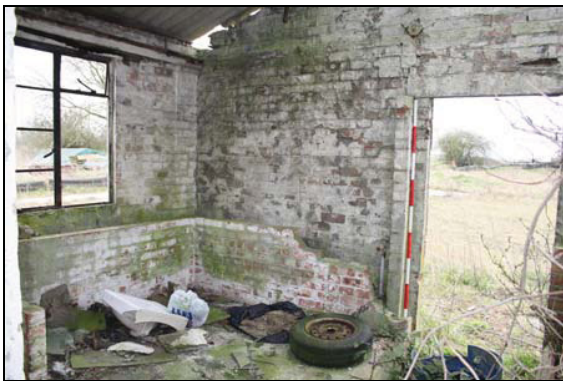
76

The meat and ration store, interior, bay 1, taken from the south-east

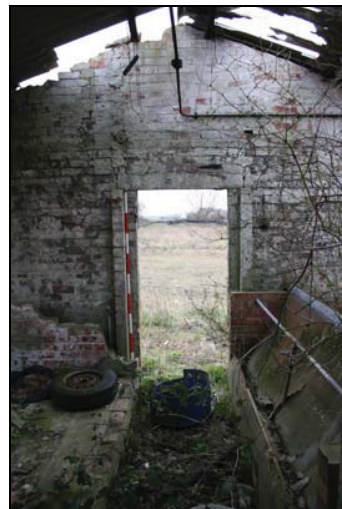
77

The meat and ration store, interior, bay 1, taken from the north-west

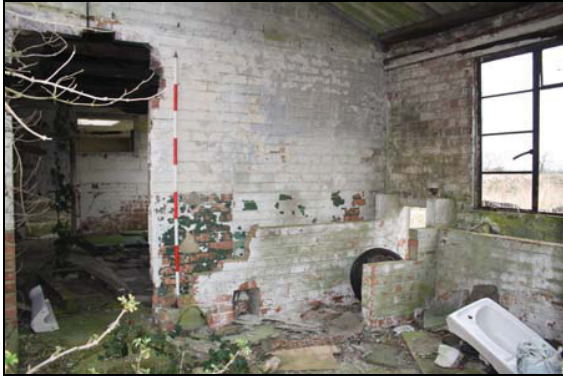
78

Entrance through south-eastern gable end, the meat and ration store, interior, bay 1, taken from the north-east

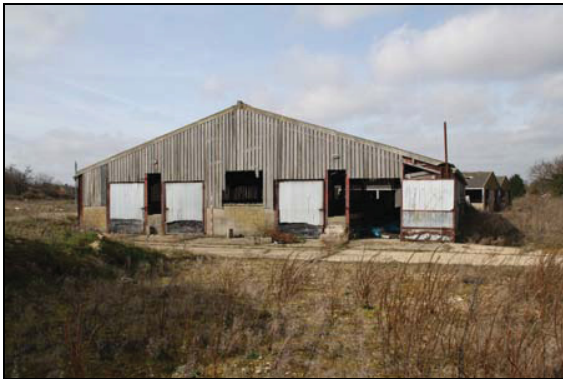
80

The stand by set house, taken from the south

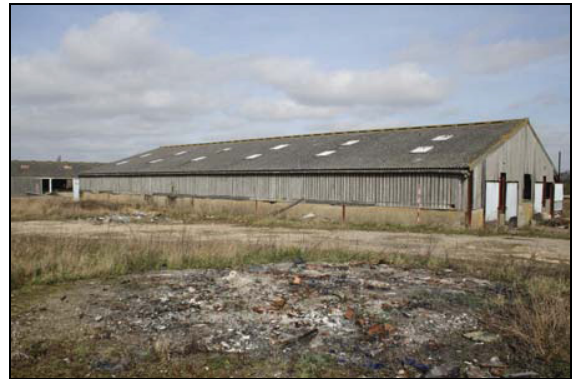
81

Modern barn, building 6, taken from the east

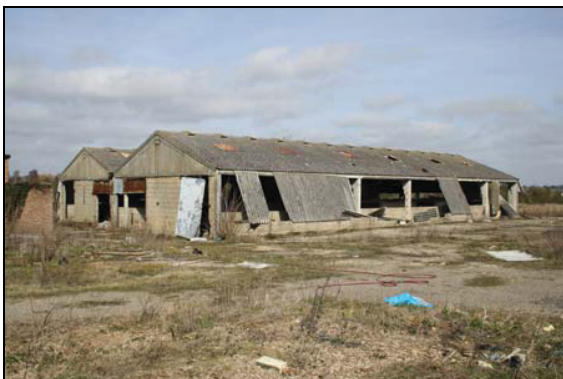
82

Modern barn, building 6, taken from the south-east

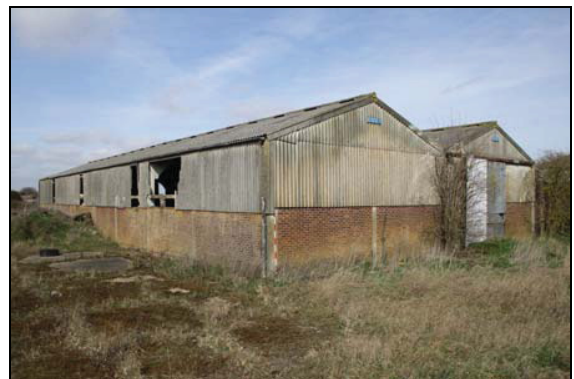
83

Modern barn, building 5, taken from the south

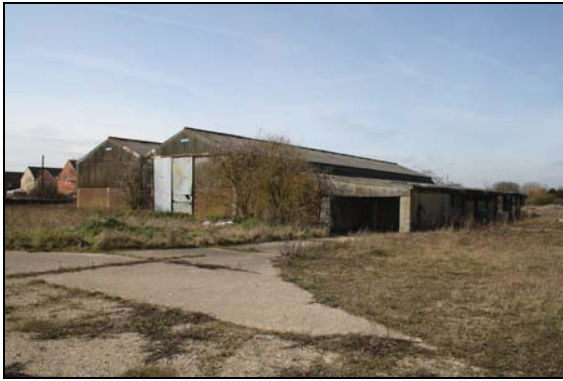
84

Modern barn, building 7, taken from the south-east

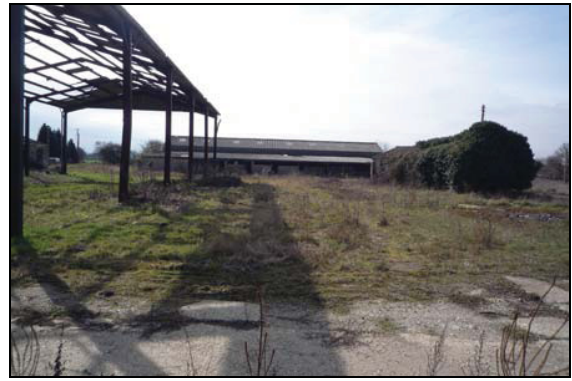
85

Modern barn, building 7, taken from the north-east

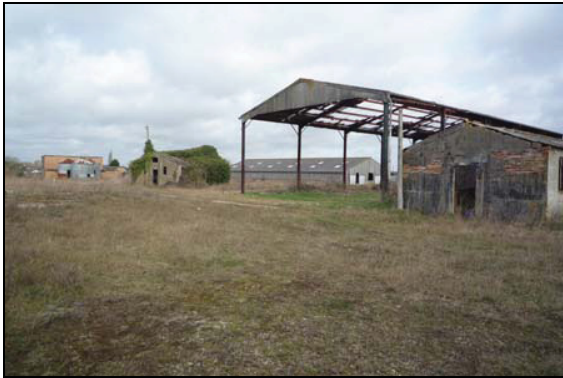
86

Buildings 2, 7 and 8 taken from the north

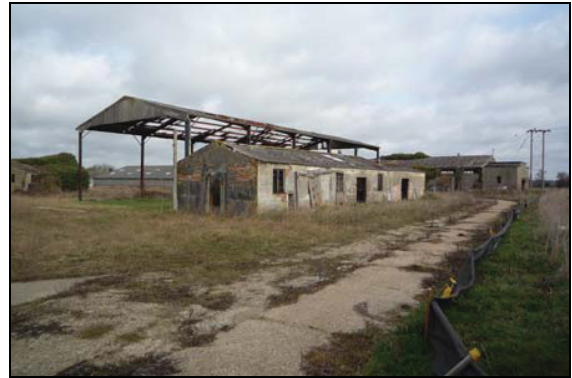
87

Buildings 1,2,4 and 8, taken from the south-east
