**CHURCH OF ST BOTOLPH,
IKEN, SUFFOLK**

HISTORIC BUILDING RECORDING

ARCHAEOLOGICAL SOLUTIONS LTD

Authors:	Tansy Collins BSc Lee Prosser PhD Peter Thompson MA Kathren Henry	
NGR: TM 0265 6235		Report No: 3592
District: Suffolk Coastal		Site Code:
Approved: C Halpin MIFA		Project No: 3499
Signed:		Date: July 2010

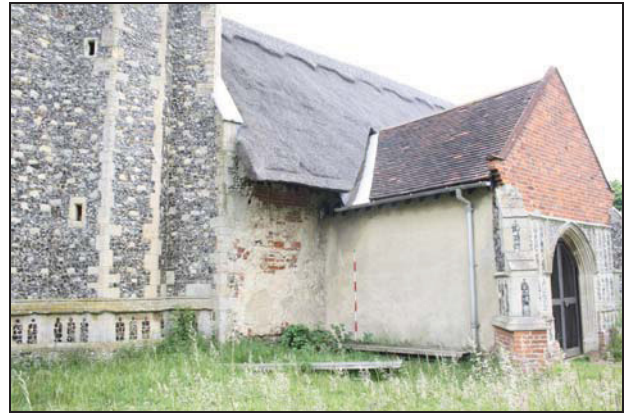
37

Detail of south nave wall, Bay 1, taken from the south

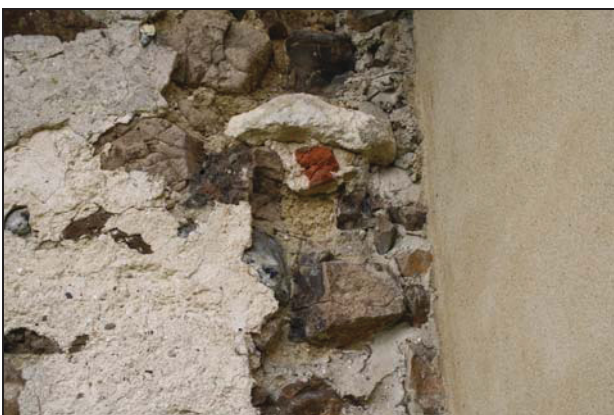
40

Possible putlog hole (P3) in Bay 1, north nave wall, taken from north

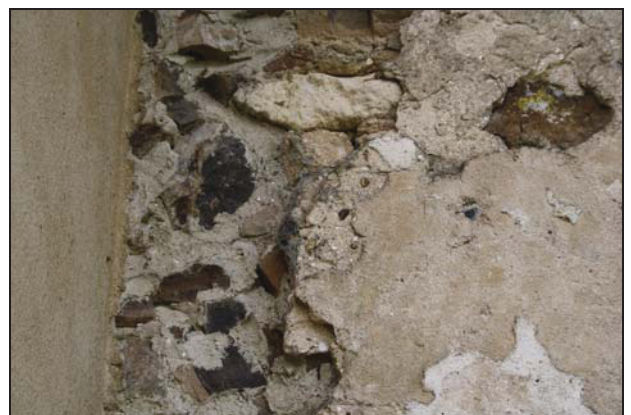
41

5.22 Two putlog holes can be traced, though one is fairly indeterminate. The western example is framed by Septaria blocks and a limestone head, infilled by brick and limey mortar similar to the infill of the lancet (Plate 8). The eastern example is mostly obscured but shows physical similarities in being topped with a limestone block.

Putlog hole (P2) in Bay 3 north nave wall, taken from the north

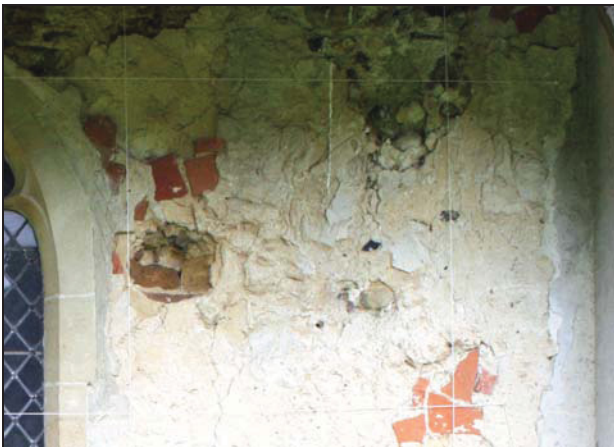
50

Detail of south nave wall, Bay 4, taken from the south
