1EW03 - Enabling Works Central

Historic Building Recording

Shepherd's Furze Farmhouse,
Steeple Claydon,
Buckinghamshire

Document Number: 1EW03-FUS_COP-EV-REP-CS06_CL09-000014

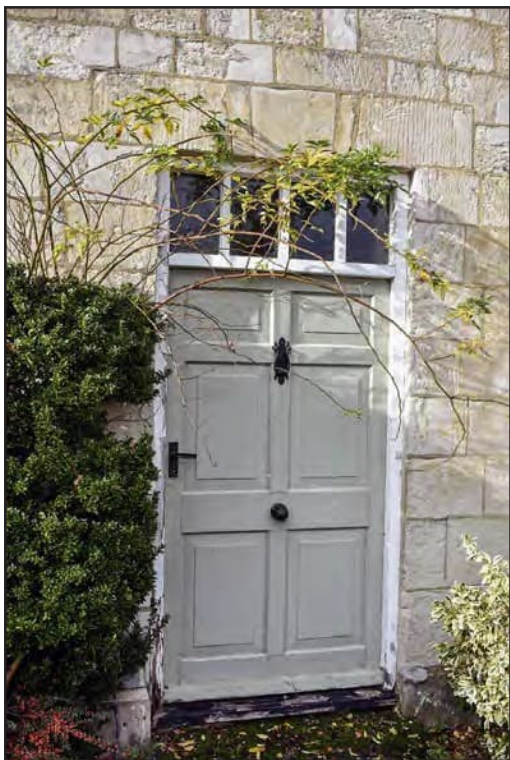
Photo A- 7: Front door to farmhouse

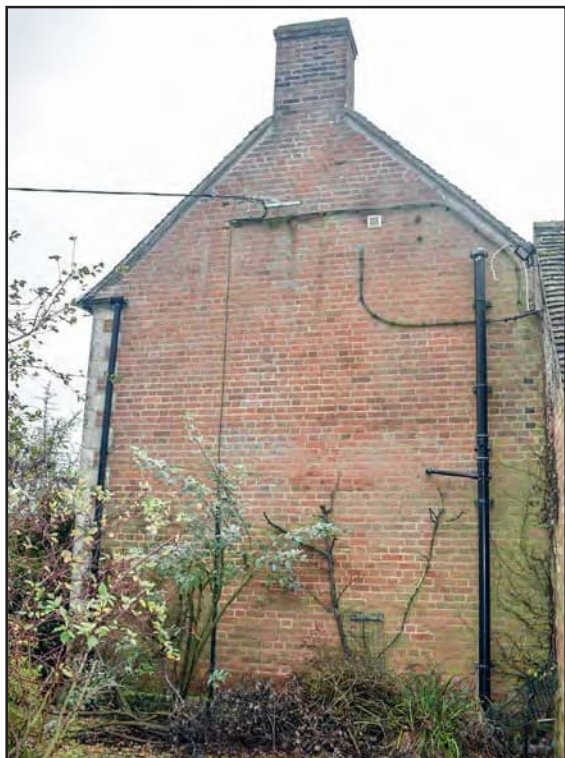
Photo A- 9: The north gable

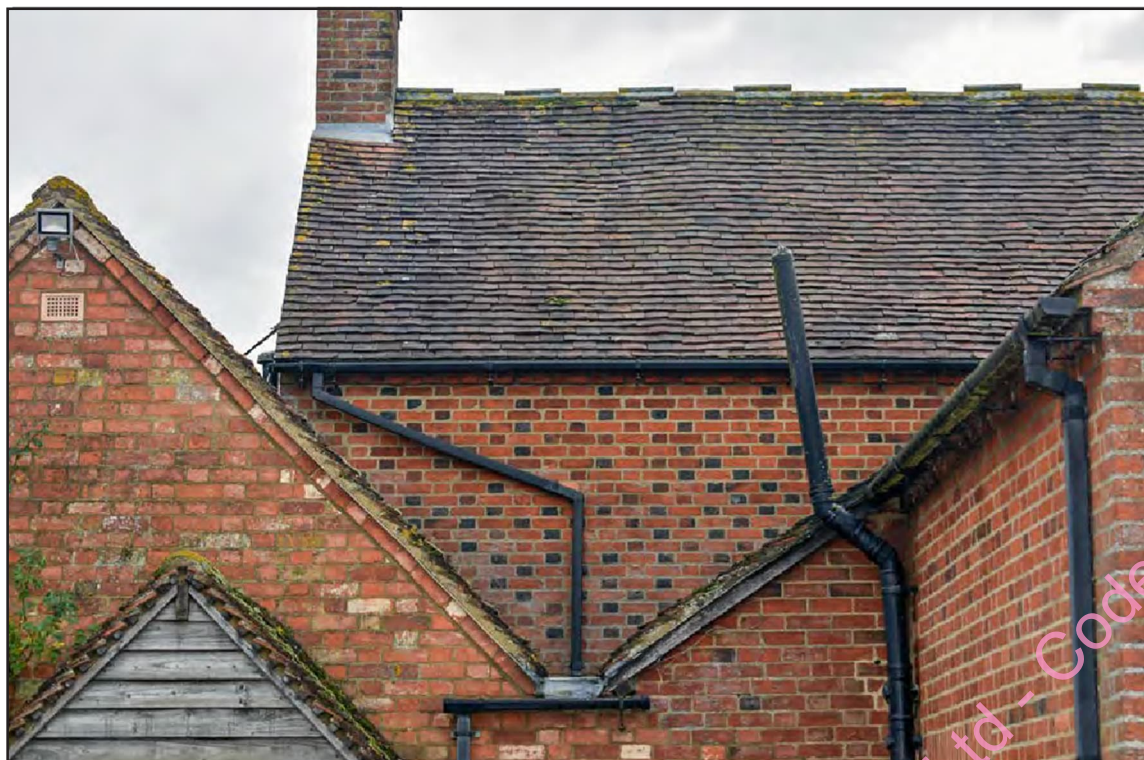
Photo A- 10: Detail of the west rear elevation of the farmhouse,

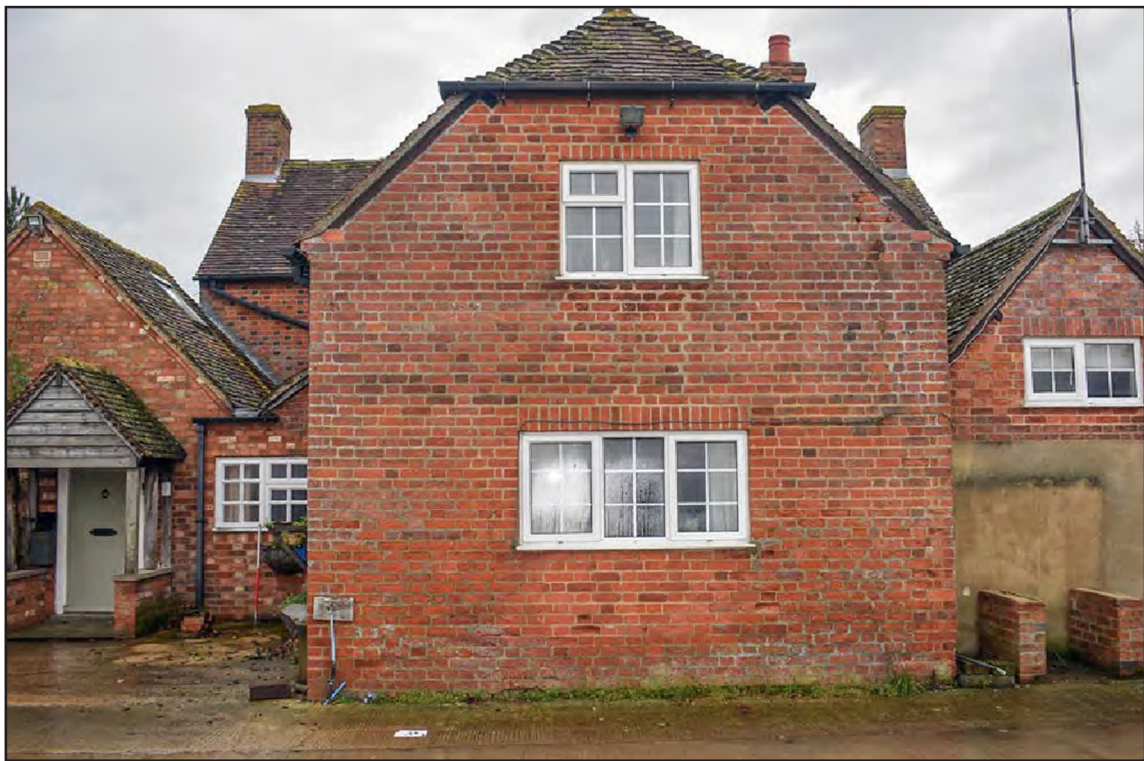
Photo A- 11: The west rear extension

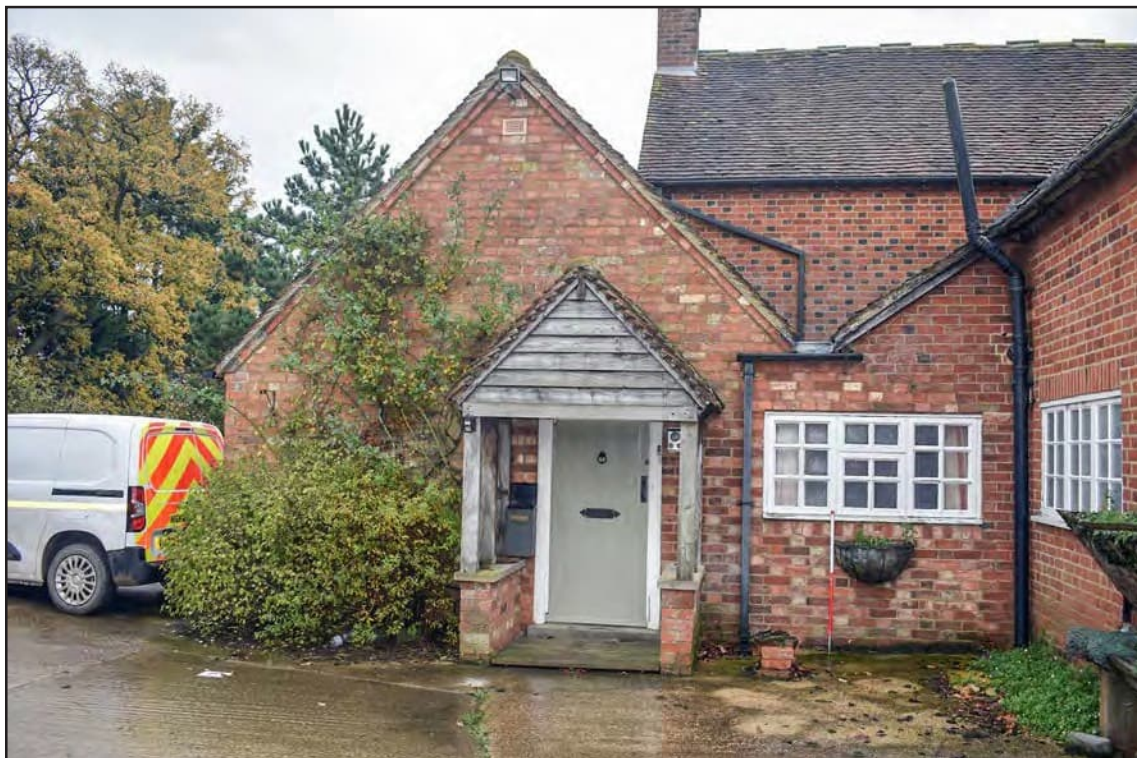
Photo A- 13: The north-west extension

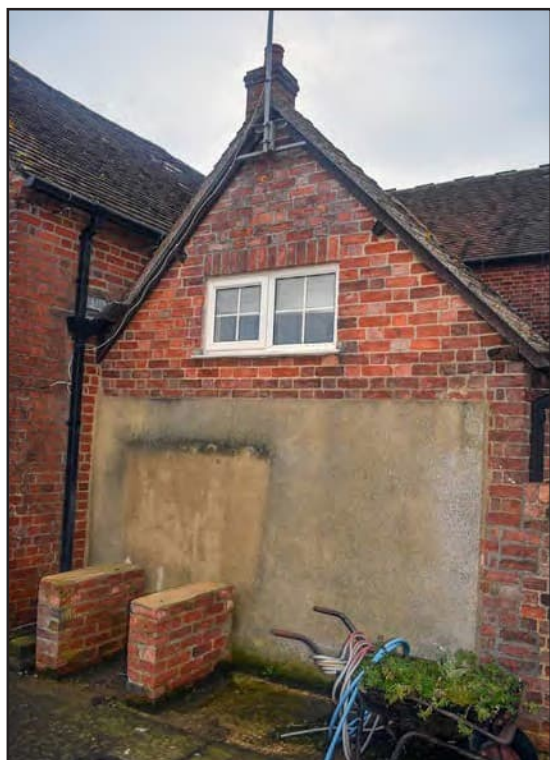
Photo A- 14: The south-west extension

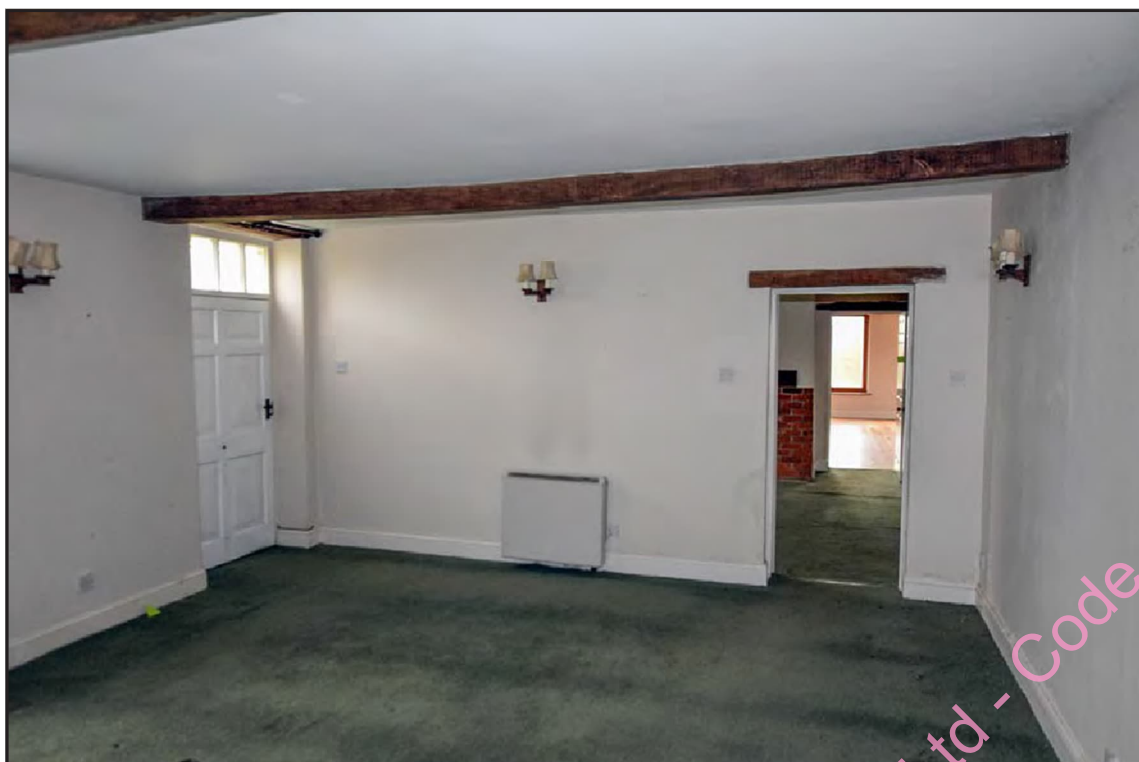
Photo A- 18: Front room, G1, looking south to G2

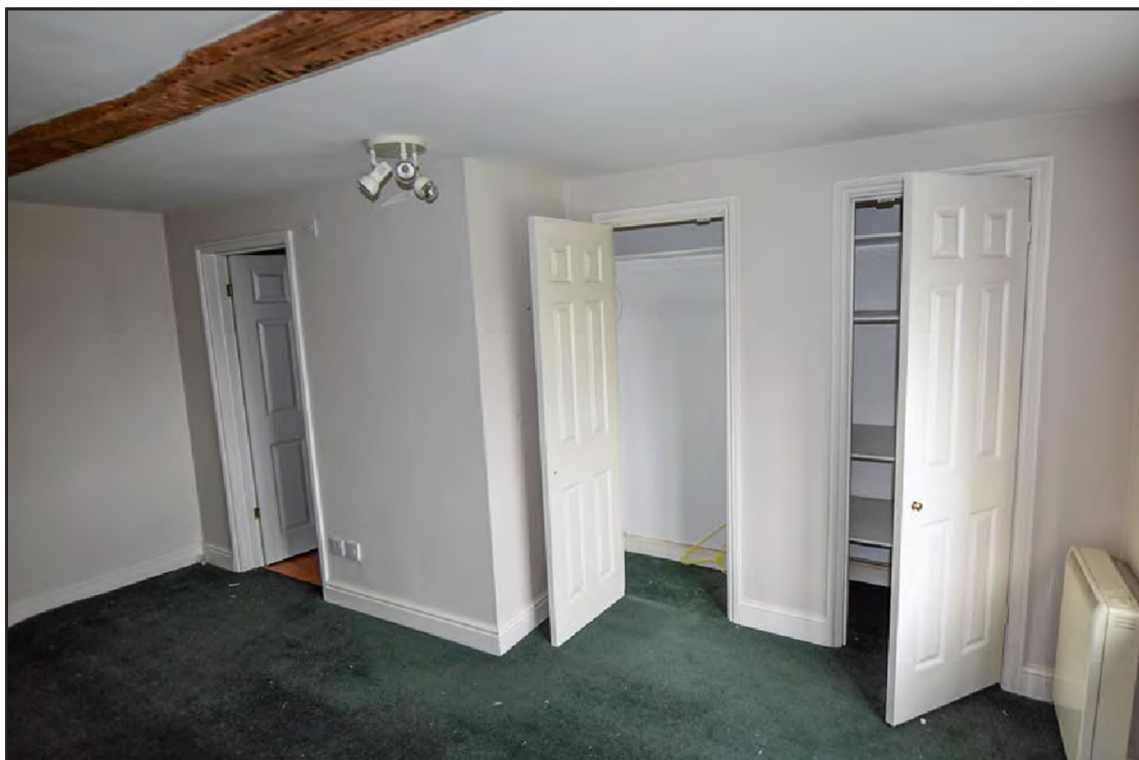
Photo A- 37: Front bedroom F1 north gable

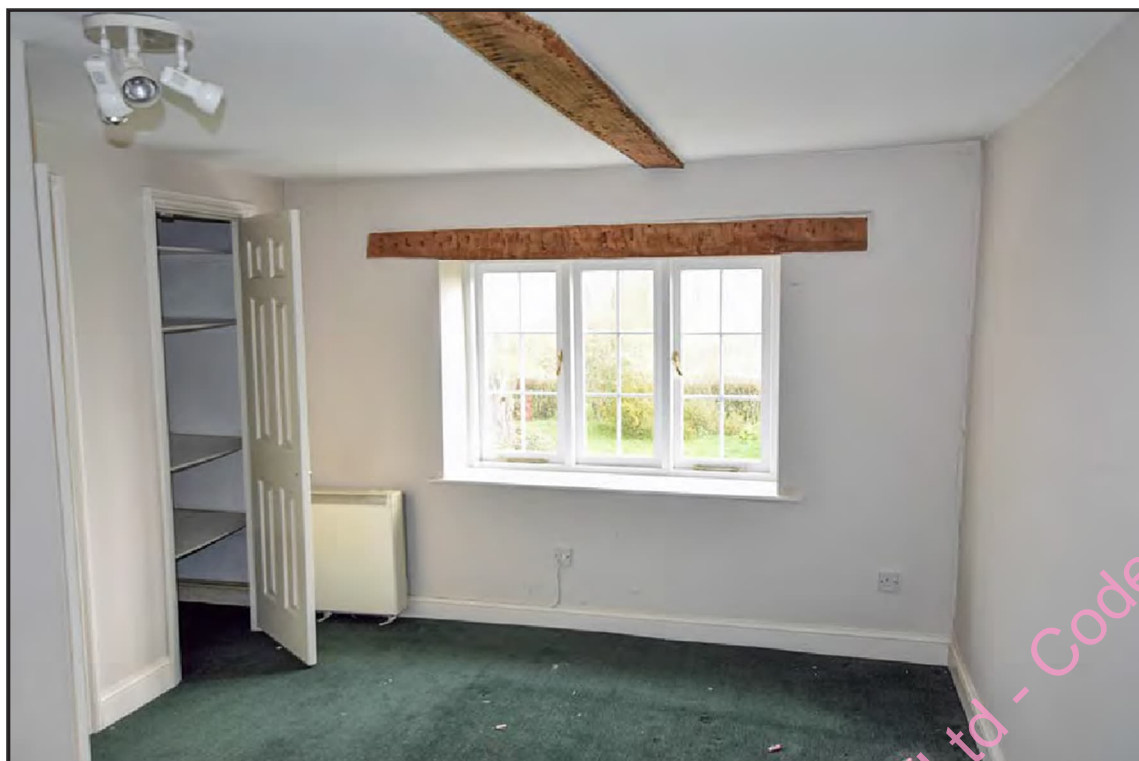
Photo A- 38: Front bedroom F1 facing to front

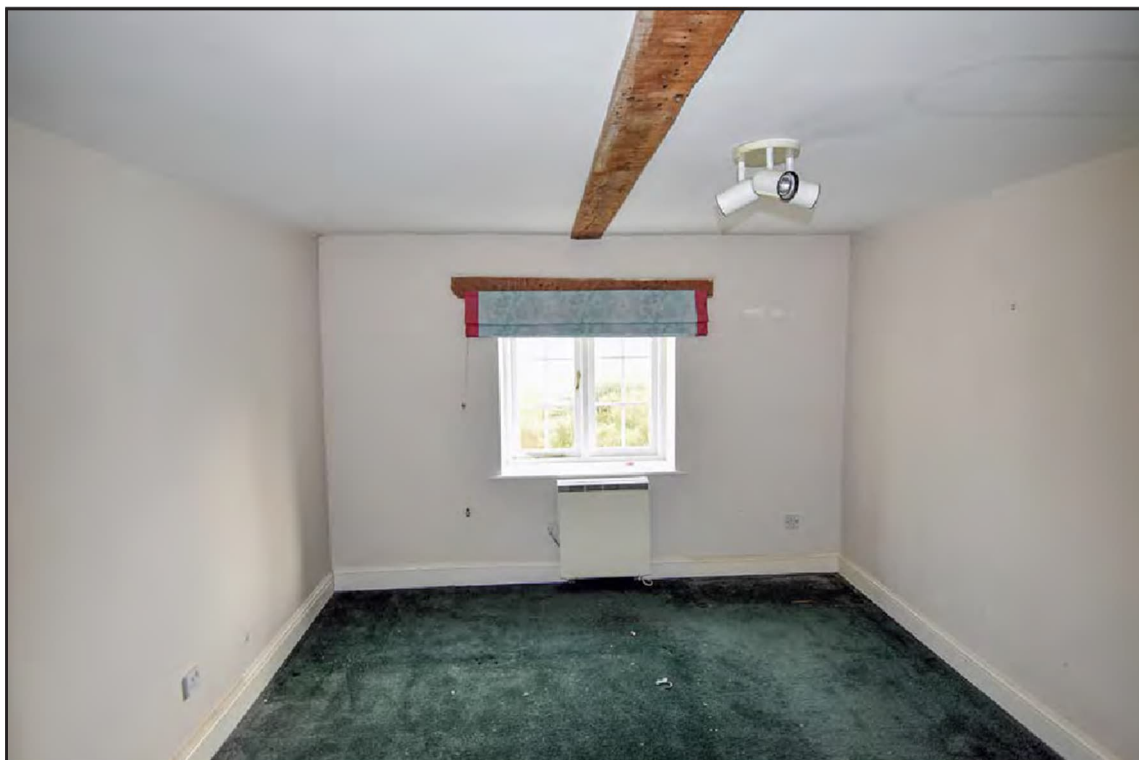
Photo A- 41: Bedroom F2 looking to front

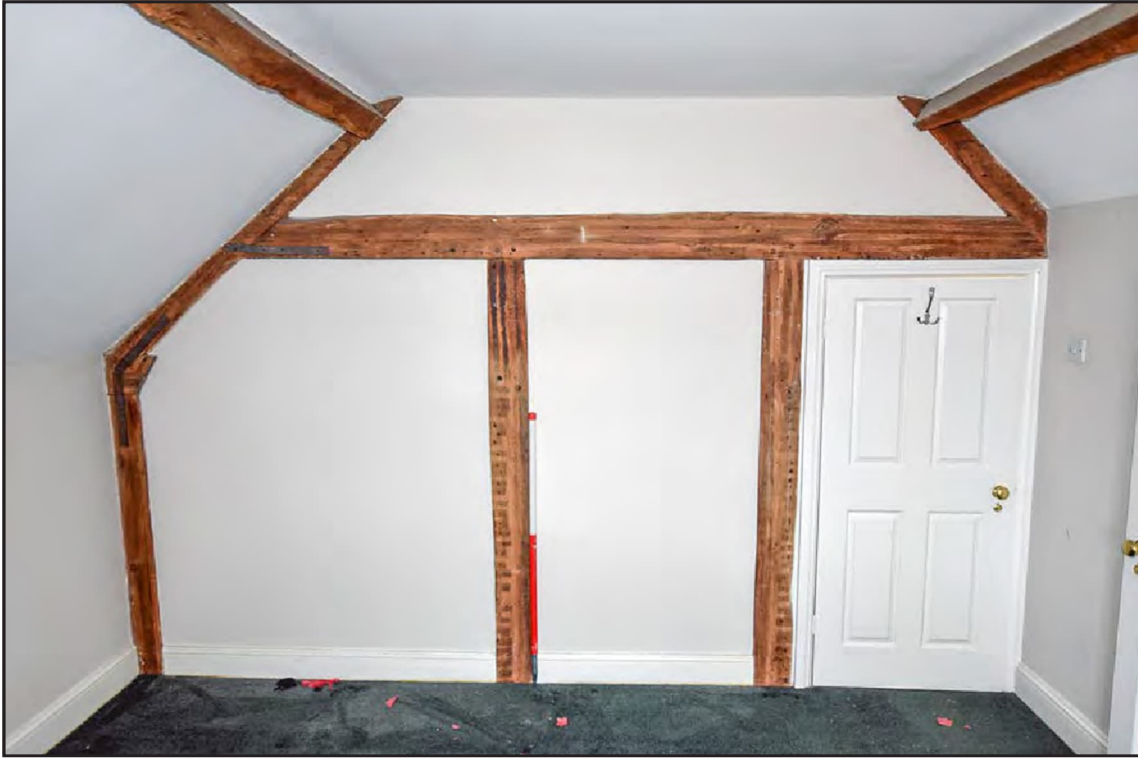
Photo A- 45: Bedroom F4, dividing wall to bathroom
