FORMER PRESBYTERIAN CHURCH, SCHOOL STREET, BARROW-IN-FURNESS, CUMBRIA

Archaeological Building Recording

Client: Barrow Borough
Council

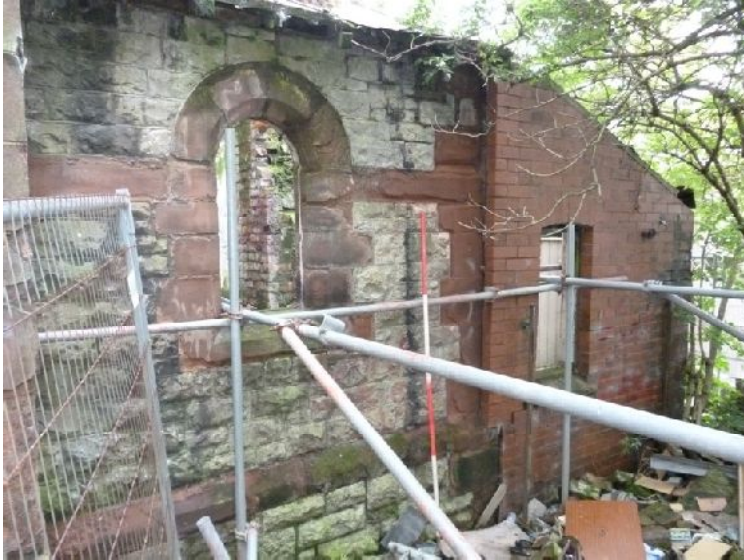
Plate 17 (left): Brick extension and outshut at north-east end

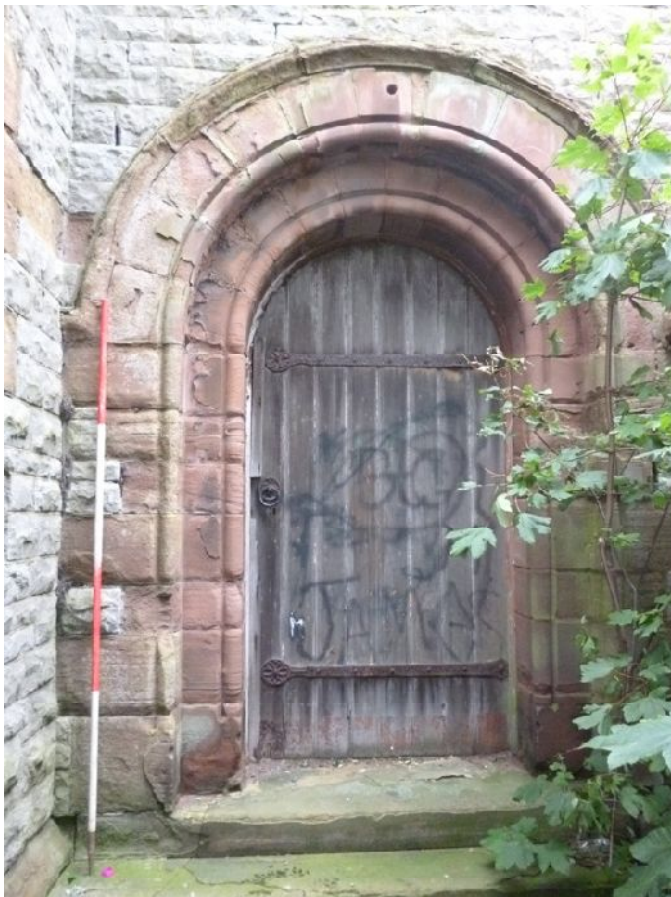
Plate 20 (left): Doorway in south-east tower, south-west external elevation

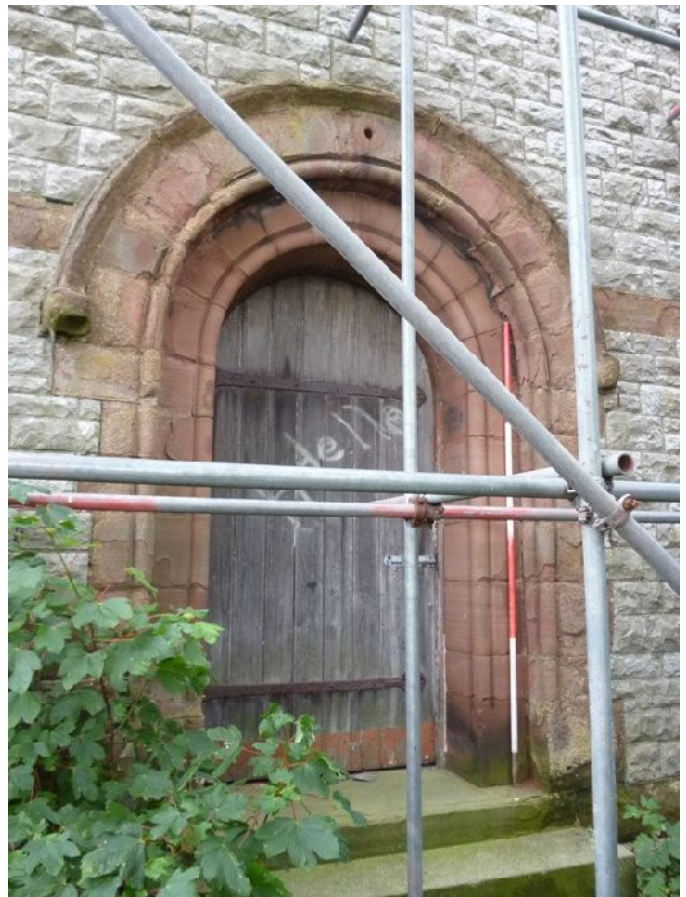
Plate 21 (right): Doorway in north-west tower, south-west external elevation

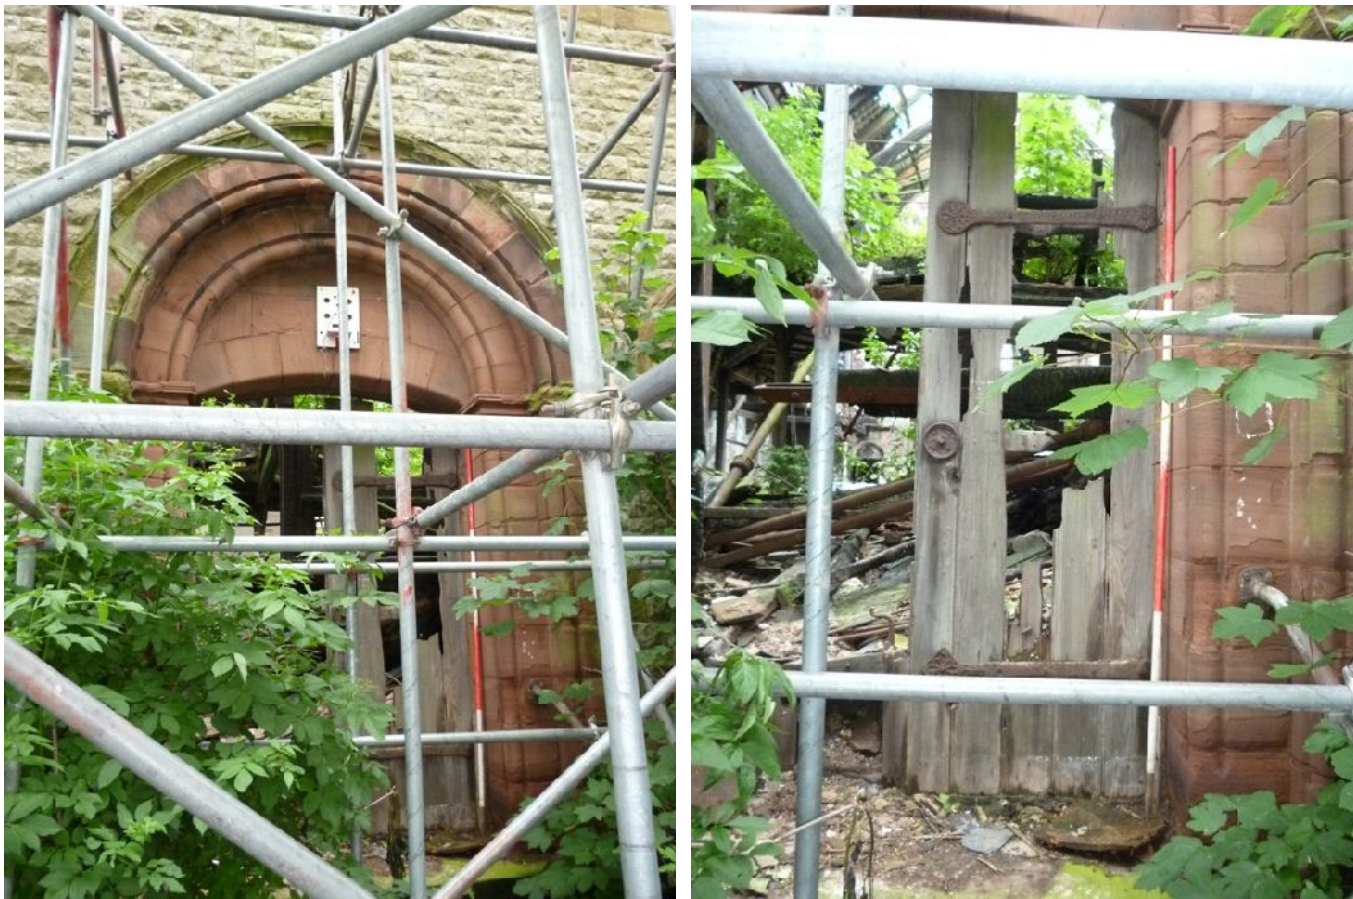
Plate 22 (left): Central doorway, south-west external elevation

Plate 23 (right): Detail of door in central doorway, south-west external elevation

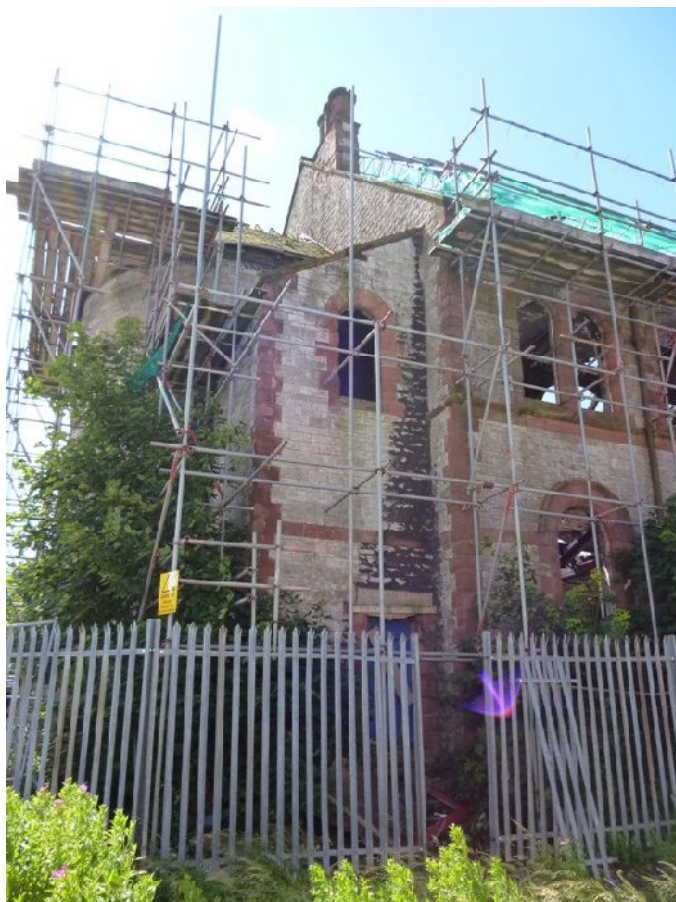
Plate 24 (left): North-east end of north-west external elevation

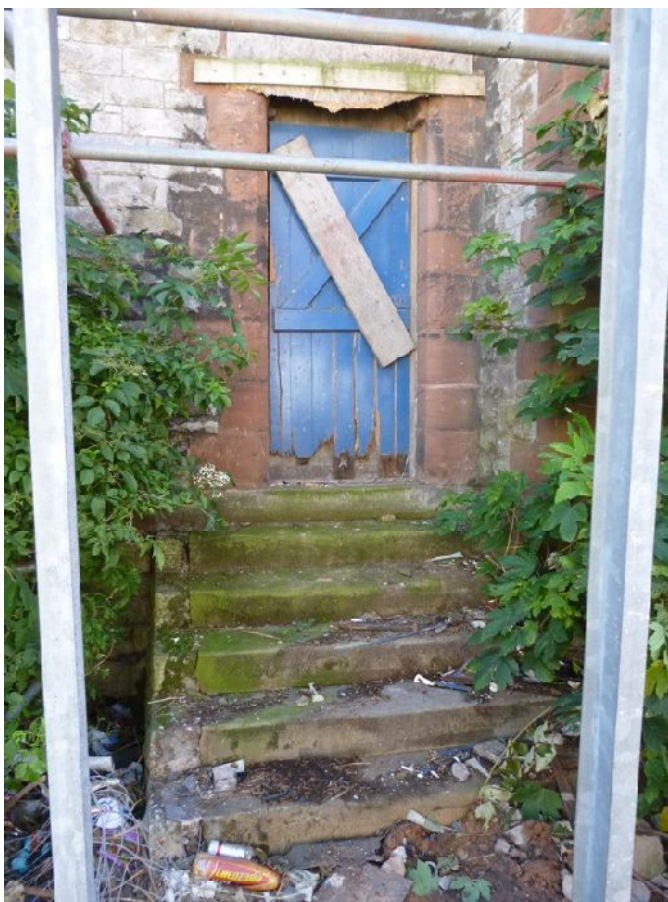
Plate 25 (right): Doorway and steps at the north-east end of the north-west external elevation

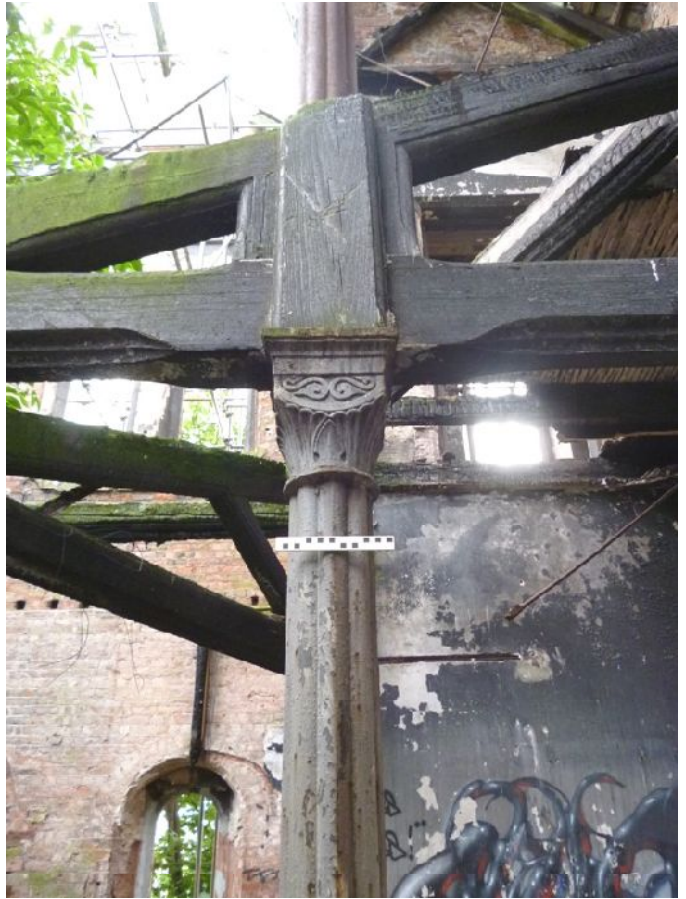
Plate 28 (right): Detail of decorative capital, Room G1

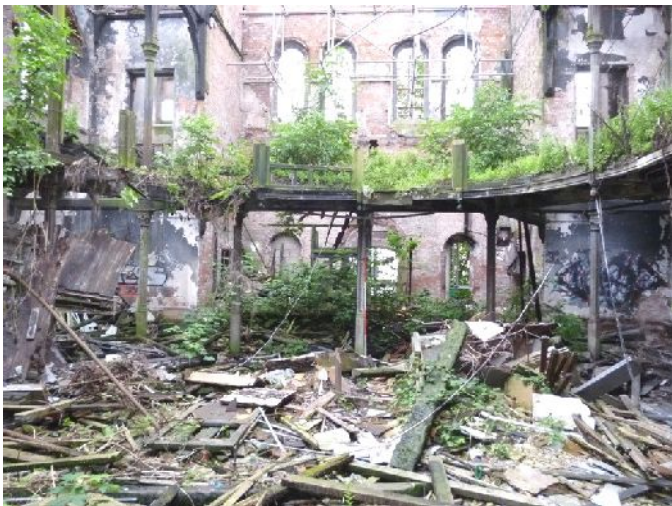
Plate 29 (left): Surviving sections of gallery walk-way, south-west side, Room G1

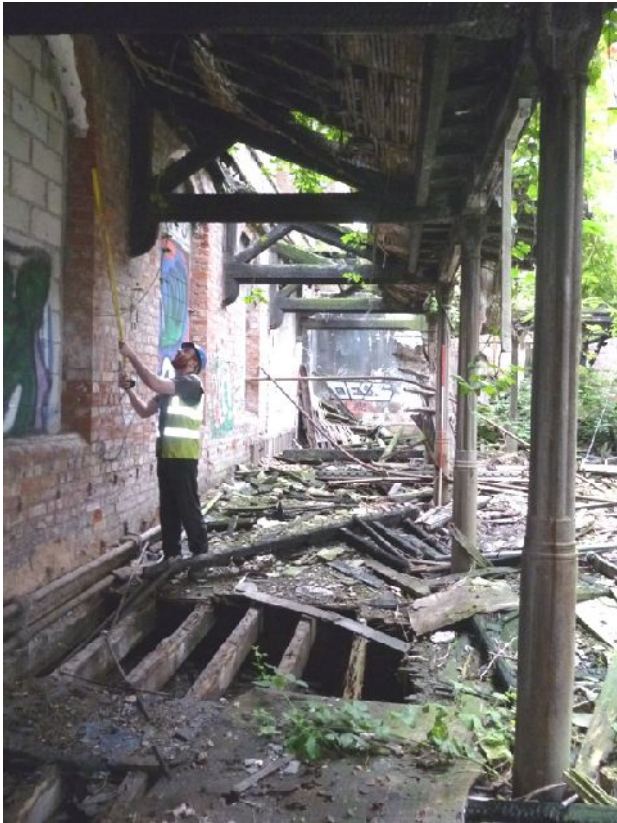
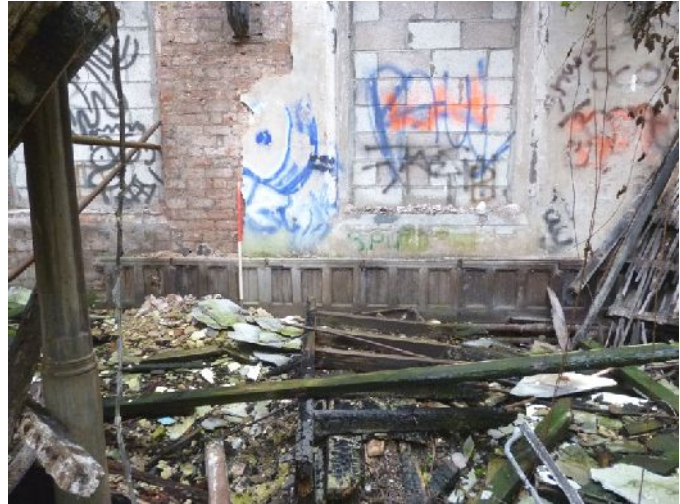
Plate 33 (left): General view along south-east elevation, Room G1

Plate 34 (right): Panelling at south-west end of south-east elevation, Room G1

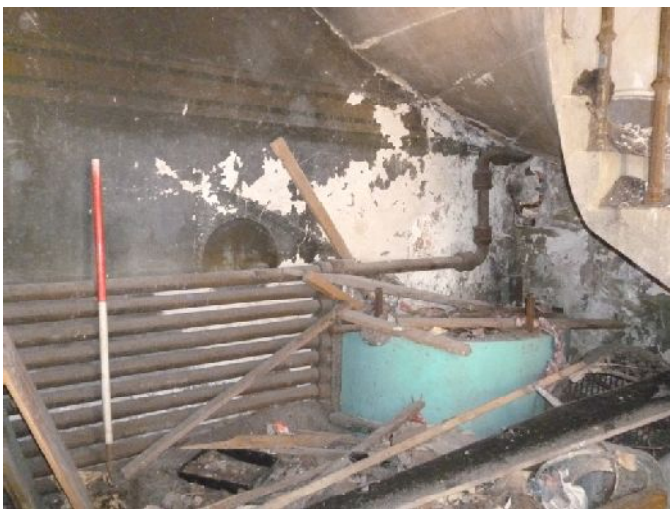
4.3.5 **Ground floor, Room 3:** this forms the interior of the tower in the west corner. Again the floor is obscured by debris and it is open to the floor above on the south-west side. The stairs are positioned against the north-east and north-west sides; the steps are constructed from pale yellow sandstone with a cast iron newel post and balusters and a moulded timber hand rail with a spiral finish (Plate 40). The walls are finished with plaster, which incorporates a roll-moulded skirting. The north-east elevation is plain and has the stairs set against it but the remains of the original painted scheme, which is the same as that in Room G2 (Plate 41). There is an iron pipe set into the wall in the north corner, presumably part of the heating system or for carrying gas around the building, and this connects to an iron box set into the wall below with a lever, presumably forming a valve. The south-east elevation has a central doorway with chamfered jambs and a round head, the top part of which has been filled leaving a recess to which is attached a scrolled iron bracket for a gas lamp. To the south-west of the doorway a chamfered timber bracket is attached to the wall, extending round the corner onto the south-west elevation, which has scrolled iron coat hooks attached (Plate 41). The south-west elevation is dominated by a large doorway with a timber door of trellis construction with iron strap hinges decorated with cross-hatching (Plate 42). Again, elements of the original paint scheme are present across this elevation and there is an early electrical fuse box in the west corner. The north-east side of the north-west corner is below the stairs and the rest is plain, apart from a row of iron pipes attached near the base, presumably also forming part of the heating system (Plate 43). Behind these is what appears to be scar for a round hole in the plaster, which has been filled and painted over (Plate 43).

Plate 43 (left): Pipes against north-west elevation and below stairs, Room G3

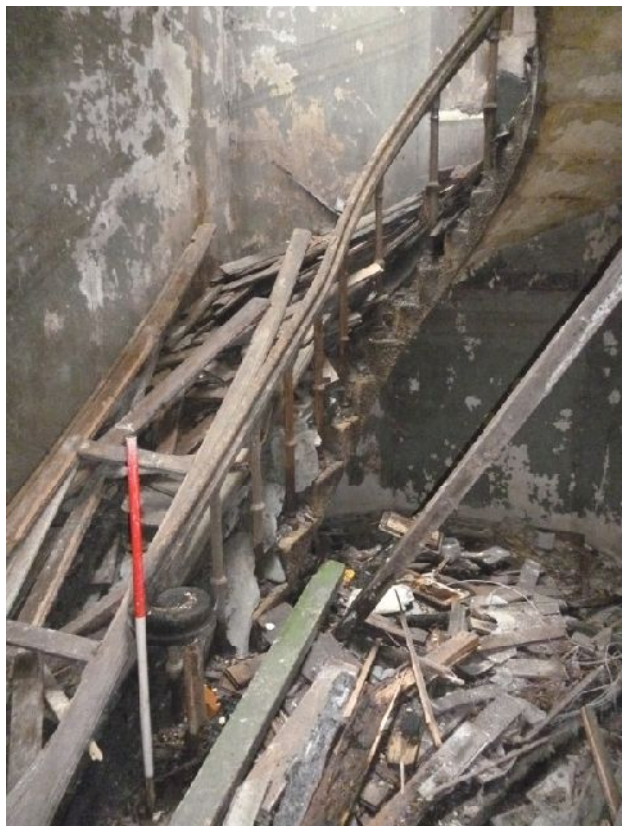
Plate 44 (right): Stairs in Room G4

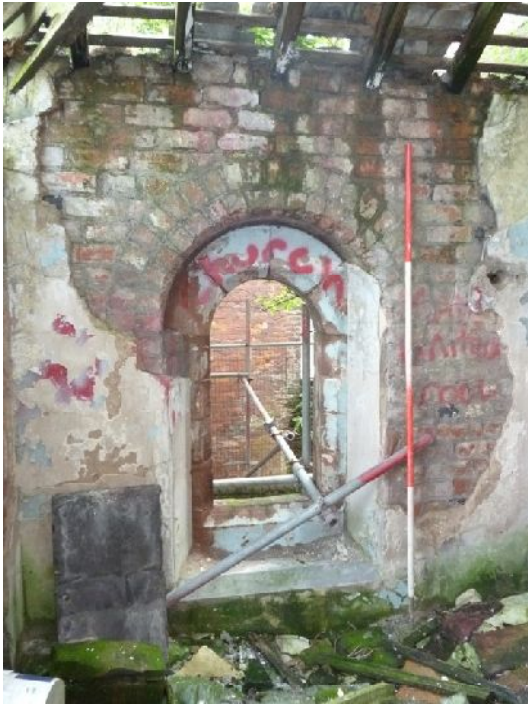
Plate 48 (left): Window in the south-east elevation of Room G5

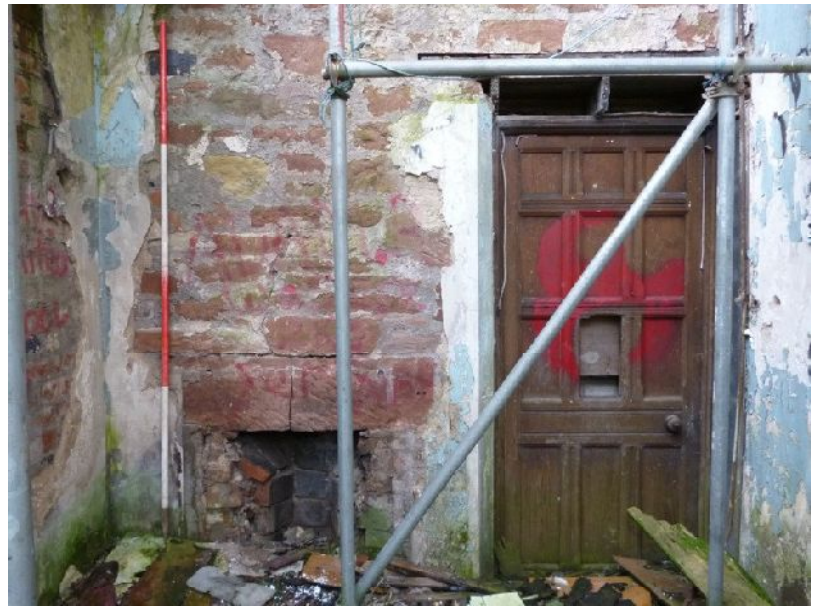
Plate 49 (right): Fireplace and doorway in the south-west elevation of Room G5

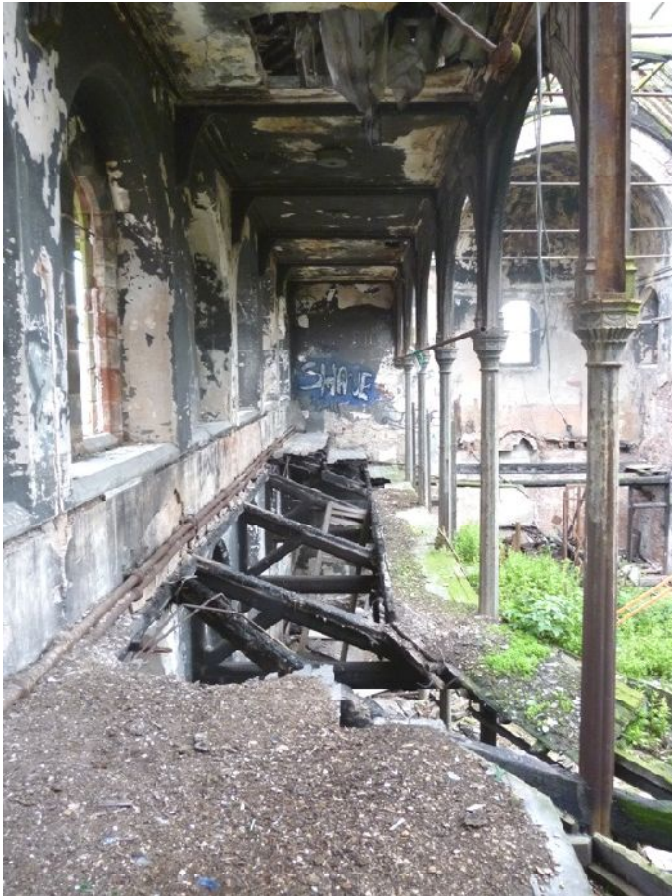
4.3.9 First floor, Room 1: this comprises the upper level of the nave, including the galleries and apse. The structure of the galleries at this level only survives in a fragmentary state; it is best preserved in the north corner and covered with vegetation along the south-east side. It could not be accessed safely at any point but the north-west side could be reasonably well viewed from the south tower (Plate 52 and Plate 54). As already described (see *Section 4.3.1*) it evidently originally held tiered floors for seating, with a level walk-way along the inner side. The arrangement at the north-east end (within the apse) and south-west side (above the main entrance) is not clear as so little is remaining in these areas. It is supported by a ring of columns situated directly above those on the ground floor and bolted to the top of the beam that they support; iron poles have been fixed along the columns presumably to act as makeshift barriers. The columns are again finished with decorated capitals, and on top of each a separate shorter column is bolted, which is decorated with fluted panels and open sections to the side (Plate 53) to house timber forming arched arcades running along each the gallery (Plate 54 and Plate 55). These only survive in reasonable condition in the north corner and comprise timber fascia or framing with moulded panels (Plate 55). The tops of the iron columns support beams forming the inner edge of the arcades and beams connecting to corbels in the outer walls, and each have an ovolo-moulded corbel on the inner face with an iron tie rod projecting through a connecting to the corbel on the opposing side of the room. In addition they support queen posts and angled struts forming part of the trusses, which are essentially of simple tie beam construction with a raised collar, attached to which is a fascia forming a large central arch (Plate 56). An iron strap fixes the principal rafters to the collar and the principals meet at a lap joint, south-east on top of north-west and are fixed with an iron bolt. There are the remains of eight trusses, including one against each end wall, making seven bays. Attached between the queen posts was originally a stud wall constructed of lathe and plaster and finished with moulded plaster panels and a row of pierced foliate-style iron grills below; this now only survives on the north-east side of the north-west elevation. Below the roof the ceiling too was originally finished with lathe and plaster with moulded panels, although only traces of this now survive, with light fittings attached. Within the galleries there was originally a lower ceiling between the beams running north-west/south-east from the tops of the columns, again of lathe and plaster construction with moulded cornices, but elements of this only survive on the north-west side. At the south-west end virtually none of the upper structure survives while in the apse the domed plaster ceiling remains intact, with a beaded outer edge and moulded plaster rail.

Plate 52 (left): First floor gallery, north-west side, Room F1

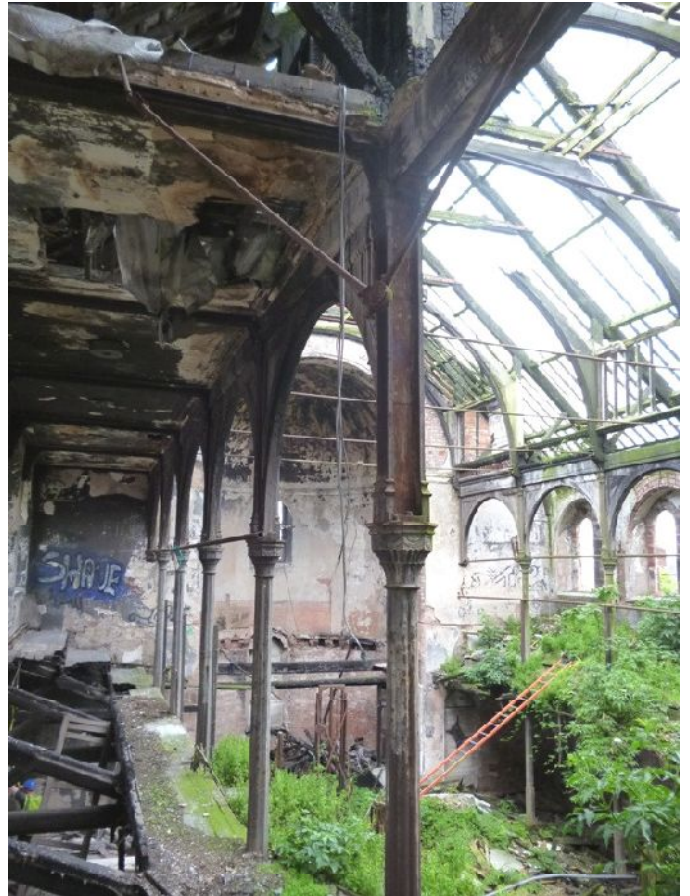
Plate 53 (right): Detail of columns, Room F1

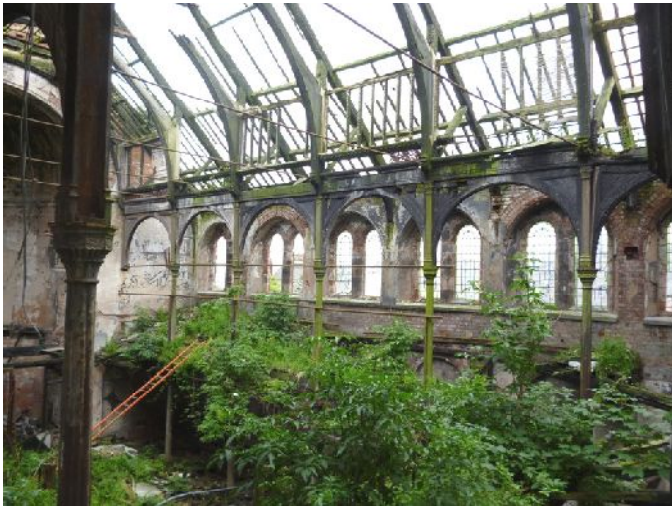
Plate 54 (left): Arcade along south-east side, Room F1

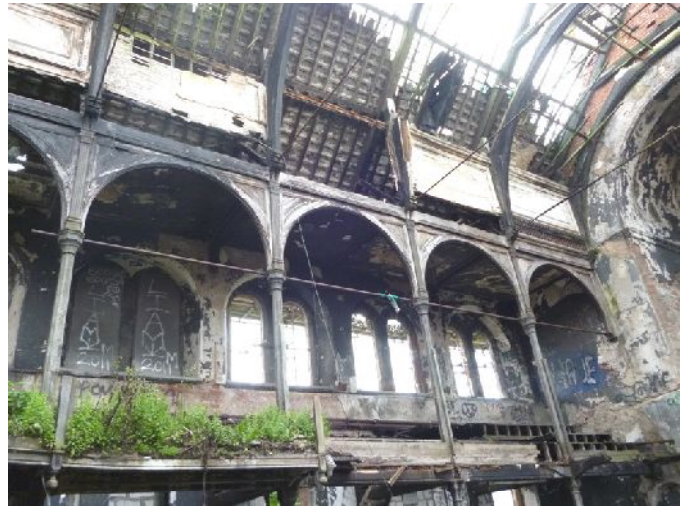
Plate 55 (right): Arcade along north-west side, Room F1, showing remaining plaster

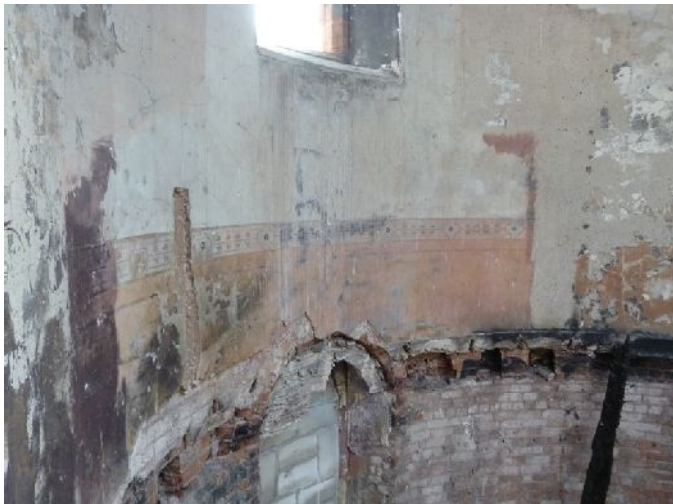
4.3.10 All of the walls were originally finished with plaster and paint, although this only remains to any extent on the north-east and north-west sides. The centre of the north-east elevation is situated within the semi-circular apse, which has remains of its paint scheme still visible – comprising linear bands with leaves and quatrefoil panels, in what appears to be green, above a block of pale orange with further dark bands (Plate 57). The wall of the apse is otherwise relatively plain; there is a central window with a round head and chamfered surround, and the return to the south-west has a doorway into the upper floor of the north tower, with a badly fire-damaged timber lintel, the upper part of the opening below having been infilled with a lathe and plaster panel. There is also a window in the south-east return, which is relatively small compared to that to the north-east but in the same style. The flat returns either side of the apse are plain, with brackets for the arcades attached. The south-east elevation has some plaster remaining but the brickwork is exposed across most of it. There are six pairs of windows, each pair set within a large round-headed opening, several of which have elements of the stained glass remaining.

Plate 57 (left): Paint scheme within the apse, north-east end of Room F1

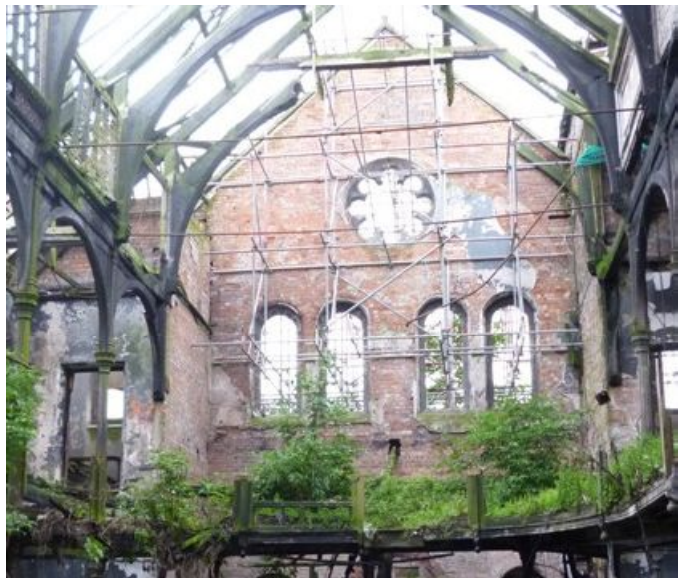
Plate 58 (right): Windows at the south-west end of Room F1

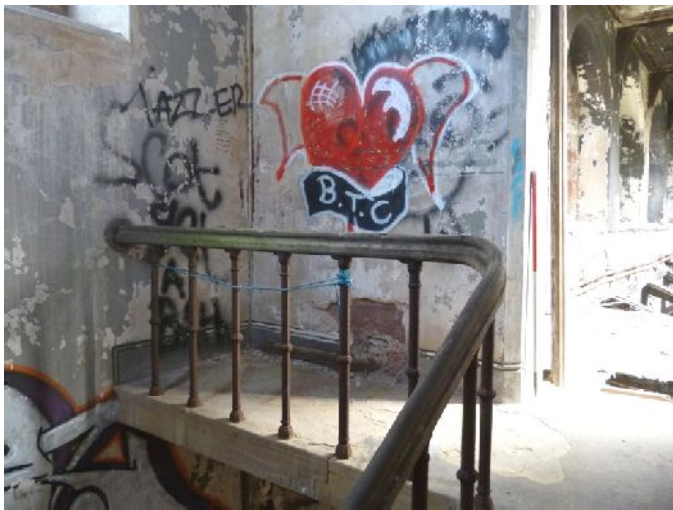
4.3.13 **First floor, Room 3:** this is the upper floor of the west tower. The ashlar yellow sandstone staircase with cast iron balusters and turned timber handrail, as per the floor below, continue to this level where they form a landing (Plate 59). The ceiling is lathe and plaster and flat, with a square access hatch, presumably an upper level roof space in the west corner. The walls are finished with plaster and paint, incorporating a moulded skirting. There are windows to the south-west and north-west with round headed, with recessed panel in the top section, and chamfered surrounds and a doorway to the north-

Plate 59 (left): Handrail and landing at the top of Room F3
