'GRANGE LIDO', GRANGE-OVER-SANDS, CUMBRIA

Archaeological Building Recording

Client: NPS North West Ltd

March 2013

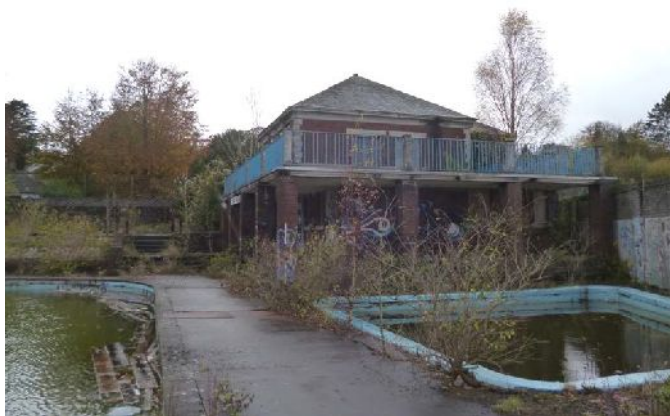
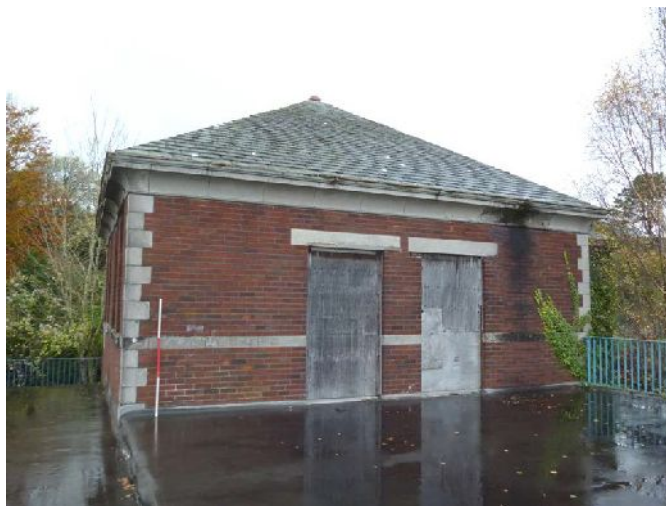
4.2.2 **North Building, East Elevation:** the ground floor part of the east elevation is situated below the walkway (Plate 29), which has a moulded concrete band along its base, and there are three narrow windows to the north, with concrete sills. The first floor has two windows, with plain concrete lintels and sills, the latter incorporated into a string course, which continue into the south elevation (Plate 30 Plate 31 Plate 32). The eaves are cavetto-moulded and support a moulded iron gutter and there are concrete quoins at the corners.

Plate 29 (left): General view of the east elevation of the north building

Plate 30 (right): First floor view of the east elevation of the north building

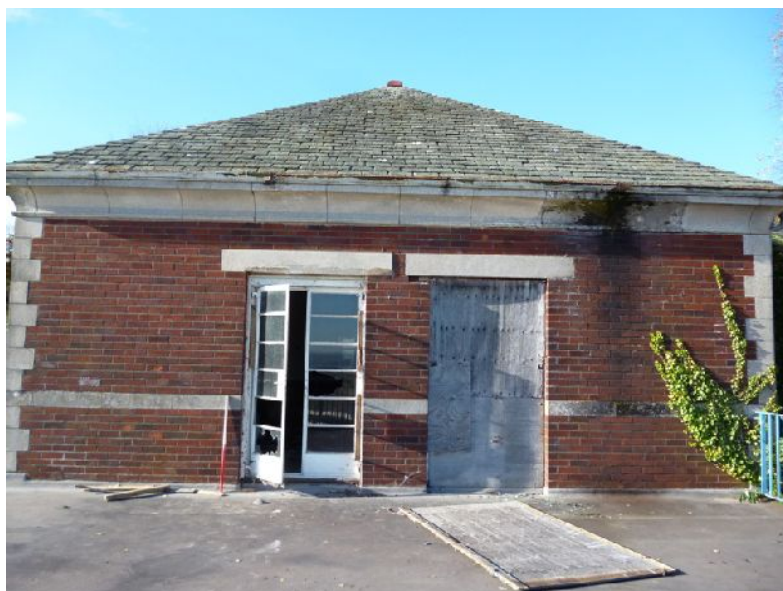
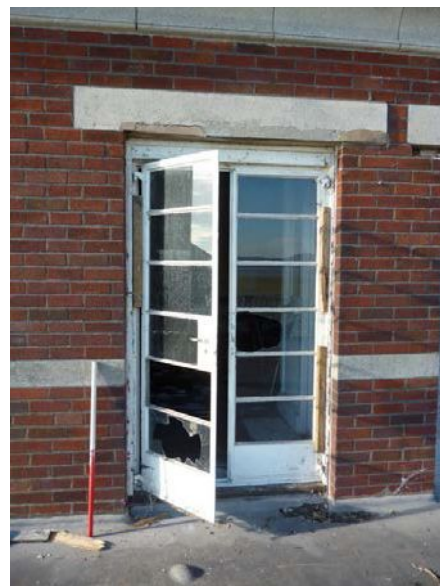
Plate 31 (left): Entrance to the east elevation of the north building on the first floor

Plate 32 (right): Doorway to the south side of the east elevation on the first floor of the north building

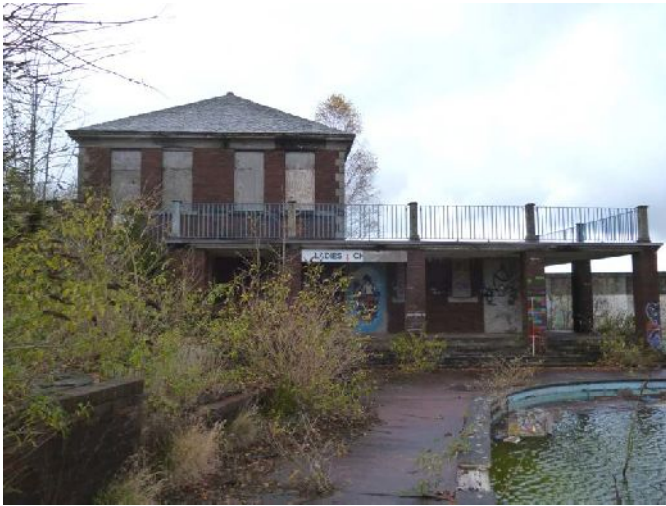
4.2.3 North Building, South Elevation: the east end of the south elevation is continued by the outer walk-way, which forms a covered canopy built of brick pillars supporting a flat roof/walkway (Plate 33). There are concrete steps up from the pool side to the canopied area and there are concrete posts with iron railings round the top of the walkway. The east end proper has three narrow windows on the ground floor, with concrete sills and lintels, with the lintels at the level of the outer walkway. There are two doorways blocked with concrete blocks on the ground floor and the elevation returns at the west end where there is a further doorway, which has a concrete lintel and is blocked with boarding. The wall then continues to the south where it connects with a wall forming part of the adjoining staircase structure; the stairs are concrete and flanked by brick walls and continue up to the first floor walkway. The first floor elevation is only really present on the west side, where there is a row of four windows each with concrete sills and lintels, incorporated into a cavetto-moulded eaves band with a moulded iron gutter on top (Plate 34). All of the windows are blocked with boarding and there are concrete quoins at the corners.

Plate 33 (left): East end of the south elevation of the north building

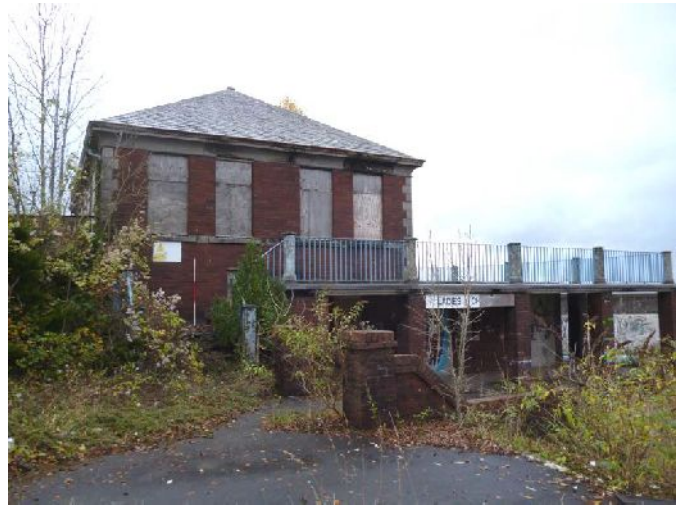
Plate 34 (right): West end of the south elevation of the north building

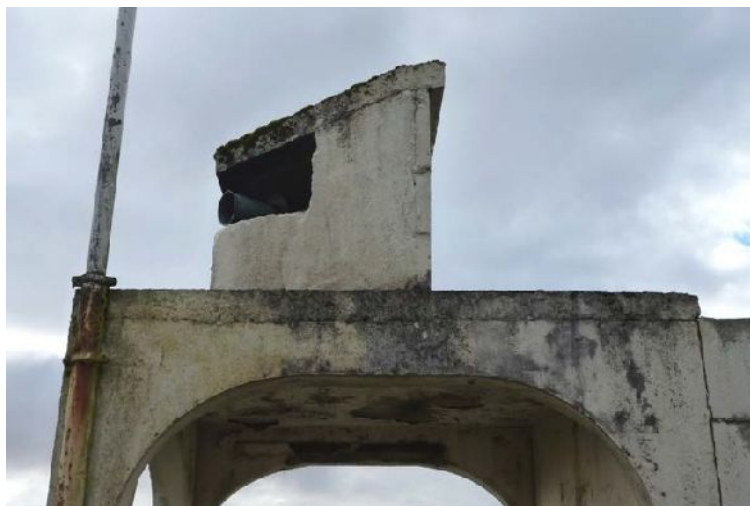
4.2.6 **East Building, East Elevation:** the lower part of the east elevation comprises the outer retaining wall (Plate 38; see Section 4.2.21 below). This is topped with a concrete stilt structure with a round arch, which has a flat roof housing a small structure containing a telescope (Plate 39). Inside this structure the main central part houses the access to the diving platforms, which is blocked with boarding. The scars of steps are apparent on the north and south sides of this structure (see Plate 37 and Plate 41), although access to the flanking diving boards is also blocked with boarding.

Plate 39: Detail of the telescope atop the east building

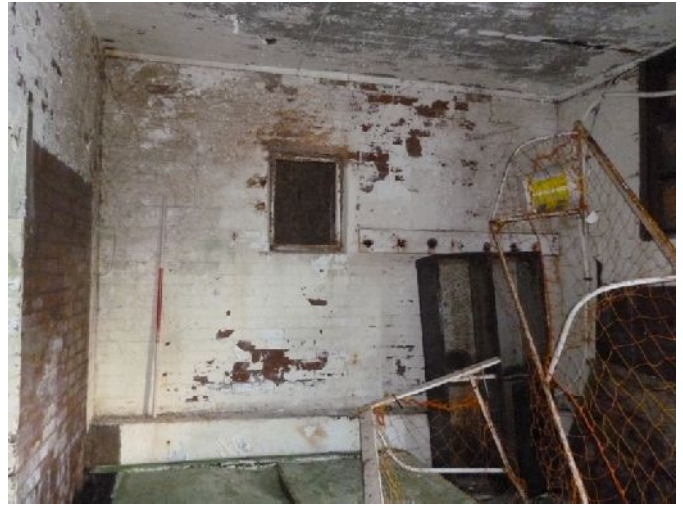
Plate 130 (right): West elevation of South Building, Ground Floor Room 3

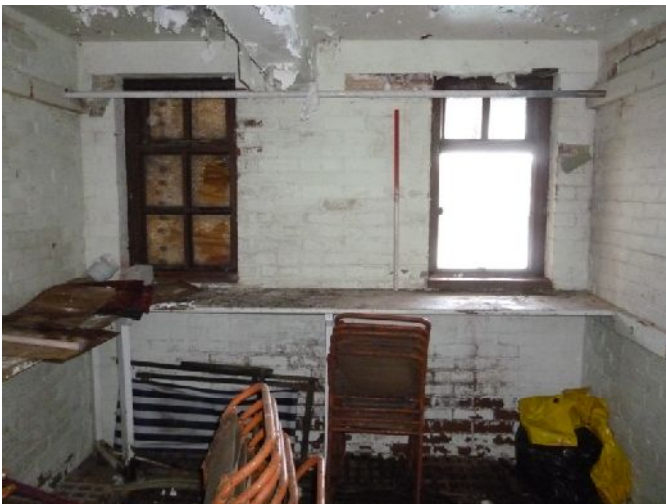
Plate 131 (left): North elevation of South Building, Ground Floor Room 5

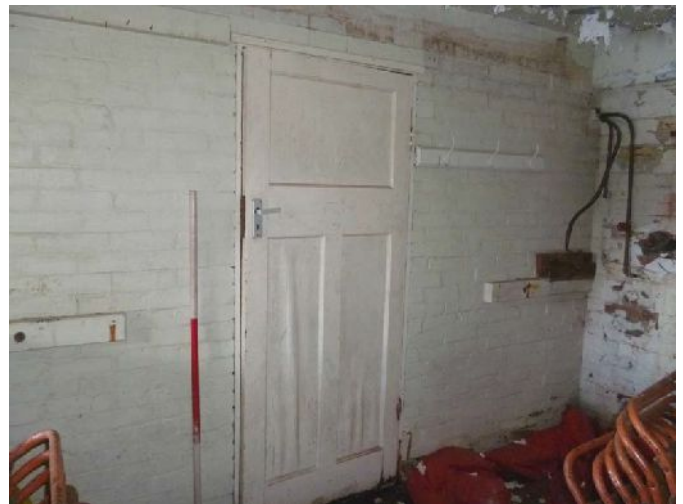
Plate 132 (right): East elevation of South Building, Ground Floor Room 5

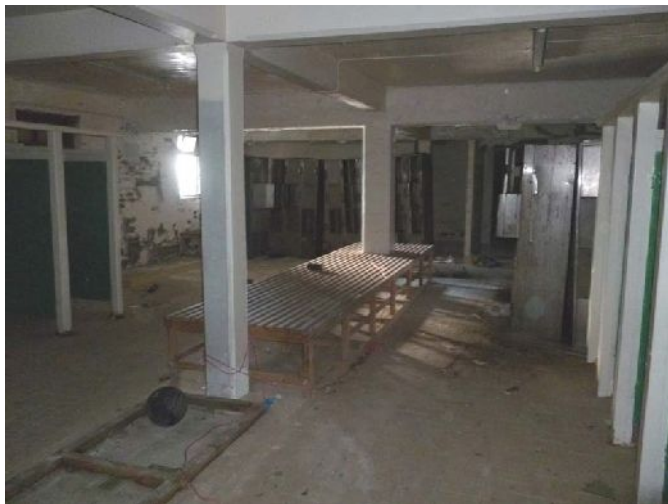
Plate 135 (left): North east corner of South Building, Ground Floor Room 6

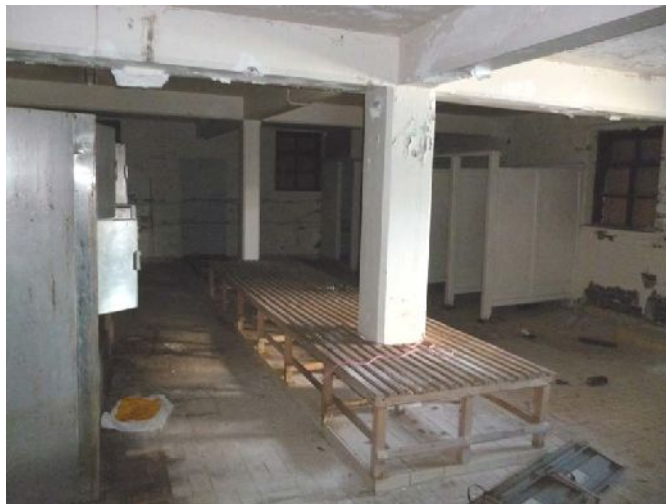
Plate 136 (right): North-west corner of South Building, Ground Floor Room 6

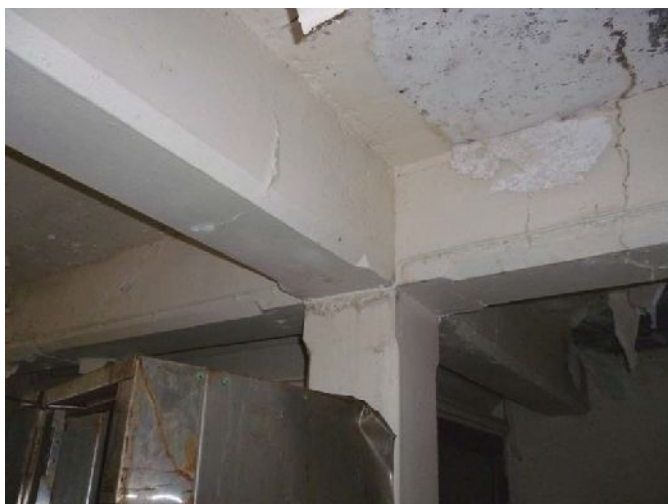
Plate 137 (left): Stop-chamfered beams in South Building, Ground Floor Room 6

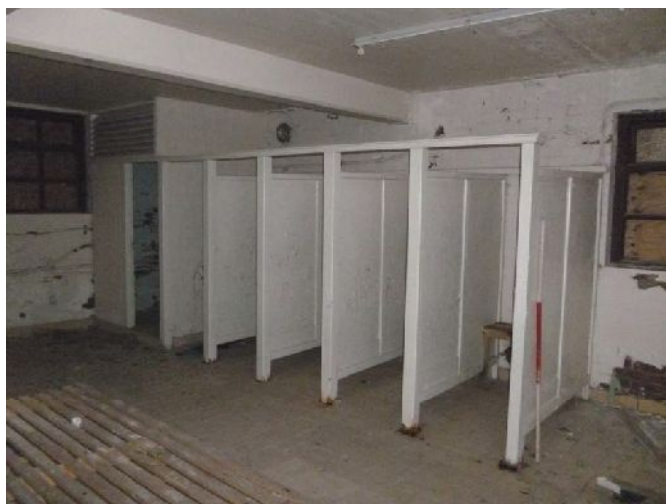
Plate 138 (right): West end of the north elevation of South Building, Ground Floor Room 6

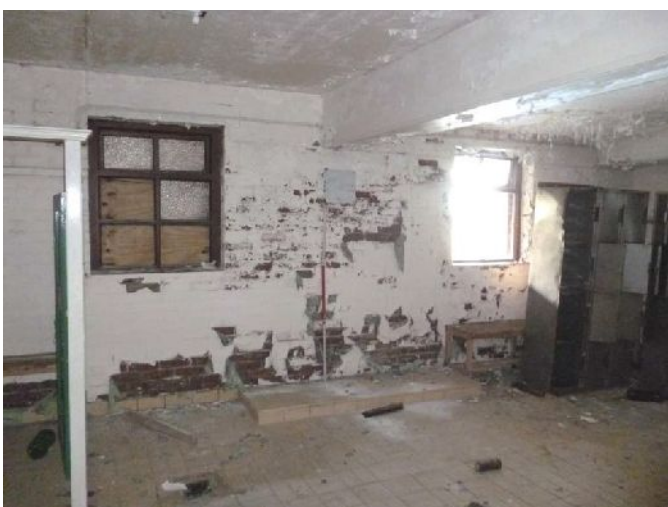
Plate 139 (left): East end of the north elevation of South Building, Ground Floor Room 6

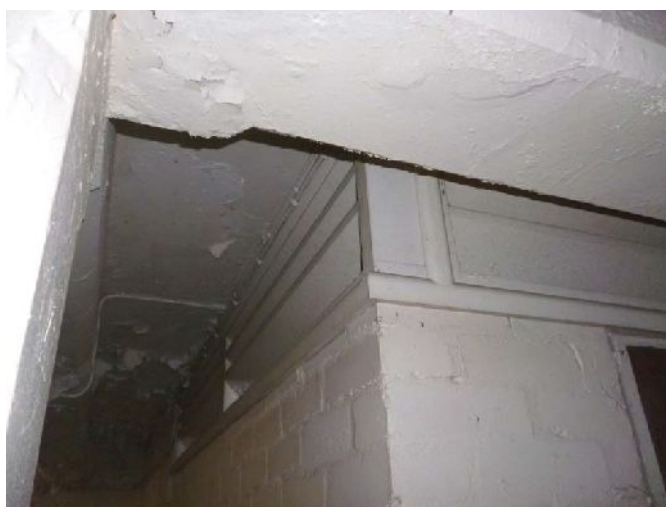
Plate 140 (right): Slatted opening in the return wall in South Building, Ground Floor Room 6

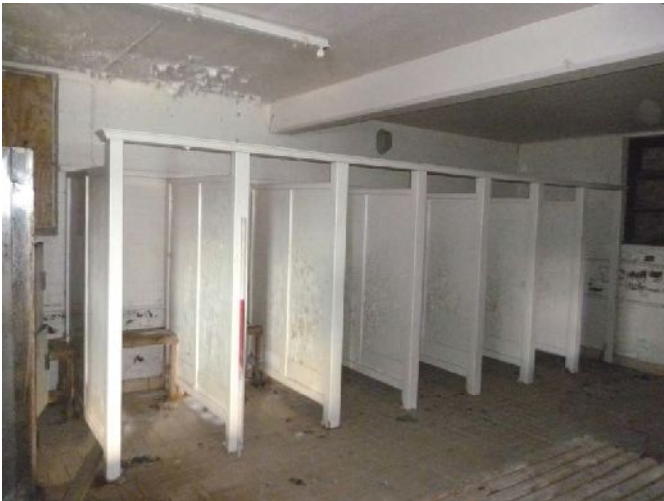
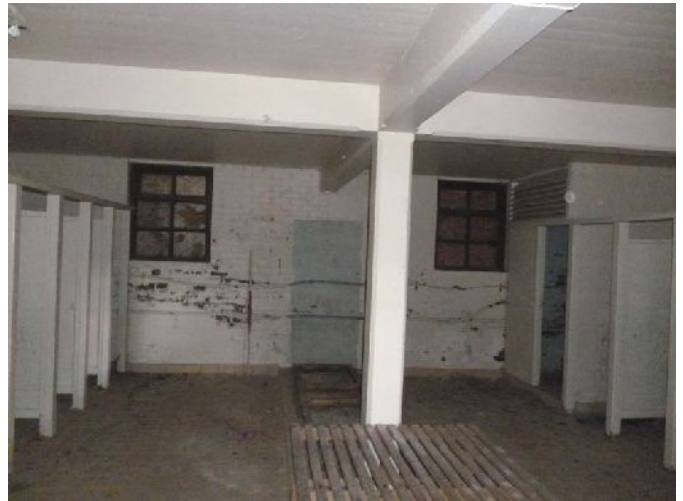
Plate 146 (left): West end of the south elevation of South Building, Ground Floor Room 6

Plate 147 (right): West elevation of South Building, Ground Floor Room 6

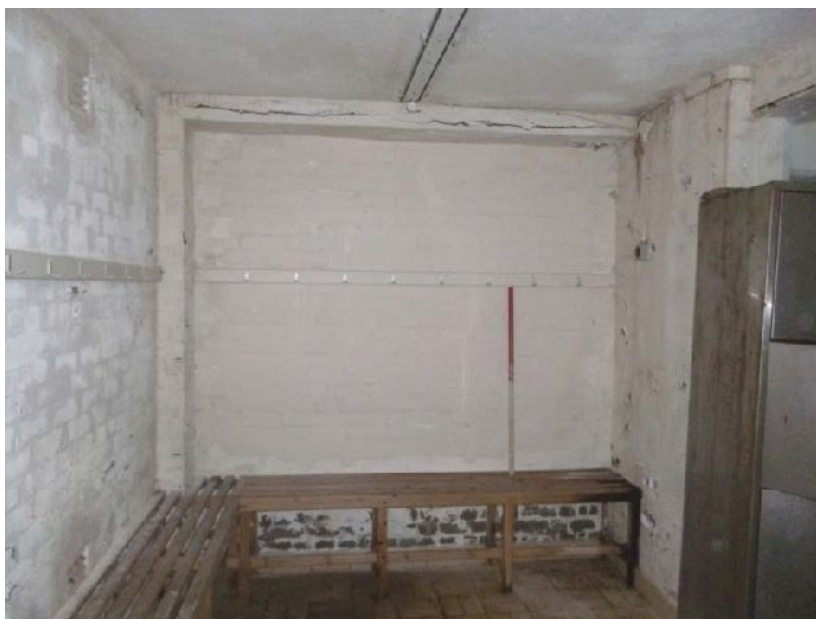
4.3.18 Room 7 has a tiled floor and painted concrete ceiling. The walls are painted brick, with a slatted bench around the east, west and south sides and battens with coat hooks above. The walls are largely plain, although there is a wide opening to the north. The west has a concrete lintel along it and there is a pillar in the south-west corner (Plate 148).

Plate 148: West elevation of South Building, Ground Floor Room 7

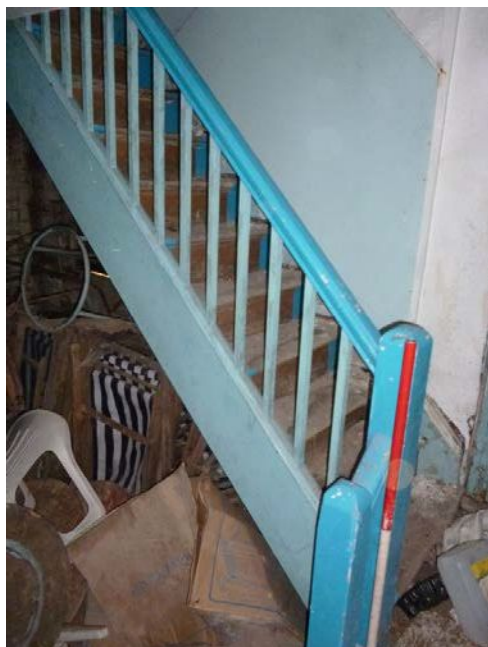
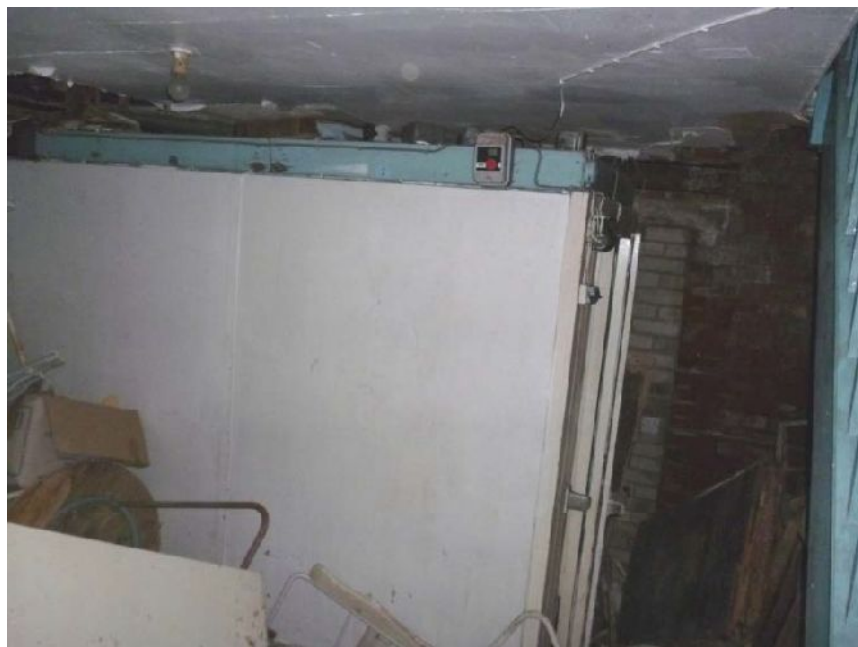
Plate 149 (left): Stairs along the south elevation of South Building, Ground Floor Room 9

Plate 150 (right): Walk-in freezer in the north-east corner of South Building, Ground Floor Room 9

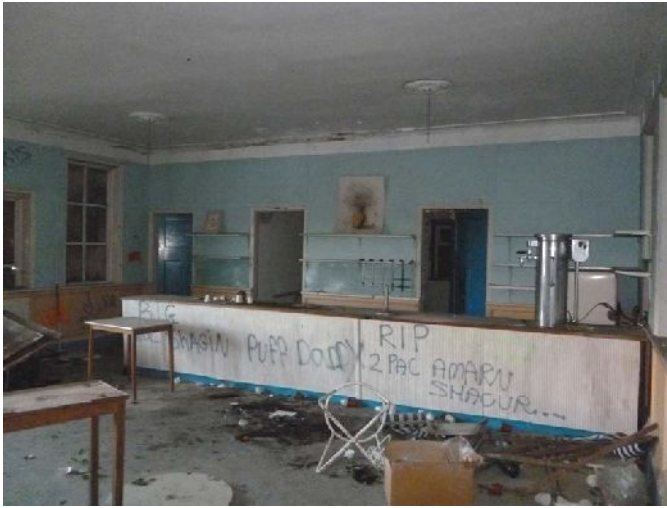
Plate 157 (left): South elevation of South Building, First Floor Room 1

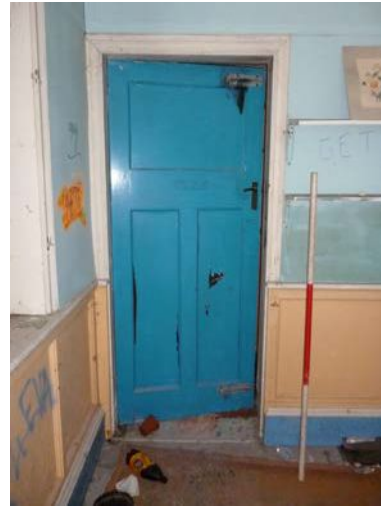
Plate 158 (right): Door at the east end of the south elevation of South Building, First Floor Room 1

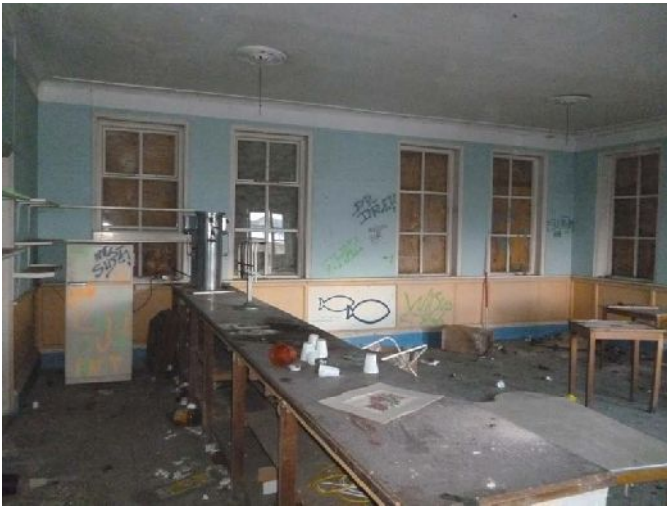
Plate 159 (left): West elevation of South Building, First Floor Room 1

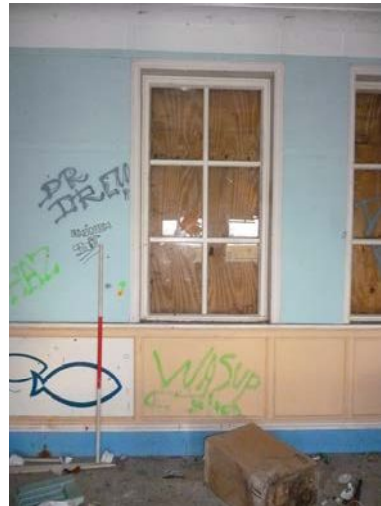
Plate 160 (right): Detail of the windows in South Building, First Floor Room 1

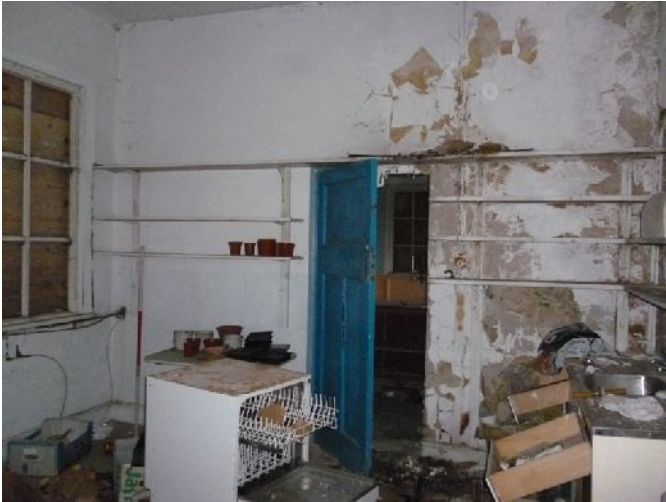
Plate 164 (left): North elevation of South Building, First Floor Room 4

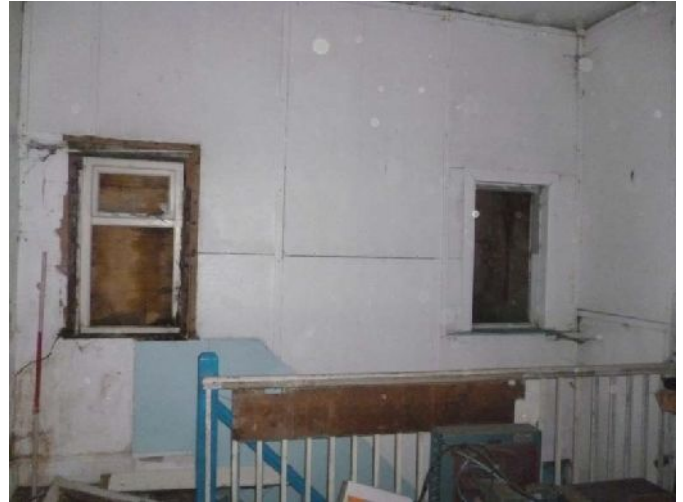
Plate 165 (right): South elevation of South Building, First Floor Room 4

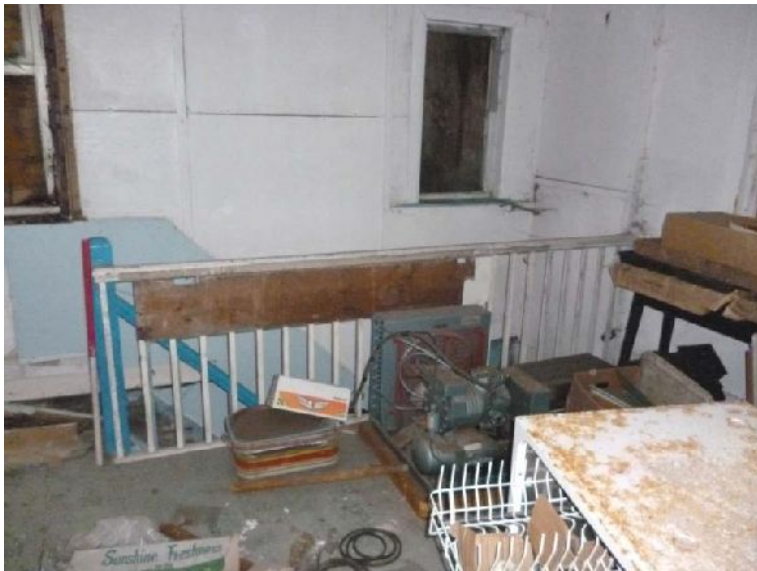
Plate 166 (left): Stairs along the south elevation of South Building, First Floor Room 4

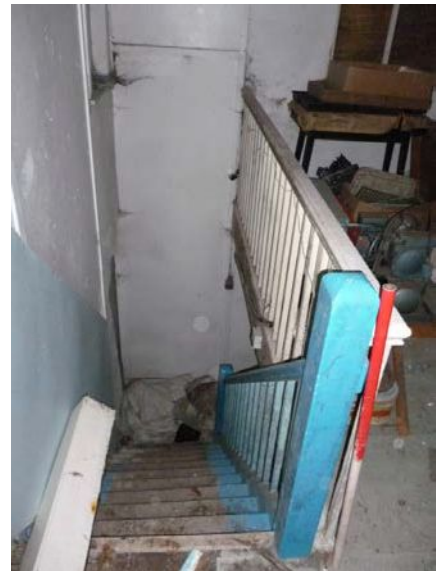
Plate 167 (right): Detail of the stairs in South Building, First Floor Room 4

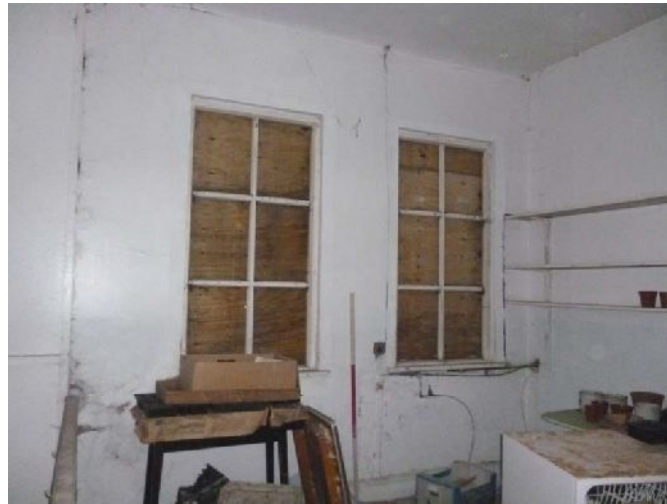
Plate 168: West elevation of South Building, First Floor Room 4

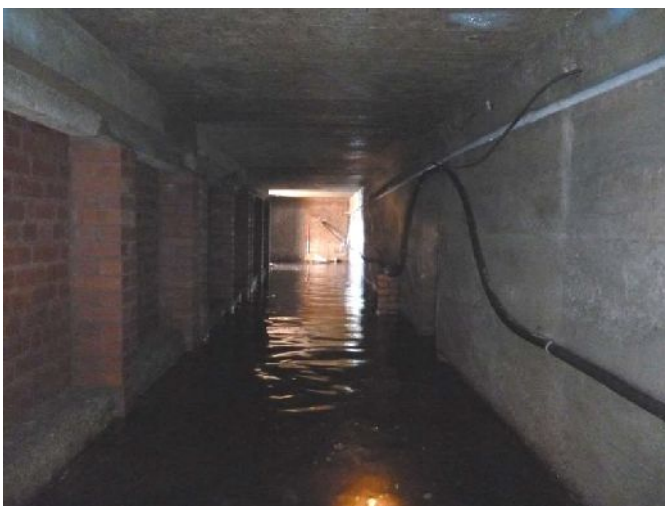
4.3.26 **West building, basement:** this was partially flooded but evidently had a concrete floor, albeit relatively rough, and the ceiling was constructed from slabs of poured concrete with the lines of plank shuttering visible in the concrete and even the saw marks. The south elevation comprises rough gravelly concrete and is plain although there is a water pipe set against it (Plate 169). The west elevation is of similar construction and also has pipes fixed to it. There is a small brick pillar south of the centre and a low narrow opening into the rooms to the west near the centre. The north elevation is the same as the south (Plate 170). The east elevation has doorways at the north and south ends with the remnants of the original timber surrounds with iron hinges still present in the south example. The wall is of brick construction with a row of concrete buttresses against it, which are perhaps a later addition, and these extend into a concrete plinth along the base and a 'beam' along the top. There is certainly added brickwork either side of the south doorway and concrete steps. One brick in the earlier fabric around the south doorway is marked 'CLAUGHTON MANOR BRICK Co CATON'. To the west of this main room, through the small doorway, are five further small rooms, not all of which were accessible. All were partially flooded and had very rough irregular floors, partially covered by silt, and poured concrete walls. The central room was smallest and had small low openings on the west side of the north and south elevations leading into a further room beyond. These two had similar openings on the west side, but the rooms beyond could not be safely accessed.

Plate 169 (left): South end of the basement in West Building

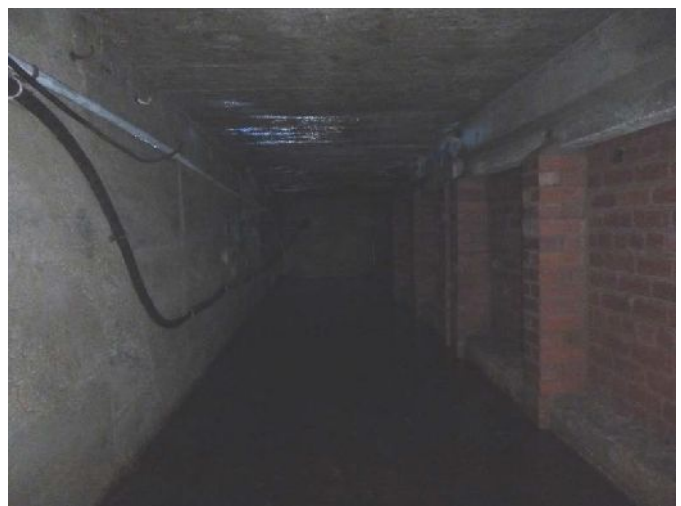
Plate 170 (right): North end of the basement in West Building

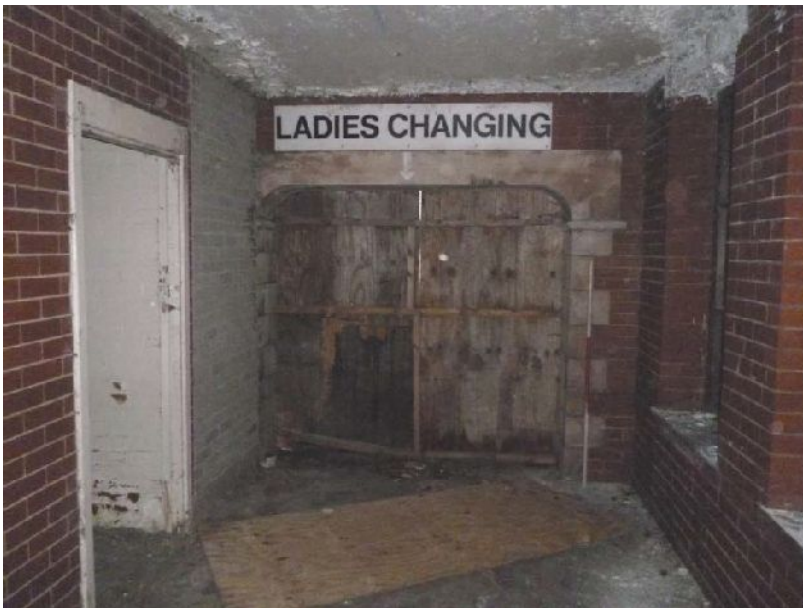
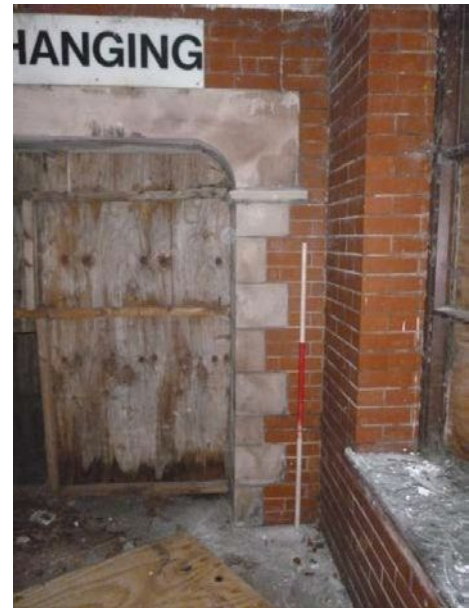
Plate 171 (left): North elevation of West Building, Ground Floor Room 1

Plate 172 (right): Detail of the doorway in the north elevation of West Building, Ground Floor Room 1

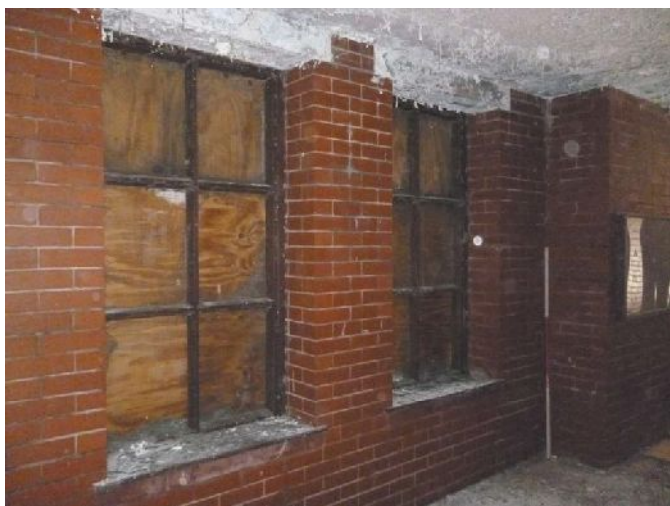
Plate 173 (left): North end of the east elevation of West Building, Ground Floor Room 1

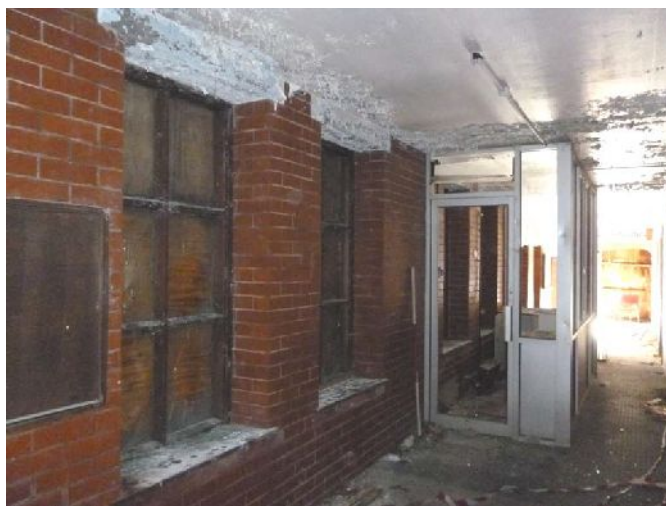
Plate 174 (right): Kiosk against the east elevation of West Building, Ground Floor Room 1

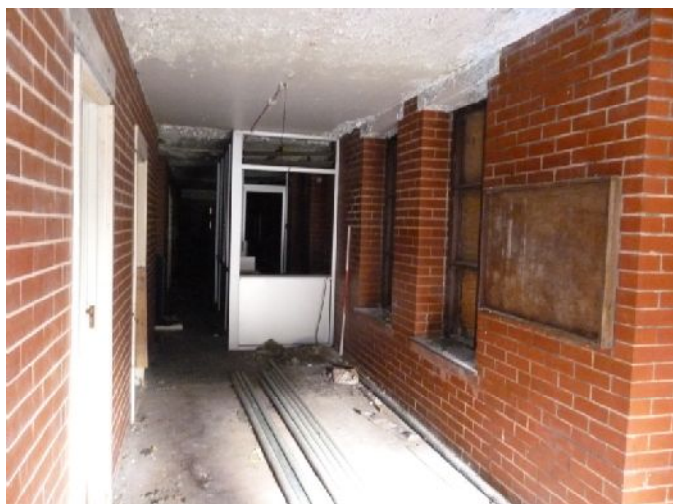
Plate 175 (left): South end of the east elevation of West Building, Ground Floor Room 1

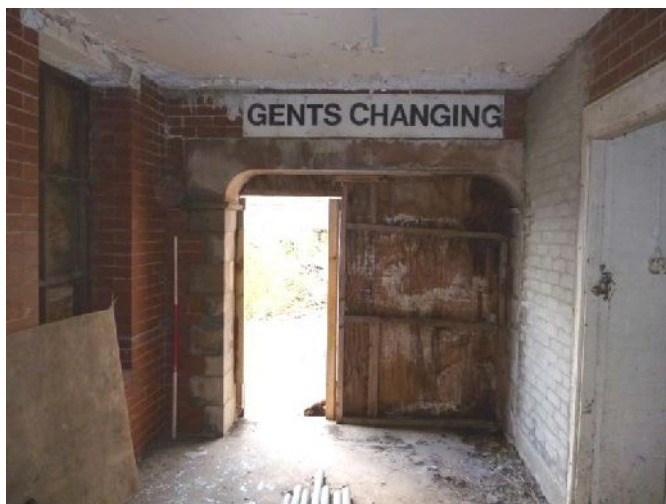
Plate 176 (right): South elevation of West Building, Ground Floor Room 1

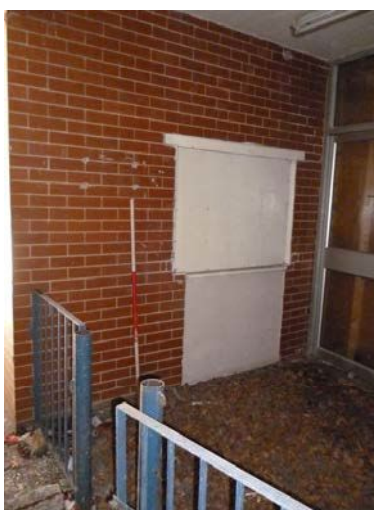
Plate 178 (right): Hatch in the south side of the return in West Building, Ground Floor Room 1

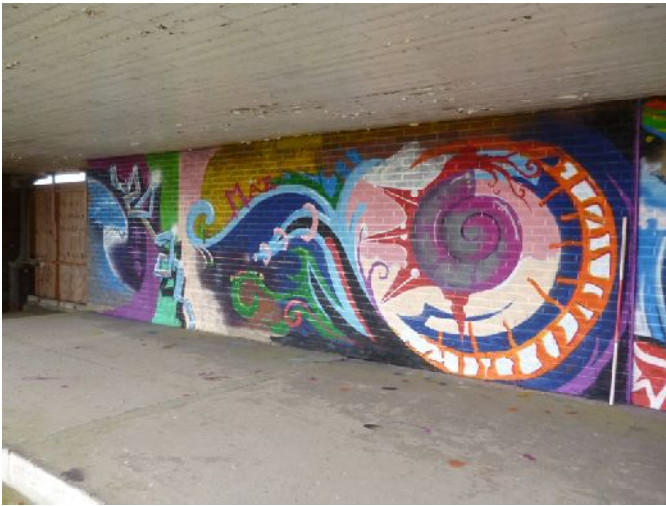
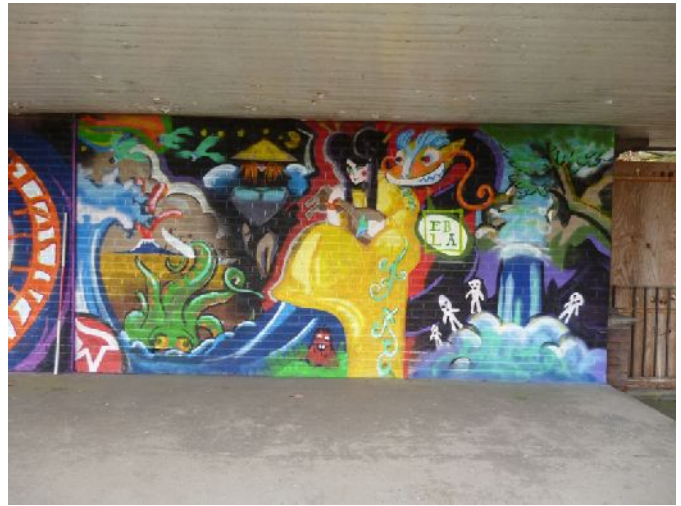
Plate 206 (left): South end of the graffiti mural on the west elevation on the first floor of the West Building

Plate 207 (right): North end of the graffiti mural on the west elevation on the first floor of the West Building

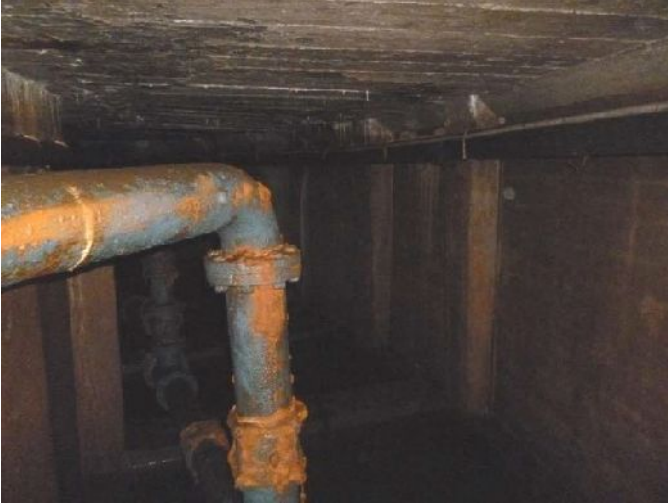
4.3.36 **Tanks:** access to these was limited due to health and safety considerations but a brief examination was made of the entire area. The tanks have an essentially symmetrical plan, mirroring each other from one end to the other and comprise a linking access corridor or subway running along the west side in an arc, a central area containing pipework associated with the pump house above on the east side and the large storage tanks to the north and south of this. The corridor is supported by a series of concrete pads radiating around between the outer walls with a large cast iron pipe along the west side, marked 'S1 85' at the south end, and a timber batten along the east side supporting a smaller metal water pipe (Plate 209). There are also strip lights attached to the west side in plastic covers. A small bore plastic water pipe is also present along the floor and there are iron ladders leading to access hatches at the north and south ends. The corridor links to the room below the pump room, at which point there are some steps down in the floor and a T-shaped iron grill in the floor presumably for drainage. The room below the pump room is full of large cast iron pipes, several supported by later concrete block columns and there are additional iron poles forming props between the floor and ceiling. Some of the valves within the pipework are clearly later additions as they are in considerably better condition than the pipes (Plate 210). The storage tanks are supported by rows of angled buttresses with upright props against the outer (east) wall (Plate 211 and Plate 212). The ceiling is formed by the tiered seating and there are pairs of drainage holes in these leading into the tanks. The ground level drops towards the

Plate 209 (left): Typical view of the access corridor or subway

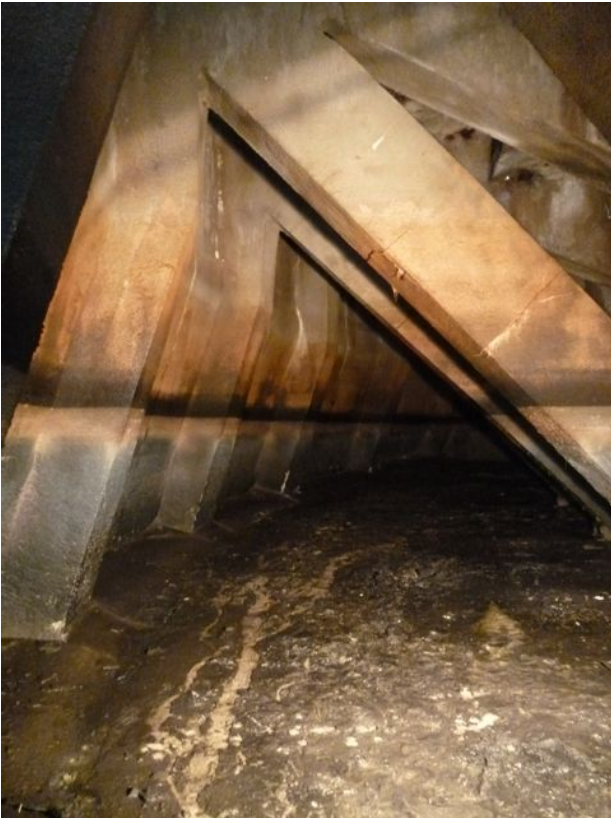
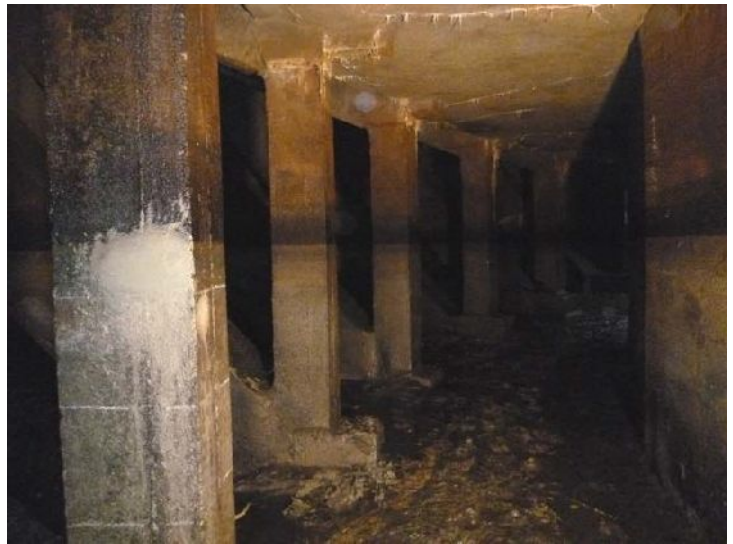
Plate 211 (left): Typical concrete struts in the south sea tank

Plate 212 (right): Typical lower struts against the west side of the south sea tank
