Archaeological building recording at 23 Regent  
Street, Northampton  
June 2013

Report 13/113

July 2013

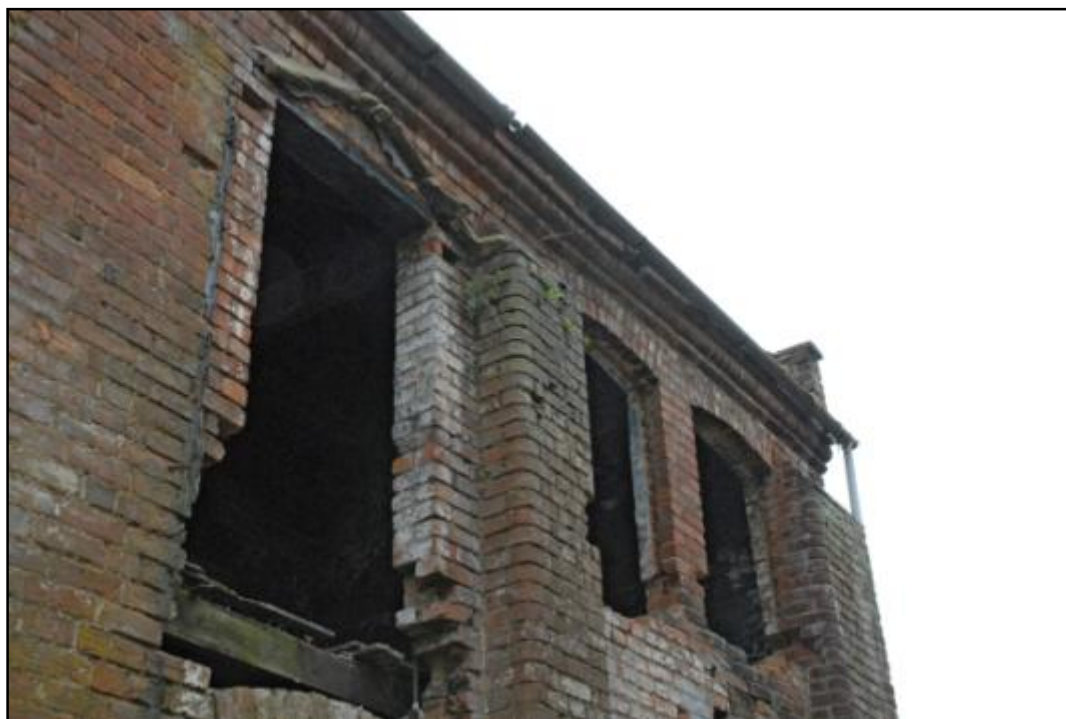
Building 1, door with peaked lintel Fig 20

A door with peaked lintel over is built into the south elevation (Figs 7 & 20). This was originally a delivery door though no evidence for a hoist survives. This door was converted to a window to accommodate the link structure.

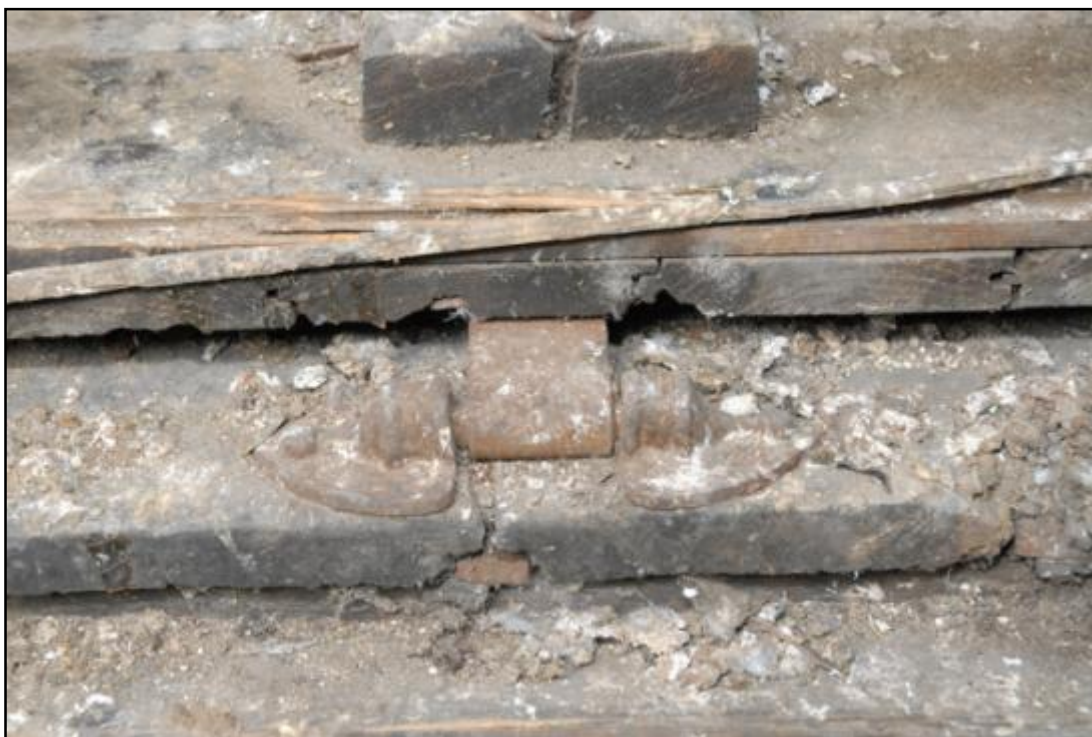
Detail of the trapdoor hinge Fig 42

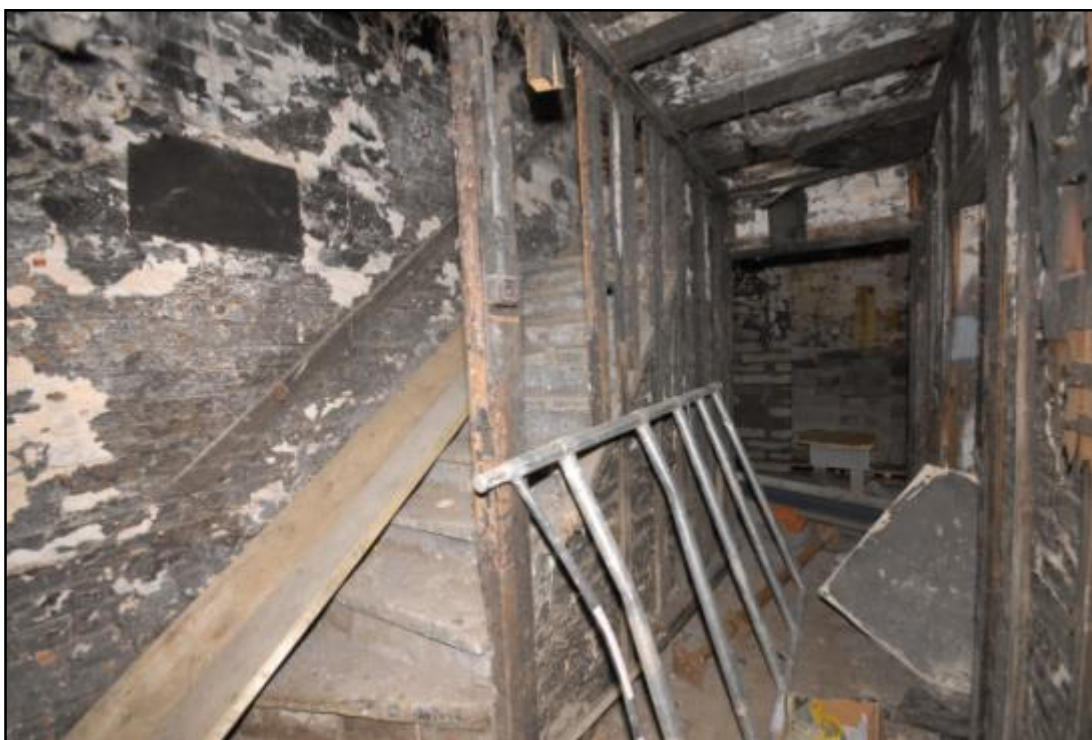
View within the lobby, looking south Fig 45

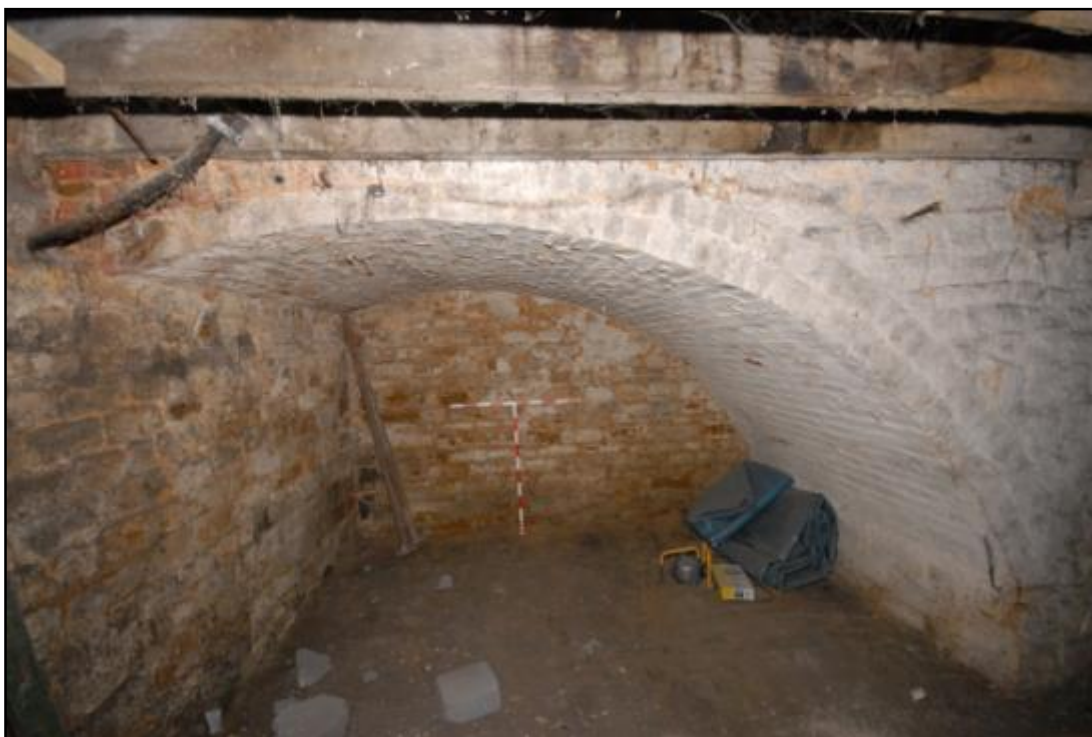
The stairs are carried over relieving arches in the basement supported on a central wall (Figs 49, 51 & 52). A light well adjacent to the stairs was blocked in brick (Fig 50).

Relieving arch beneath the main stair Fig 52

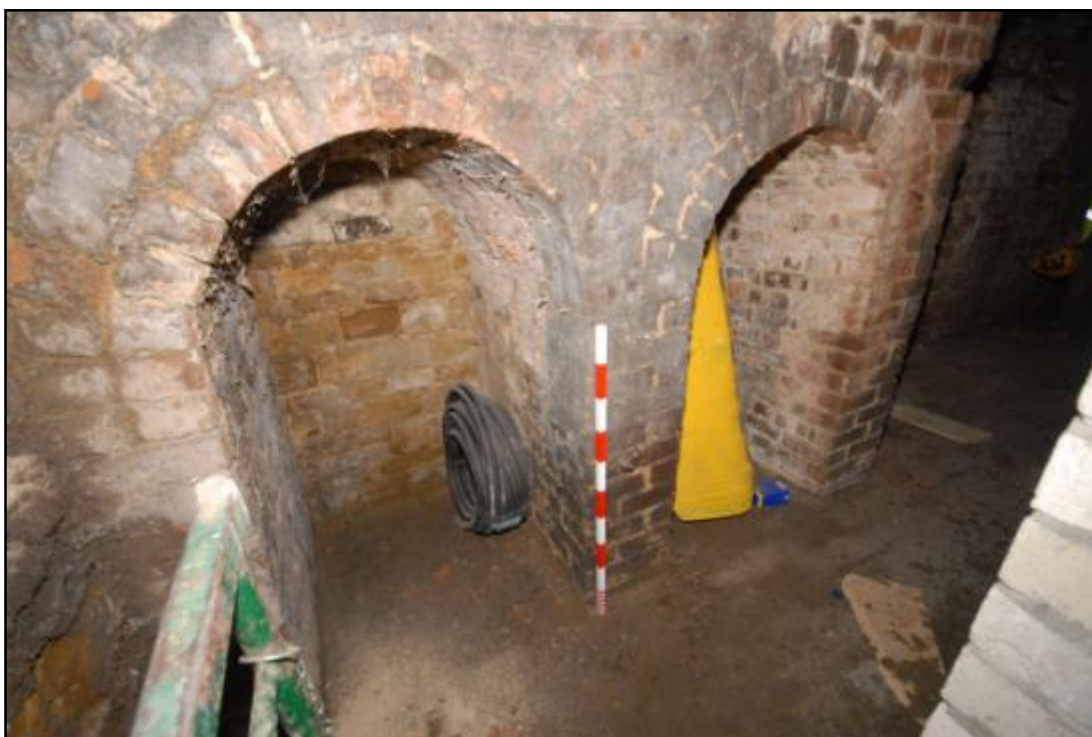
A central wall of dressed ironstone, which divides Rooms 1 and 2, was partially demolished by the time of this survey (Fig 53). A pair of arched openings, most likely serving as storage are in the south-west corner of Room 1, built against the west wall (Fig 55). An electrical switch is fixed to the wall in the north-west corner of the room (Fig 56 & 57). The remains of a metal boiler or heater are present in this room, though not *in situ* (Fig 62).

Room B2, storage arches Fig 55
