BEASLEY WEIR DULVERTON EXMOOR NATIONAL PARK WEST SOMERSET

Results of Historic Building Recording

Report No.: 150202
Date: 02.02.15
Author: B Morris

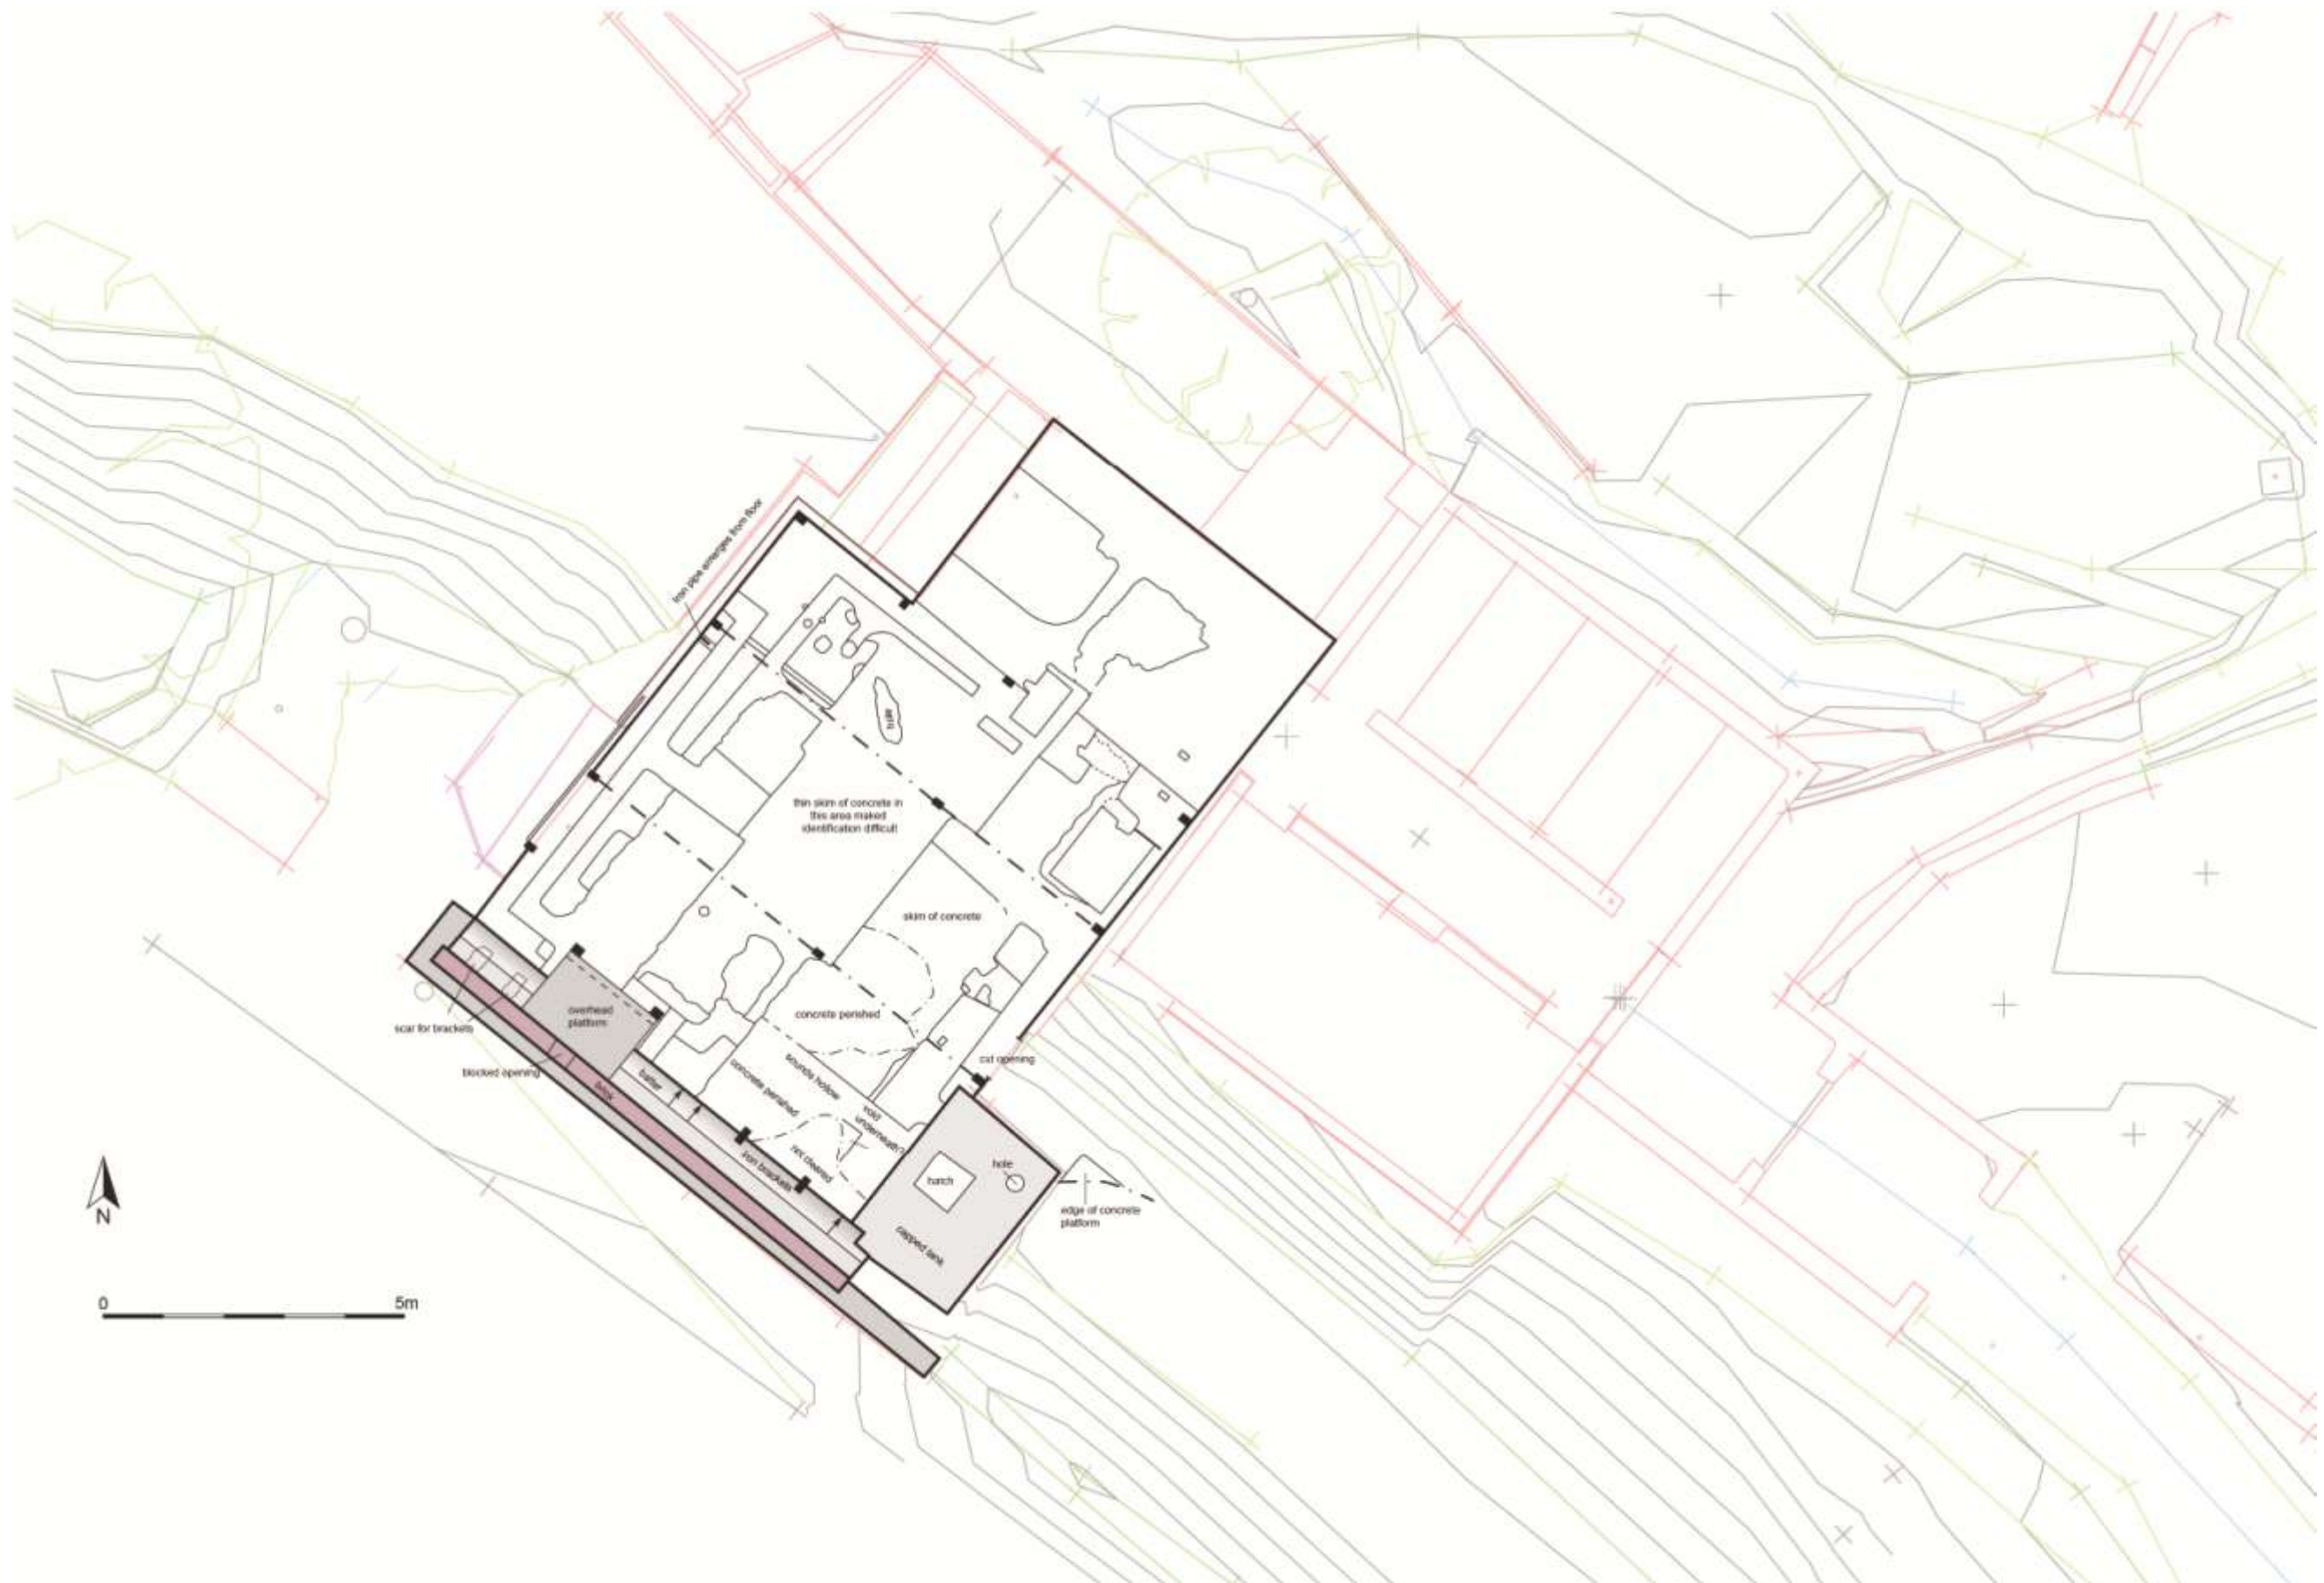
Figure 7: Plan of B1 and B2, overlain on the site topographical survey.

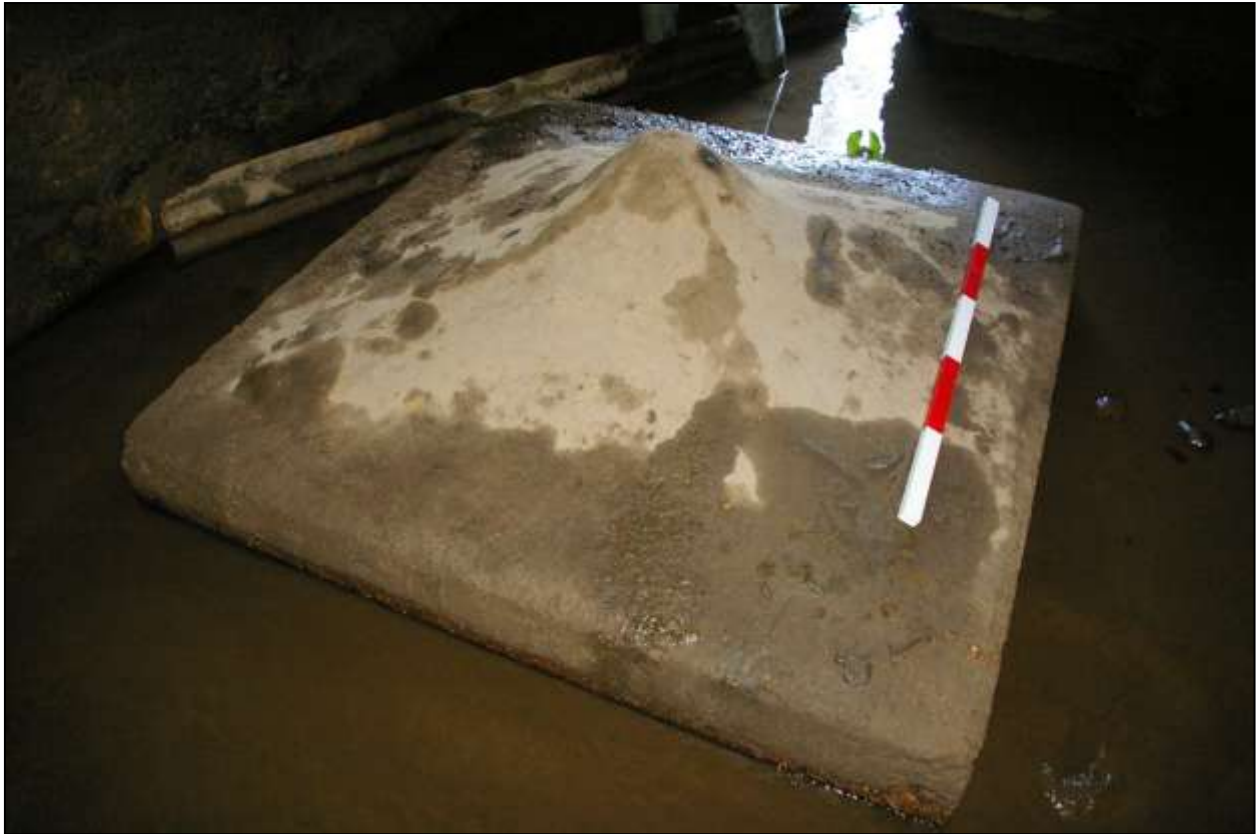
Figure 91: The pyramidal concrete block on the floor of the chamber; viewed from the south-west (scale 1m).

Figure 92: As above, viewed from the north-west (scale 1m).

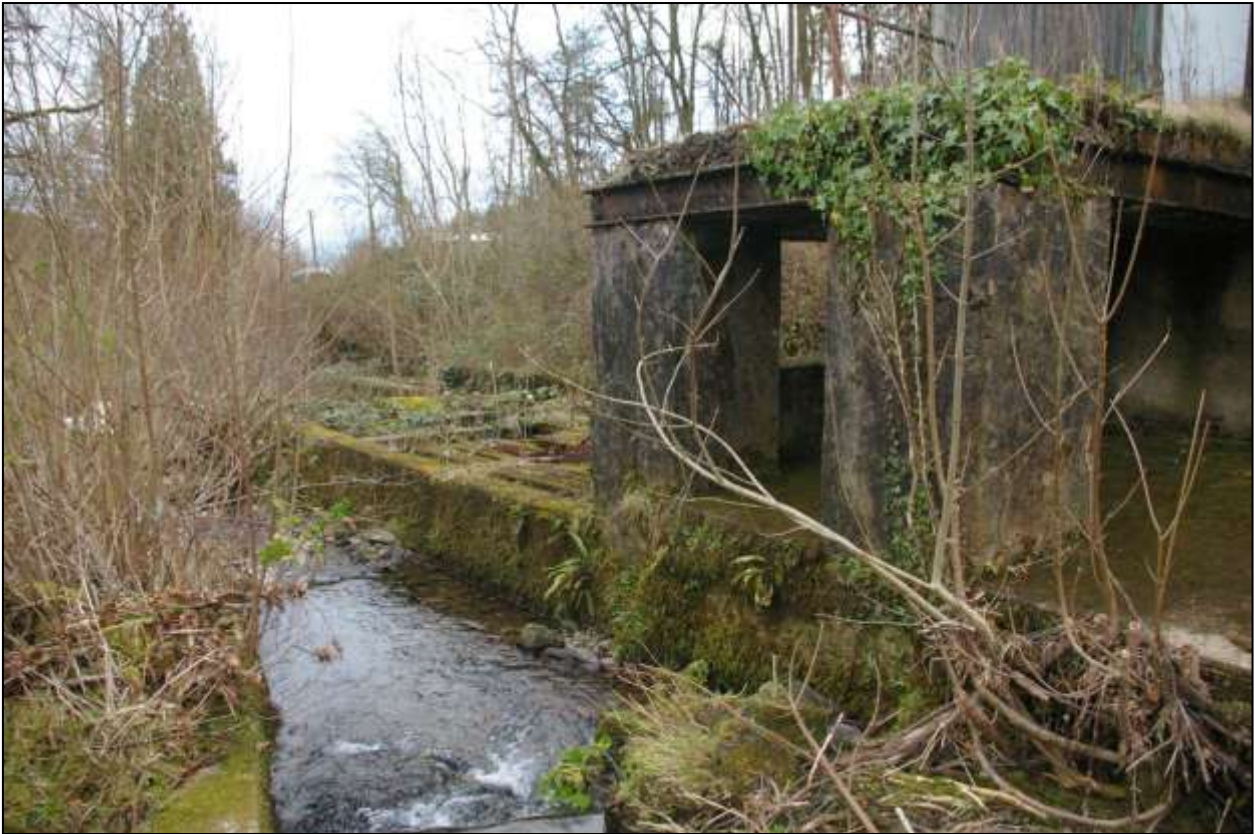
Figure 103: Detail of one of the filter screens at the site.

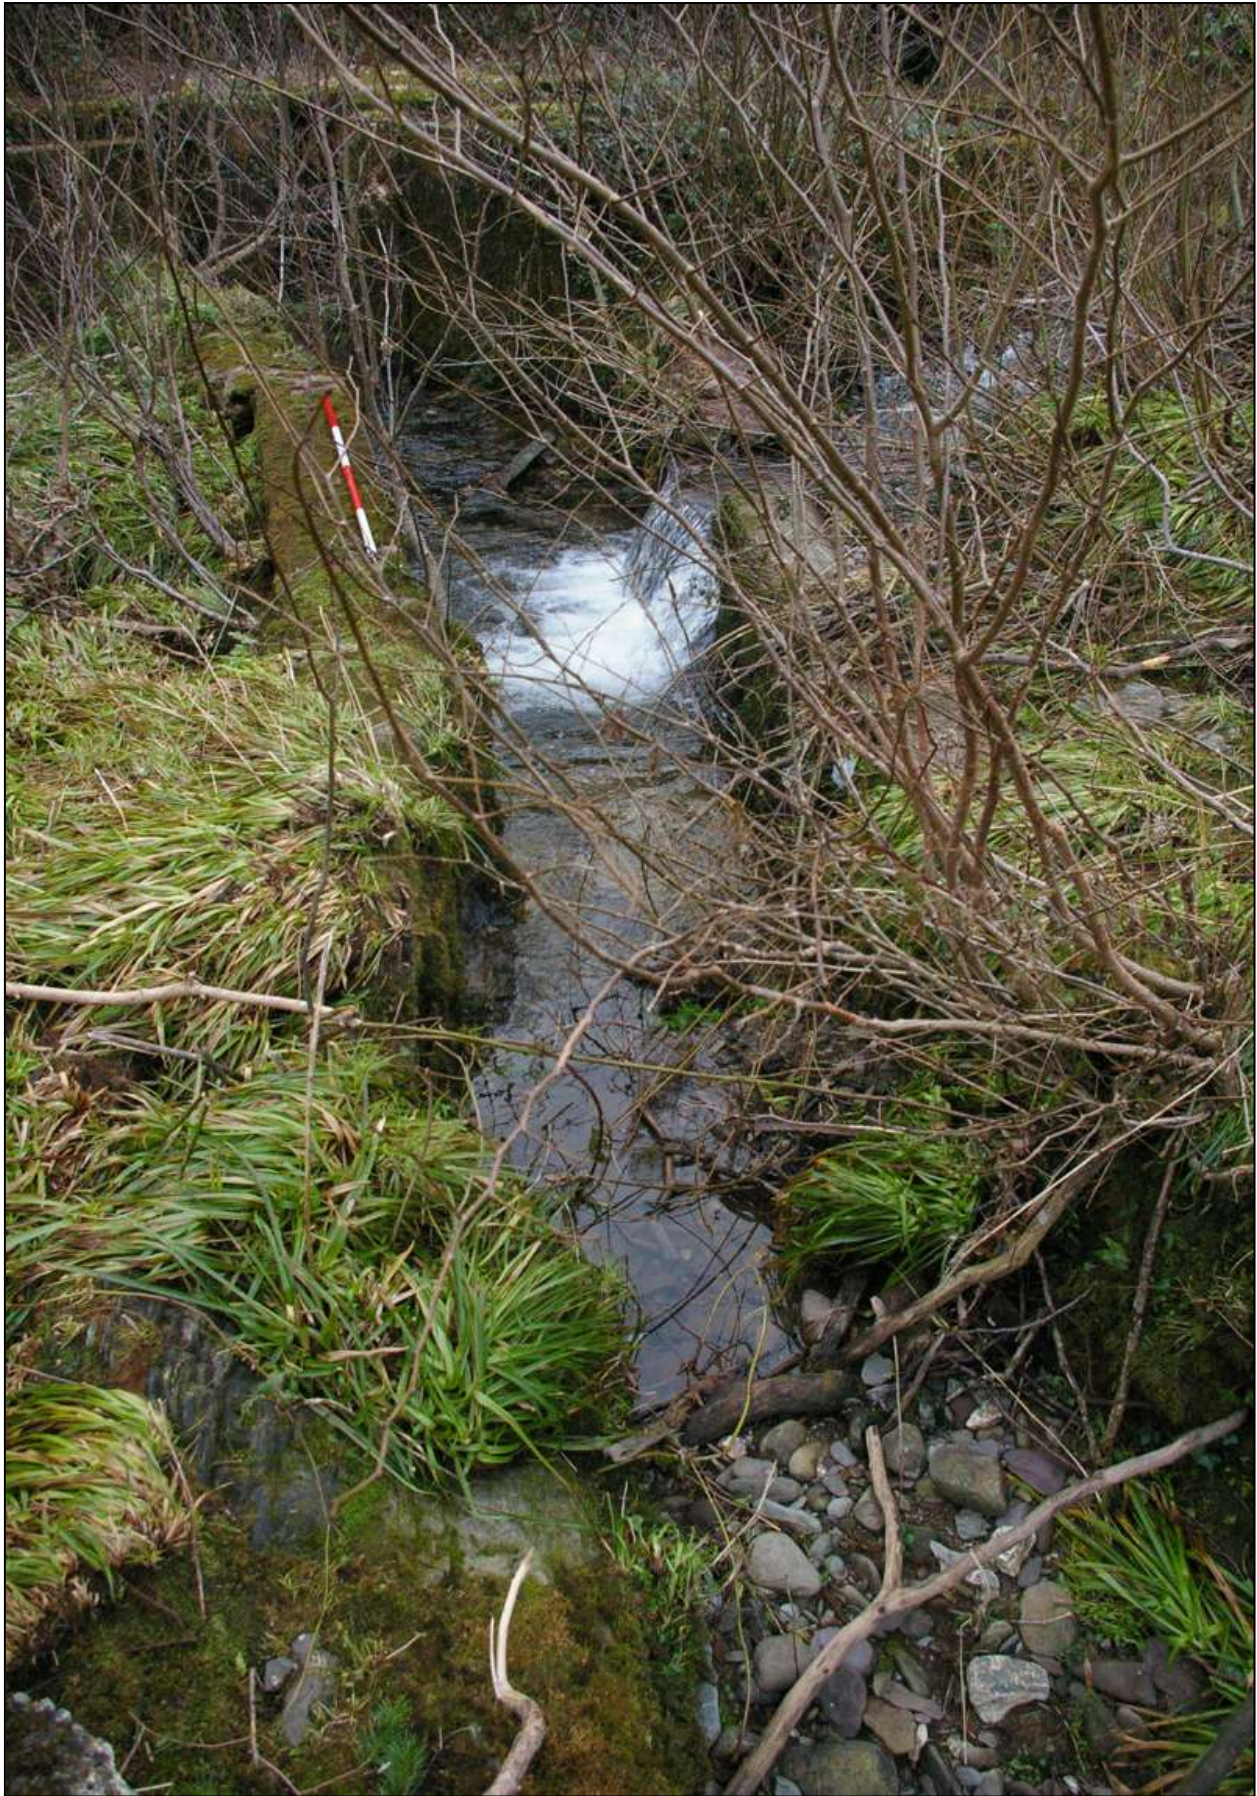
Figure 111: Wall 1, showing it cut by Leat 2; viewed from the south-east (scale 2m).

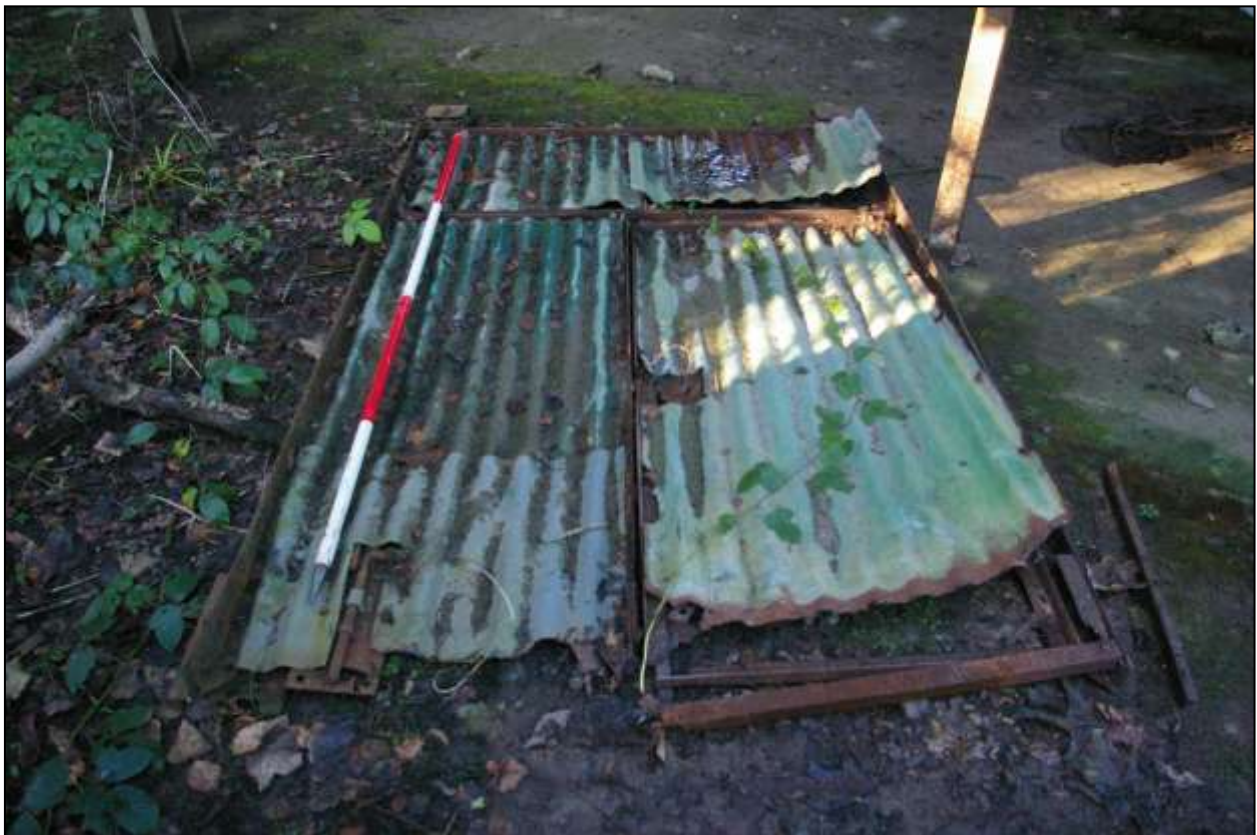
Figure 131: As above.

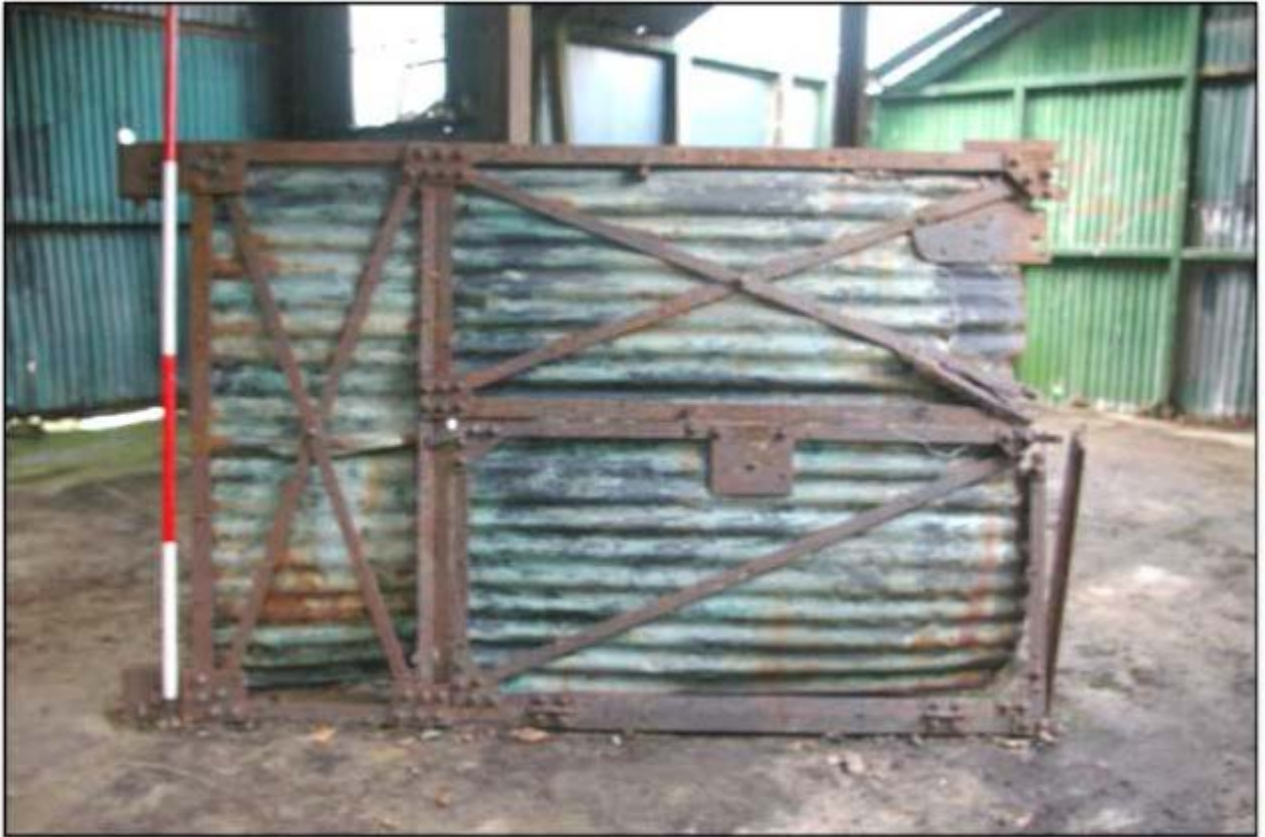
Figure 132: As above.
