# CLEEVE FARM BARN IVYBRIDGE SOUTH HAMS DEVON

Historic Building Recording

South West Archaeology Ltd. report no. 170613

By E. Wapshott & N. Boyd  
Report Version 02  
13<sup>th</sup> June 2017

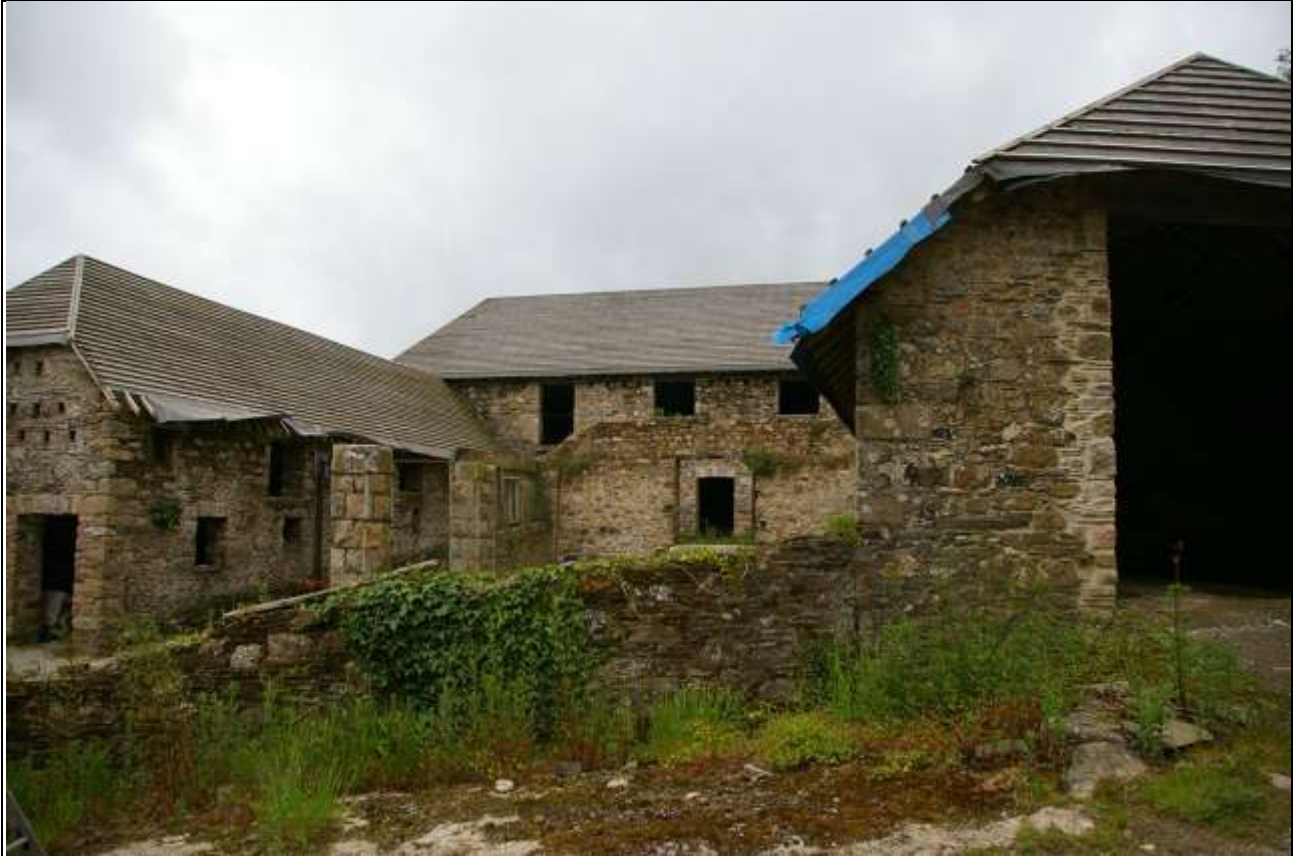
FIGURE 85: SIMPLE PURLINS TO THE WEST OF BARN D, AS IT ABUTS BARN B, POSSIBLY A REPLACEMENT ROOF; FROM THE NORTH-EAST.
