# THE BARN ANDERTON FARM LAUNCELLS CORNWALL

Historic Building Recording

South West Archaeology Ltd. report no. 170814

14<sup>th</sup> August 2017

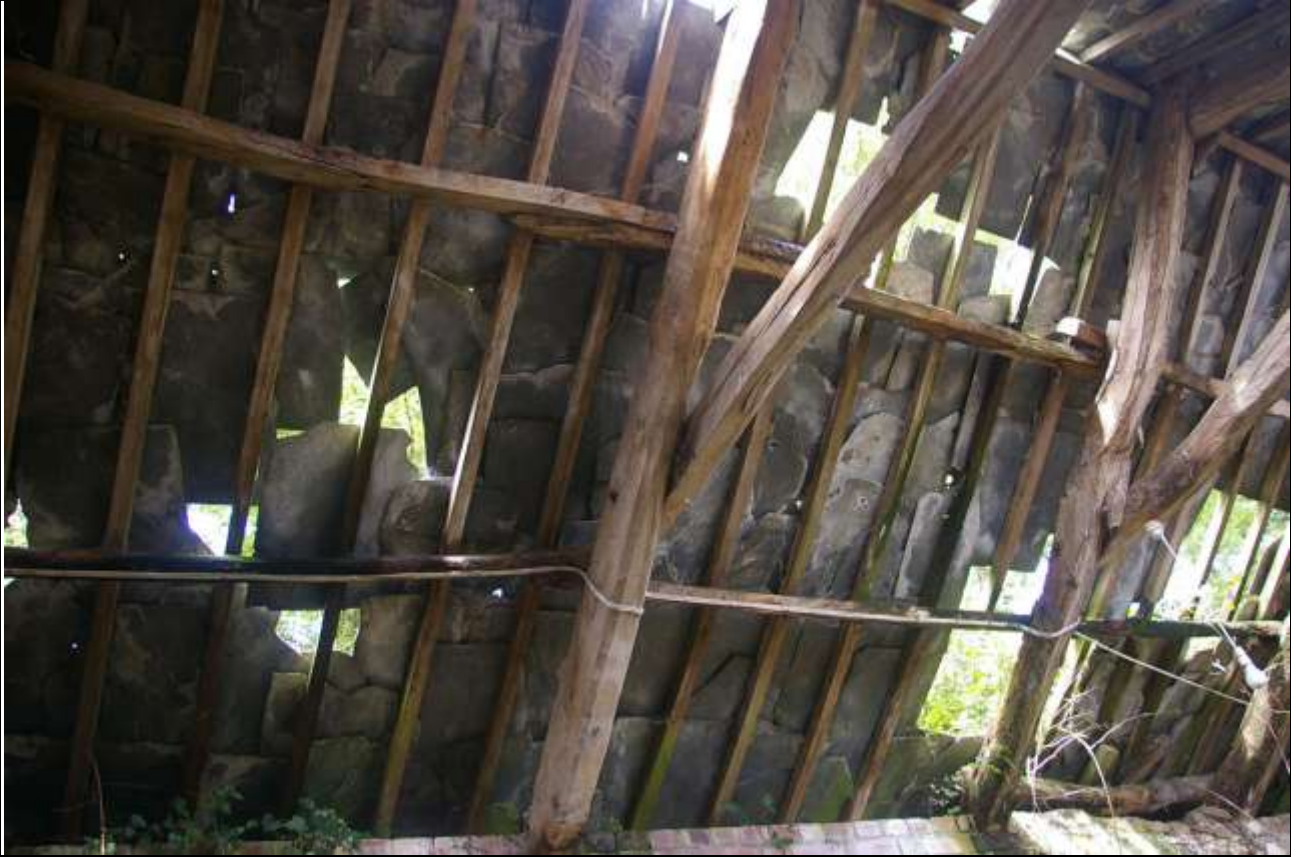
THE LARGE SLATES ON THE ROOF OF BARN 1; FROM THE WEST, SOUTH-WEST

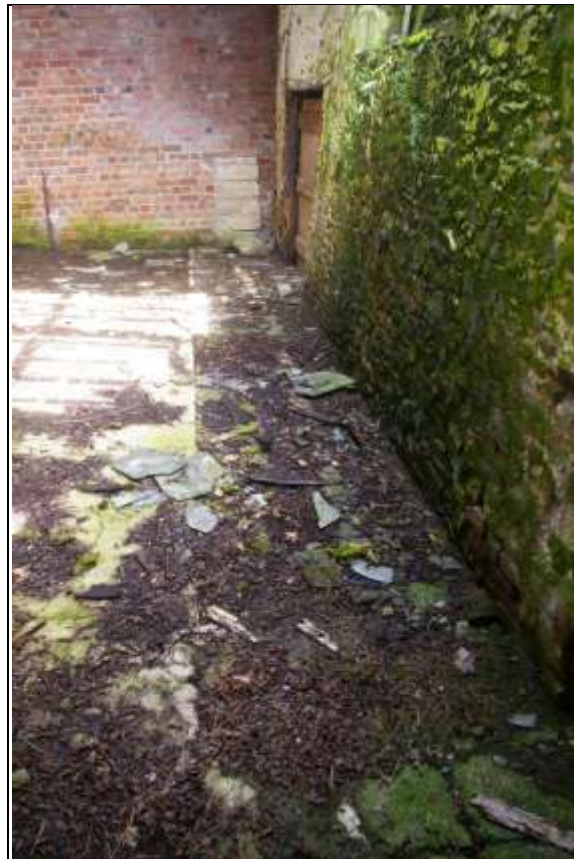
Floor:		Concrete floor, slightly sloping. Sunken area to the south side, infilled with loosely cemented concrete blocks, probably former drain.
Ceiling:		Open to roof, no ceiling.
Roof Structure:		Timber A-frames, of a mix of pine and reused earlier oak blades, some rough semi-embarked beams. There are four trusses over compartment 1; the roof contiguous with that over compartment 2, the whole roof of eight bays. All trusses have a mixture of both spiked and bolted joints, pointing to a more traditional form of build. All trusses have a ½ lapped, notched overlap at the ridge and surface mounted collars, of cruder narrower scantling. At the ridge it can be seen that there are cut out sockets and many of the truss blades have been cut off and truncated, reused from much wider spans. Several truss blades sport peg holes, again indicating their reuse. The scantling of the truss blades varies between almost square profile and chamfered heavy pine, beams and narrower but deeper tapered oak and pine blades. There are two purlins to each pitch and chunky rafters and battens, all being more modern than the trusses. The roof is of scantle slates, with terracotta ridge, partly replaced by felt sheeting and tarpaulin to the south side.

THE SUNKEN AREA IN THE FLOOR IN COMPARTMENT 1, BARN 1, INFILLED WITH CONCRETE BLOCKS; FROM THE WEST.

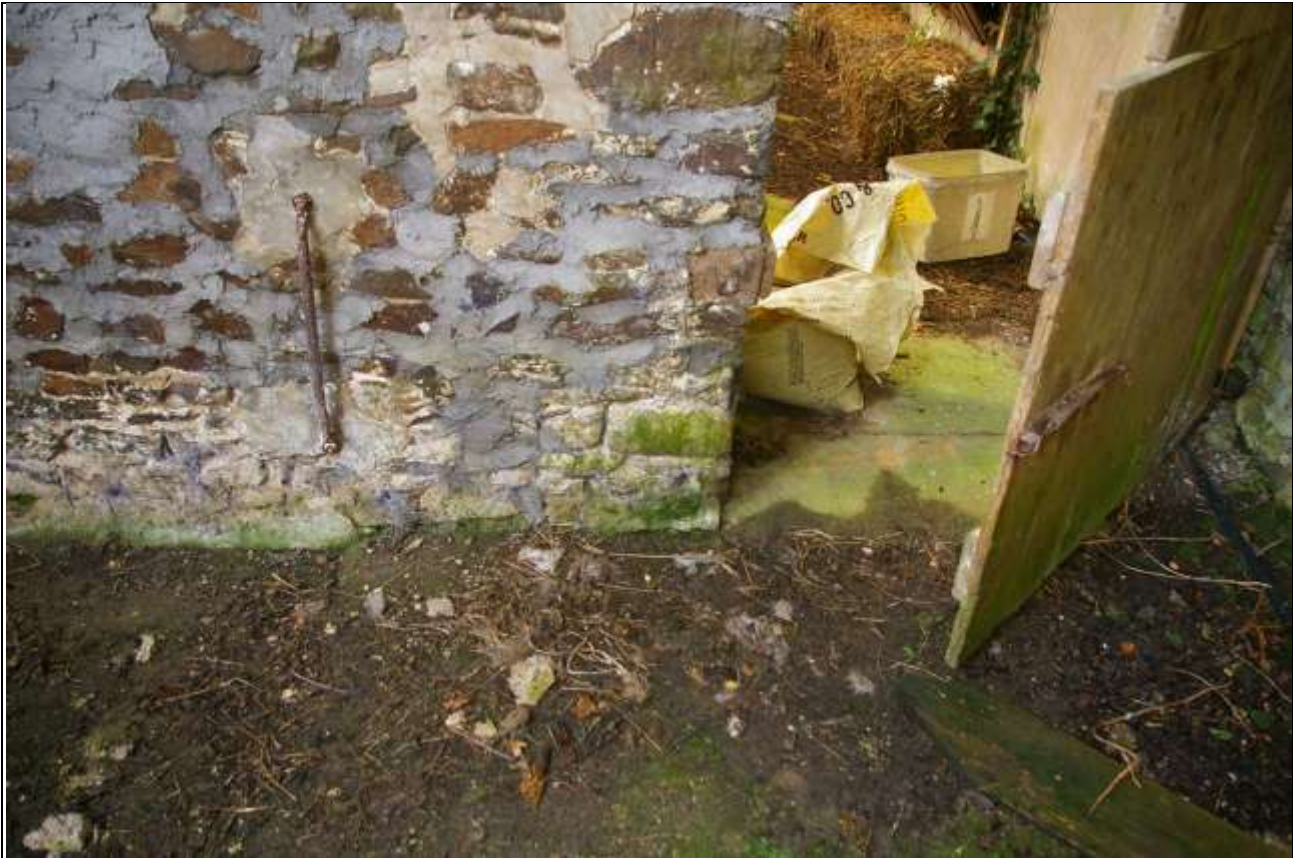
THE SMALL DRESSED BLOCKS USED IN THE QUOINS OF THE DOOR TO BARN 2, FORM BARN 1, IN THE WEST WALL; FROM THE EAST.

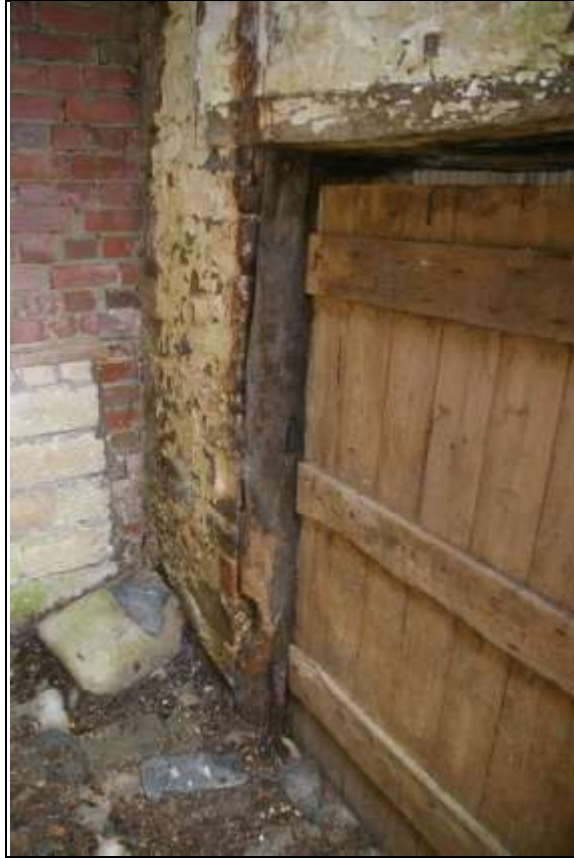
THE REUSED TIMBER WITH CUT SOCKETS IN THE EASTERN DOOR IN THE SOUTH WALL OF BARN 1, COMPARTMENT 1; FROM THE WEST, NORTH-WEST.

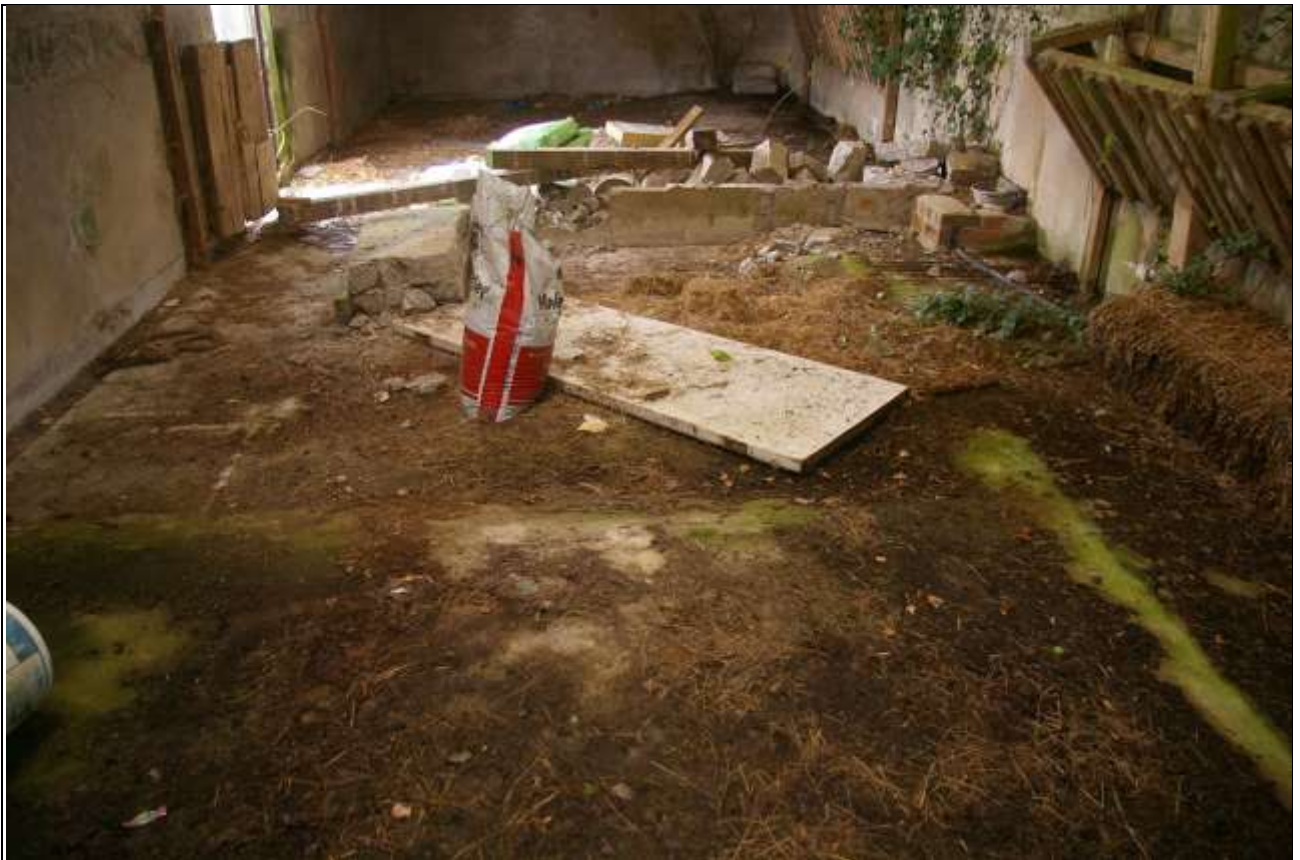
*There is potential for the survival of elements of previous structures under the concreted floor of Barn 2, which is raised. Groundworks in this area of the site may therefore reveal more information about the history of the barn range and the preceding domestic range. It is unlikely that works to the walls or roofs of the extant barns will expose any significant historic fabric or details.*

THE CONCRETE FLOOR IN BARN 2; FROM THE EAST.

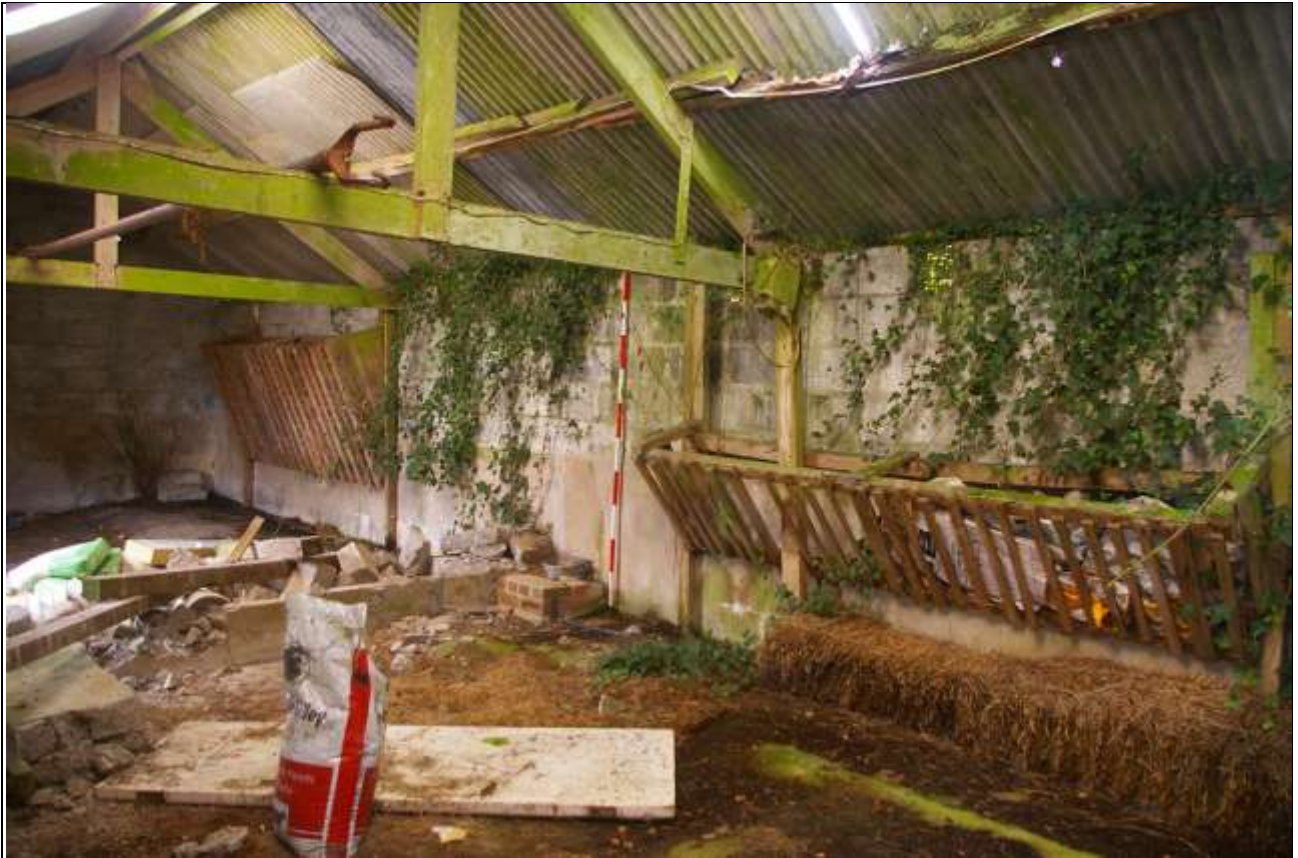
THE INTERIOR FACE OF THE NORTH WALL OF BARN 2 WITH TIMBER FIXINGS; FROM THE SOUTH-EAST (2M SCALE).

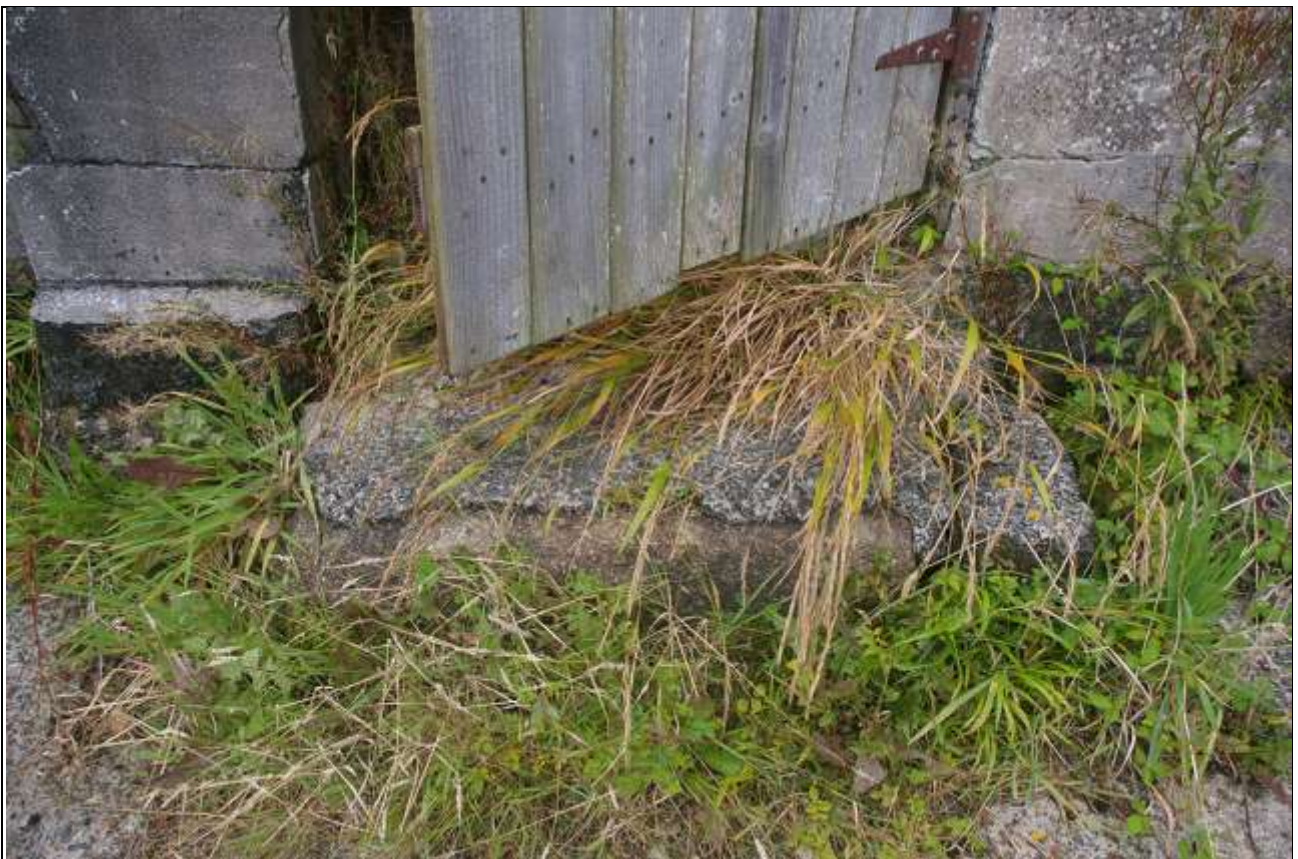
THE WESTERN SET OF STEPS INTO BARN 2, SHOWING LARGE REUSED BLOCK OF GRANITE; FROM THE SOUTH.

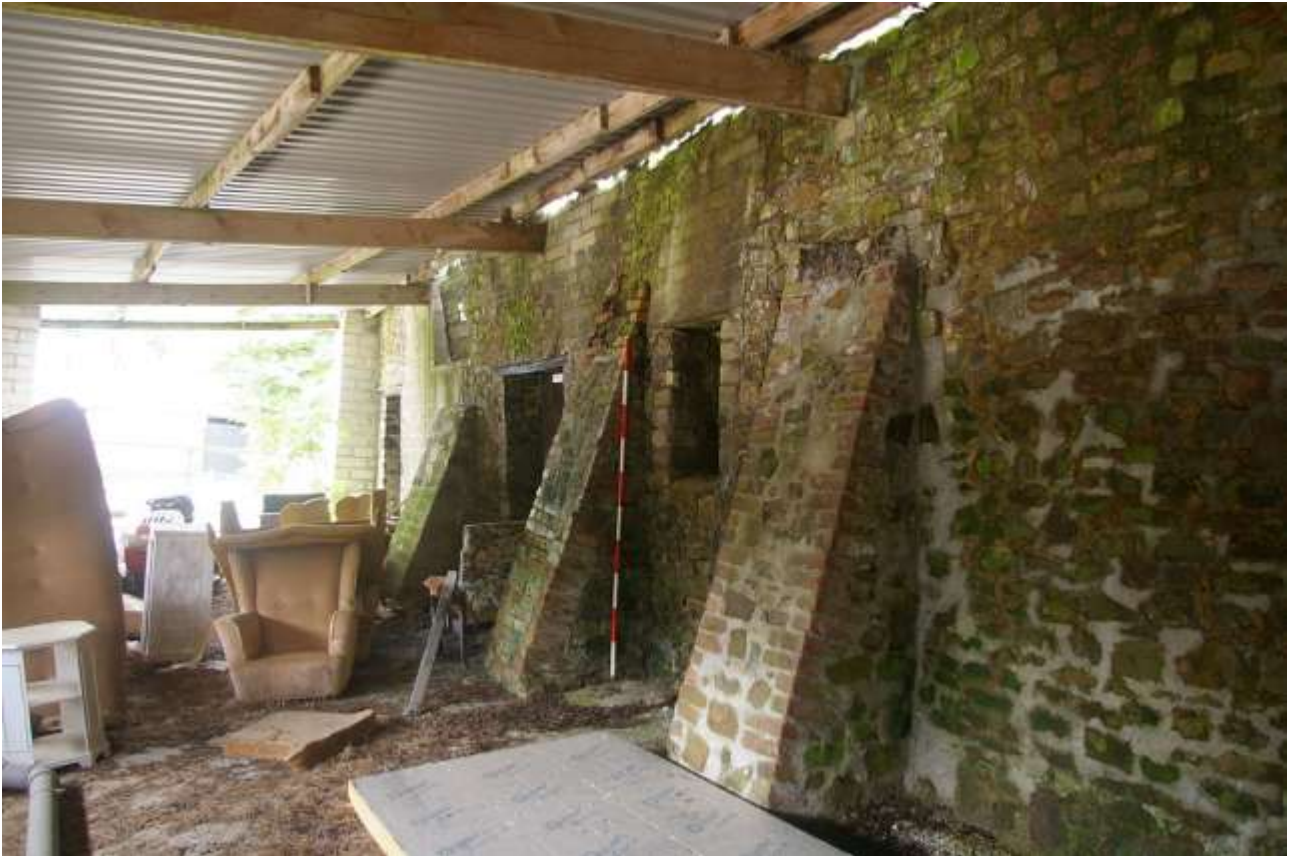
THE SOUTH WALL OF BARN 1, WITHIN BARN 3; FROM THE EAST-SOUTH-EAST (2M SCALE).

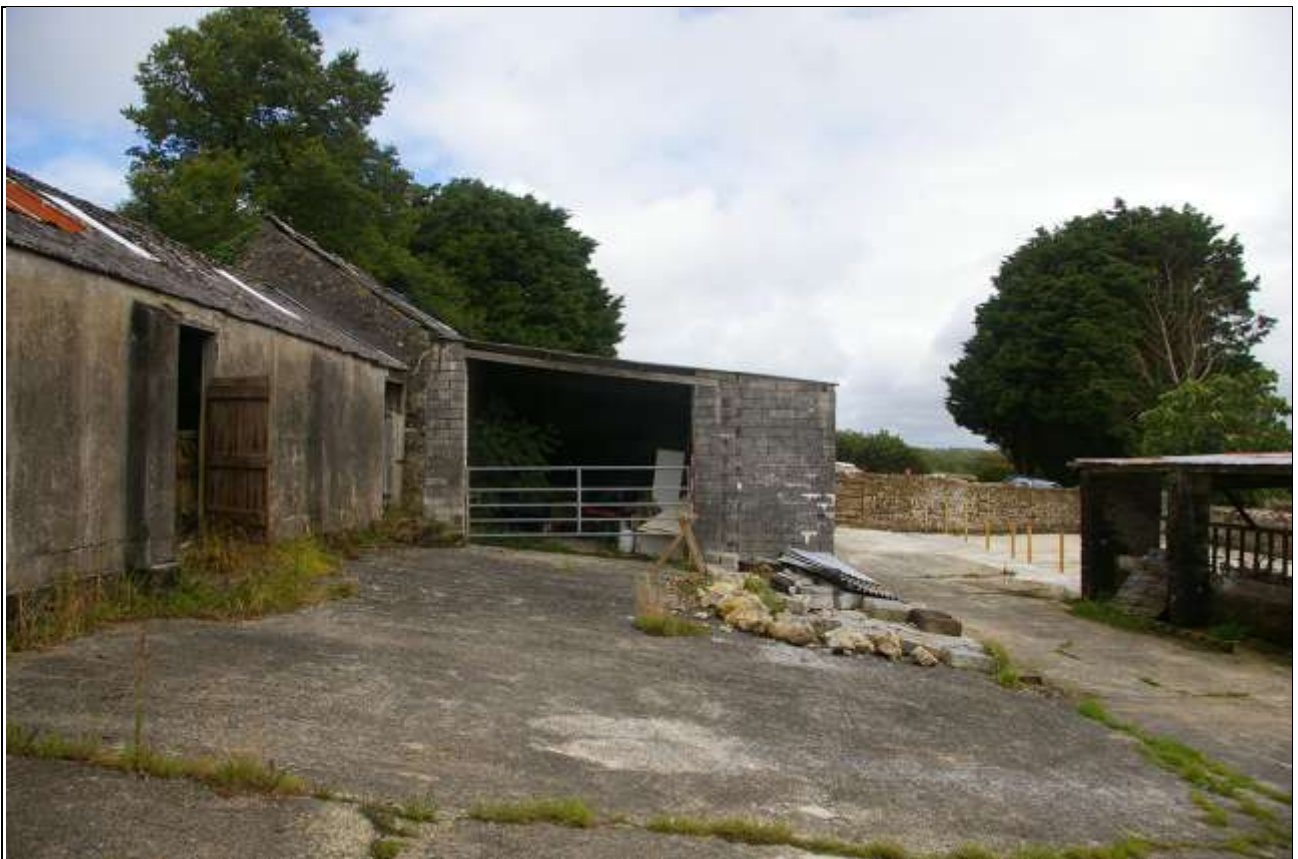
THE WEST ELEVATION OF BARN 3; FROM THE WEST (2M SCALE).

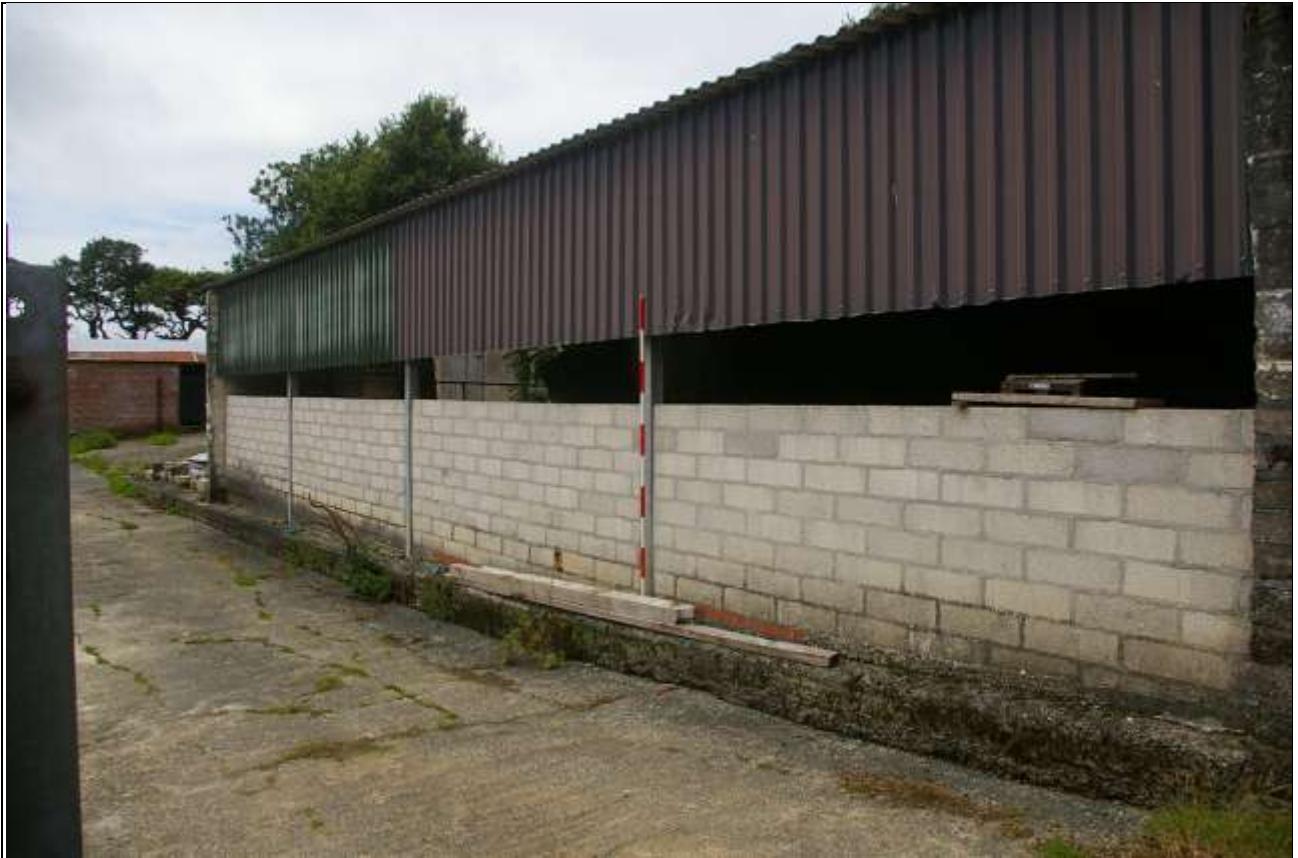
BARN 3, THE SOUTH WALL, FACING ACROSS THE COURTYARD TO THE FARMHOUSE; FROM THE EAST, SOUTH-EAST (2M SCALE).

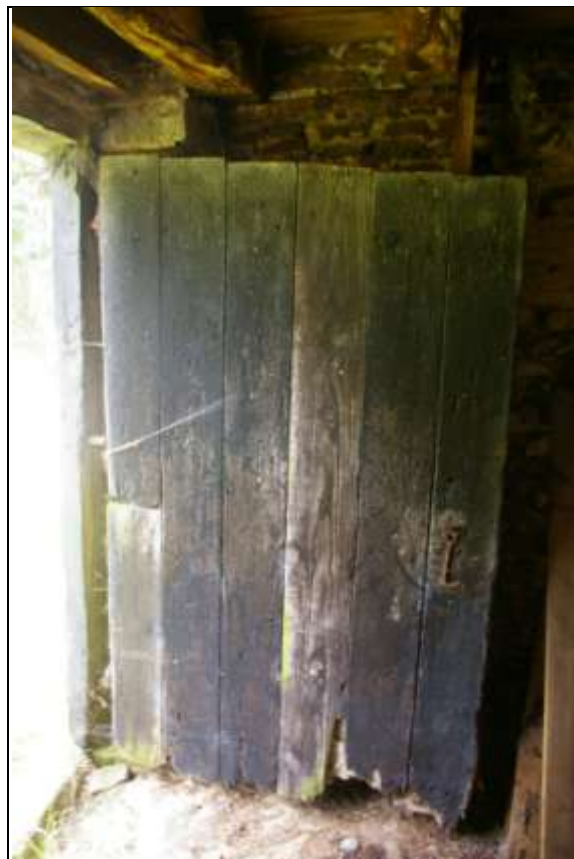
THE DOOR TO COMPARTMENT 2, IN THE EAST WALL, RESET IN THE GABLE, WITH CHUNKY TIMBER FRAME, THE DOOR COVERED IN HISTORIC GRAFFITI; FROM THE NORTH-NORTH-WEST.

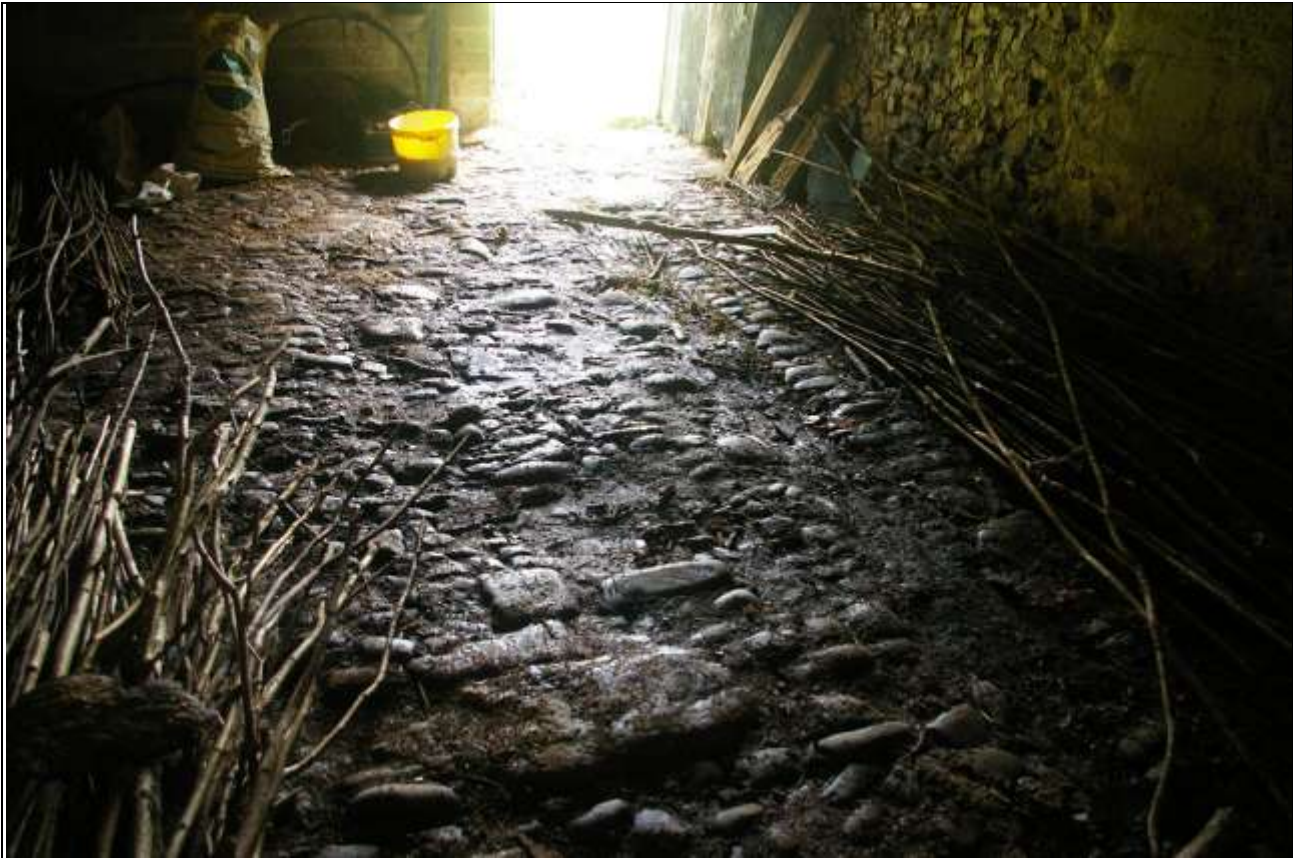
THE COBBLED FLOOR IN COMPARTMENT 2, BARN 1; FROM THE WEST-NORTH-WEST.

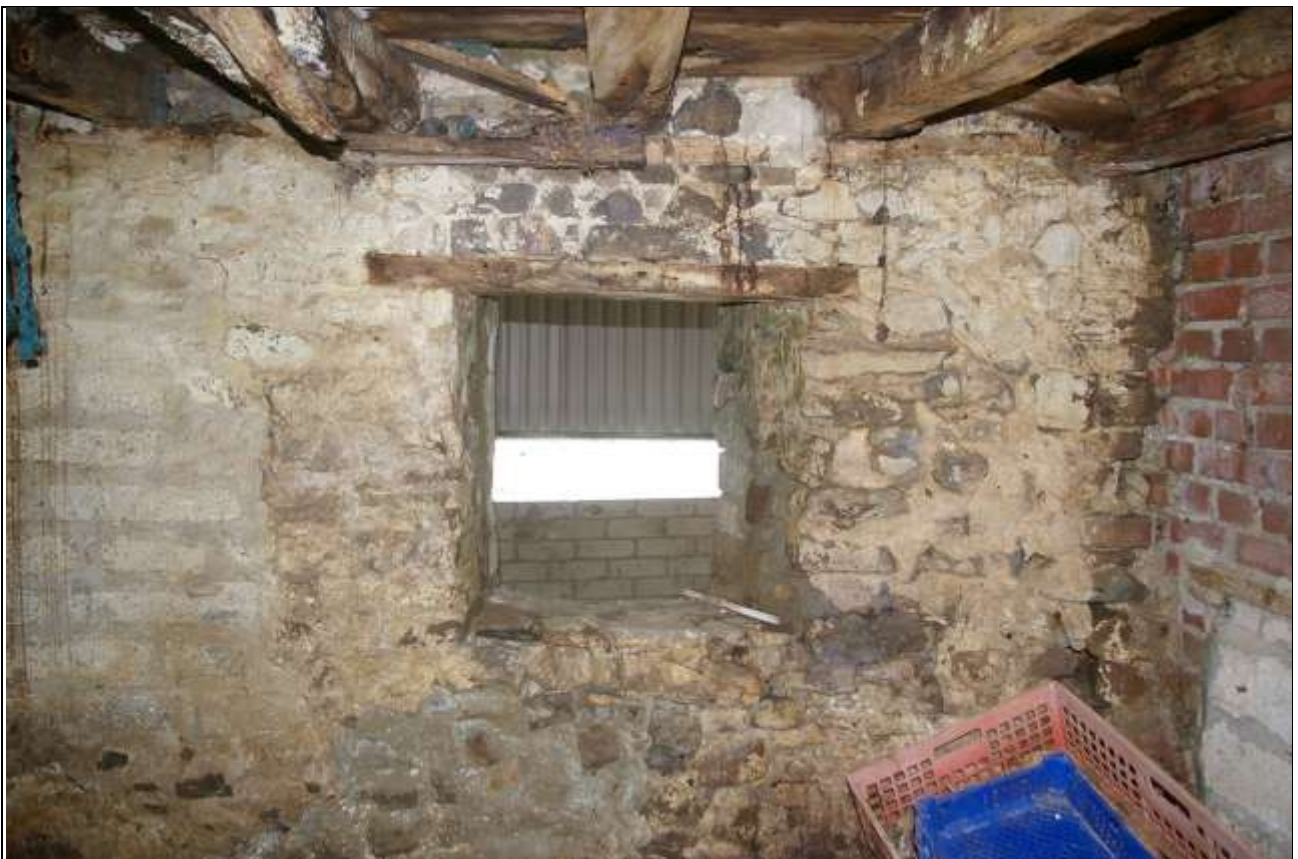
THE WINDOW IN COMPARTMENT 2, BARN 1; FROM THE NORTH.

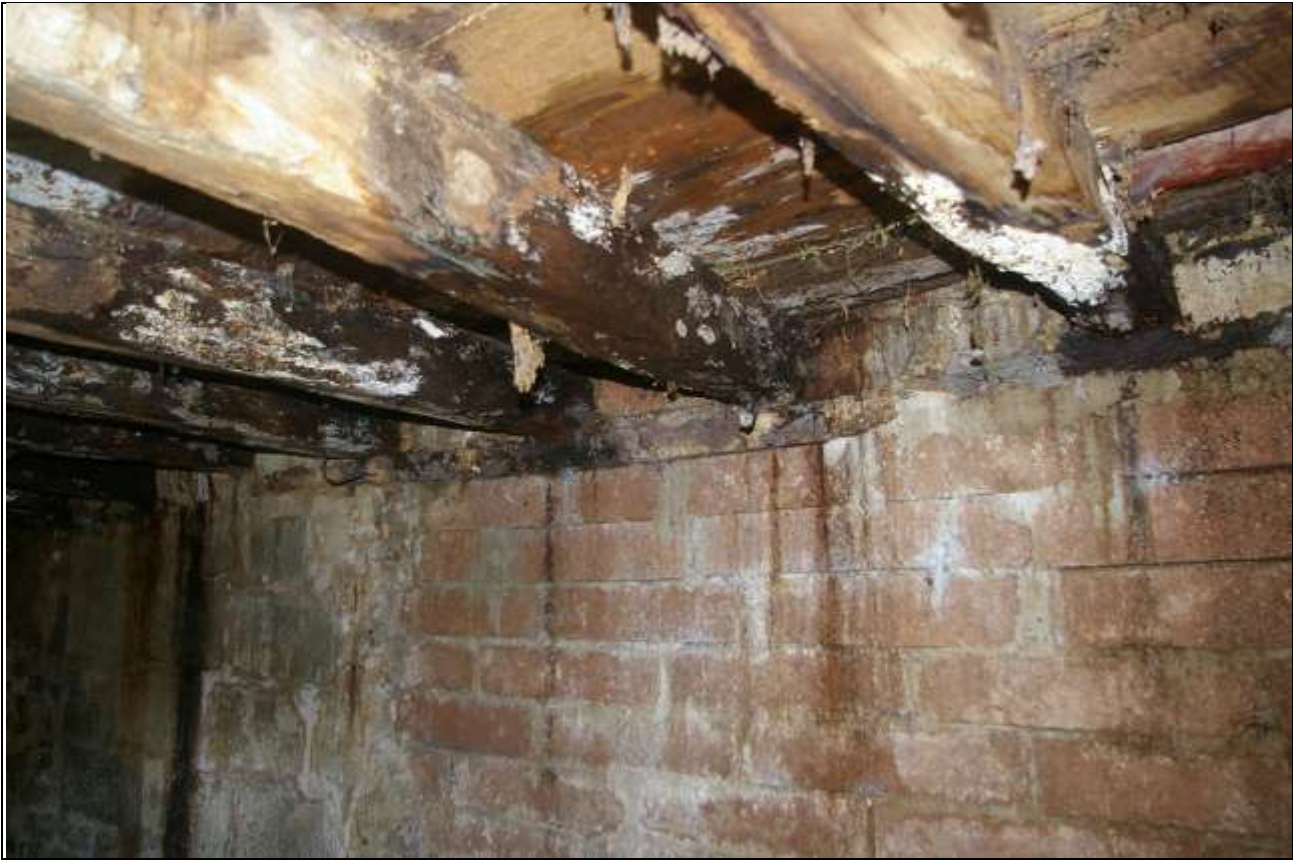
THE HEAVY JOISTS OF THE LOFT STRUCTURE WHERE THEY SOCKET INTO THE NORTH WALL, SITTING ON A WALL PLATE; FROM THE EAST-SOUTH-EAST.

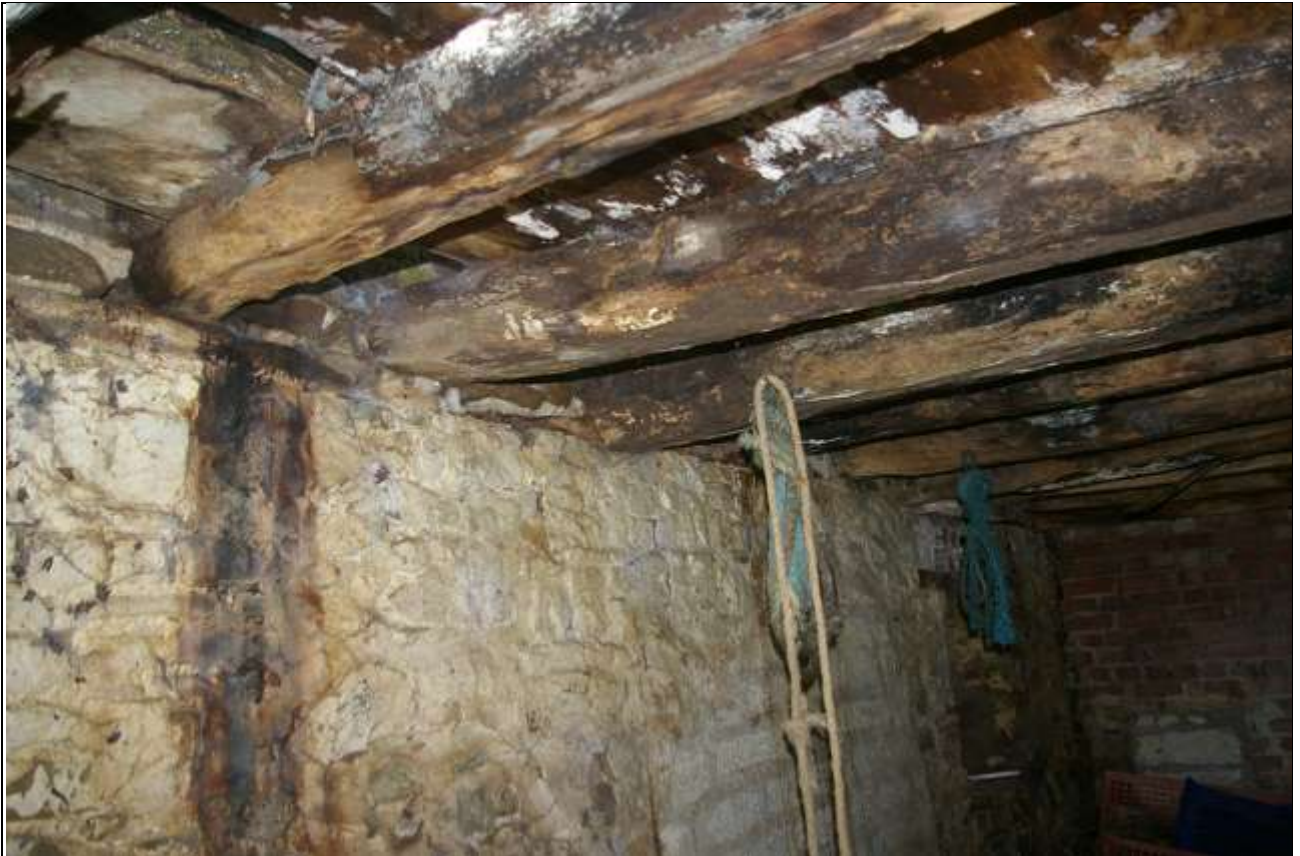
THE HEAVY JOISTS OF THE LOFT STRUCTURE WHERE THEY SOCKET INTO THE SOUTH WALL, SITTING ON A WALL PLATE; FROM THE EAST-NORTH-EAST.

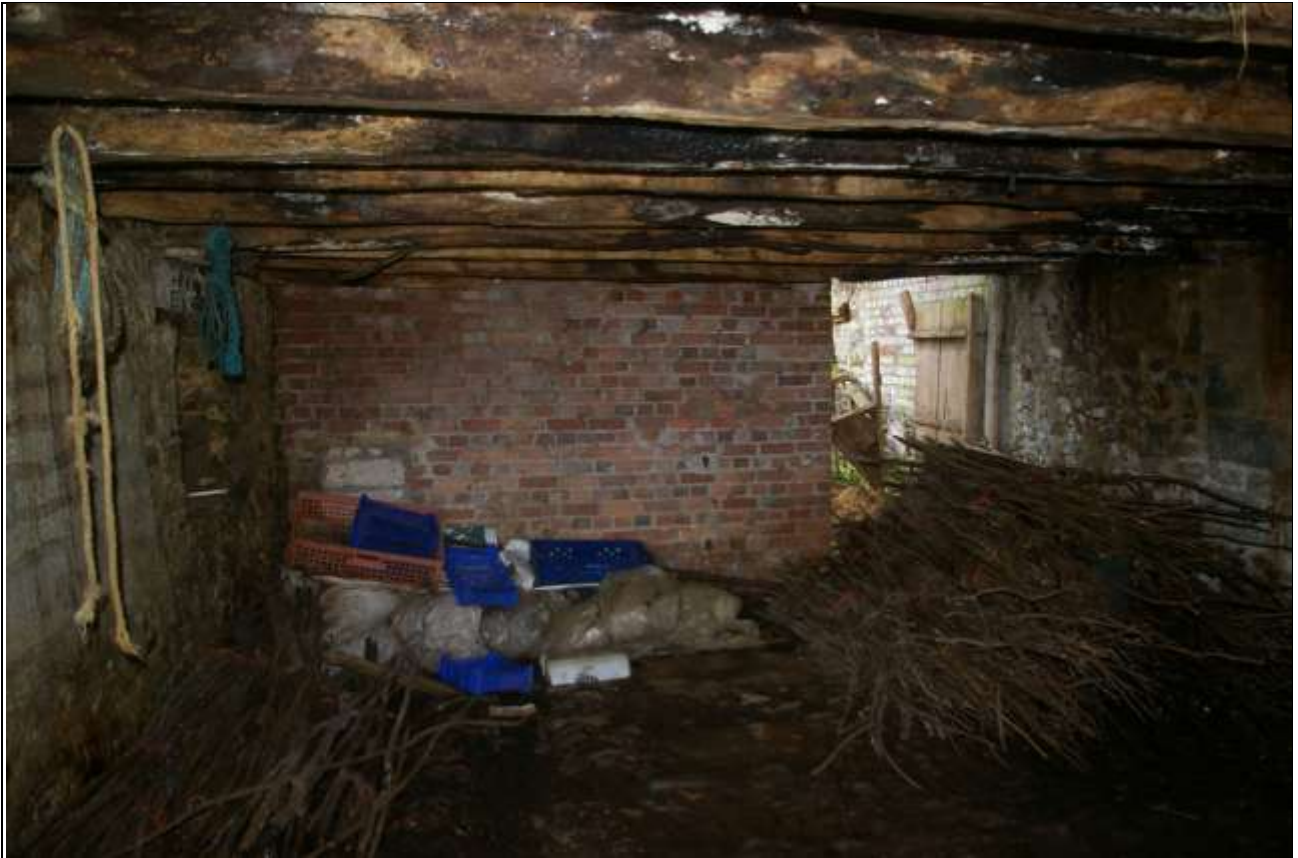
THE BRICK PARTITION WALL WHICH DIVIDES COMPARTMENTS 1 AND 2; FROM THE EAST-SOUTH-EAST.

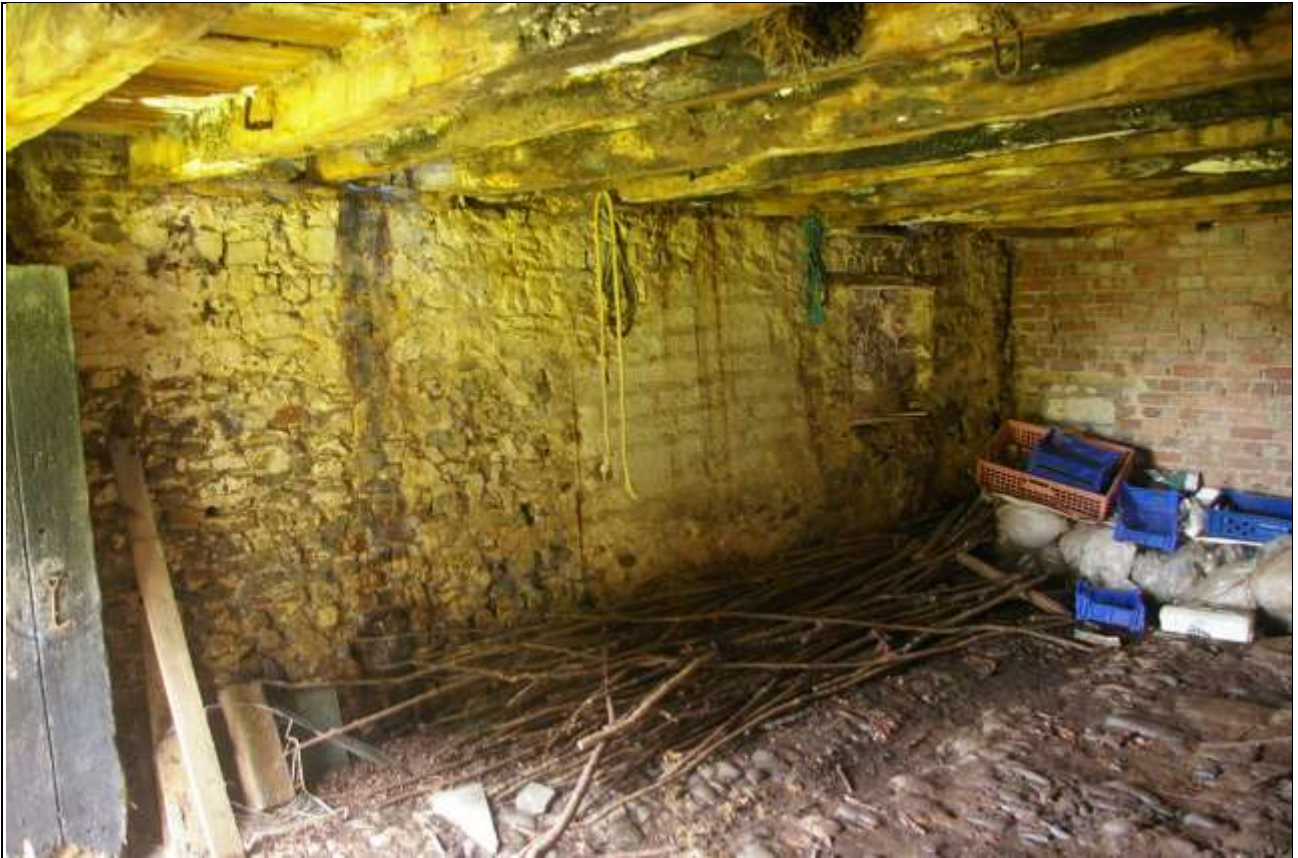
THE SOUTH WALL OF BARN 1, EASTERN END, WITHIN COMPARTMENT 2; FROM THE NORTH-EAST.

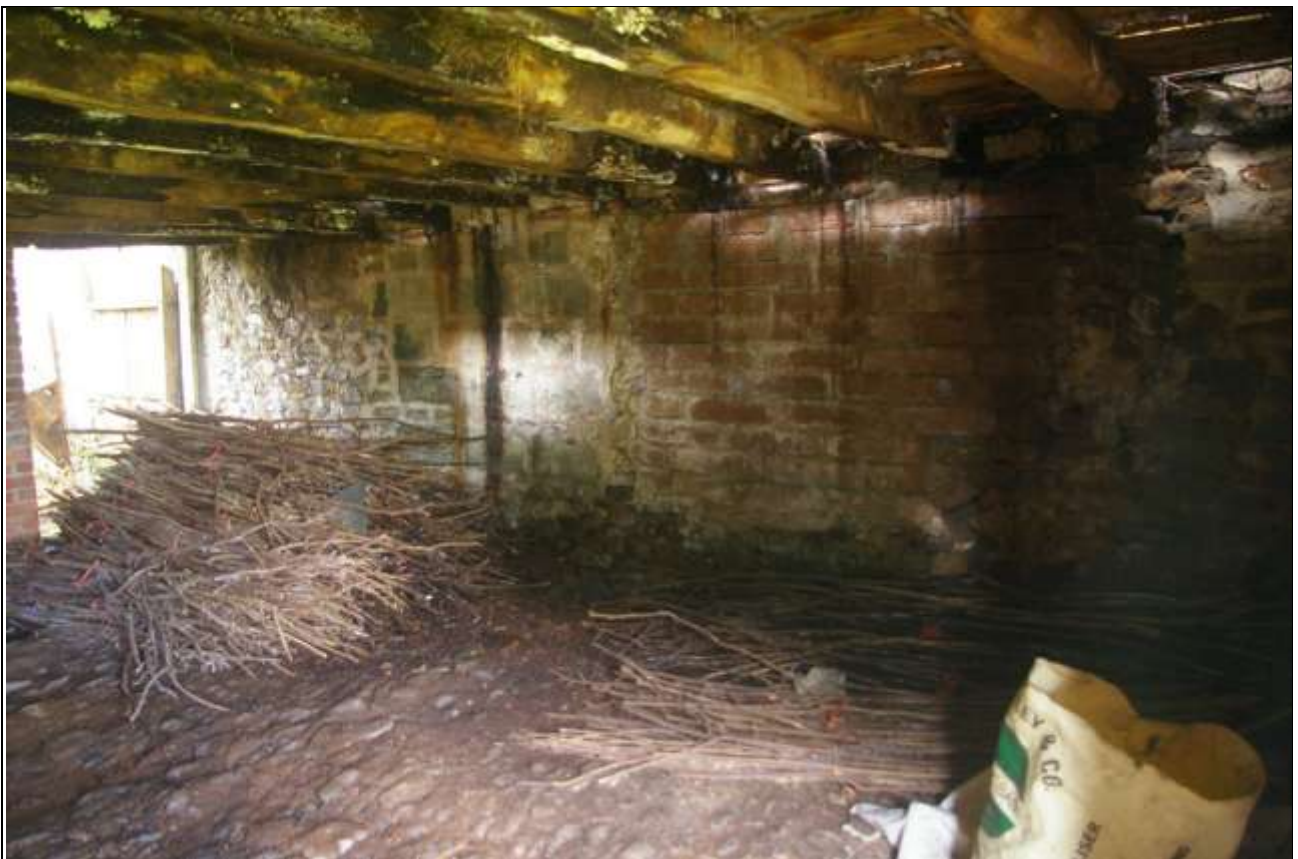
THE NORTH WALL OF BARN 1, THE EASTERN END, WITHIN COMPARTMENT 2; FROM THE SOUTH-EAST.

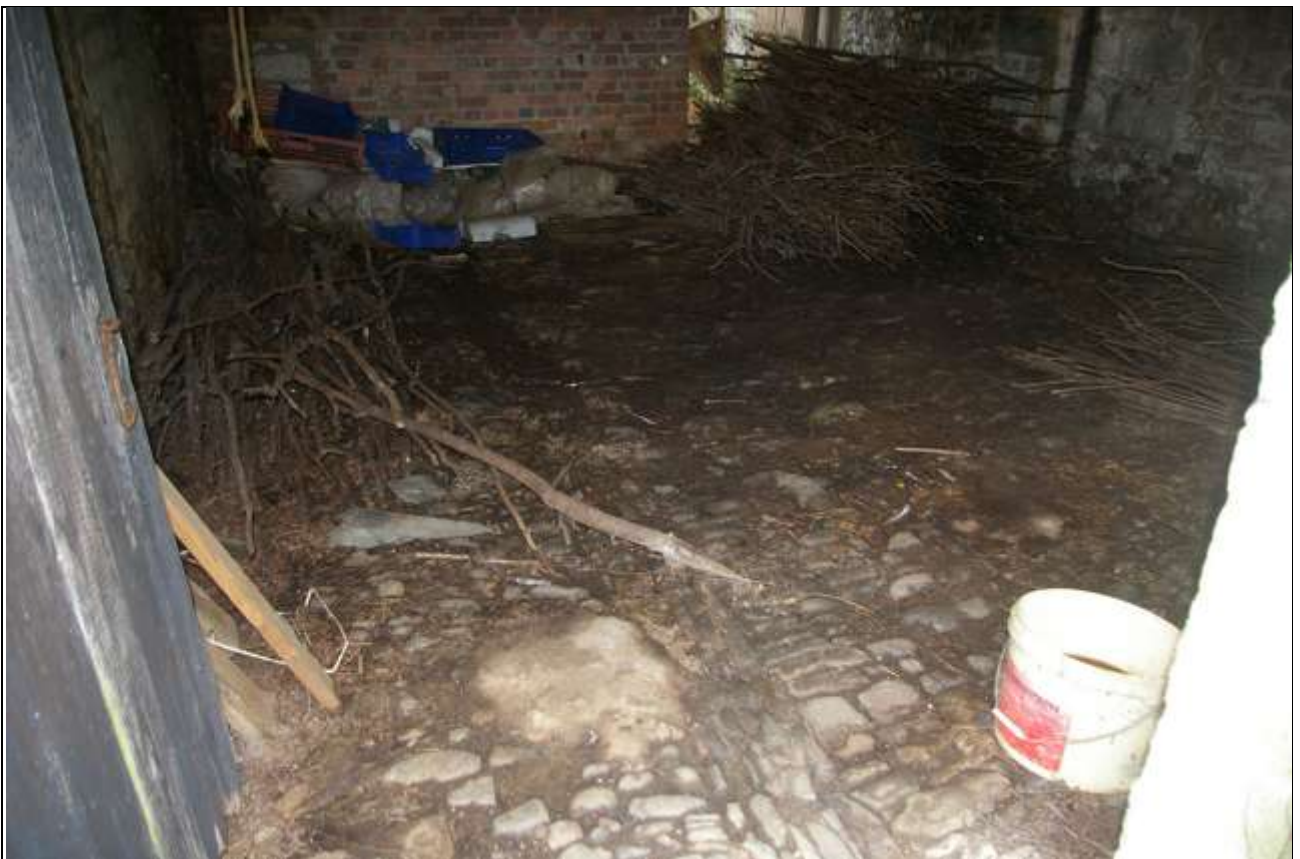
THE CRUDE COBBLED FLOOR IN COMPARTMENT 2 OF BARN 1; FROM THE EAST-SOUTH-EAST.

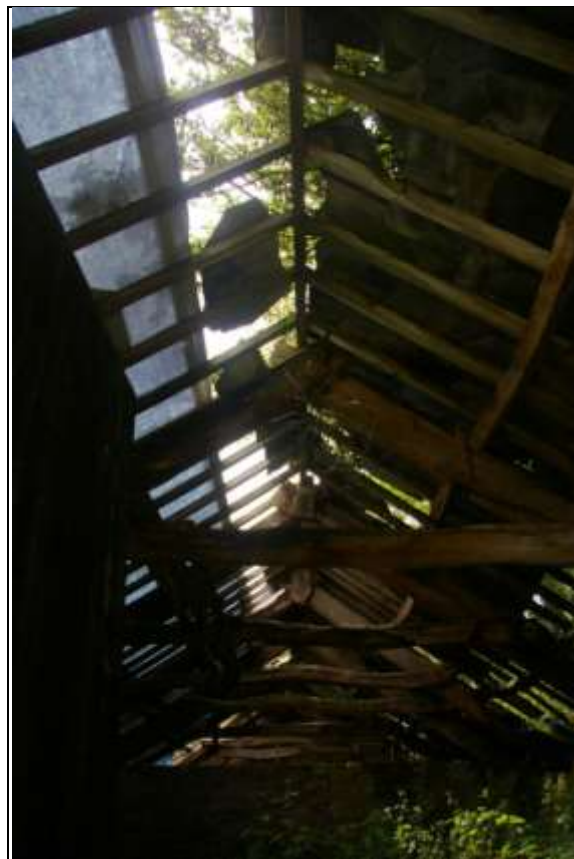
THE RIDGE OF THE ROOF OVER BARN 1; FROM THE EAST.

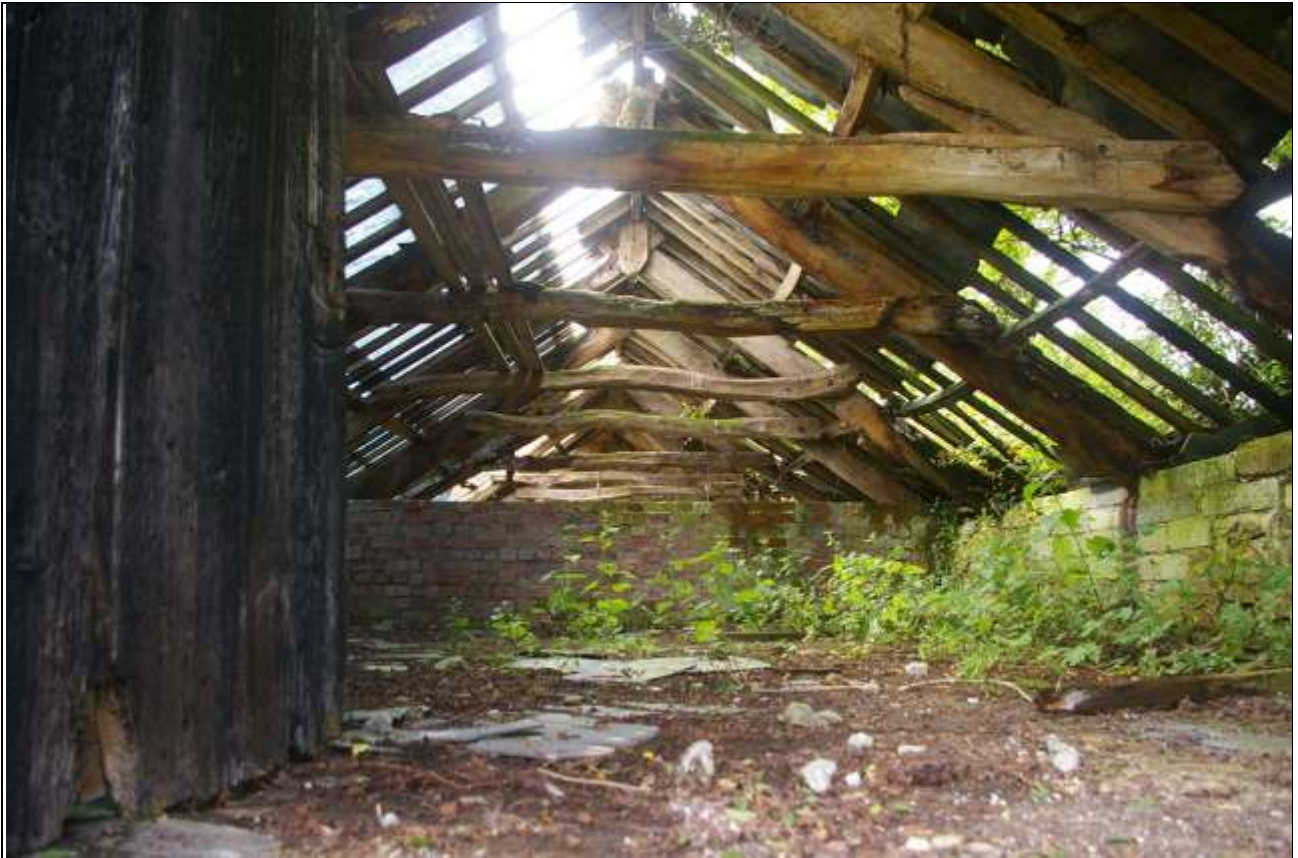
THE LOFT AREA OVER COMPARTMENT 2 OF BARN 1, FORMED USING TIMBER BOARDS, ENCLOSED BY BRICK PARTITION WALL TO THE WEST; VIEWED FROM THE EAST.

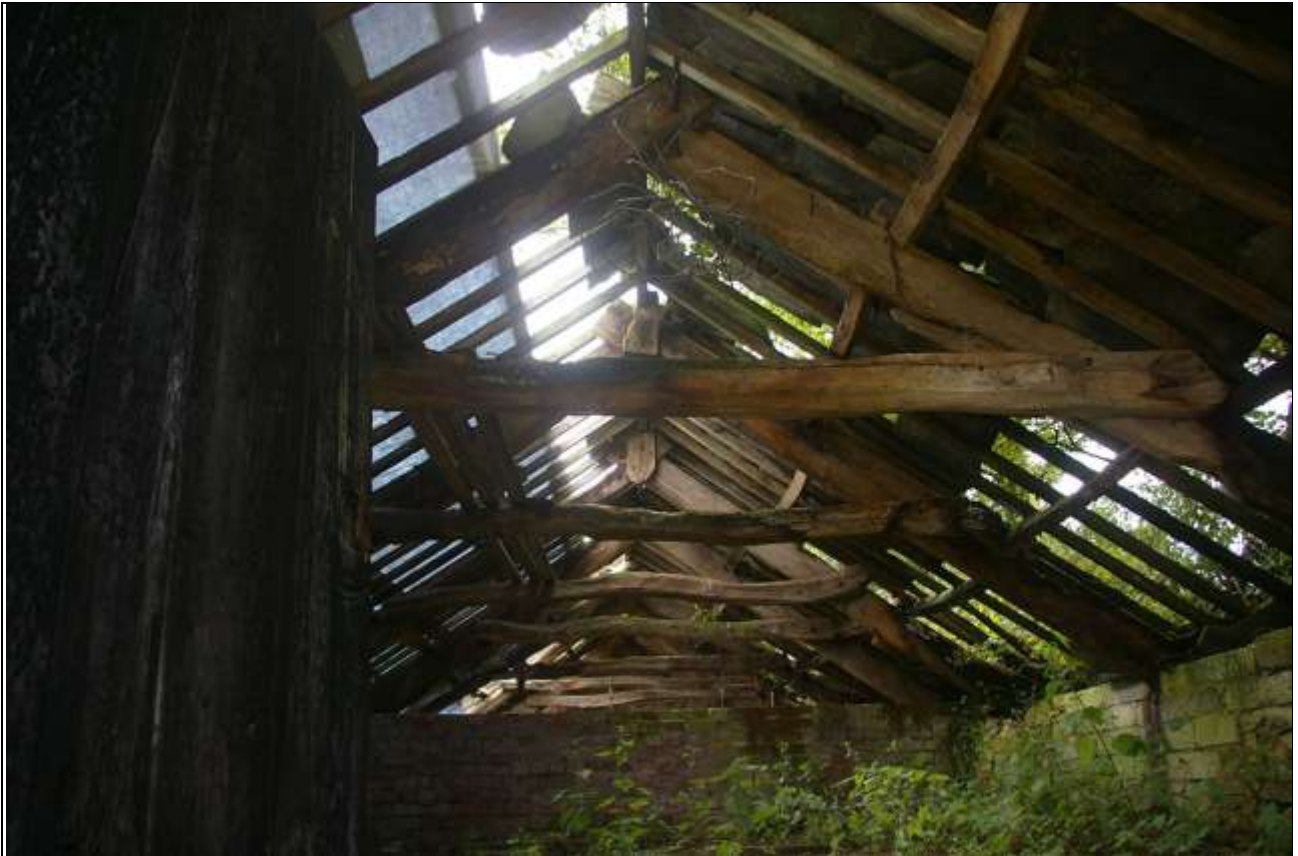
VIEW OF THE ROOF OF BARN 1, FROM THE LOADING DOOR TO THE LOFT OF BARN 1, COMPARTMENT 2; FROM THE EAST.
