# THE BARN ANDERTON FARM LAUNCELLS CORNWALL

Historic Building Recording

South West Archaeology Ltd. report no. 170814

14<sup>th</sup> August 2017

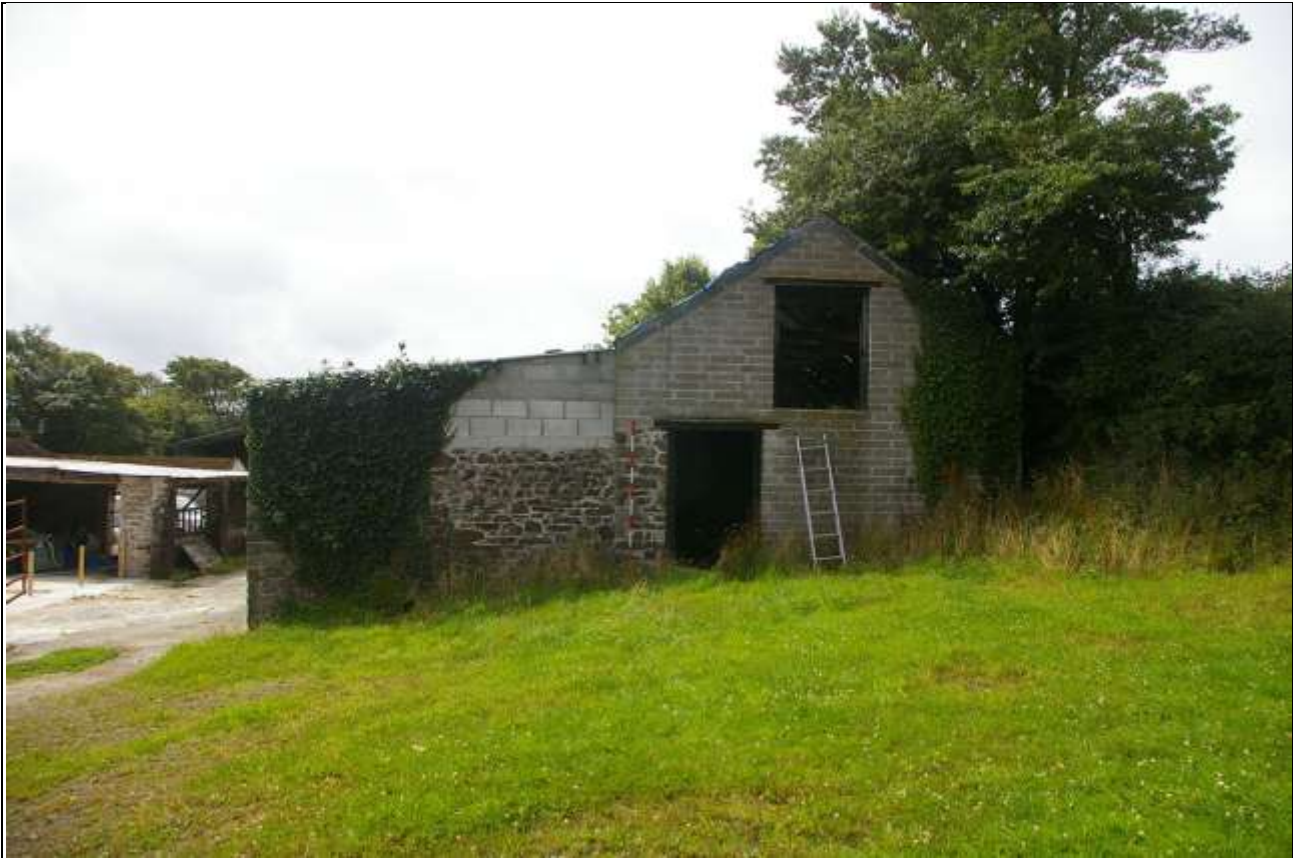
THE EAST TWO STOREY GABLE OF BARN 1 AND THE EAST STONE WALL OF BARN 3; FROM THE EAST (2M SCALE).
