# SESSLAND FARM SOUTH TAWTON CREDITON DEVON

Desk-Based Assessment & Historic Building Recording

South West Archaeology Ltd. report no. 180104

04<sup>th</sup> January 2018

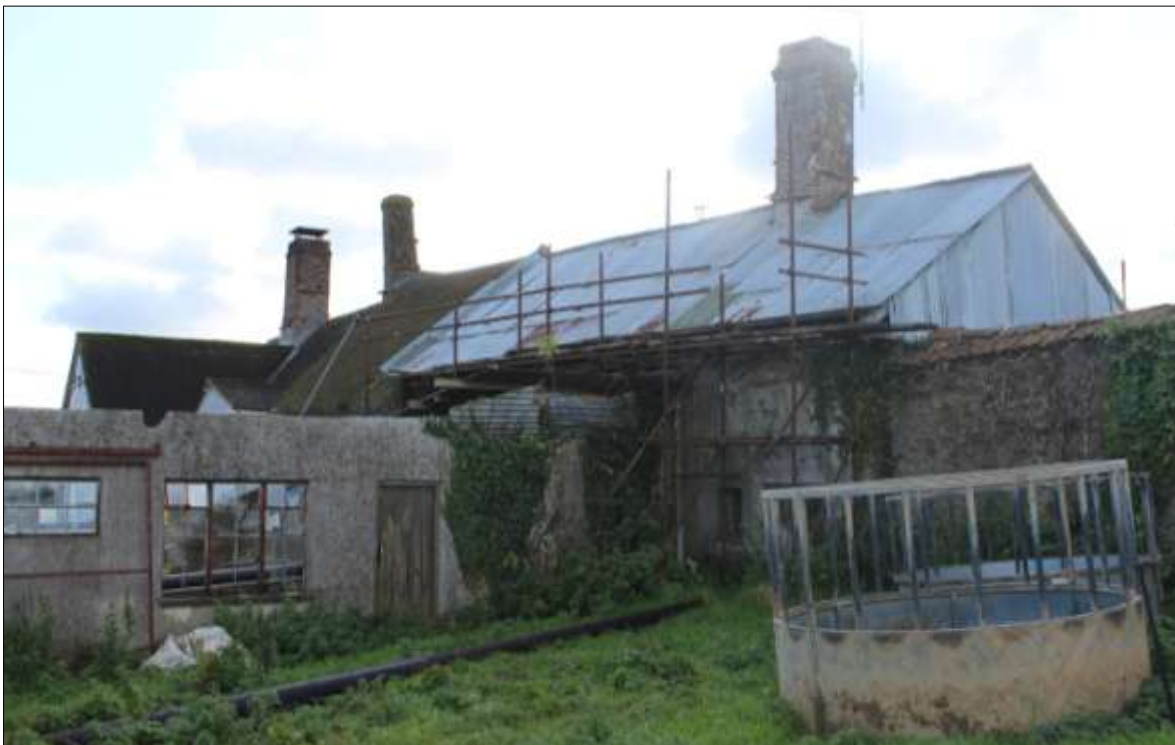
FIGURE 9: NORTH-EAST ELEVATION, VIEWED FROM THE NORTH.

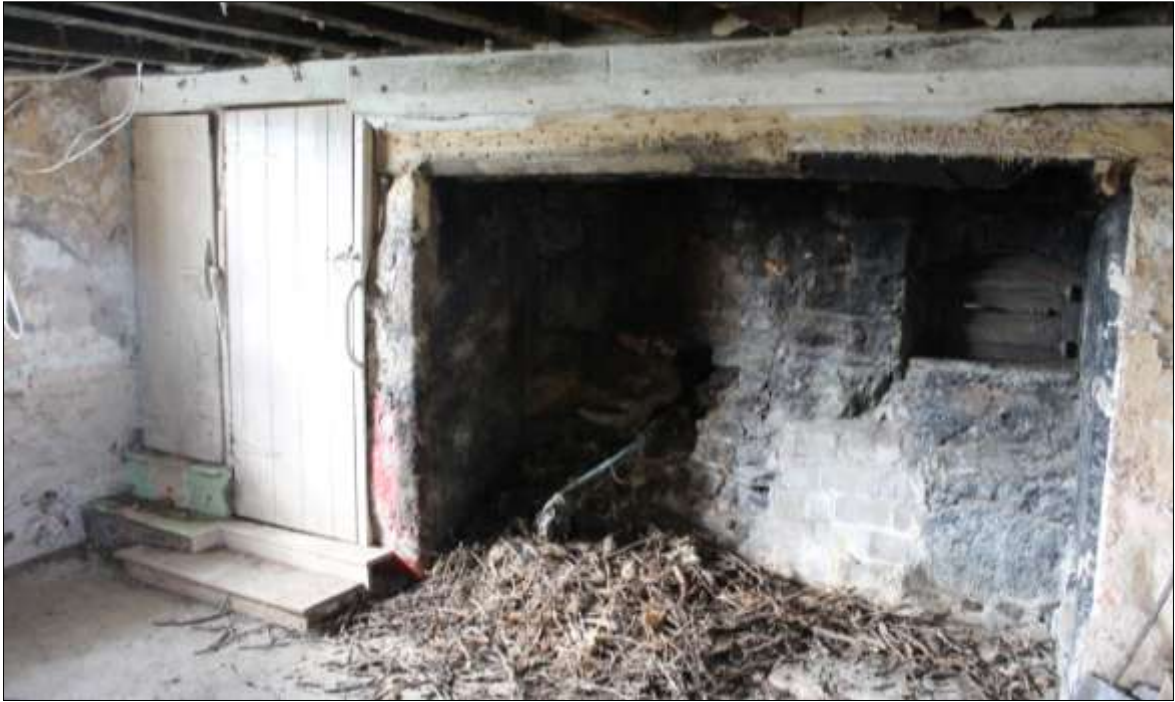
FIGURE 10: THE FIREPLACE IN R1, VIEWED FROM THE EAST.

Significant Details:		Large open hearth to the north-west wall, with heavy chamfered timber bressumer beam, with cut stop to west side. Hacked for plaster in later times, this would have been exposed. Sockets cut for upright sets. The ceiling beam is cut around this bressumer beam. Massive granite orthostat upright, cut with narrow chamfers. Stone rubble to the rear, patched with looser rubble, cob and brickwork, when a range has been recently removed. Possible blocked oven or smoking bay etc to west side (where passage to R2 forced through), very disturbed. Contemporary opening for bake oven to rear of hearth on the northern side, with tall tapering arched opening, now infilled with stone with a low brick arch to a 19 <sup>th</sup> century bread oven with iron frame and door. The rest of the oven was removed and the

opening blocked when the toilet was inserted in R2. The stack is open and rises, tapering to the square dressed stone shaft. Two small square sockets above head height to north and south for axial beam. Stone slab hearth, damaged and cracked. There is a blocked doorway in the north side of the south-east wall. All joists are hacked and marked with nail rust, where a lath-and-plaster ceiling has been removed.
Fittings:		Some iron hooks on the beams and to the fireplace there is a cut section and iron fittings, possibly for a spit or similar.
<b>Room 2a (R2)</b>		
Function:		Small addition, store room, converted to kitchen in the early 20 <sup>th</sup> century.
Walls:		Cob walls on a stone plinth, lime plastered walls over cob plaster. Painted various colours and partly tiled to ½ height to the north end, in small square 20 <sup>th</sup> century ceramic kitchen wall tiles. Wall to R2b is a 20 <sup>th</sup> century partition of lath-and-plaster. Some narrow low skirting boards survive in places.

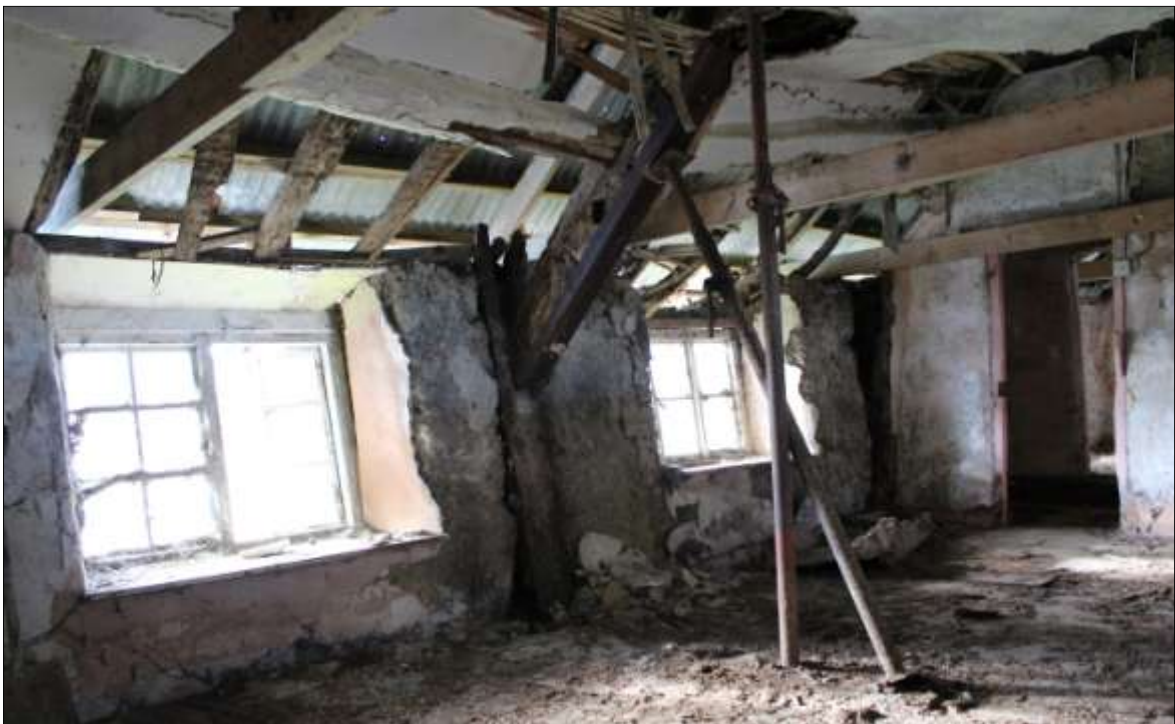
FIGURE 11: R4, VIEWED FROM THE EAST.

Floor:		Relatively-modern boarded floor where water ingress had damaged the floorboards.
Ceiling:		Lath-and-plaster ceiling encloses sloping eaves and boxes out the ridge, as well as covering the heavy purlins. This is carried on lightweight joists between the main trusses.
Roof Structure:		One complete truss of heavy plain truss blades and reset collar. Evidence for two sets of earlier lower lap-jointed and knotted collars with pegged joints. Current collar is bolted, and dates the lath-and-plaster ceiling. The roof has been raised, the truss blades having been jacked up on crude heavy posts sat in the walls. Two sets per pitch of very heavy purlins, on side set, recut into truss blades, butt purlins, other sockets visible. One truss blade survives to the west side of the stack, bracing the purlins of the roof. Split wide battens of very agricultural character carried historic thatch (now missing), pegged to the thin rafters, which in turn are pegged to the purlins. This is a later 16 <sup>th</sup> or early 17 <sup>th</sup> century roof structure, jacked up to provide more headroom when the open space was ceiled, during a heavy remodelling of this building. Later altered in the 18 <sup>th</sup> and 19 <sup>th</sup> century, when the roof structure was ceiled in.

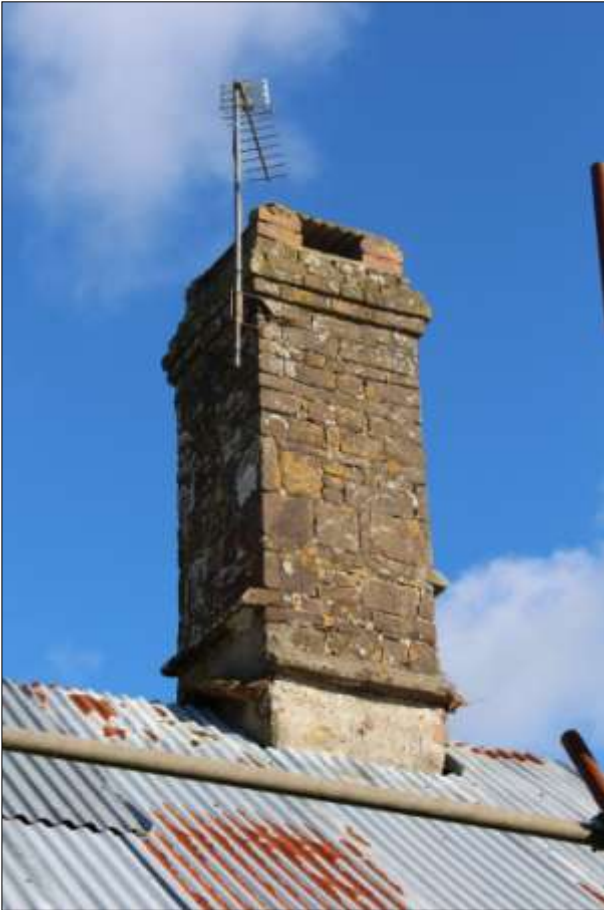
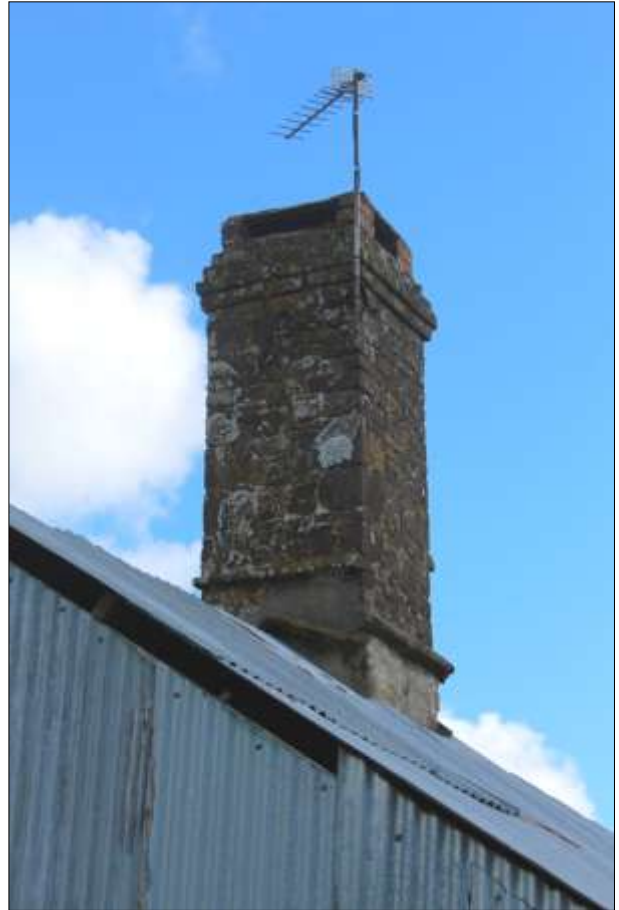
GOOD QUALITY CHIMNEY STONE STACK WITH CHAMFERED DRIP MOULDS; VIEWED FROM THE SOUTH WEST [LEFT] AND SSW [RIGHT].

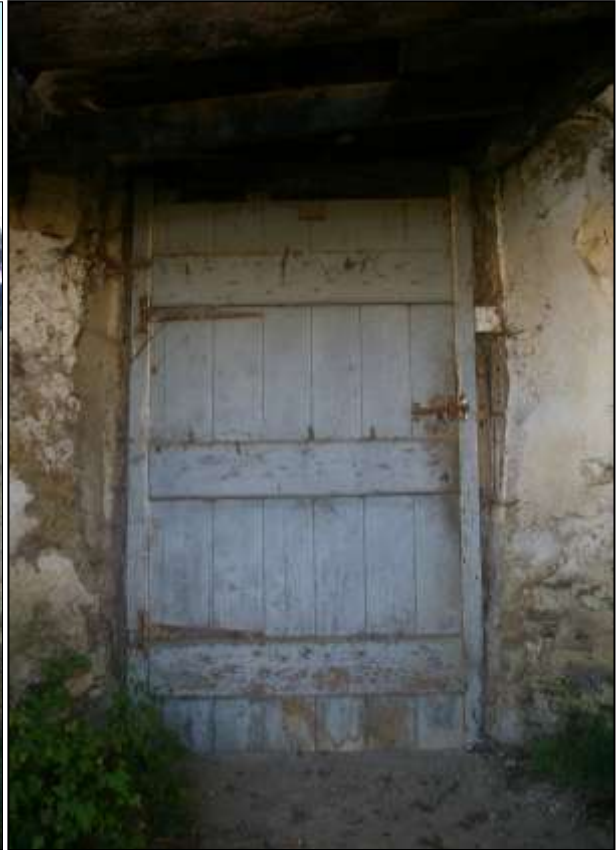
Openings – Doors:	2	Door on the GF to the southern side; a wide forced doorway set with a heavy chamfered pegged doorframe of 16 <sup>th</sup> or 17 <sup>th</sup> century date. Set within this is a narrow plain frame and a heavy narrow beaded plank door, probably later 19 <sup>th</sup> century in date, with heavy iron thumb latch. Above this doorway is a modern timber fillet, some loose stone and cob packing around the edge of the frame. The badly-fitting pegs in the corners indicate much alteration, and this doorframe may have been removed from the blocked opening to the north (see below). At FF level there is a forced doorway set in a wide pegged beaded frame with a two-panelled boarded door on LH hinges of early 19 <sup>th</sup> century date.
Blocked Openings:	1	One wide blocked doorway at GF level to the north side, clear in outline but blocked with rubble and cob and plastered and painted over. The cavity is used as a cupboard on the Farmhouse side of the wall.

RIGHT: THE CURRENT FRONT DOOR, WITHIN A FORCED OPENING WITH A RESET CHAMFERED AND PEGGED DOORFRAME. VIEWED FROM THE NORTH-EAST.

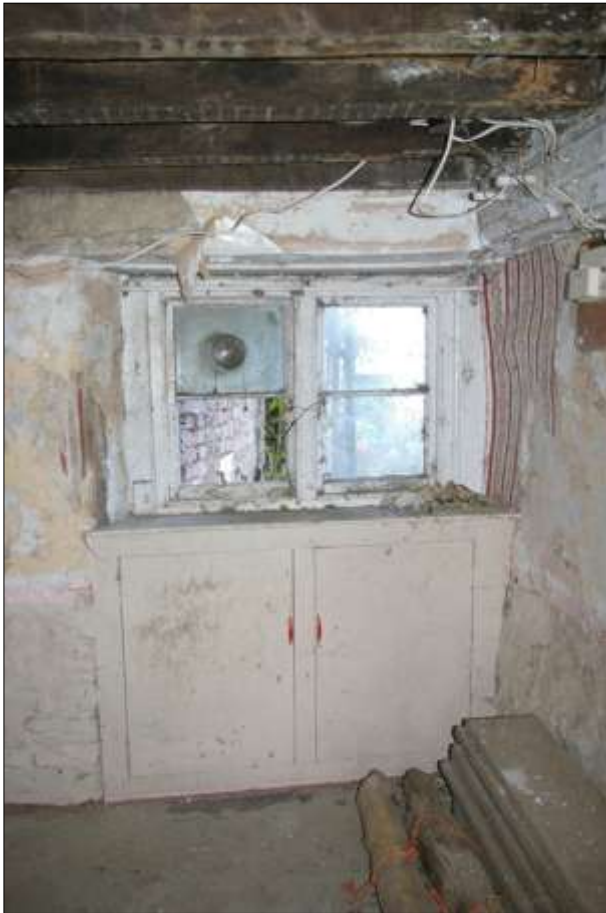
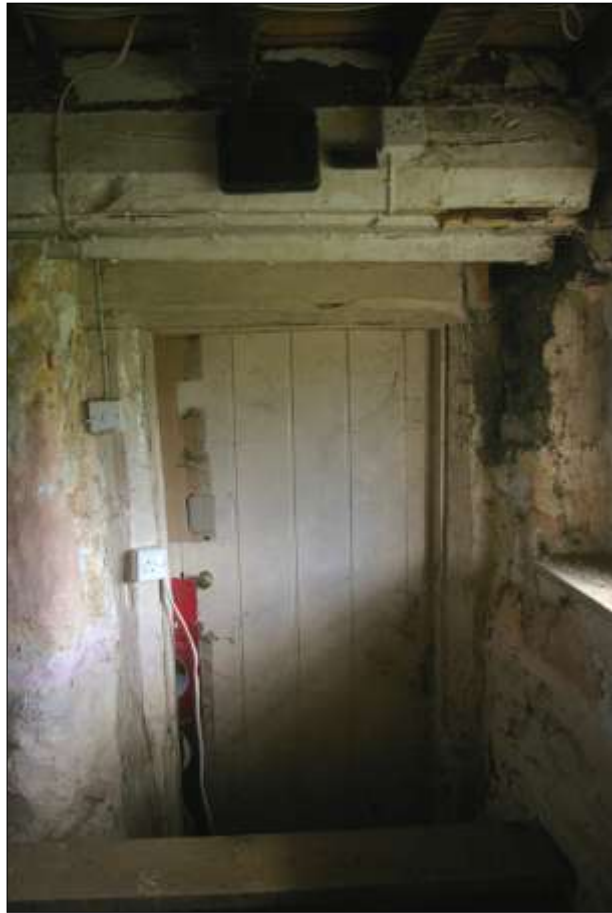
The door in R1 to the farmyard was blocked and a cupboard and window installed. The door to the Linhay was refitted with a new frame and narrow plank door with iron latch. The Linhay which was in poor condition was demolished and replaced with a concrete garage. A brick-built dairy or outhouse (R6) was built against the north-west elevation. The ground floor store was fitted out as a small kitchen and bathroom, with a toilet installed in the 1960s, demolishing the back of the bread oven. Some of the timber casement windows were replaced or altered. The building was redecorated, most noticeably in R1, which was wallpapered with a striking food motif; this wallpaper survives in part and is a charming and authentic mid 20<sup>th</sup> century decorative feature. The partly-blocked open hearth was fitted with a modern range stove, or heater, as the bressumer beam has been cut to fit a second flue. The building has not been occupied since the 1990s, and no further modernisation has occurred.

LEFT: EAST ANGLE OF R1, SHOWING THE FORCED BLOCKED DOORWAY WITH WINDOW AND CUPBOARD. VIEWED FROM THE SOUTH-WEST.  
RIGHT: SOUTH ANGLE OF R1, SHOWING THE FORCED DOORWAY. VIEWED FROM THE NORTH-WEST.

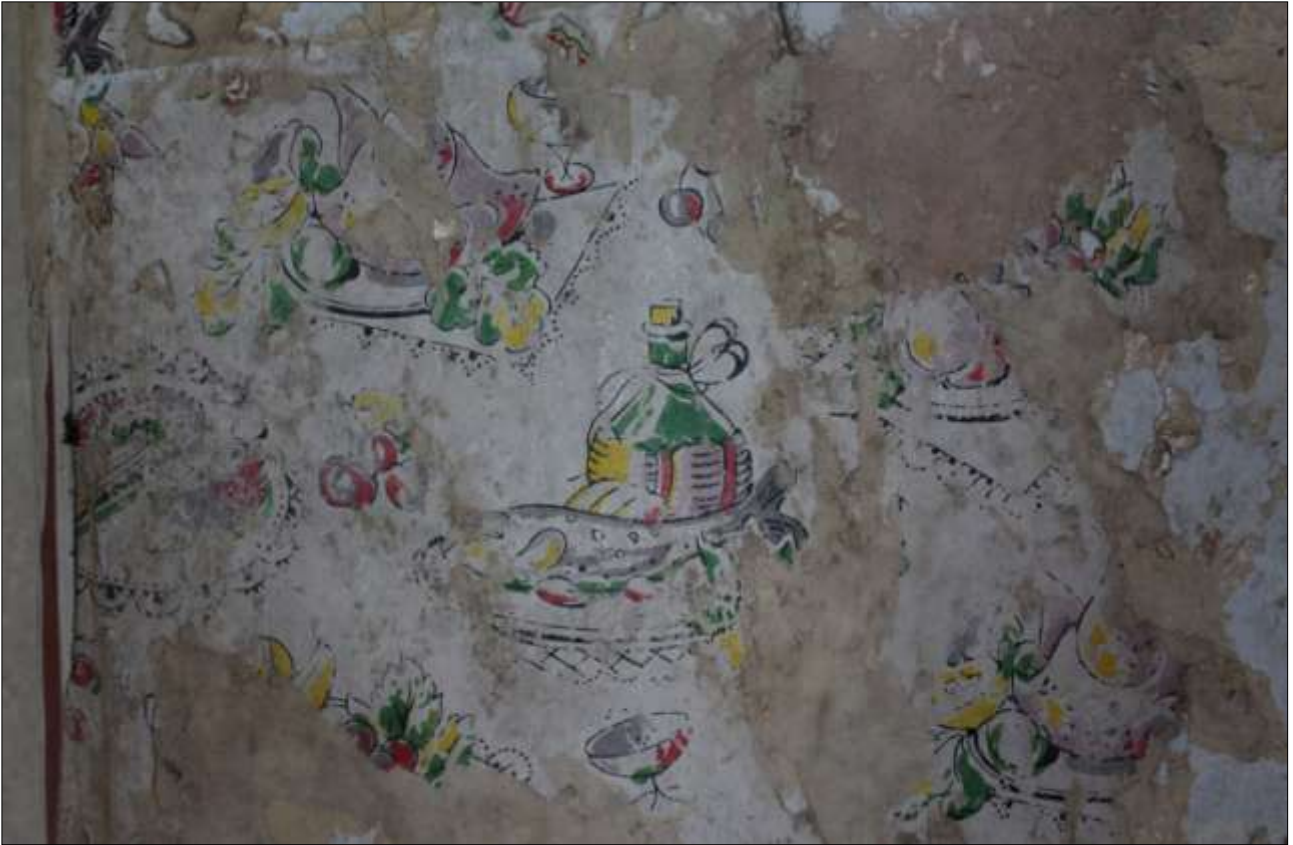
R1, DETAIL OF THE WALLPAPER.

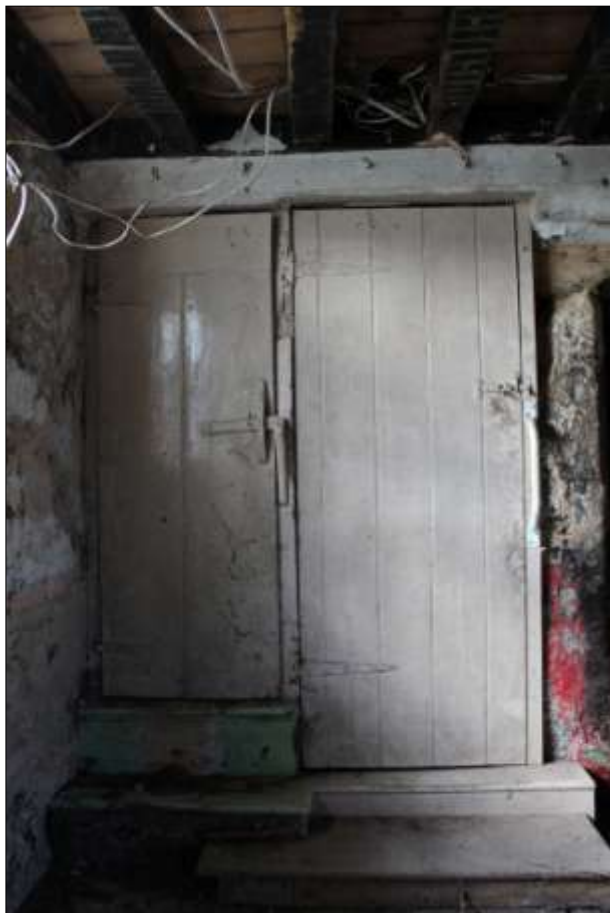
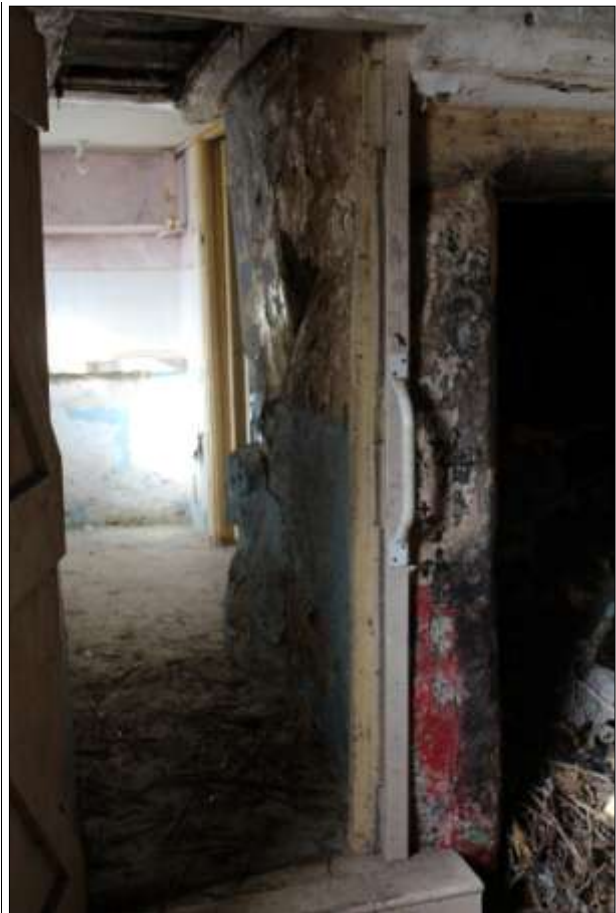
LEFT: R1, DETAIL OF THE DOORS LEADING INTO R2 (RIGHT) AND R3 (LEFT); VIEWED FROM THE SOUTH-WEST.  
RIGHT: R1, VIEW THROUGH TO R2; VIEWED FROM THE SOUTH-WEST.

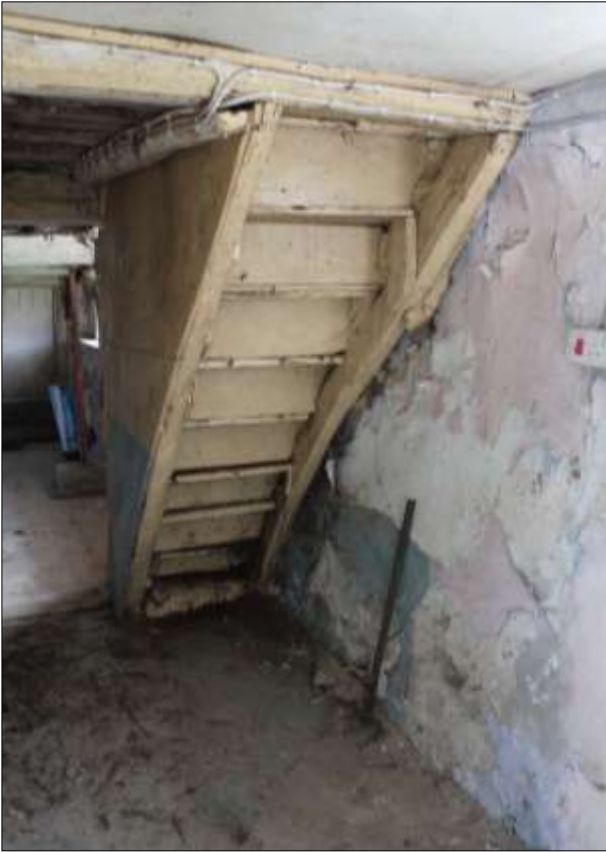
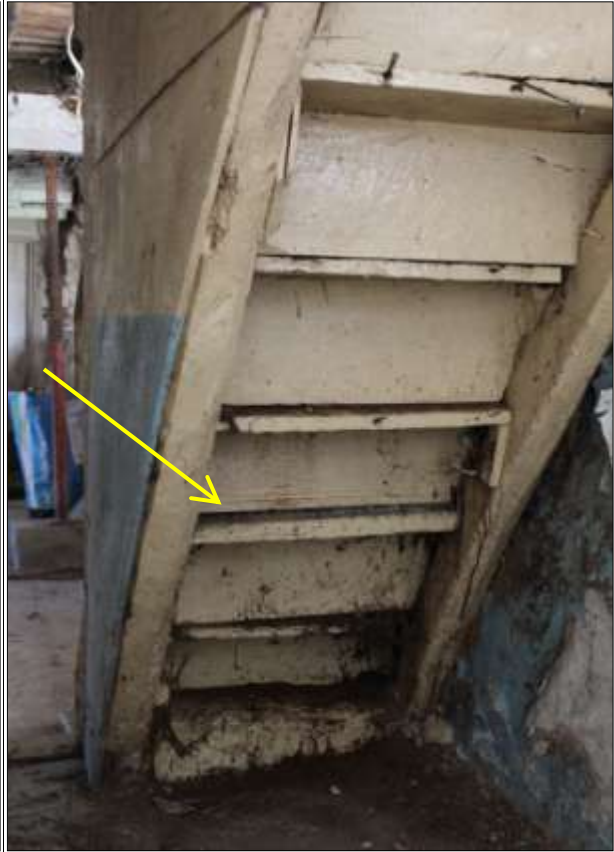
LEFT: R2, THE UNDERSIDE OF THE STAIRS IN R3; VIEWED FROM THE WEST.

RIGHT: AS ABOVE, SHOWING DETAIL OF THE REUSED BEADED PLANKS (INDICATED); VIEWED FROM THE WEST.

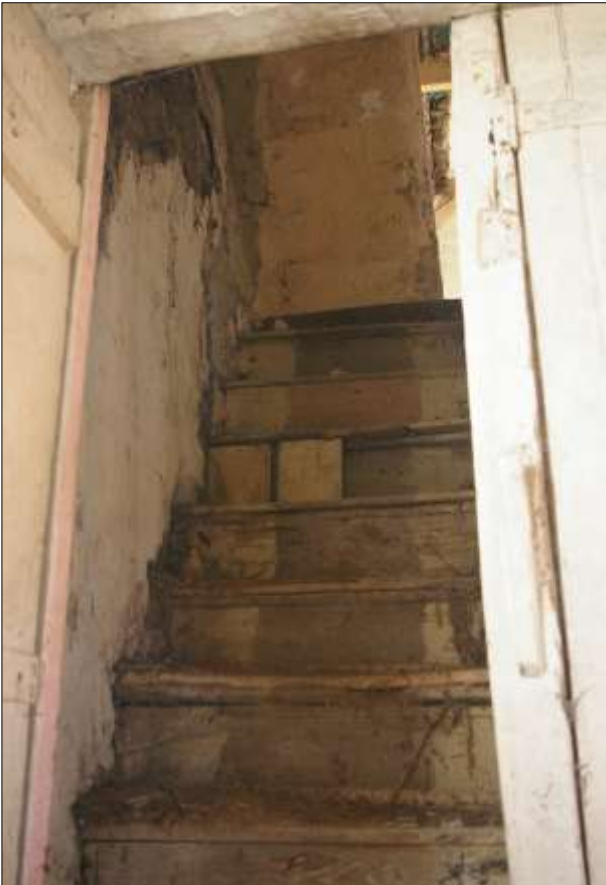
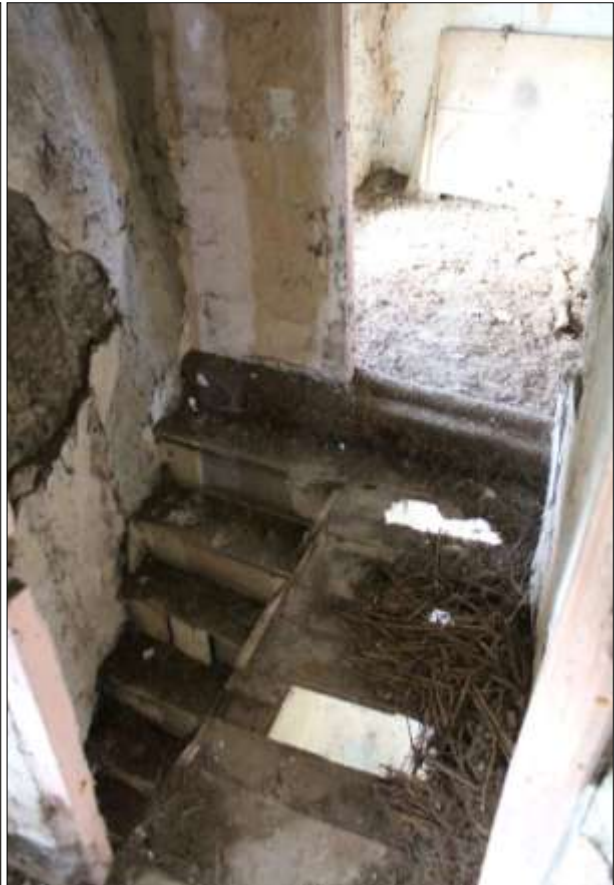
THE STAIRS FROM R1 TO R3; VIEWED FROM THE SOUTH-EAST FROM R1 (LEFT), AND FROM R4 (RIGHT).

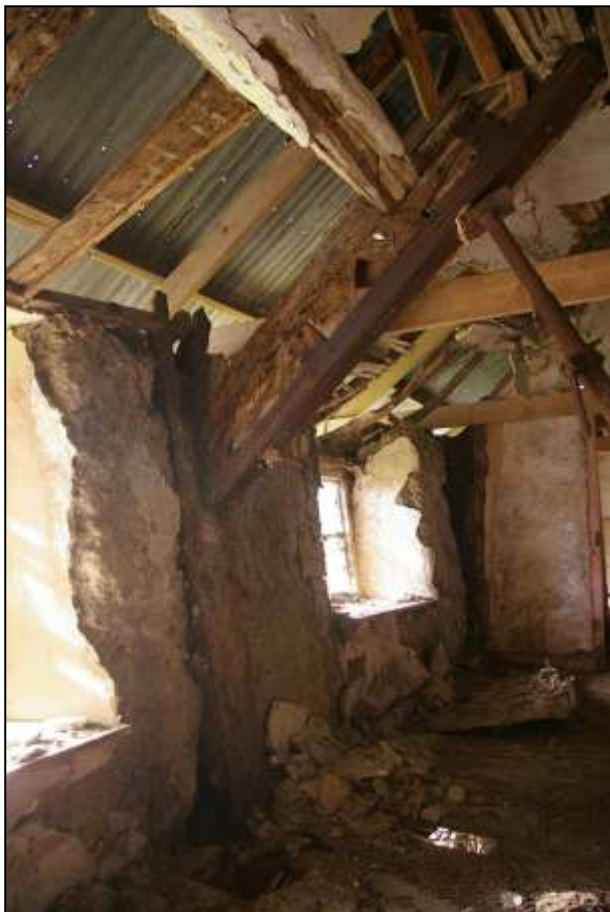
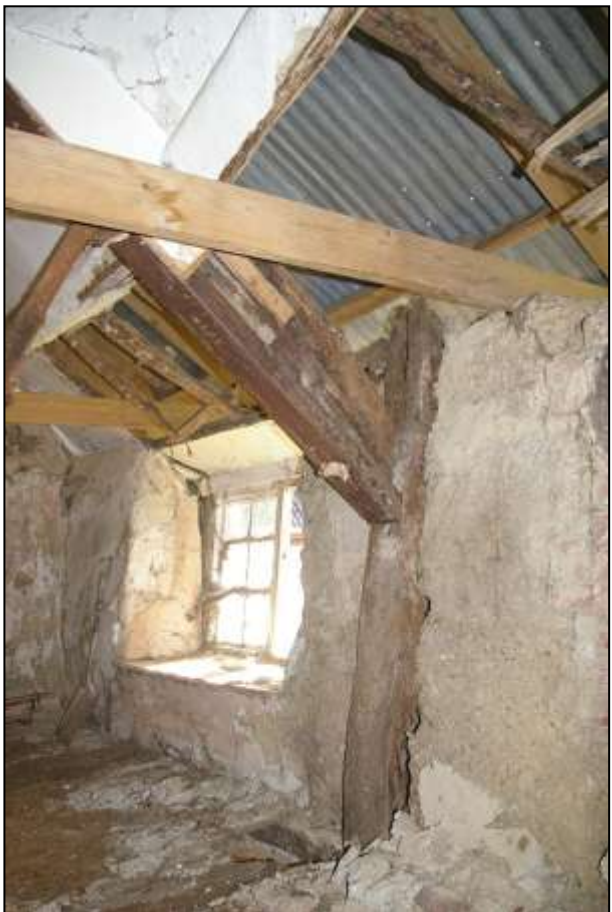
R4, THE UPRIGHT AND TRUSS BLADE IN THE SOUTH-WEST WALL (TRUSS #1); VIEWED FROM THE EAST (LEFT) AND NORTH (RIGHT).
