# THE LOWER DRY CHARLESTOWN St AUSTELL CORNWALL

Results of a Desk-Based Appraisal, Historic Building Assessment &  
Heritage Statement

South West Archaeology Ltd. report no. 170906

By B. Morris  
Report Version: 02  
29<sup>th</sup> September 2017

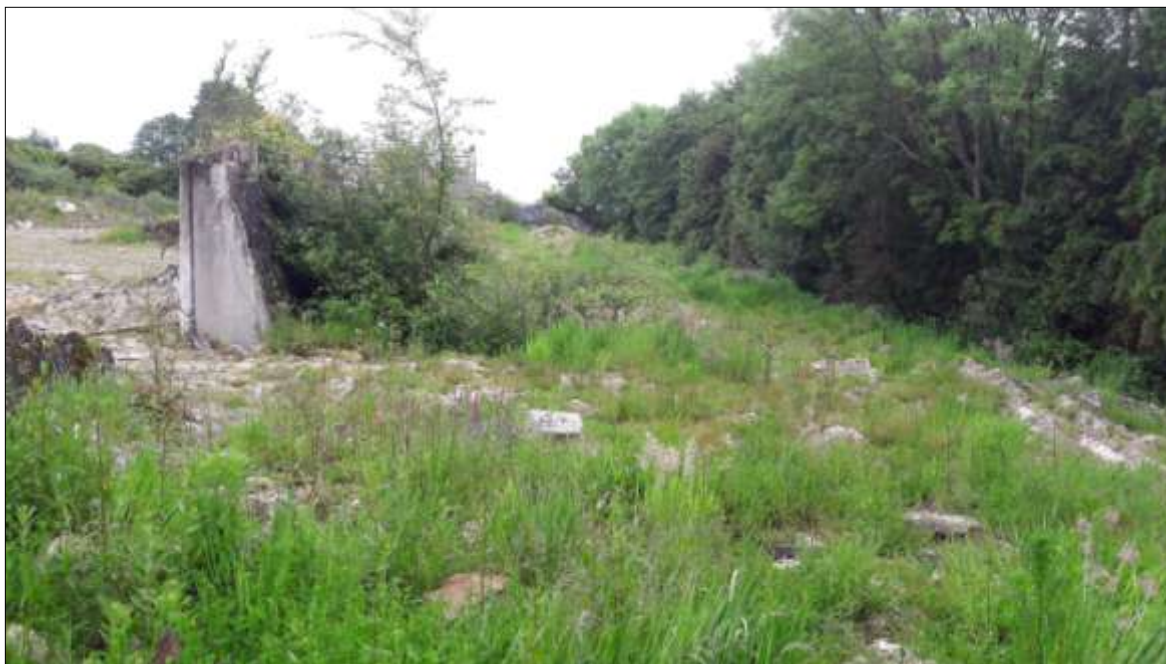
FIGURE 15: THE DRYING FLOOR, VIEWED FROM THE NNW.

The drying floor is currently largely concealed beneath a layer of redeposited china clay, with detail visible only at the southern and northern ends, and intermittently along its length. When

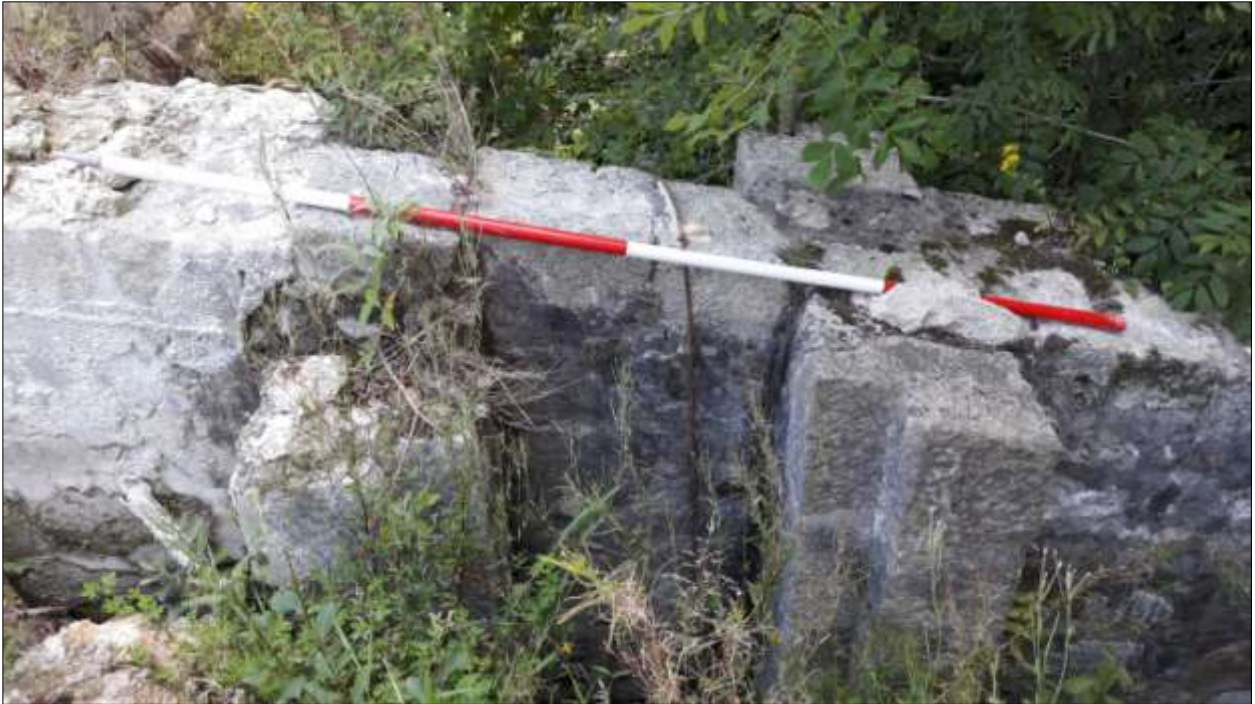
The possible opening in the wall separating C4 and C5, with its strong projecting reveals; viewed from the north (scale 2m).
