**YOUNGCOTT BARN
MILTON ABBOT
WEST DEVON
DEVON**

Historic Building Recording

South West Archaeology Ltd. report no. 170913

By N. Boyd & E. Wapshott
Report Version FINAL
13th September 2017

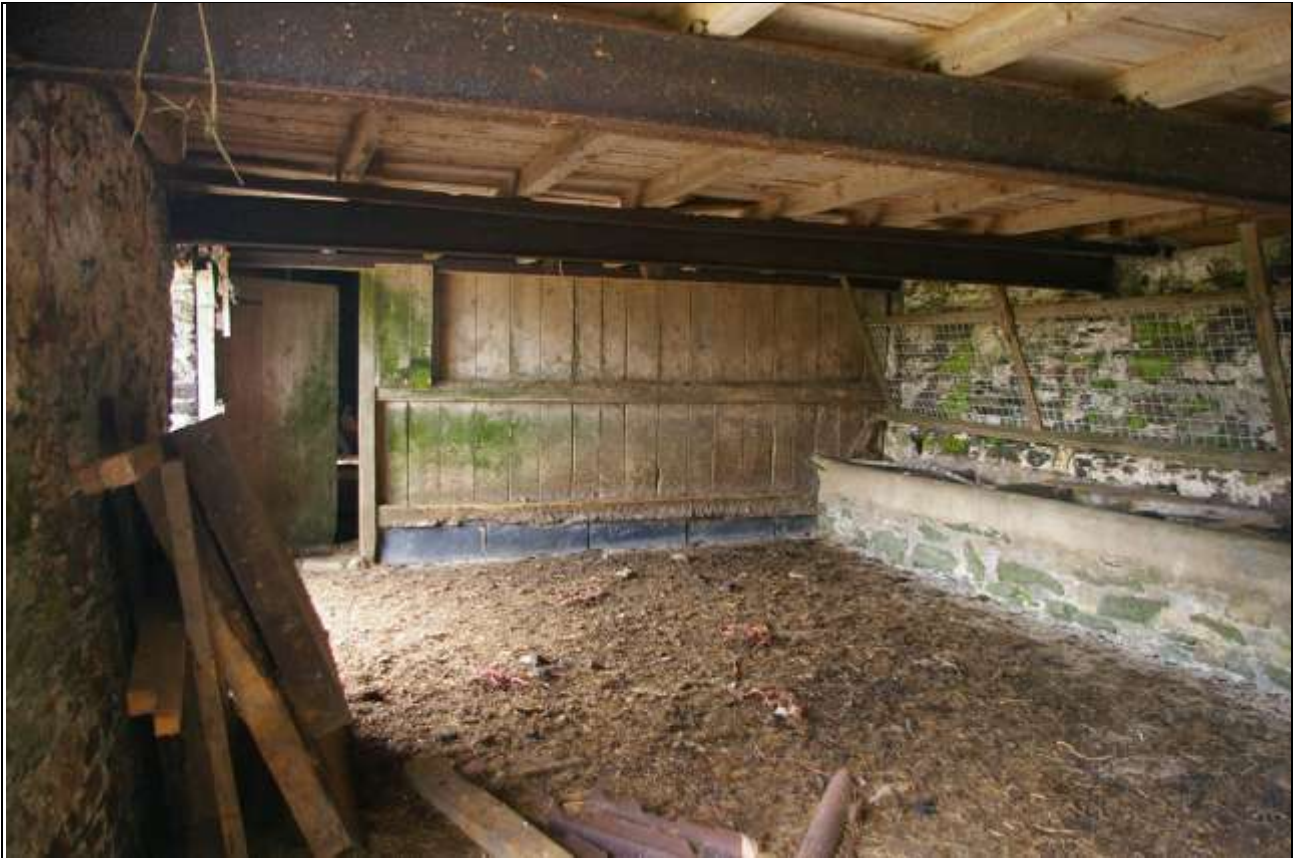
The interior of Barn 2; from the south-west corner.

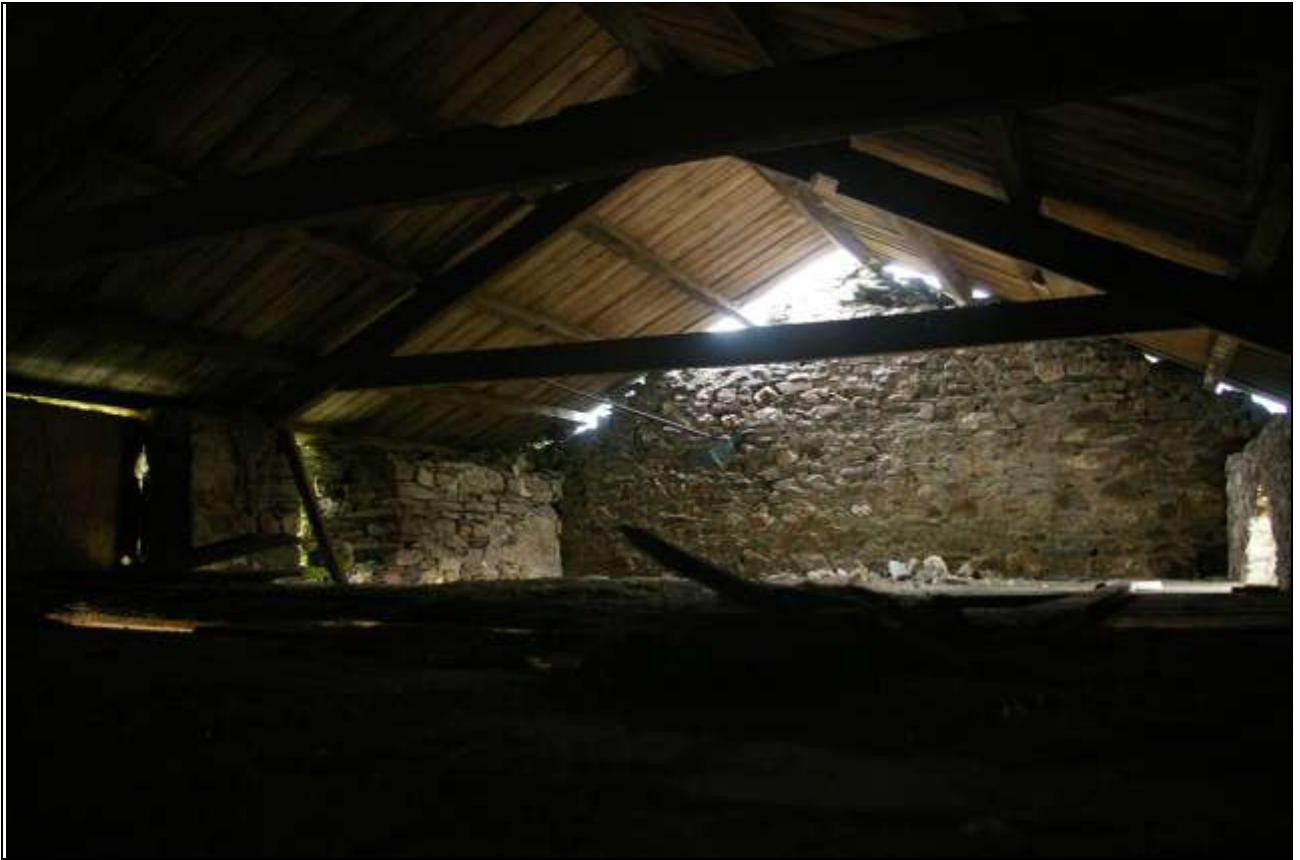
The rails, girders and other ironwork seen used in the bracing of the 20th century loft structure within Barn 2 have certainly been sourced from elsewhere, as scrap or similar. The rails, two long sections, one shorter and one short welded section; are heavy cast and of small gauge, for a tram or small engine. However, without a stamp or identity/makers mark to directly associate with the nearby or other regional mine or mining heritage, there is no conclusive route to identify their original source. The entire ironwork framework is forced into the walls and patched and reset in cement repaired ragged holes, clearly a late and relatively poor quality repair/replacement to the loft.

The loft in Barn 2, viewed from the north-west corner.

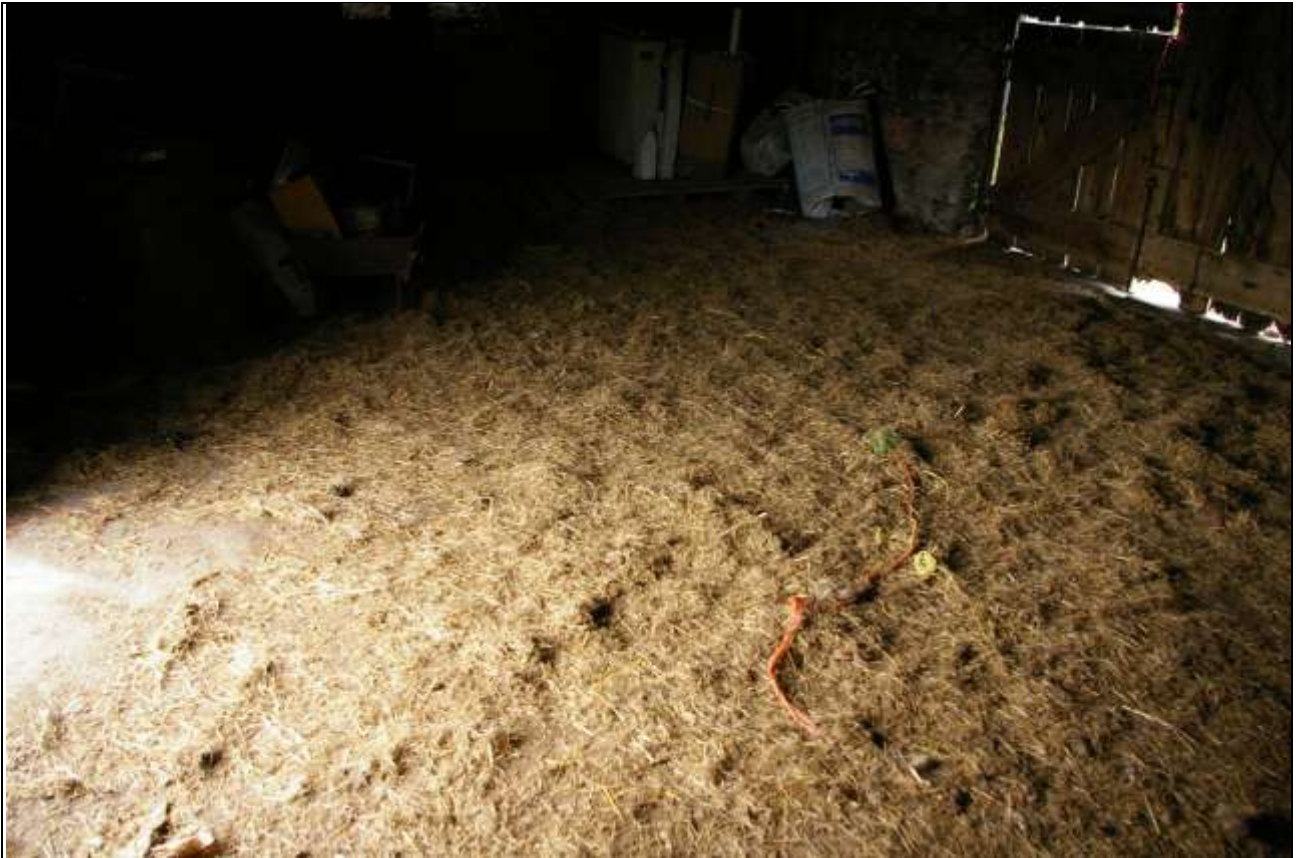
The floor of Barn 1; from the south-south-west.
