MAYOR'S AVENUE TRAVIS PERKINS

DARTMOUTH

Desk-Based Assessment & Historic Building Recording

South West Archaeology Ltd. report no. 181127

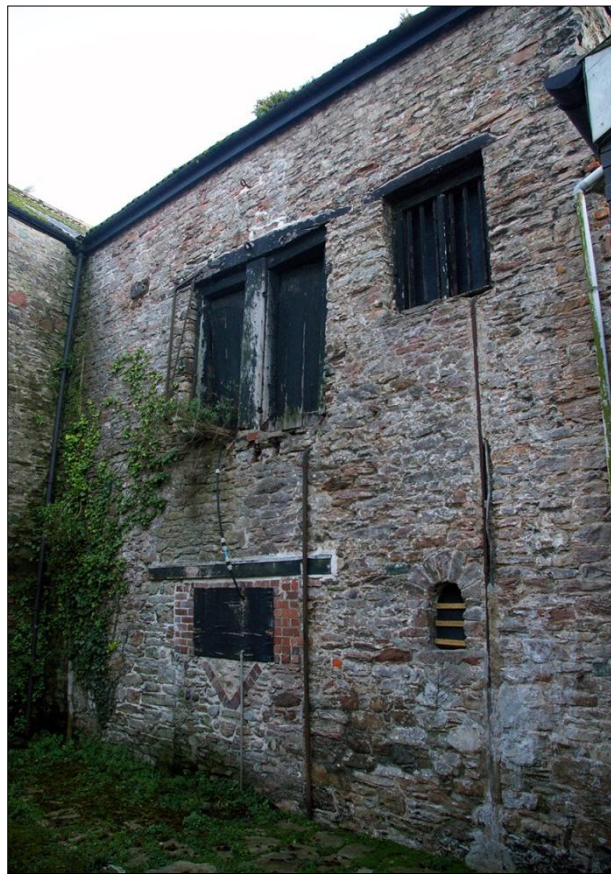
3. RIGHT: THE NORTH WALL OF B1, SHOWING THE VARIOUS GROUND-FLOOR (GF) AND FIRST-FLOOR (FF) OPENINGS; VIEWED FROM THE NORTH-WEST.

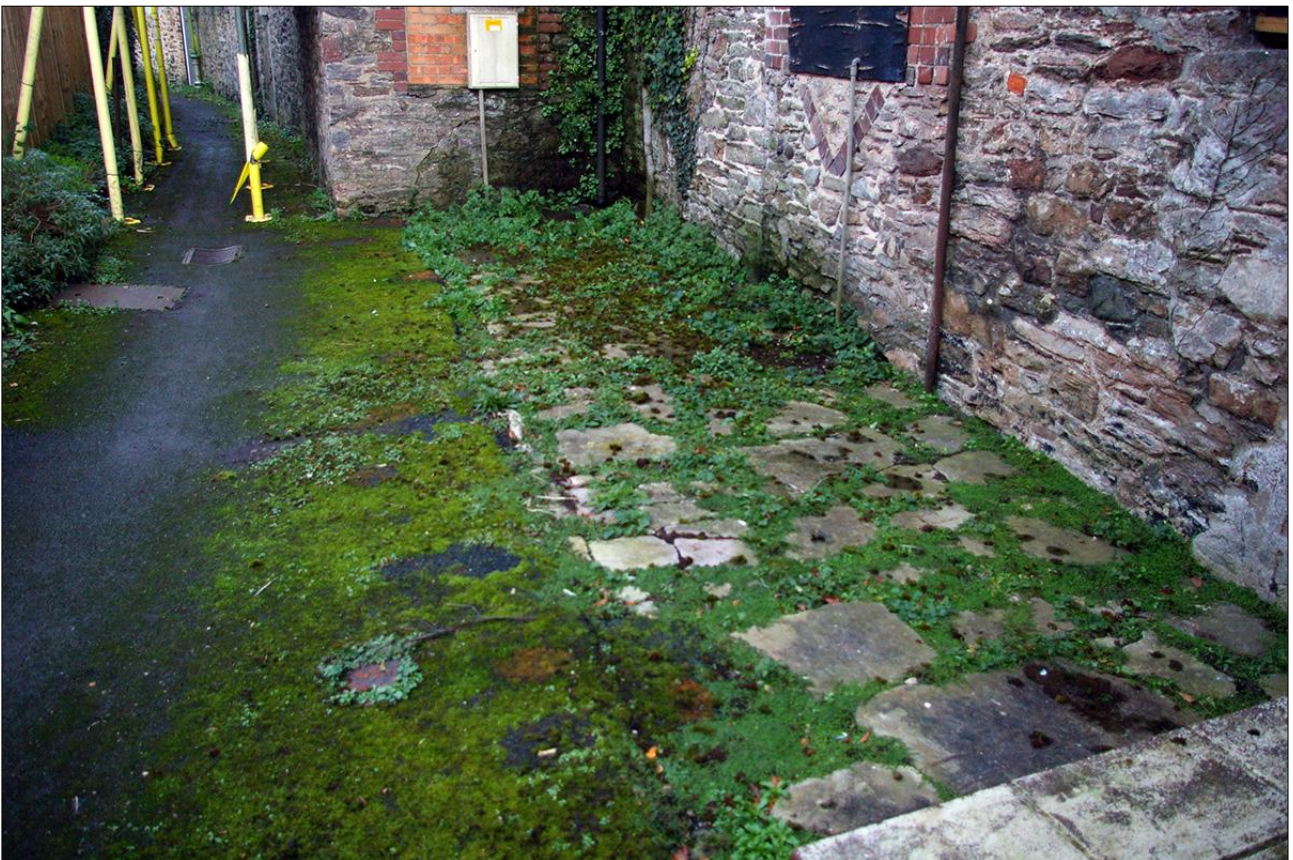
10. THE PAVED AREA (SIGNIFICANT FEATURE 2 (S2)) TO THE NORTH OF B1; VIEWED FROM THE WEST.

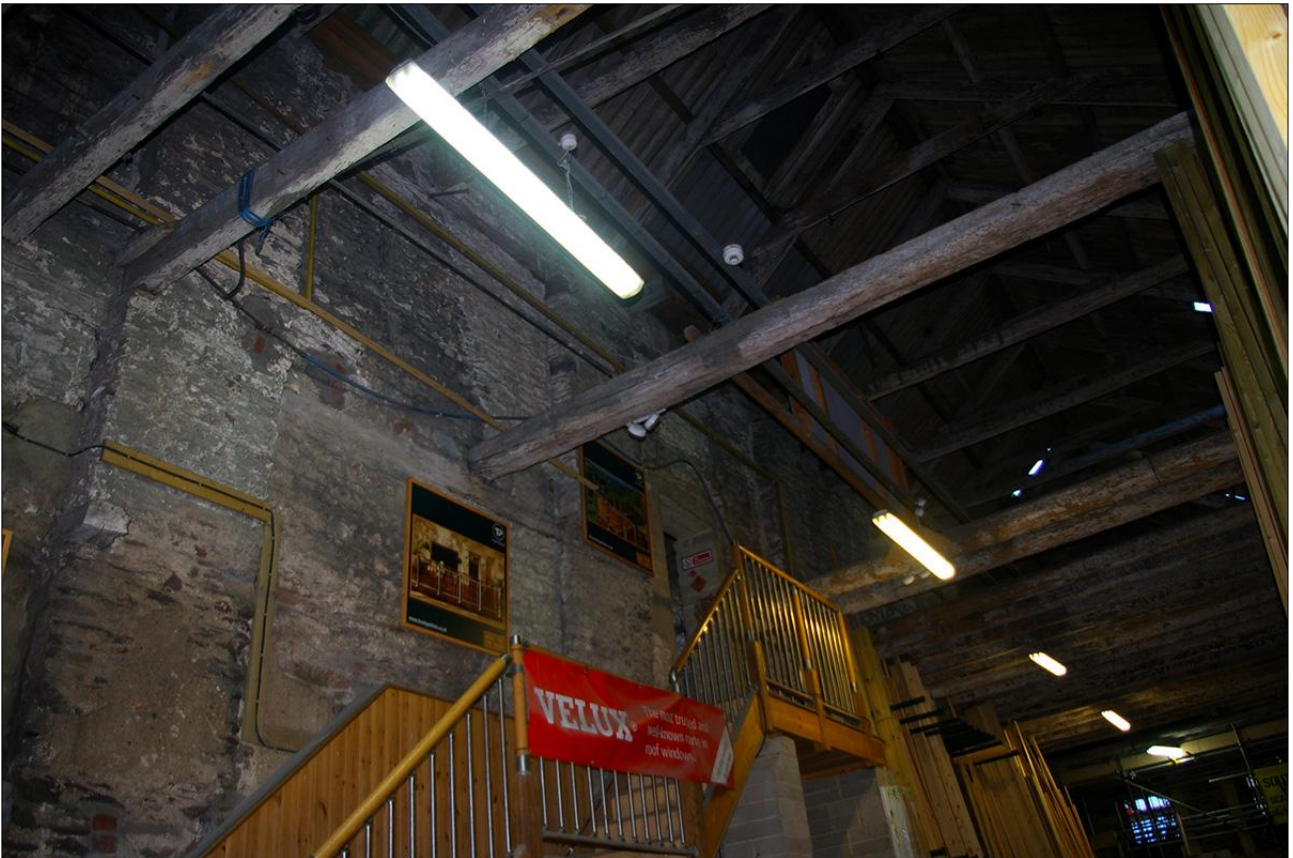
11. THE CENTRAL PART OF THE EAST WALL OF B1 (WITHIN B2); VIEWED FROM THE SOUTH-EAST.

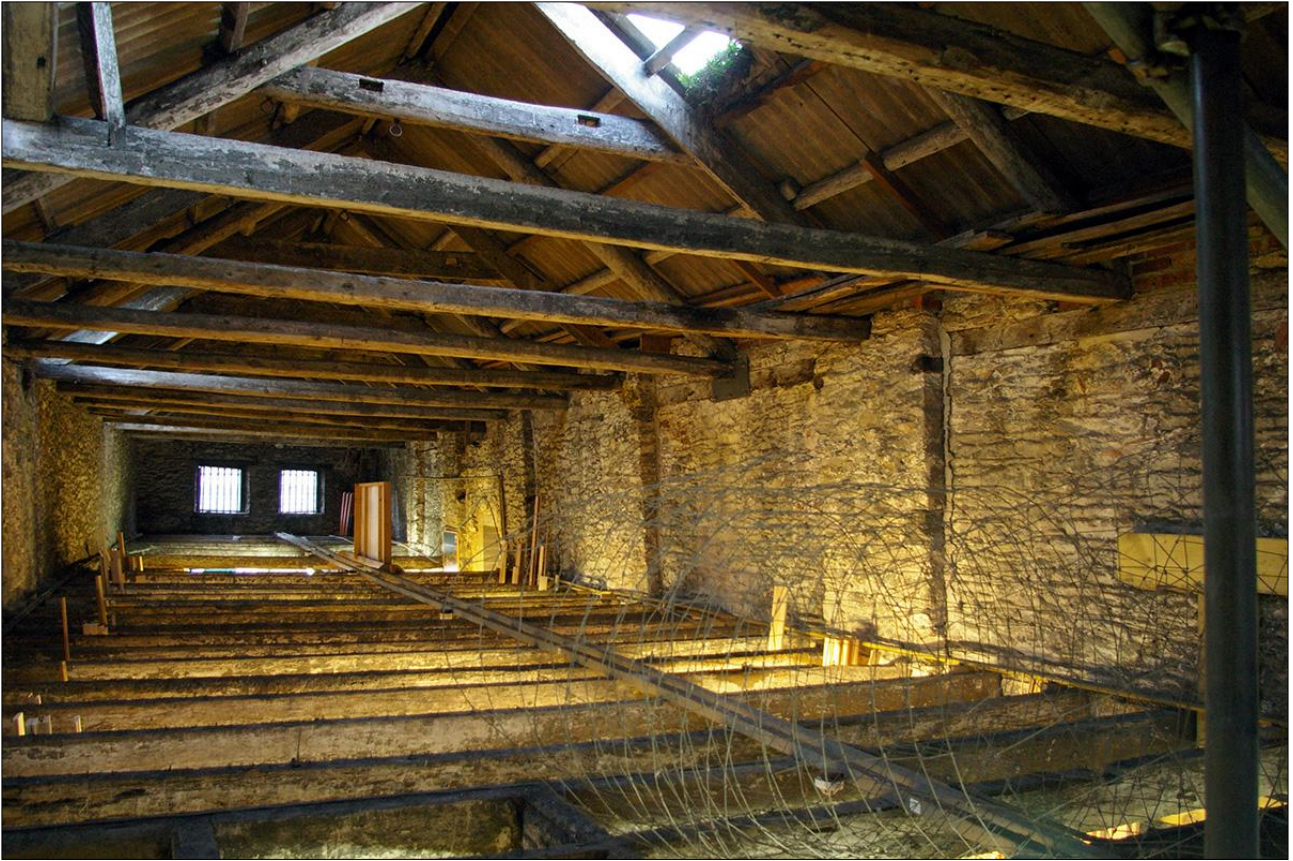
15. THE EAST WALL OF B1 AT SF LEVEL; VIEWED FROM THE NNE.

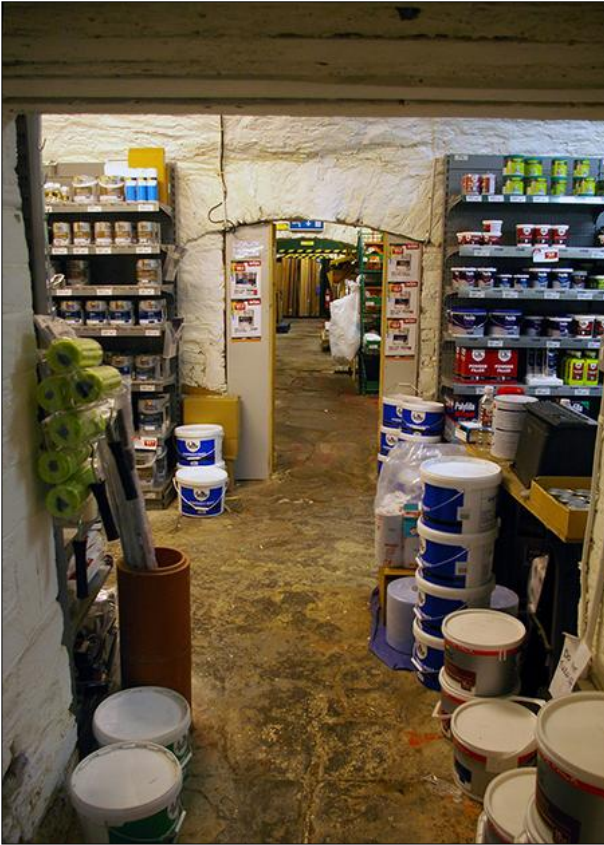
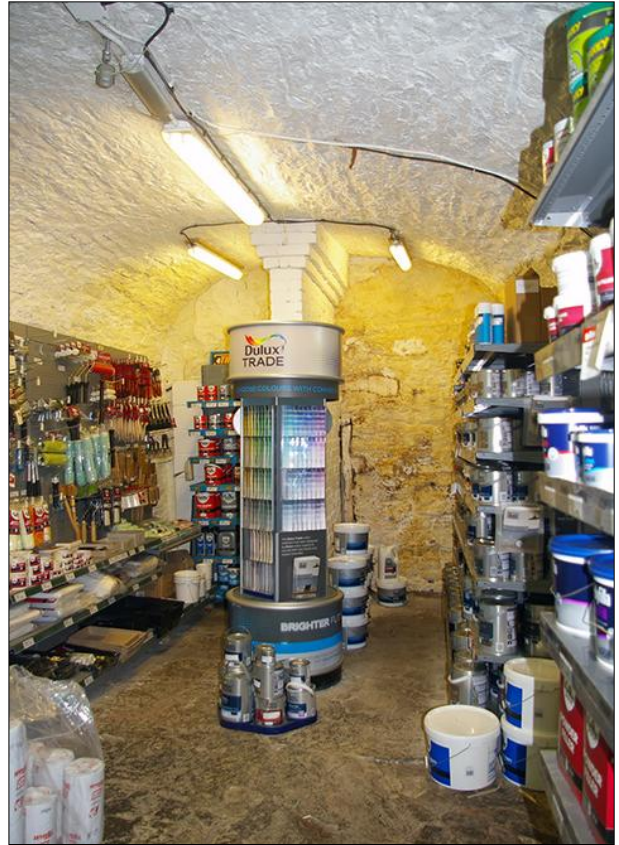
20. LEFT: B1 GF, VIEW THROUGH D1 INTO VAULT 1 (V1); VIEWED FROM THE SOUTH.
21. RIGHT: B1 GF, THE SOUTHERN HALF OF V1; VIEWED FROM THE EAST.

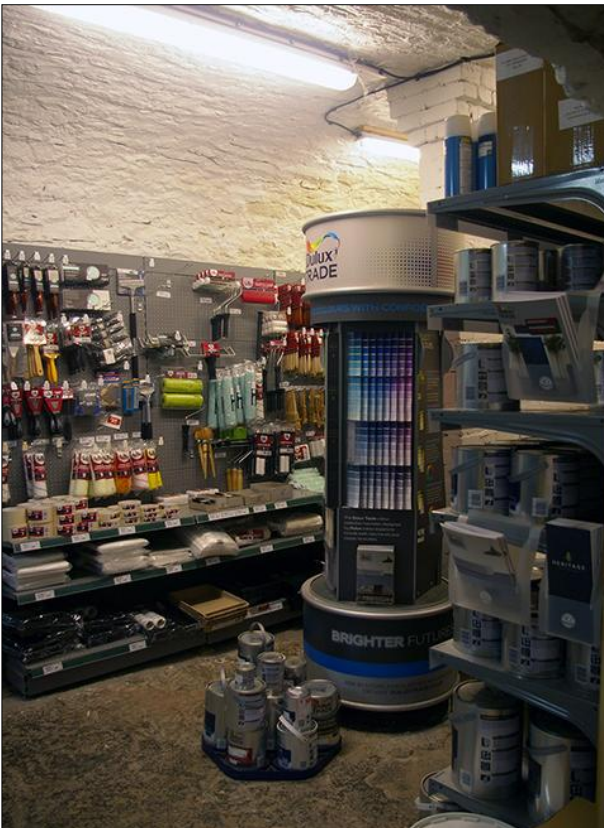
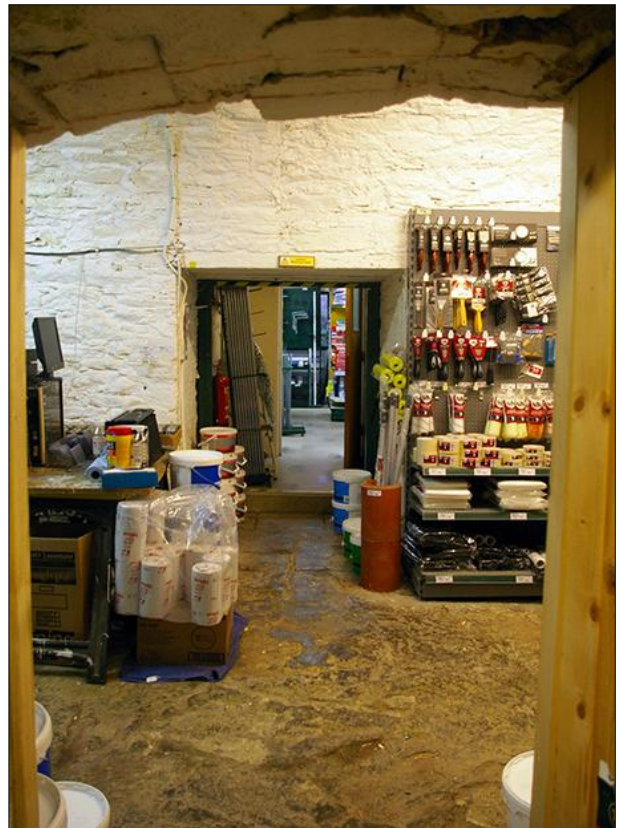
22. LEFT: AS ABOVE; VIEWED FROM THE NORTH-EAST.
23. RIGHT: B1 GF V1, LOOKING THROUGH D2/BO9 TO THE SOUTH ENTRANCE (D1); VIEWED FROM THE NORTH.

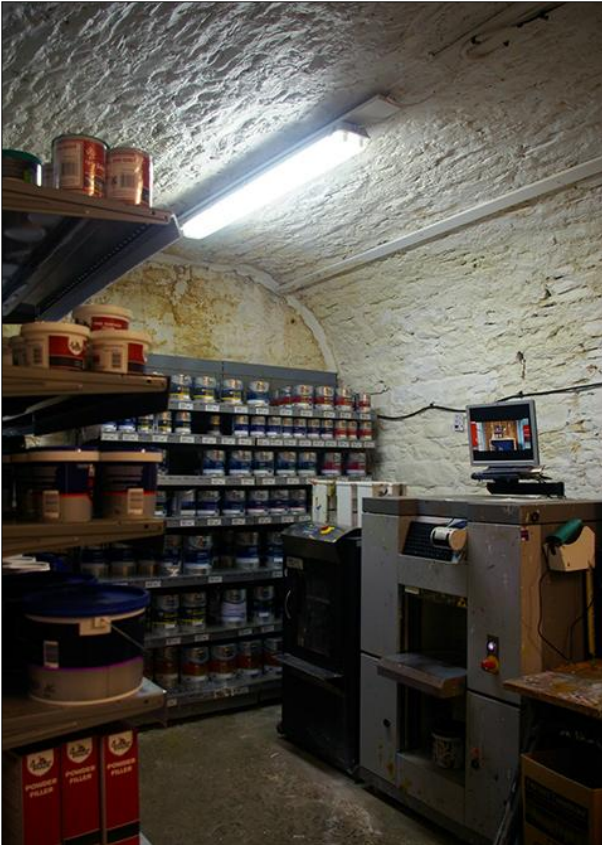
24. LEFT: B1 GF, THE NORTH END OF V1; VIEWED FROM THE WNW.

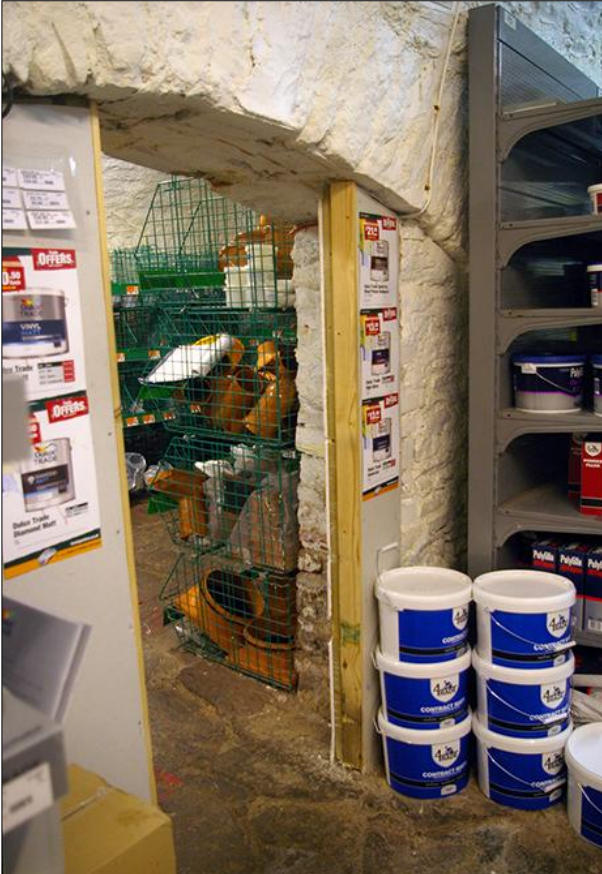
26. LEFT: B1 GF, D2/BO9 BETWEEN V1 AND V2; VIEWED FROM THE SOUTH-WEST.

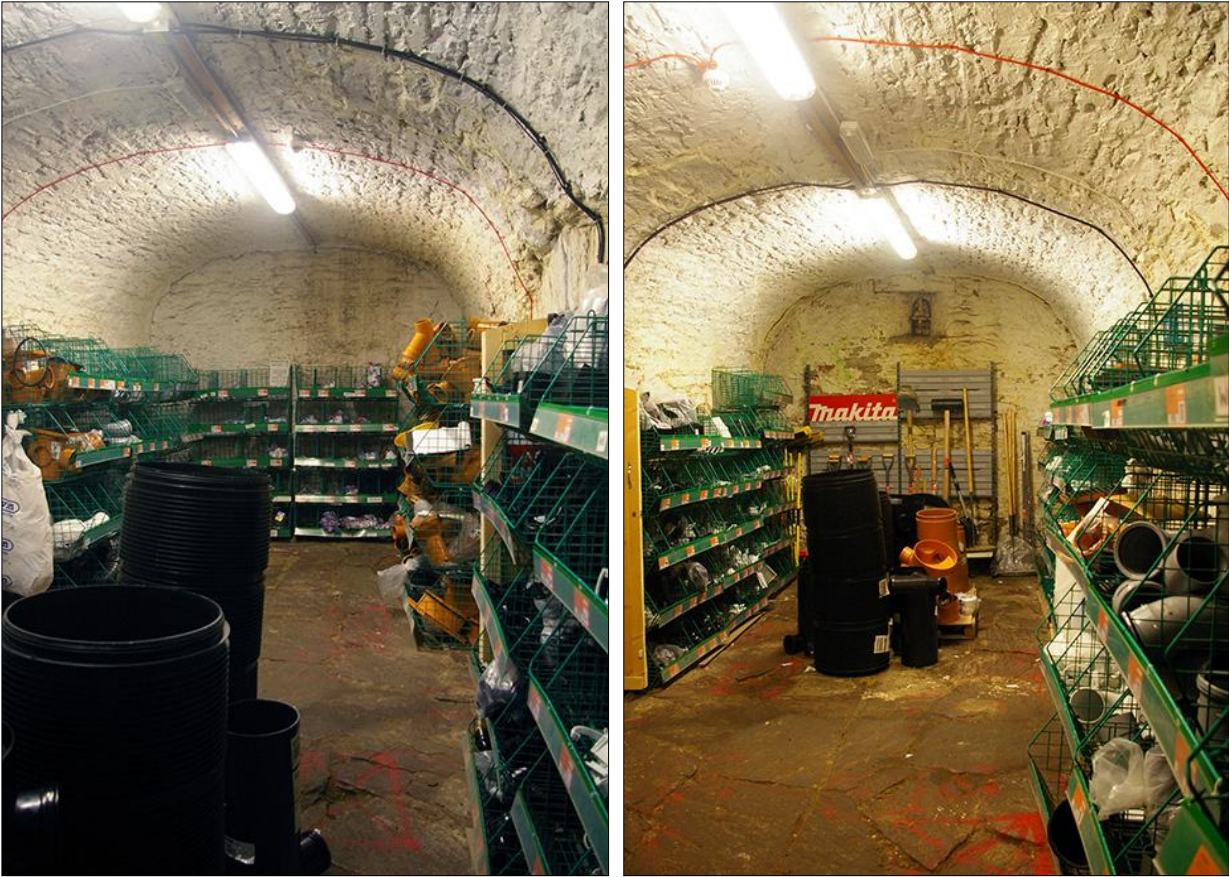
- 28. LEFT: B1 GF V2; VIEWED FROM THE WEST.
- 29. RIGHT: AS ABOVE, SHOWING BO2 AND W2 IN THE WEST WALL; VIEWED FROM THE EAST.

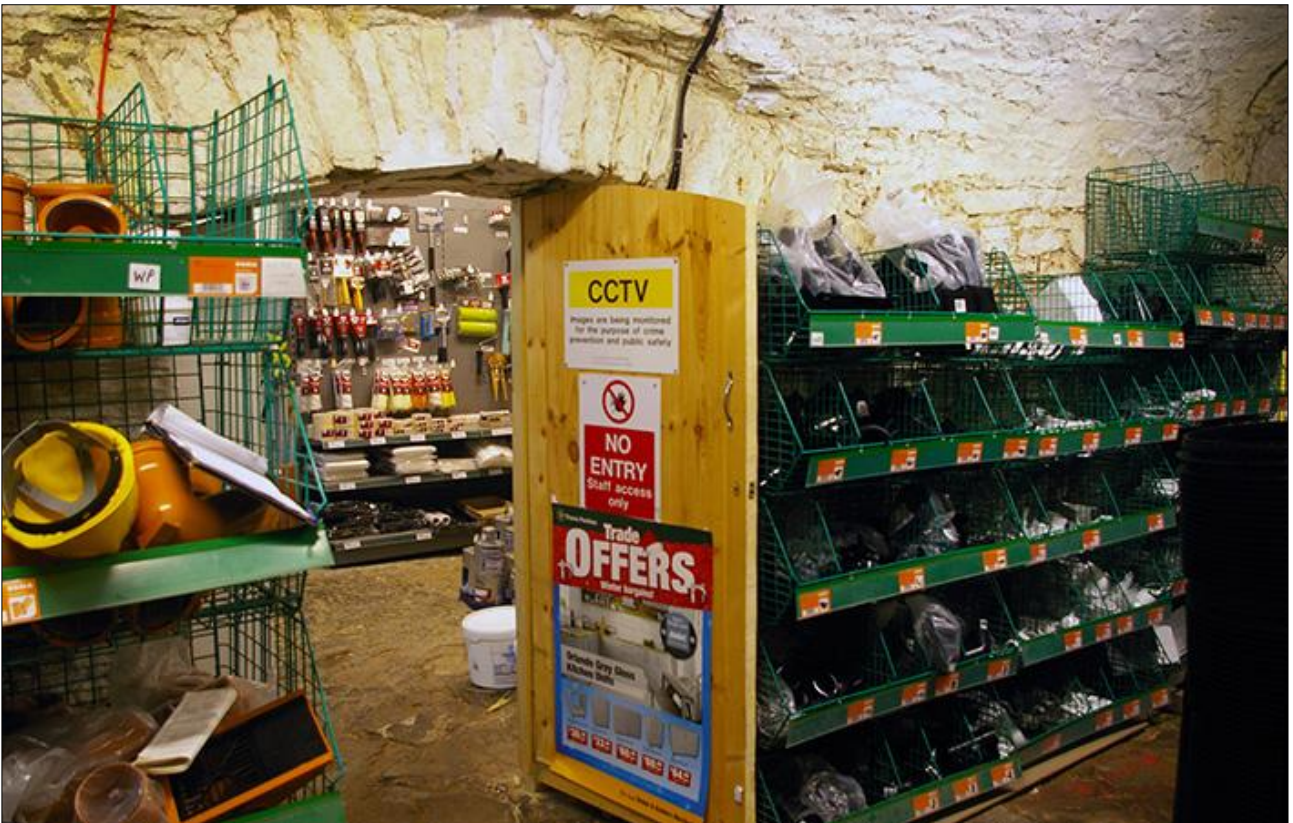
- 30. B1 GF, THE DOORWAY BETWEEN V1 AND V2 (D2/BO9); VIEWED FROM THE NORTH-EAST.

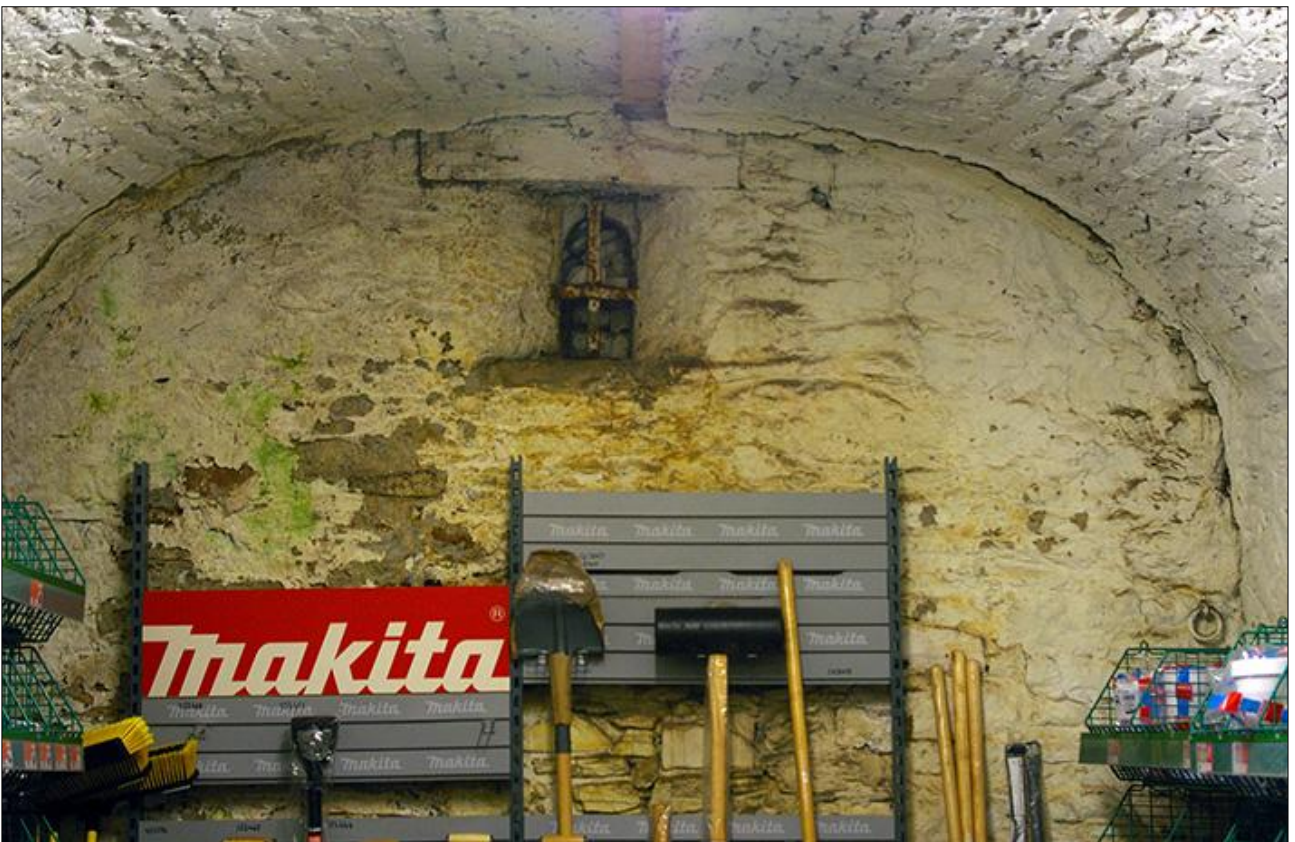
- 33. AS ABOVE; VIEWED FROM THE EAST.

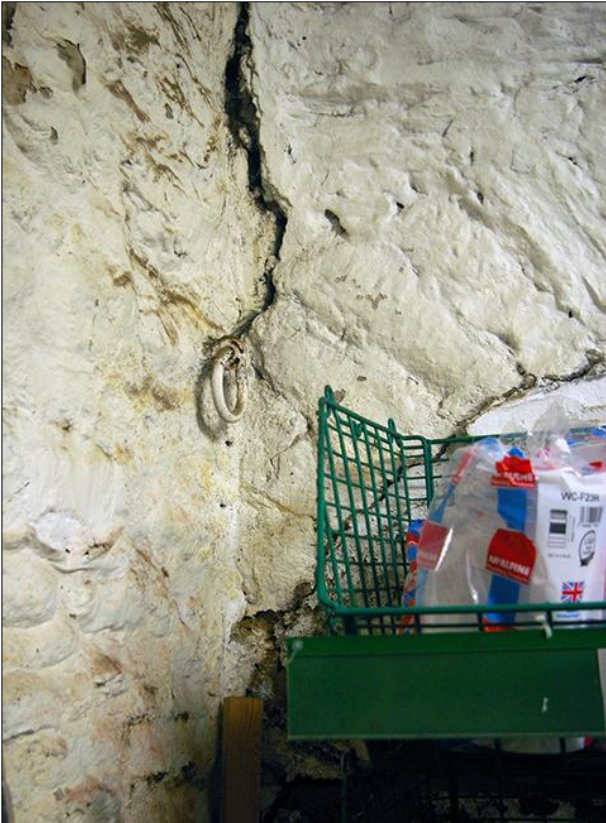
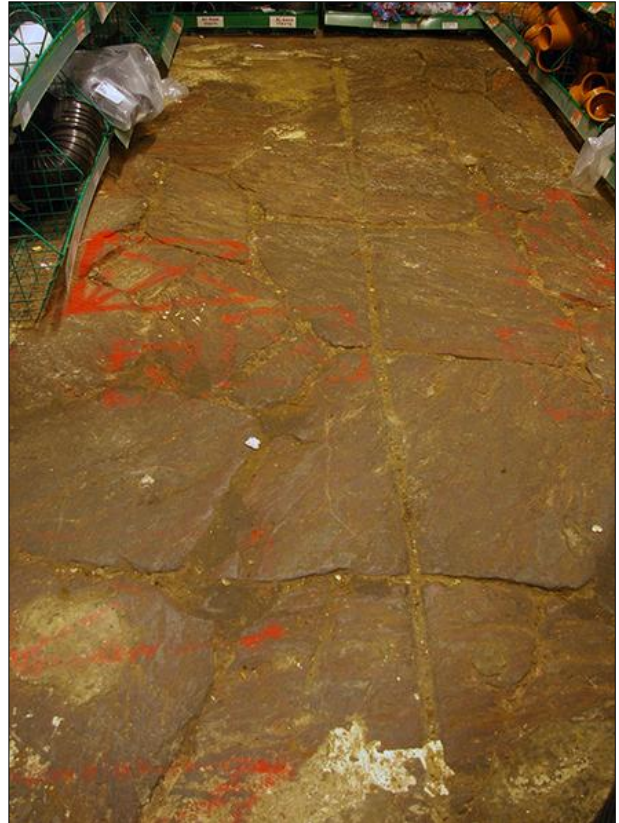
34. LEFT: B1 GF, THE SOUTH END OF V2, SHOWING THE ARCH OF BO14; VIEWED FROM THE SOUTH.
35. RIGHT: B1 GF, THE STONE SLAB FLOOR OF V2; VIEWED FROM THE WEST.

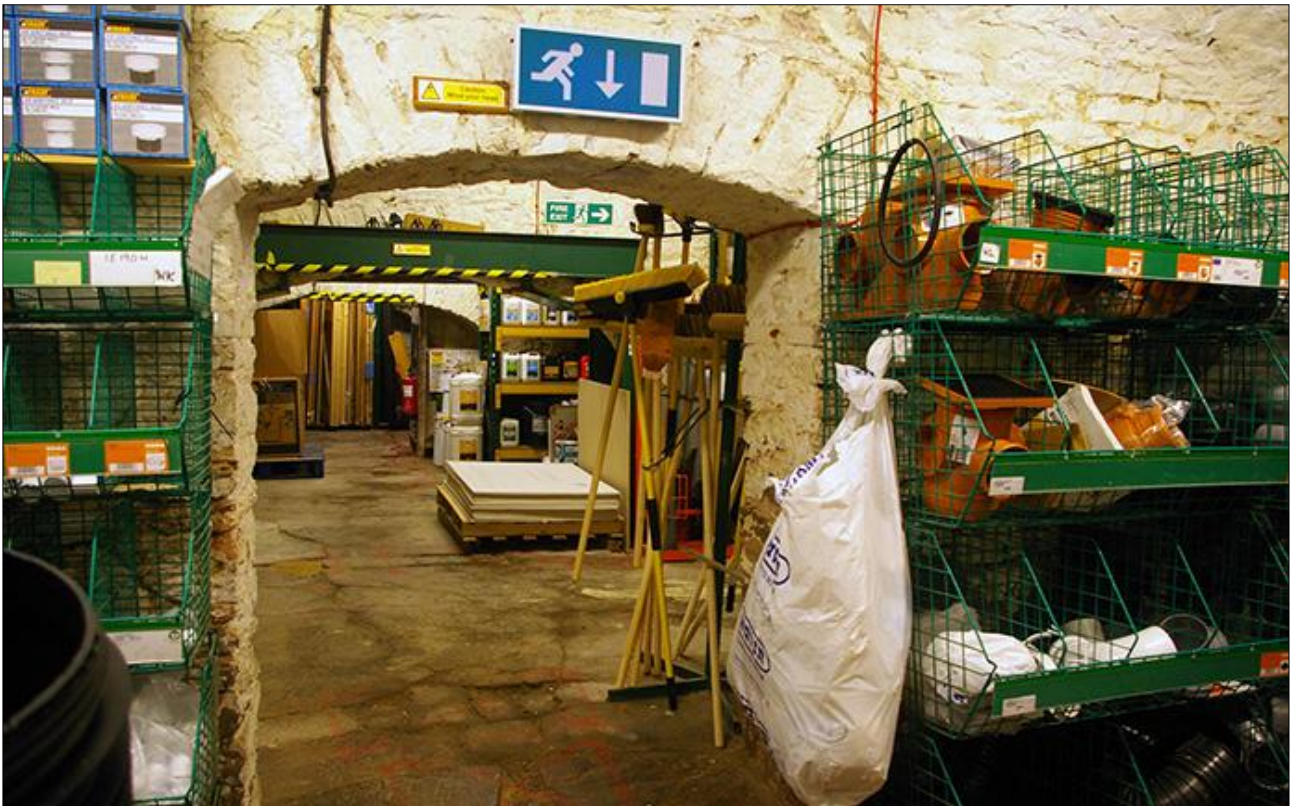
36. B1 GF, VIEW THROUGH D3/BO13 TO V3 AND V4; VIEWED FROM THE SOUTH.

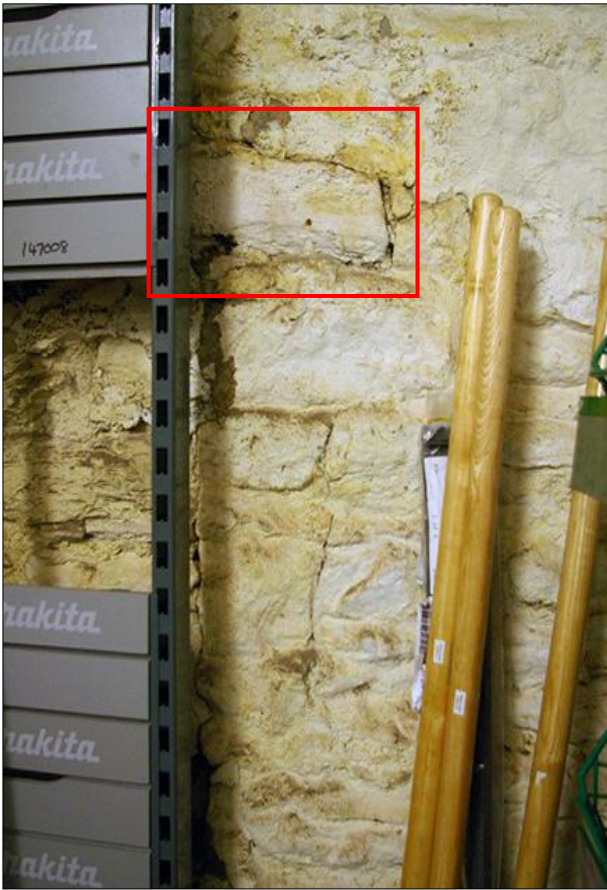
37. LEFT: B1 GF, DETAIL OF THE LINTEL (INDICATED) OVER BO2 IN V2; VIEWED FROM THE EAST.

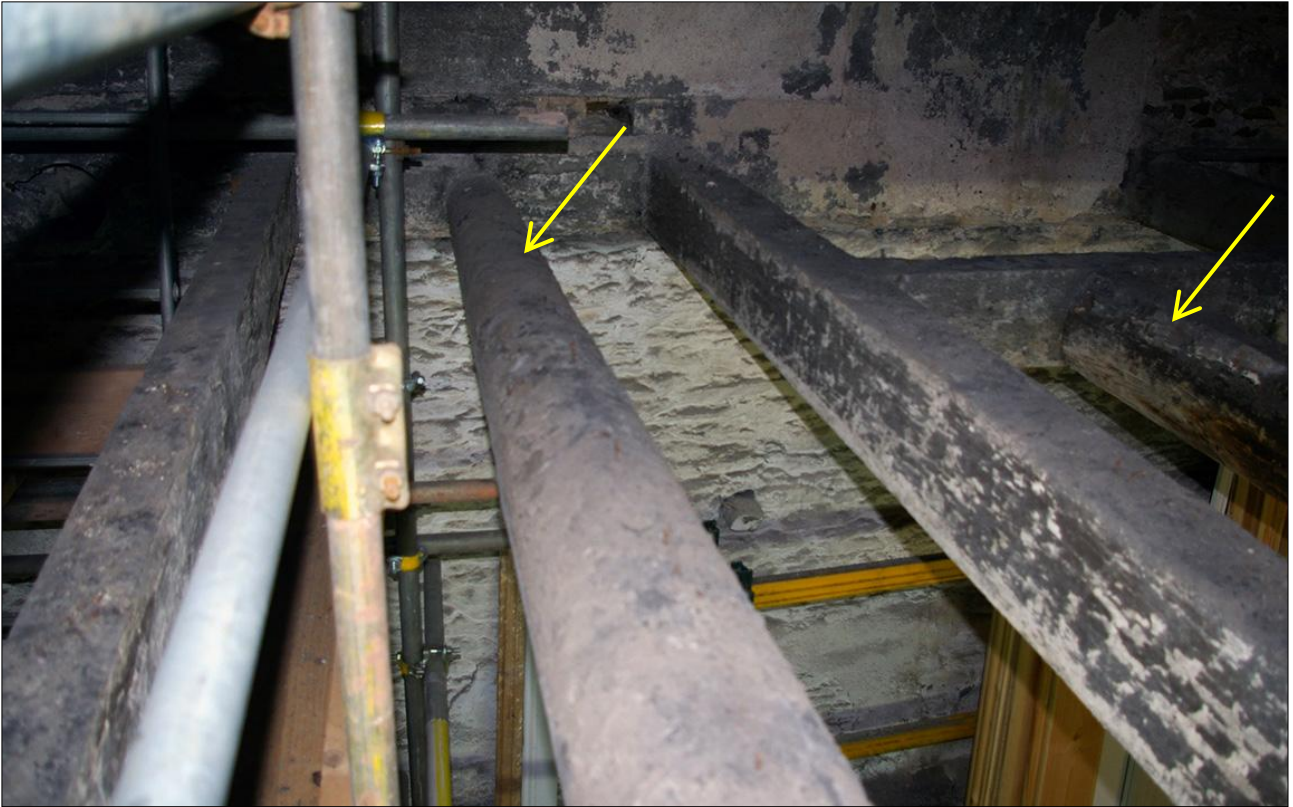
127. B2 SF INTERIOR, SHOWING THE BEAMS AND RE-USED SHIPS TIMBERS S22 (INDICATED); VIEWED FROM THE WEST.

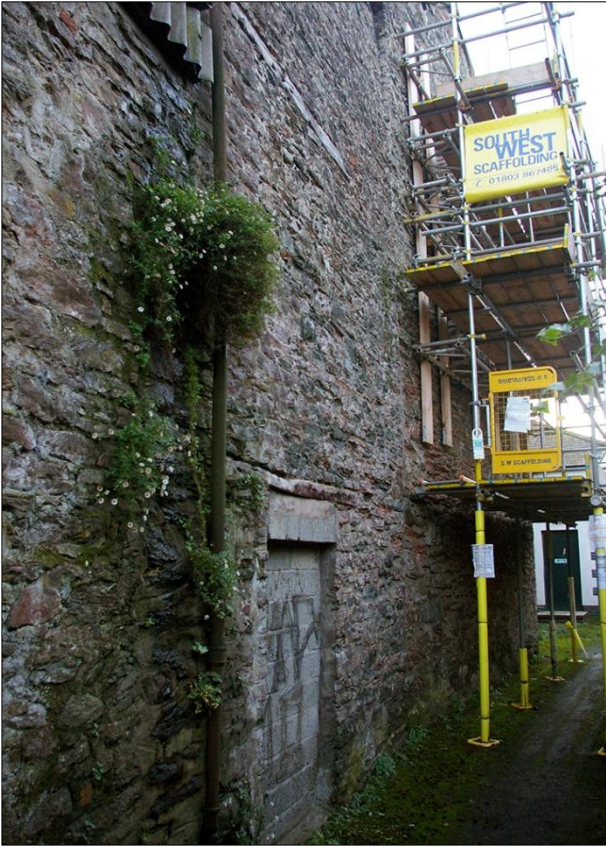
134. LEFT: THE NORTH WALL OF B3, SHOWING GF BO34 AND FF BO46; VIEWED FROM THE EAST.

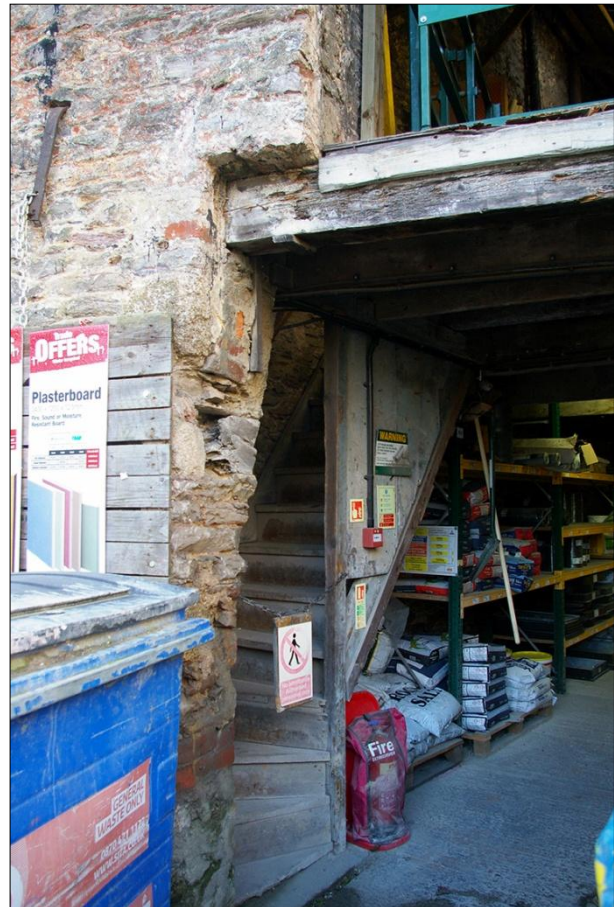
140. RIGHT: THE SOUTH ELEVATION OF B3 SHOWING THE WIDENED DOORWAY D13 WITH STAIRS (S3) BEHIND; VIEWED FROM THE SSE.

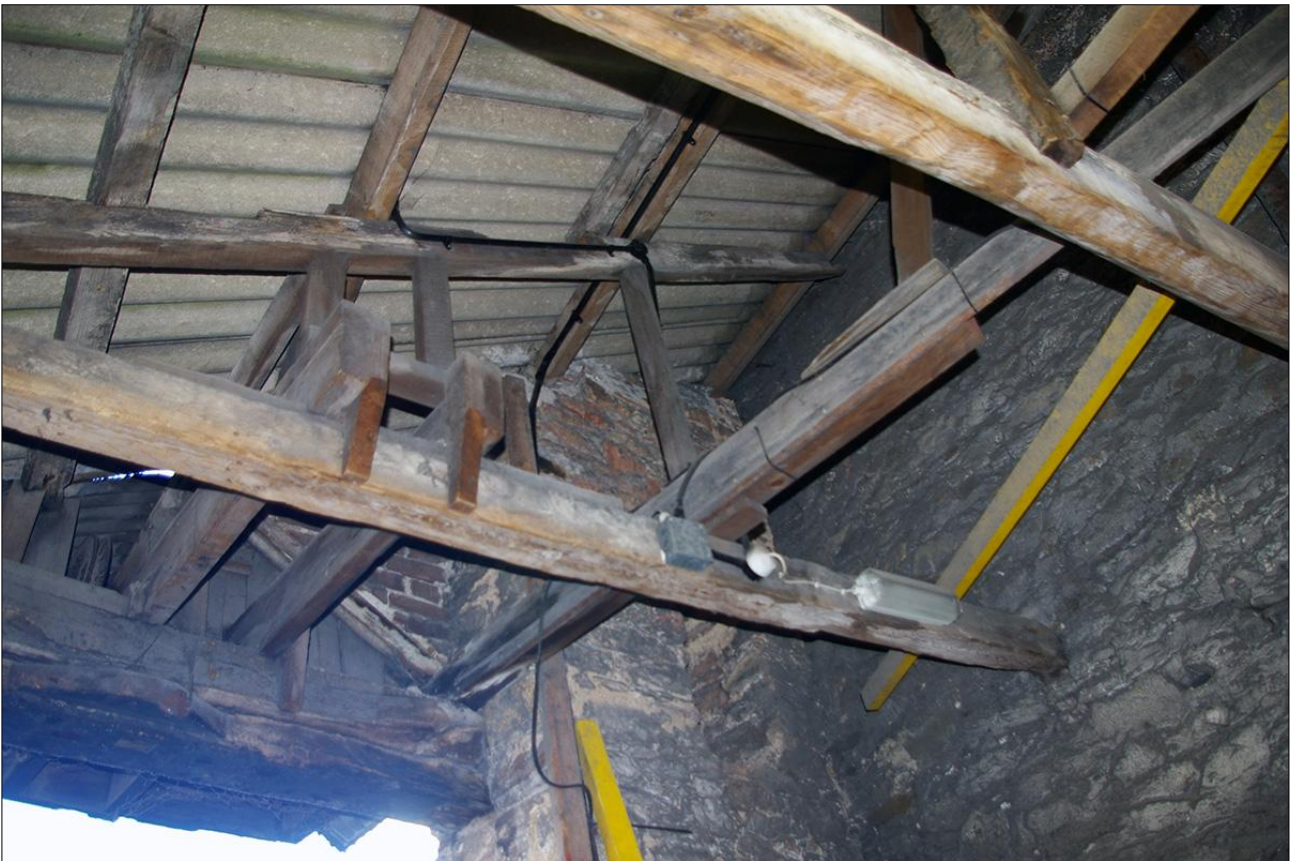
169. B3 FF INTERIOR, THE ROOF STRUCTURE OVER THE SOUTHERN END AND BEAMS FOR HOIST (S23); VIEWED FROM THE NNE.

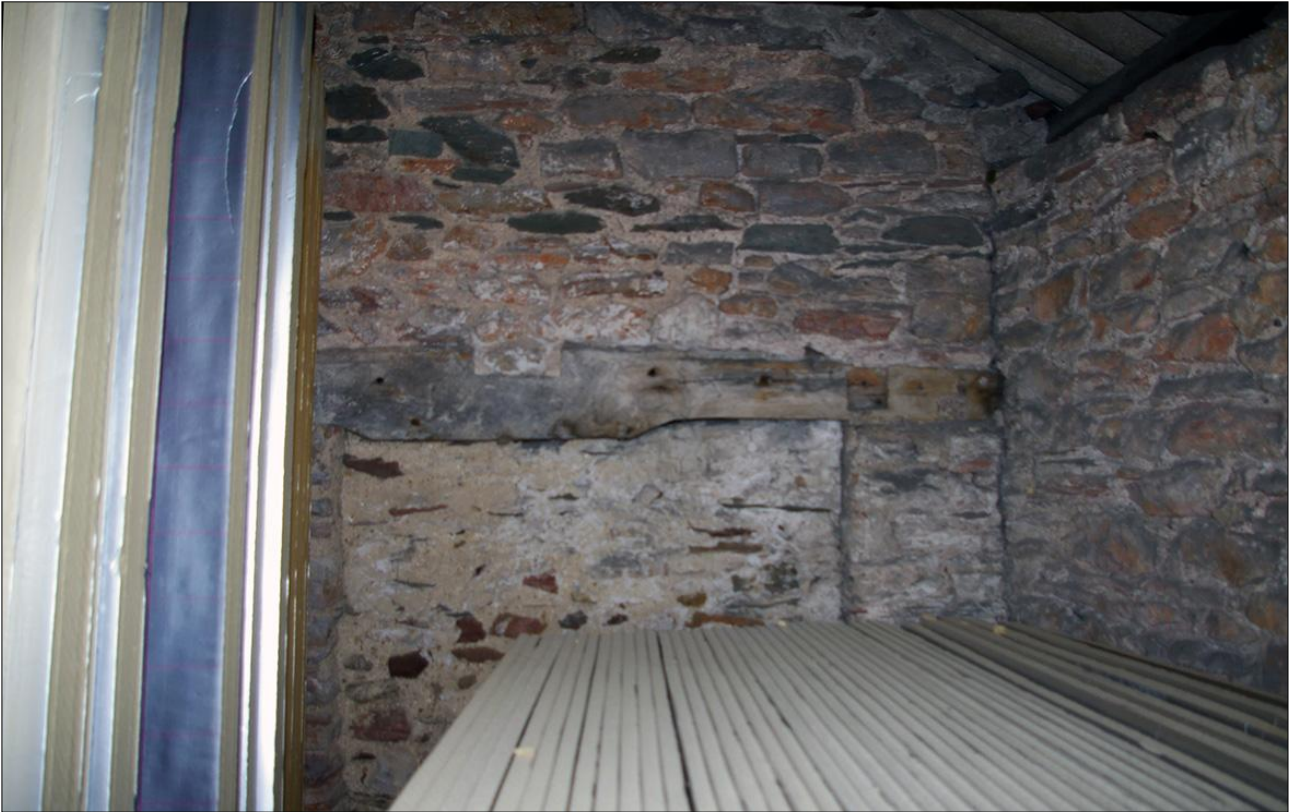
185. B3 FF INTERIOR, THE NORTH WALL SHOWING BO46 WITH UPSIDE-DOWN YOKED LINTEL; VIEWED FROM THE SOUTH.
