# EMPACOMBE HOME FARM MOUNT EDGCUMBE MAKER CORNWALL

Statement of Significance & Heritage Impact Assessment

South West Archaeology Ltd. report no. 171207

7<sup>th</sup> December 2017

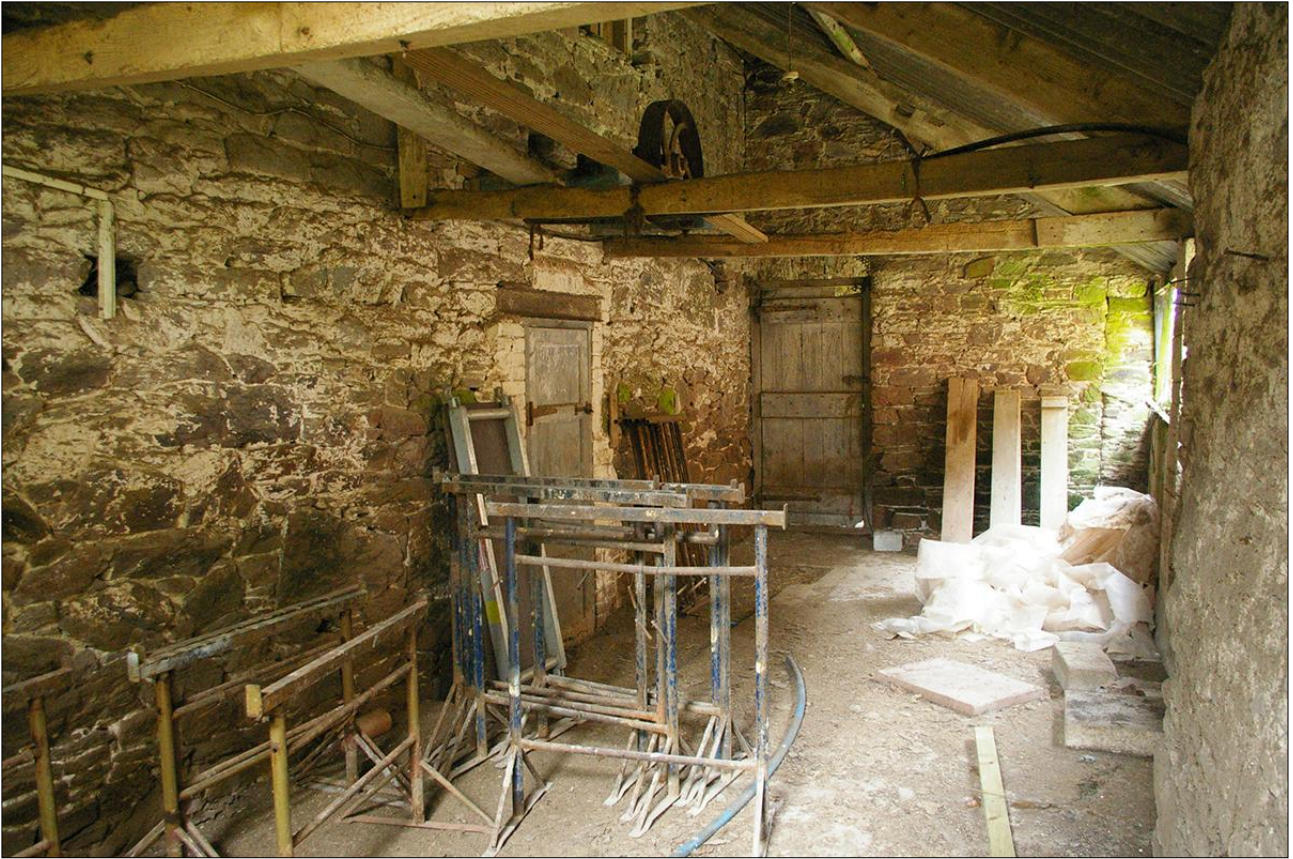
Cartsheds with access for a machine/engine to drive the flywheel in B1.5c, probably replaced with a fixed engine when the concrete block walls were built.

THE INTERIOR OF B1.5C; VIEWED FROM THE SOUTH.
