PENDREA BARNs
St BURYAN
PENZANCE
CORNWALL

Historic Building Recording

South West Archaeology Ltd. report no. 200514

14th May 2020

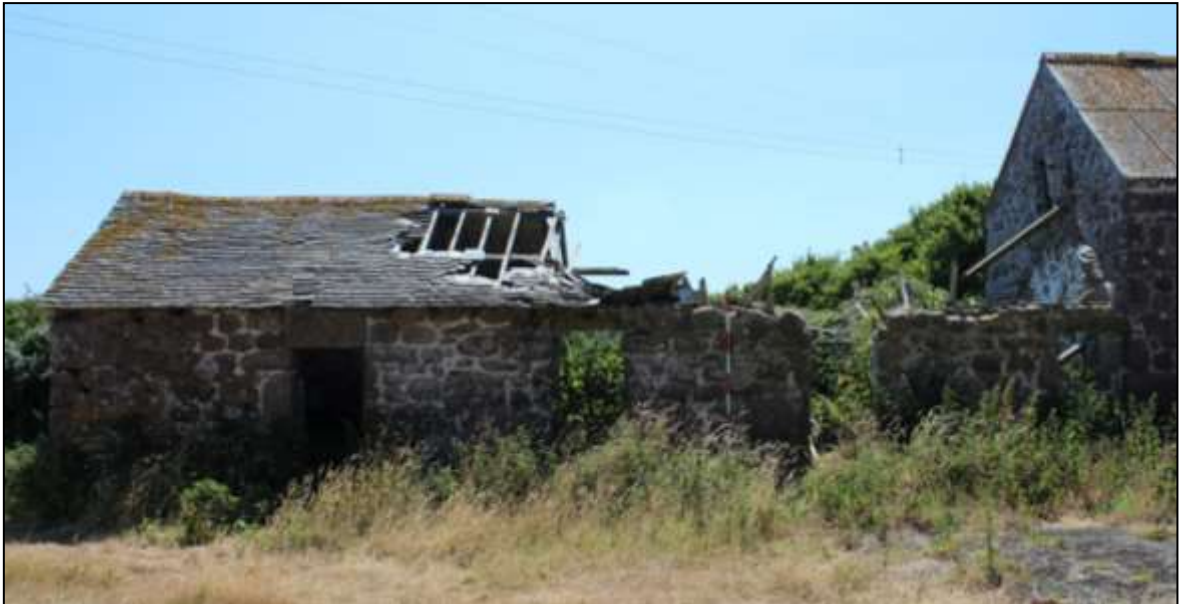
Long, low single storey pigsty, rectangular with four internal cells. Very vernacular in appearance, built in the local granite rubble, stones massive and of irregular form, natural boulders used as quoins, south-east side wall partly collapsed. Shallow-pitched ridged slate roof, gabled to north-east, south-western half has fallen in. Slates of graduated size, terracotta ridge tiles with raised integral air vents. The north-west (front) elevation has four small doorways to individual pig pens inside. The north-east gable end wall is blind, while the south-east side wall contains three further doors, possibly for feeding. The roof is carried on A-frame roof trusses with halved, nailed joints, blades crossed to apex, supporting ridgepole; single purlin each side on backs of blades, five common rafters per bay with slates nailed to laths and torched with cream plaster to underside, all then limewashed. Walls whitewashed internally, three individual pens and a larger farrowing pen to the north-east end, divided by large upright granite slabs, each pen having its own wooden manger with angled hayrack above; that in farrowing pen is the best preserved.

FIGURE 7: B1; NORTH-WEST ELEVATION; VIEWED FROM THE NORTH-WEST (SCALE 2M).

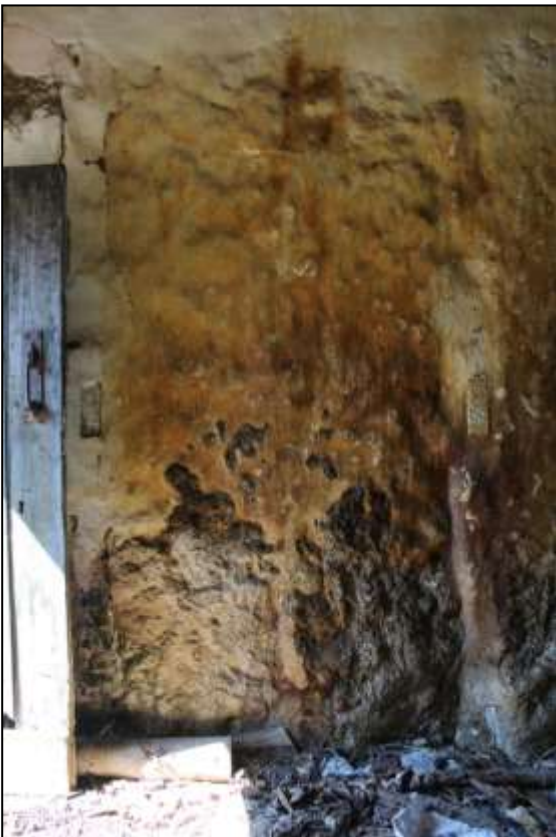
152. LEFT: B5 INTERIOR, THE SOUTH-WEST WALL COMPRISED OF GRANITE ORTHOSTATS; VIEWED FROM THE EAST.
