# ASHREIGNEY METHODIST CHAPEL

HISTORIC BUILDING RECORDING

SOUTH WEST ARCHAEOLOGY LTD. REPORT NO. 181102

*South West Archaeology Ltd. was commissioned to undertake historic building recording for the Ashreigney Methodist Chapel. This work was undertaken in advance of the conversion of the building to a residential property.*

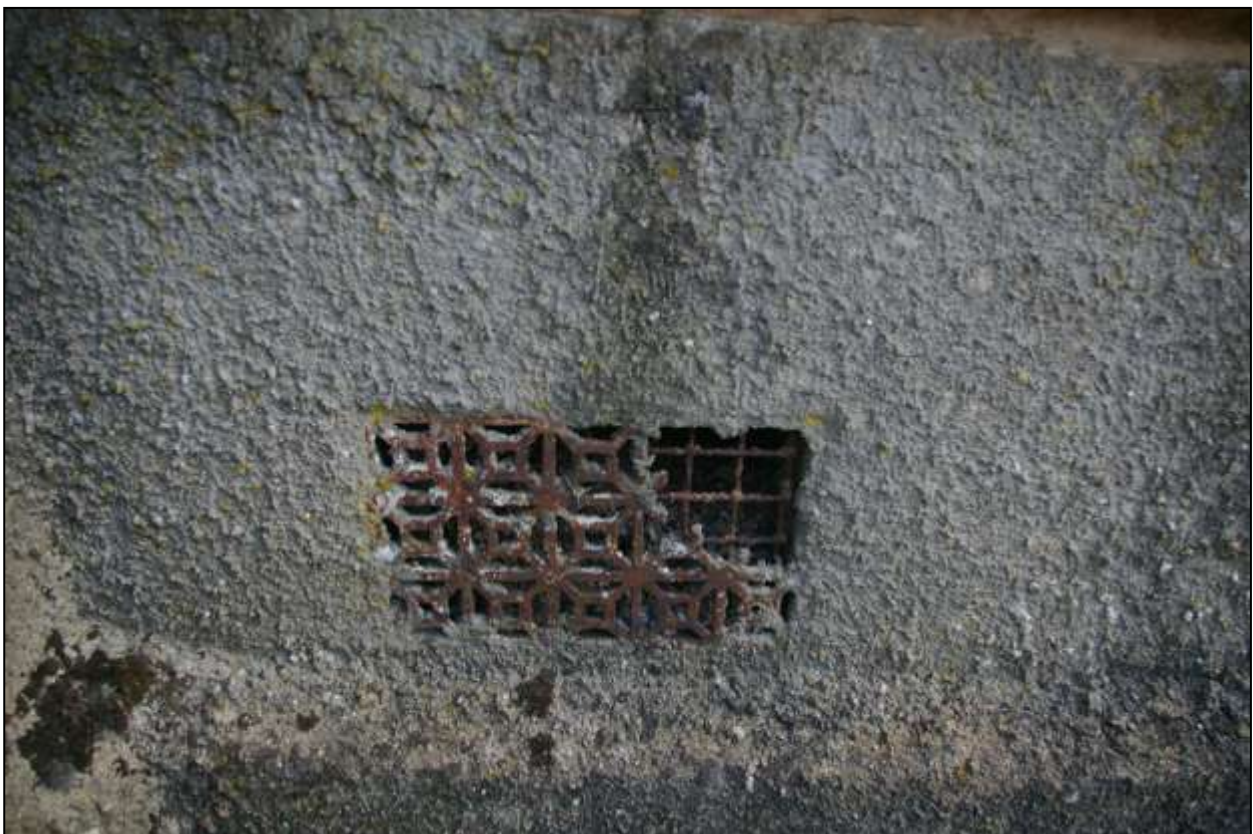
- The original air vents to the west wall have been replaced with modern plain grills, a noticeable style change to the plain plastered walls.
- The pulpit has been brought forward to incorporate the organ, which was obviously a later addition, with lots of modern woodwork, dated 1995, installed beneath and around the pulpit to brace the floor for the heavier weight.

3. ONE OF THE STONWARE AIR VENTS ON THE WEST ELEVATION; FROM THE SOUTH-WEST.

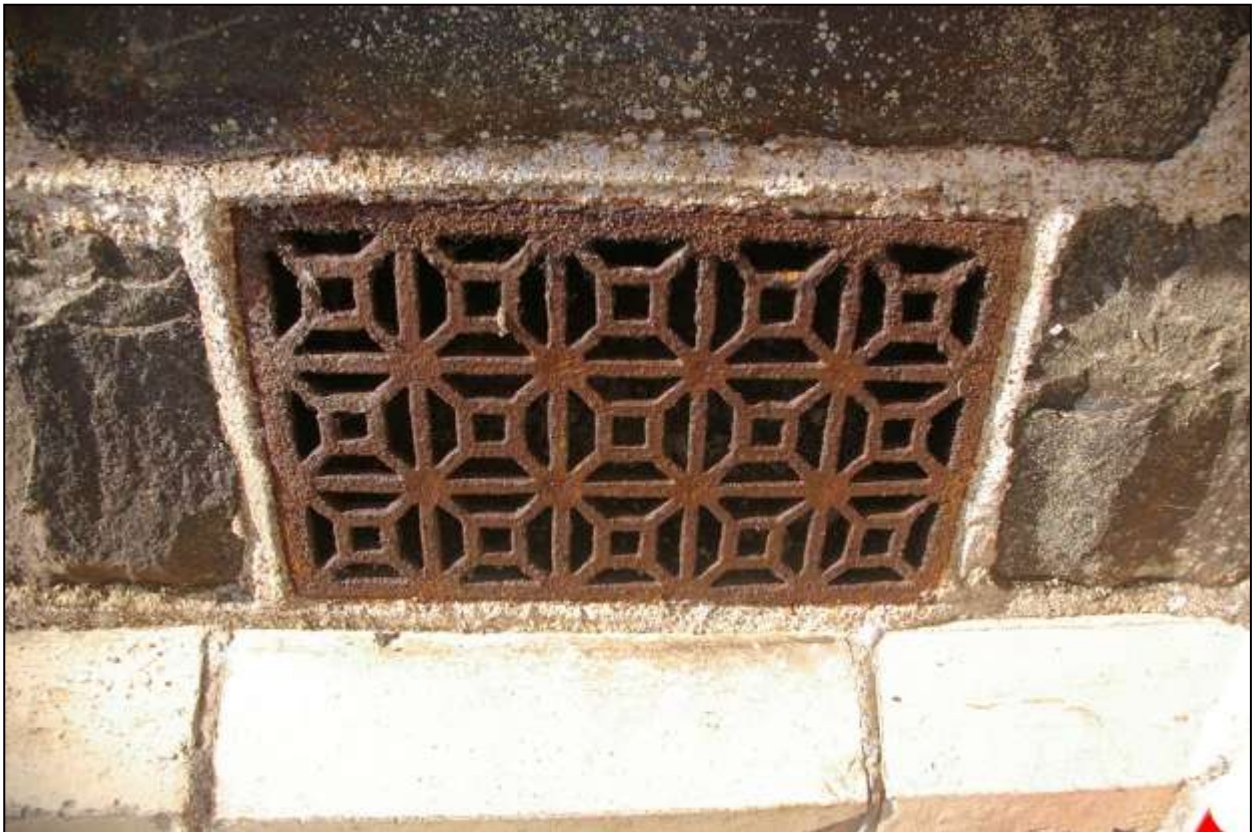
11. THE IRONWORK GRILLS TO THE AIR VENTS ON THE EAST WALL OF THE CHAPEL; FROM THE NORTH-EAST.

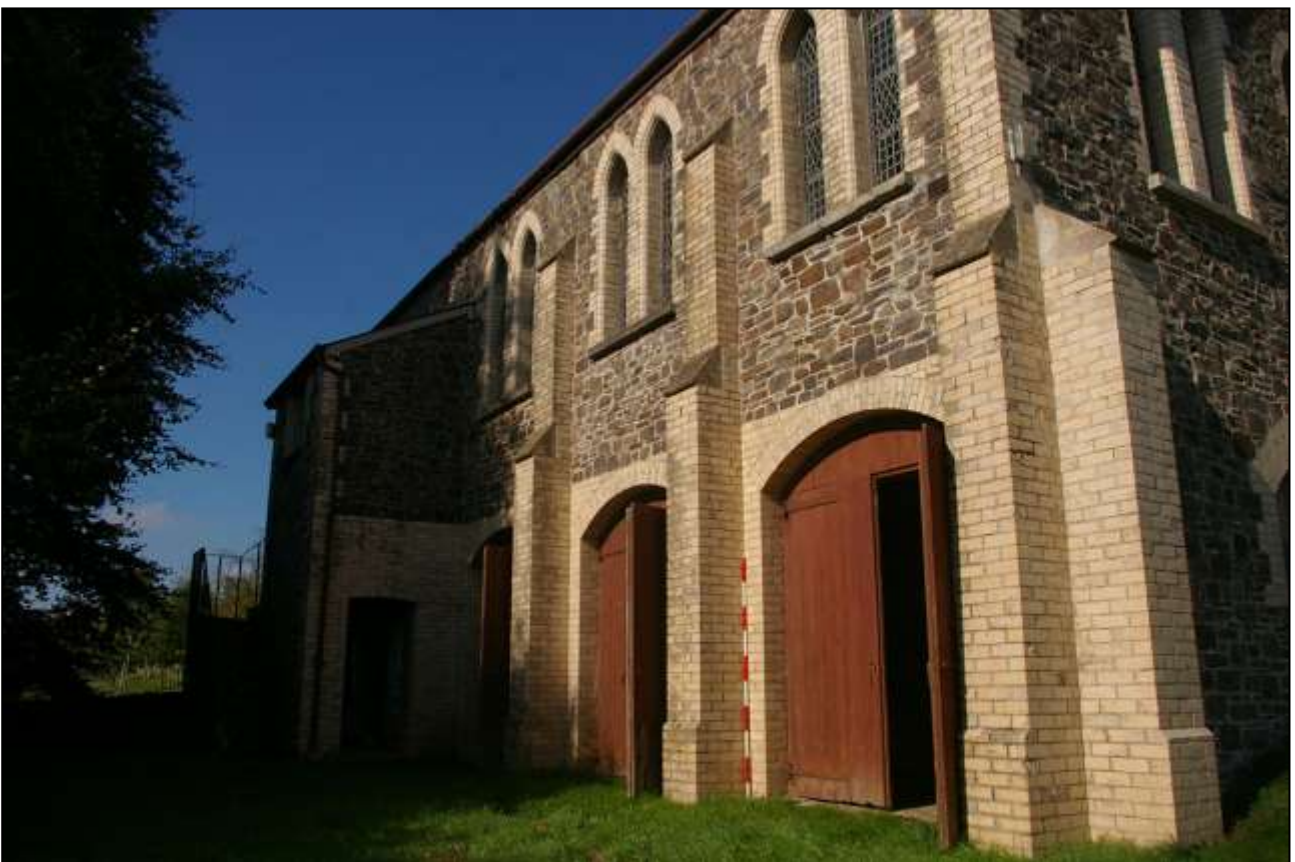
22. THE SOUTH ELEVATION OF THE CROSSWING, SHOWING SUBTLE DIFFERENCES IN BUILD, SUCH AS BRICK BUTTRESSES AND LOWER GROUND FLOOR; FROM THE SOUTH-EAST.

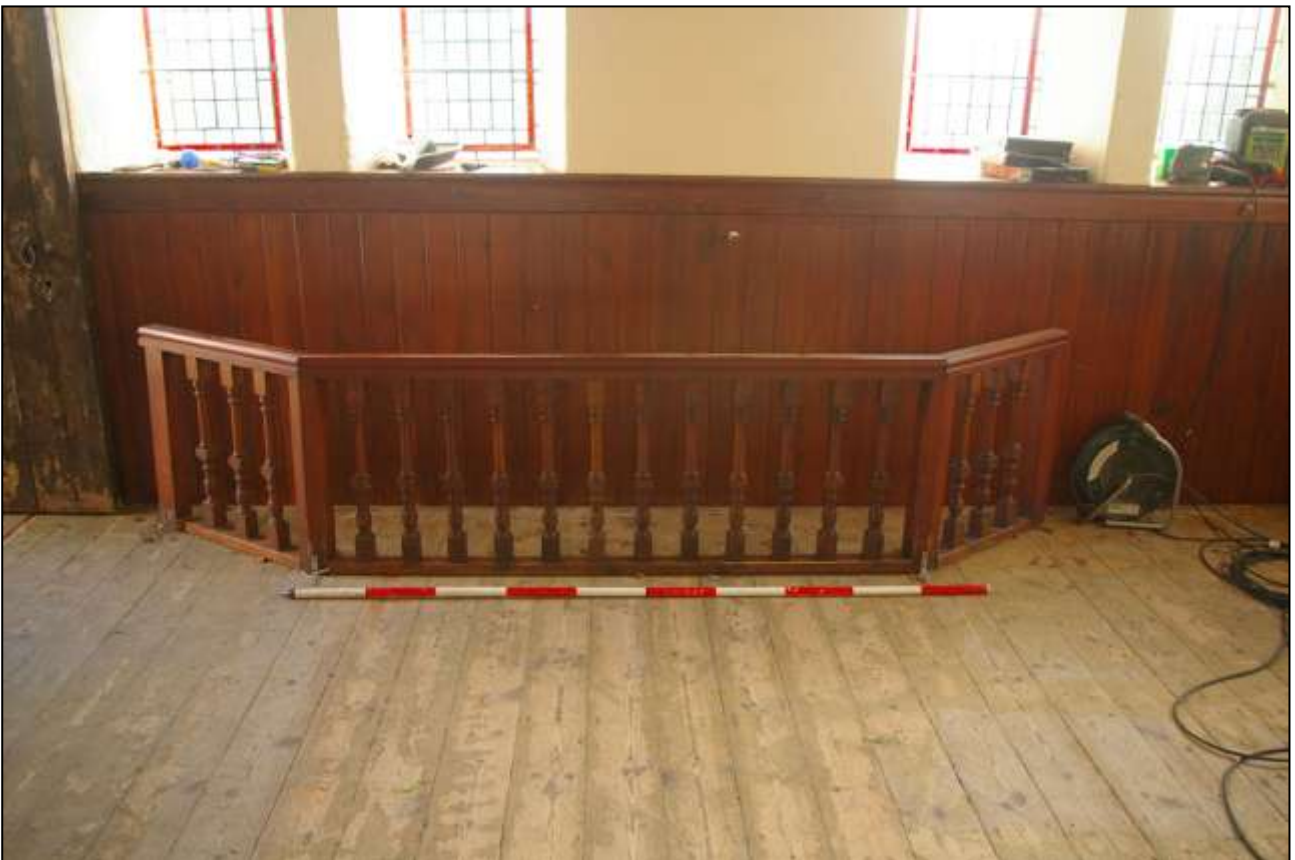
73. THE REMOVED COMMUNION RAIL, WITH 2M SCALE; FROM THE WEST.

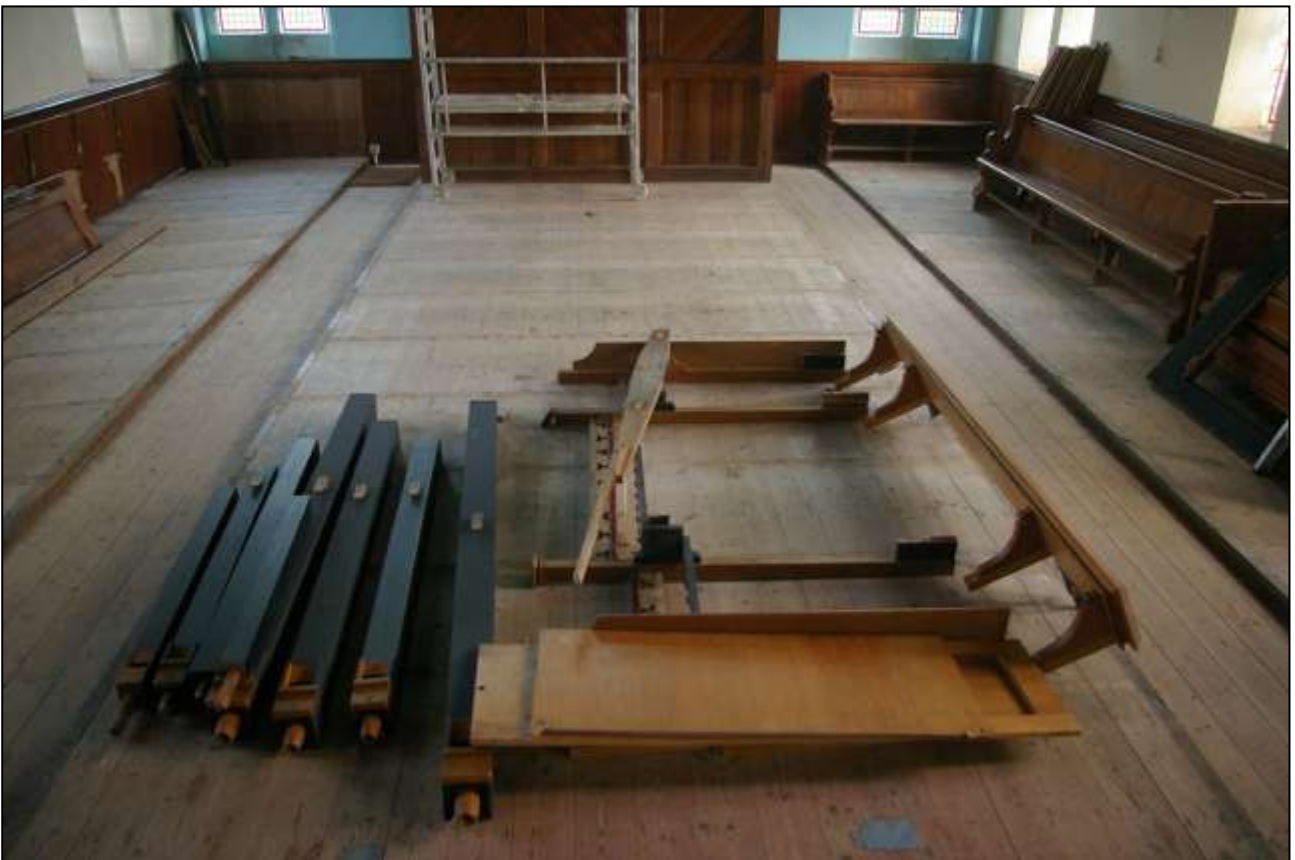
75. PIECES OF THE DISMANTLED ORGAN; FROM THE SOUTH.

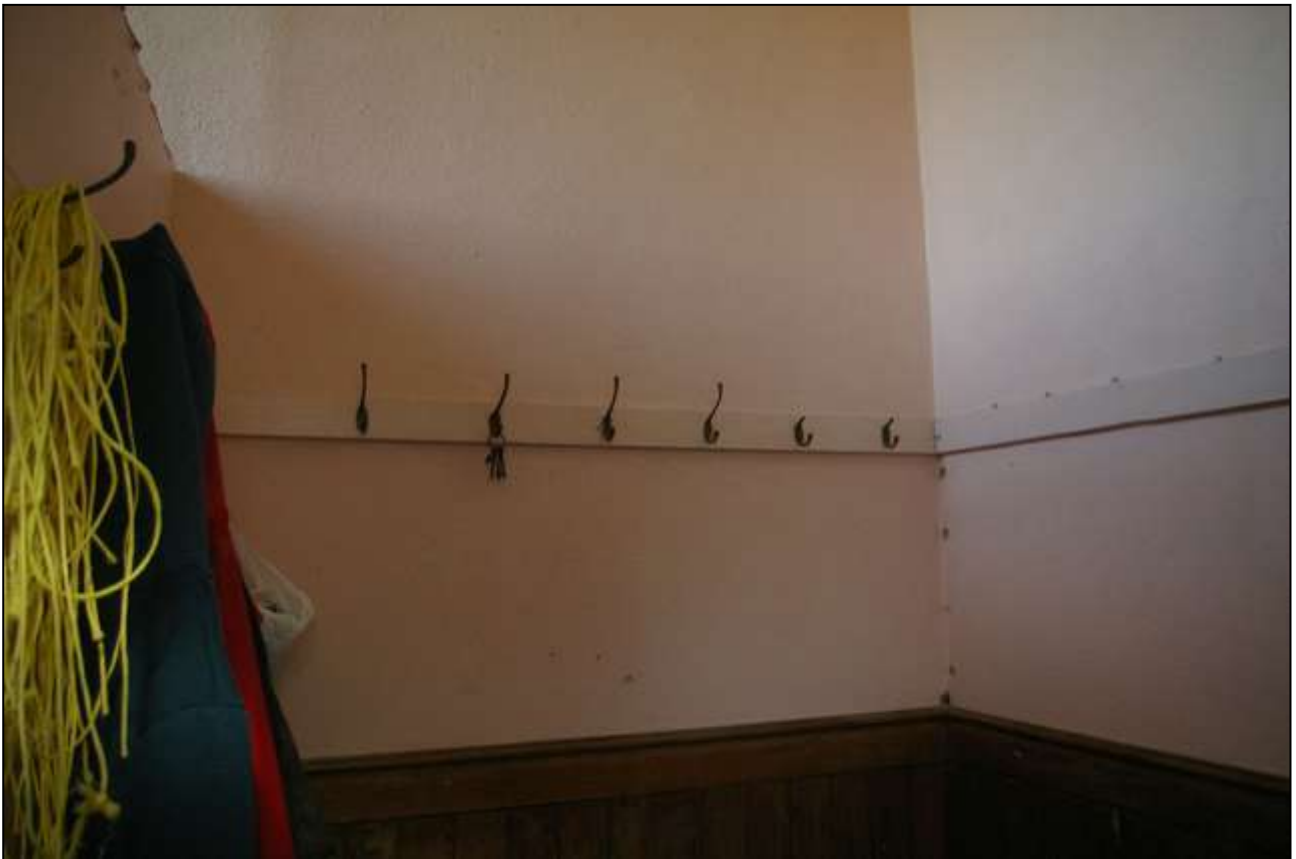
116. THE EVEN LATER PARTITION FORMING A LADIES TOILET CUBICLE; FROM THE SOUTH-EAST.
