# TRELEW FARM MYLOR CORNWALL

Historic Building Recording

South West Archaeology Ltd. report no. 180910

## Trelew Farm, Mylor, Cornwall Historic Building Recording

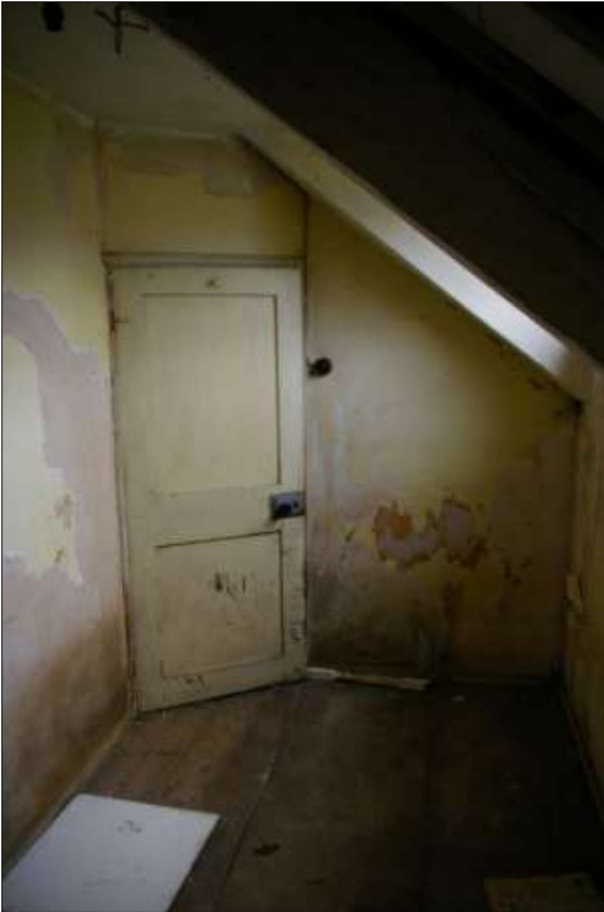
LEFT: R9 AND DF1; VIEWED FROM THE NORTH.

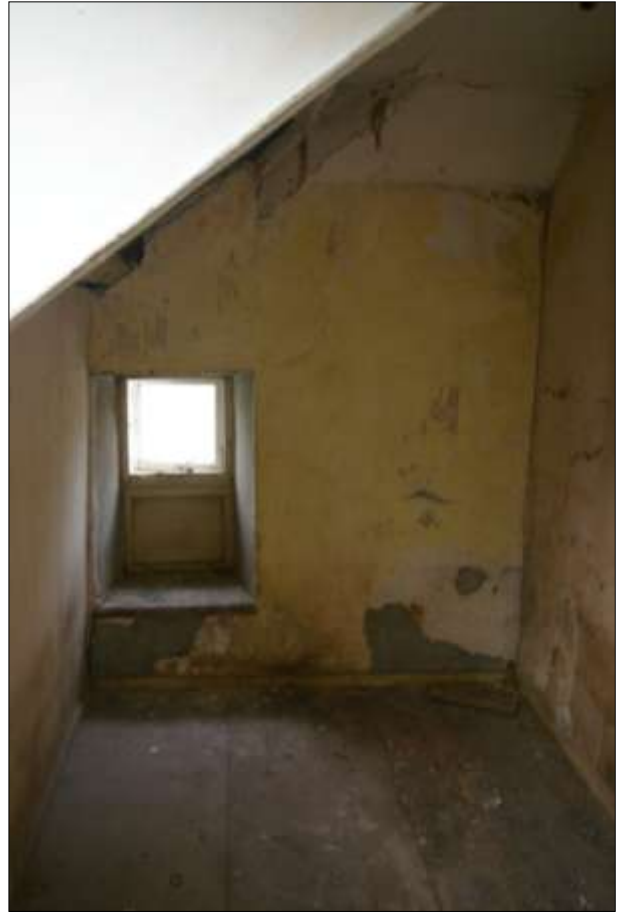
RIGHT: THE NORTH END OF R9, WITH WF8; VIEWED FROM THE NORTH.

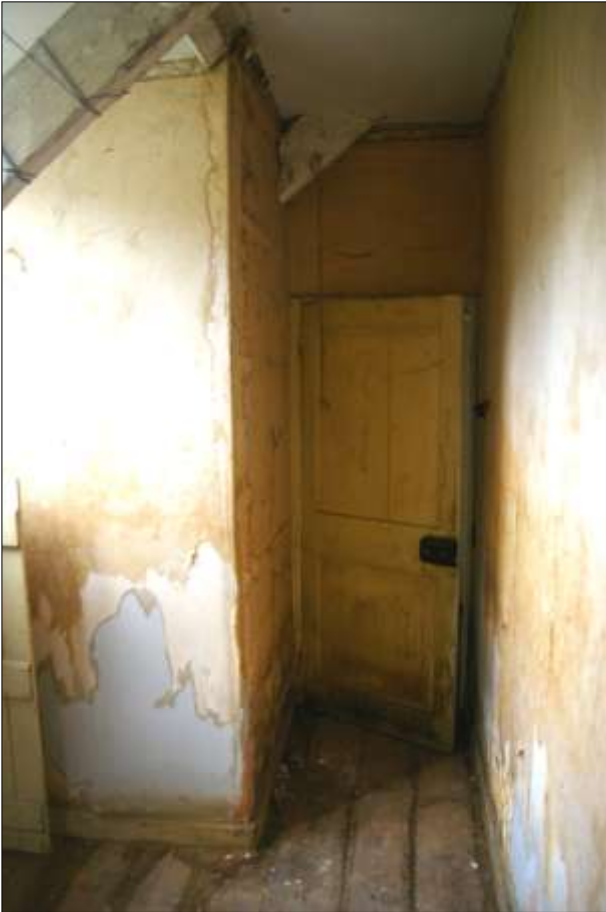
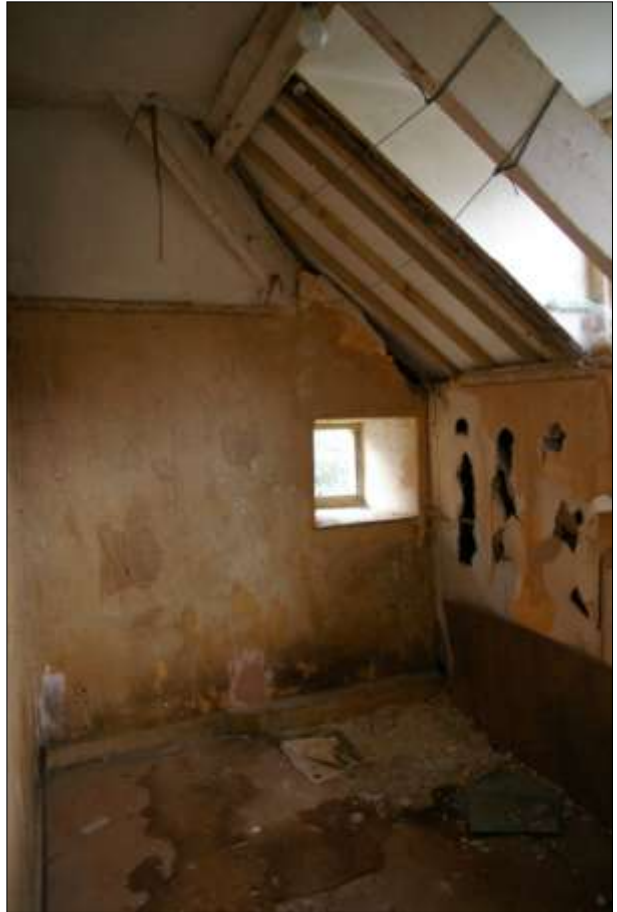
LEFT: R10, SHOWING DF4 AND THE WALL AROUND THE STAIRWELL; VIEWED FROM THE SOUTH.  
RIGHT: R10, SHOWING WF4; VIEWED FROM THE NORTH.

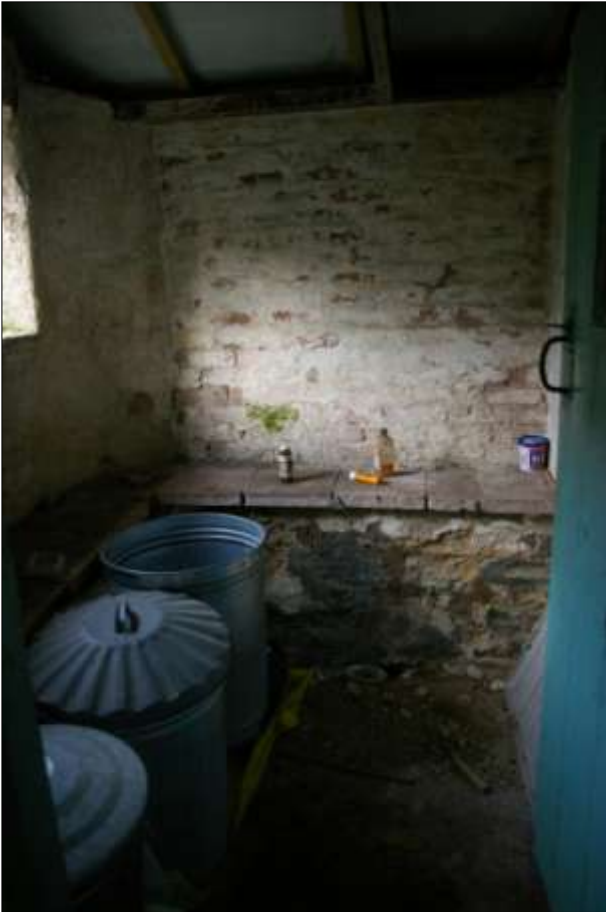
R11, SHOWING THE PLINTH WITH QUARRY TILES; VIEWED FROM THE SOUTH.

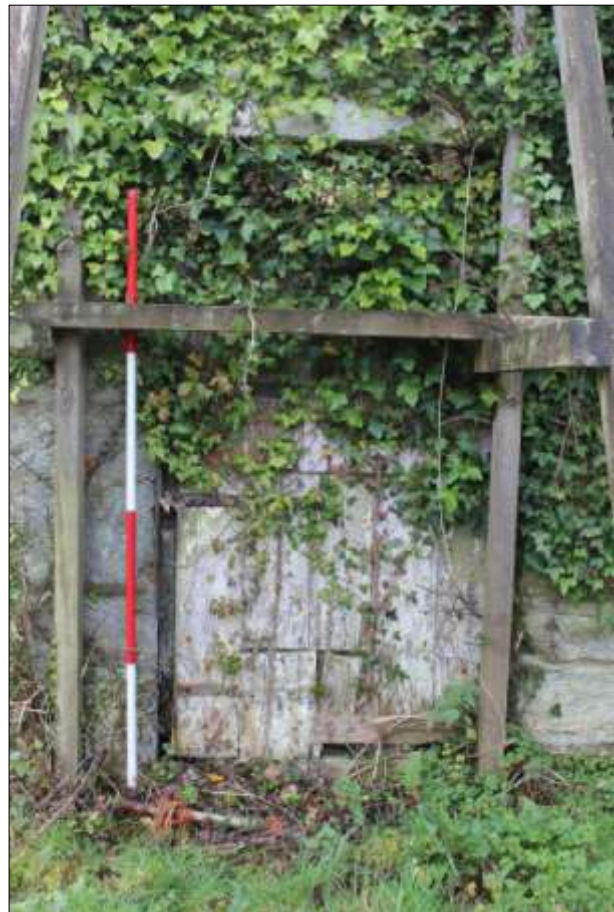
RIGHT: DOORWAY D1; VIEWED FROM THE NORTH (SCALE 2M).

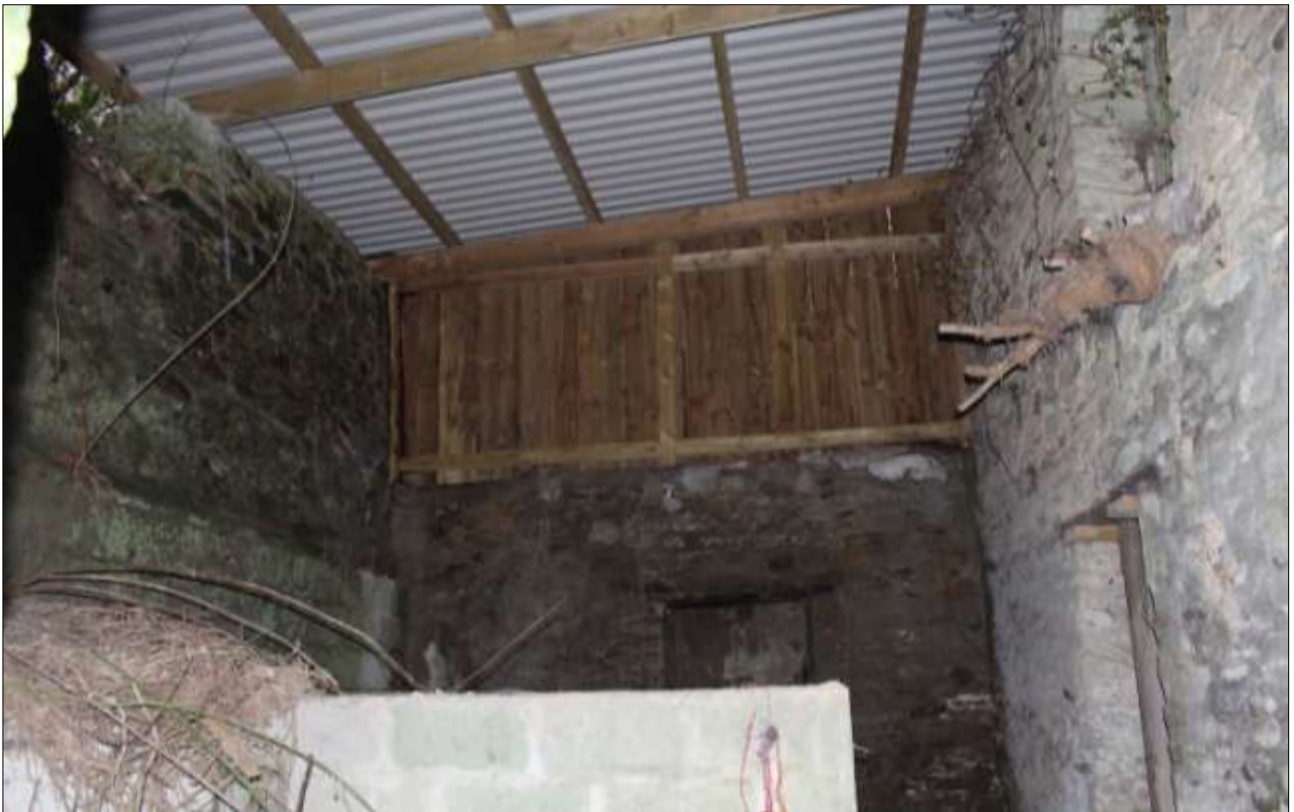
THE INTERIOR OF FB1; VIEWED FROM THE EAST.

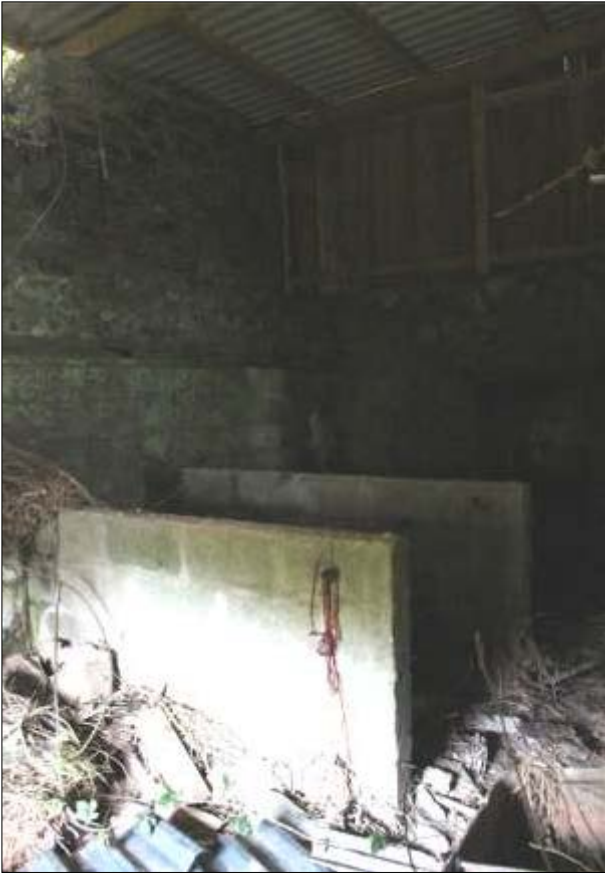
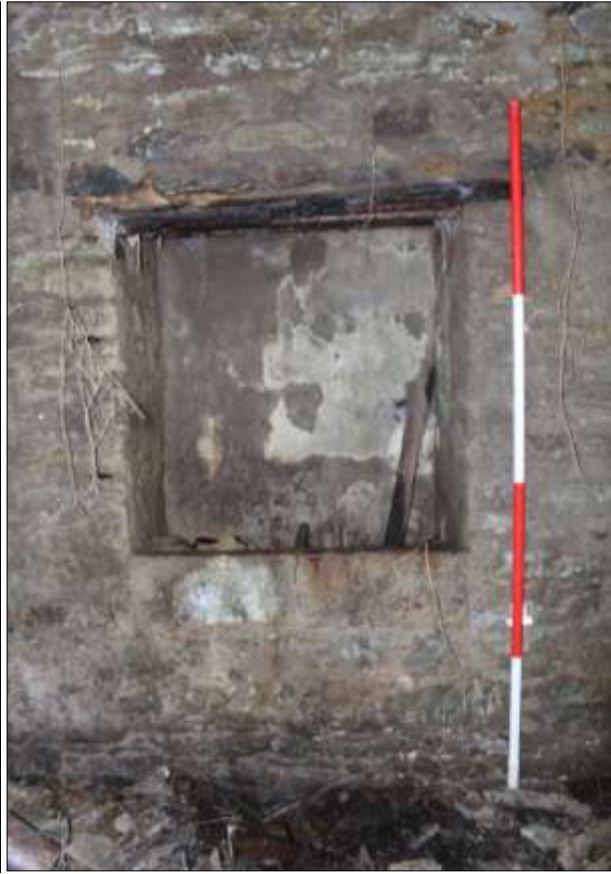
LEFT: THE INTERIOR OF FB1 SHOWING THE CONCRETE PARTITION WALLS; VIEWED FROM THE ENE.  
RIGHT: BO1 IN FB1; VIEWED FROM THE EAST (SCALE 2M).

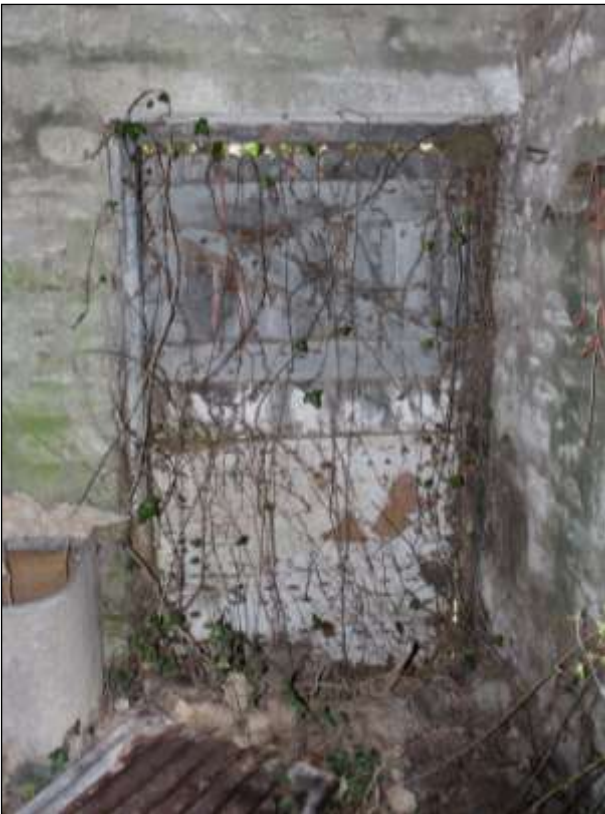
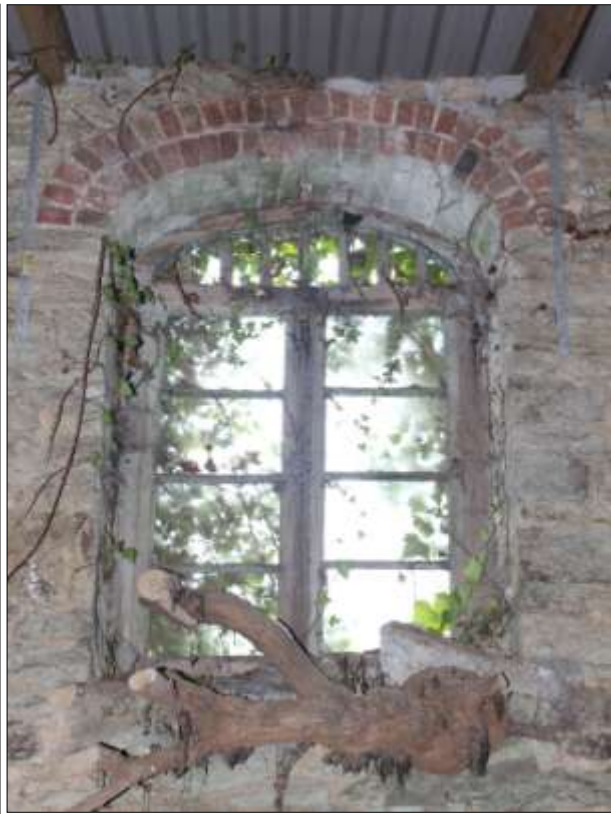
LEFT: D1 IN FB1; VIEWED FROM THE SOUTH.  
RIGHT: D9 IN FB1; VIEWED FROM THE SOUTH.

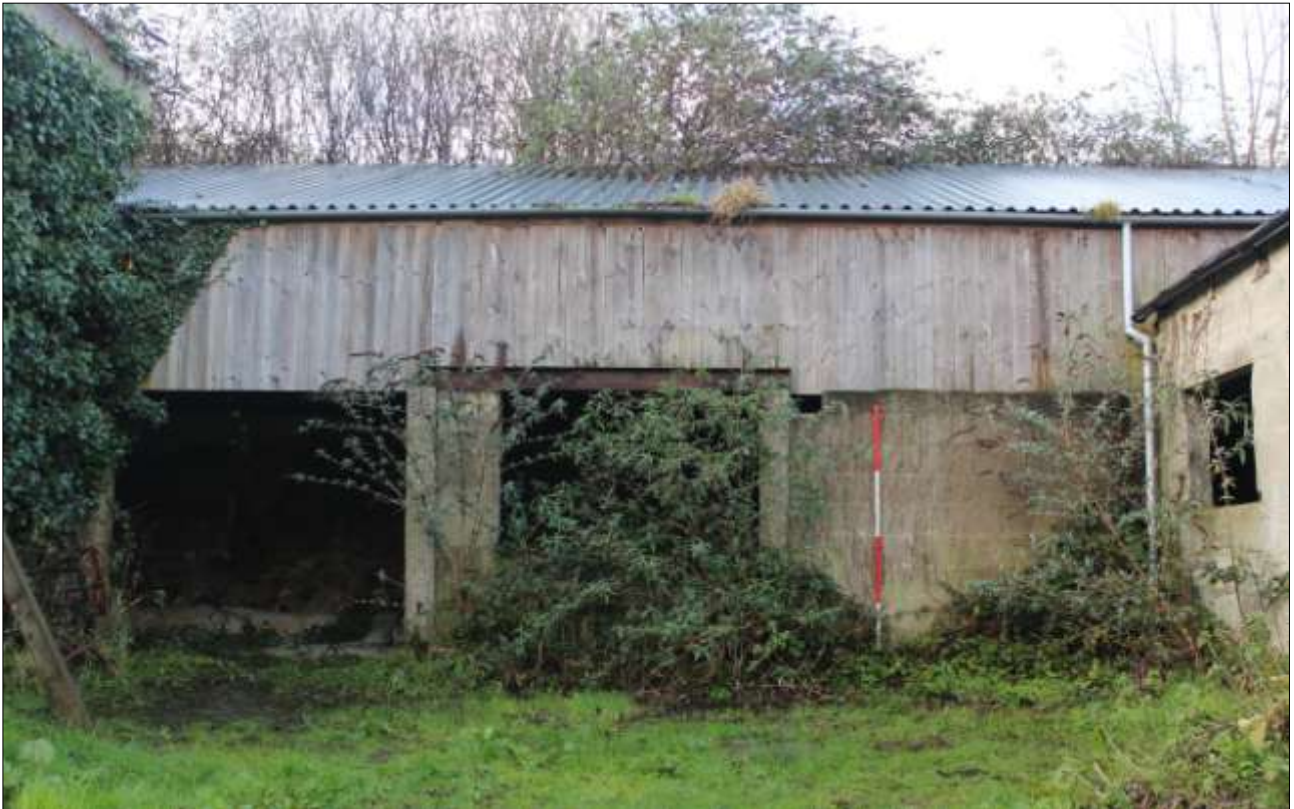
THE EAST ELEVATION OF FB2; VIEWED FROM THE EAST (SCALE 2M).

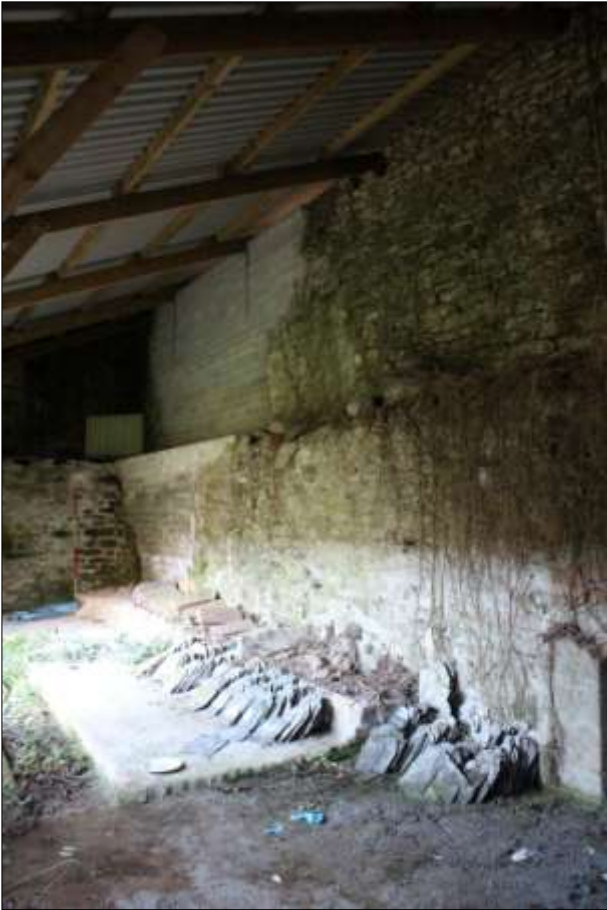
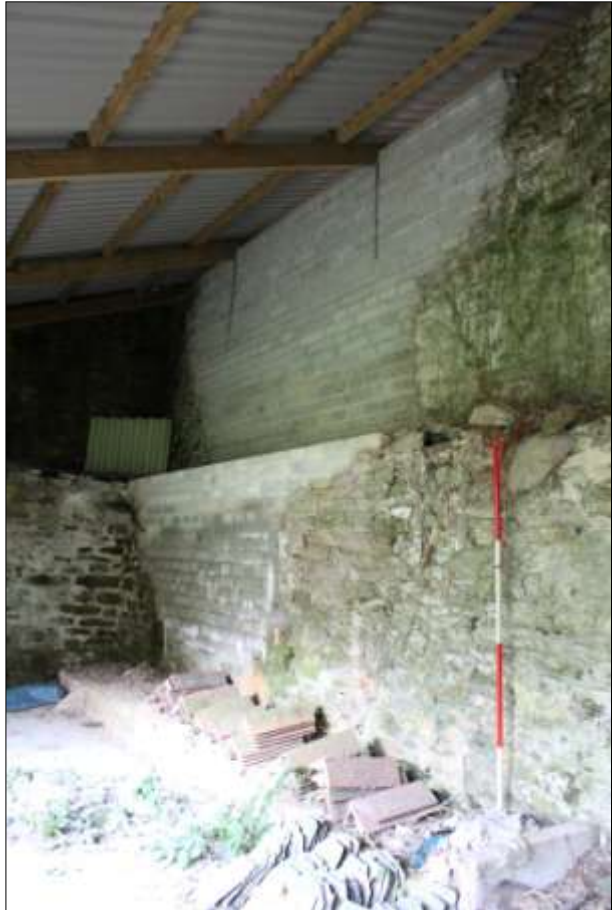
LEFT: THE BACK (WEST) WALLS OF B2A; VIEWED FROM THE NORTH-NORTH-EAST (NO SCALE).  
RIGHT: AS ABOVE (SCALE 2M).

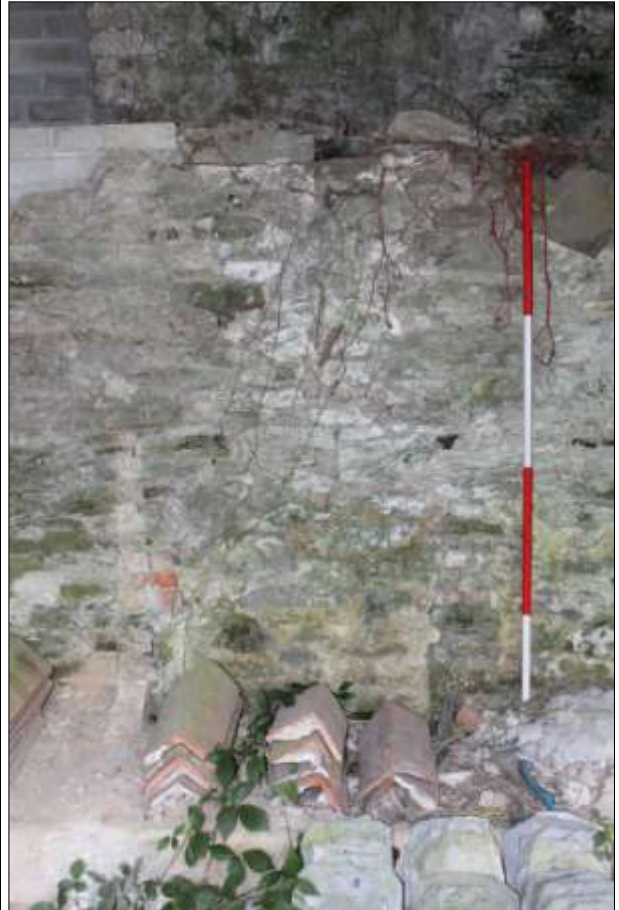
RIGHT: BO3; VIEWED FROM THE EAST (SCALE 2M).

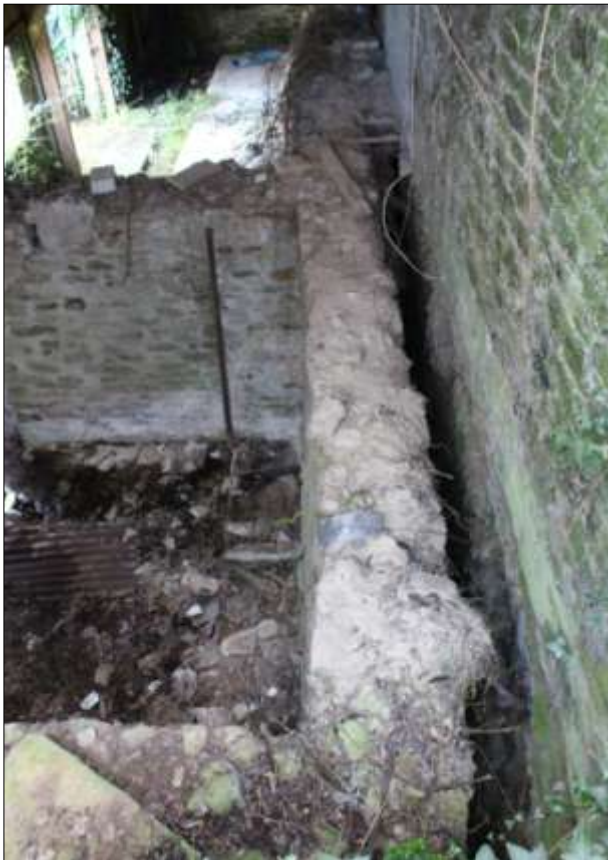
THE INTERIOR OF B2, LOOKING DOWN INTO THE STRUCTURE; VIEWED FROM THE NORTH.

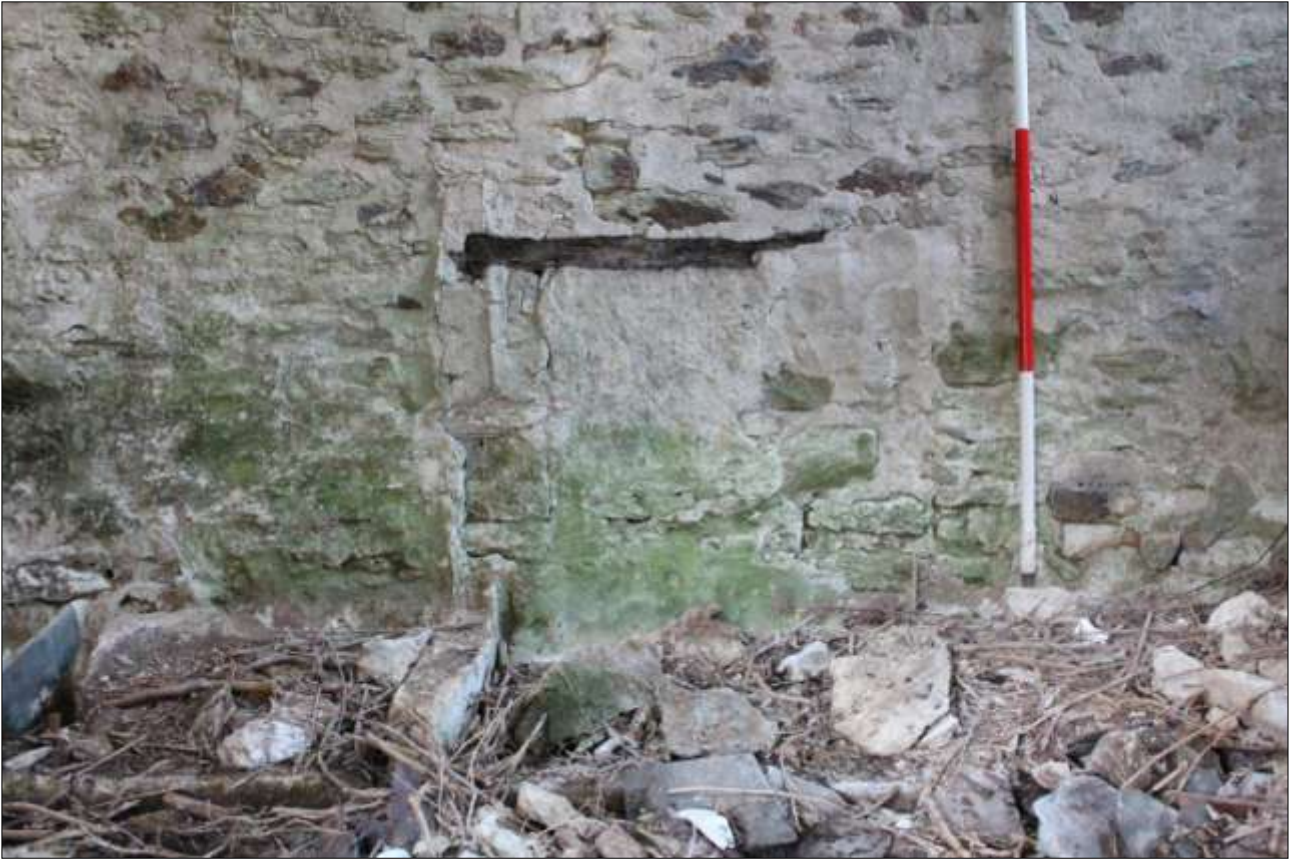
DETAIL OF BO5; VIEWED FROM THE EAST (SCALE 2M)

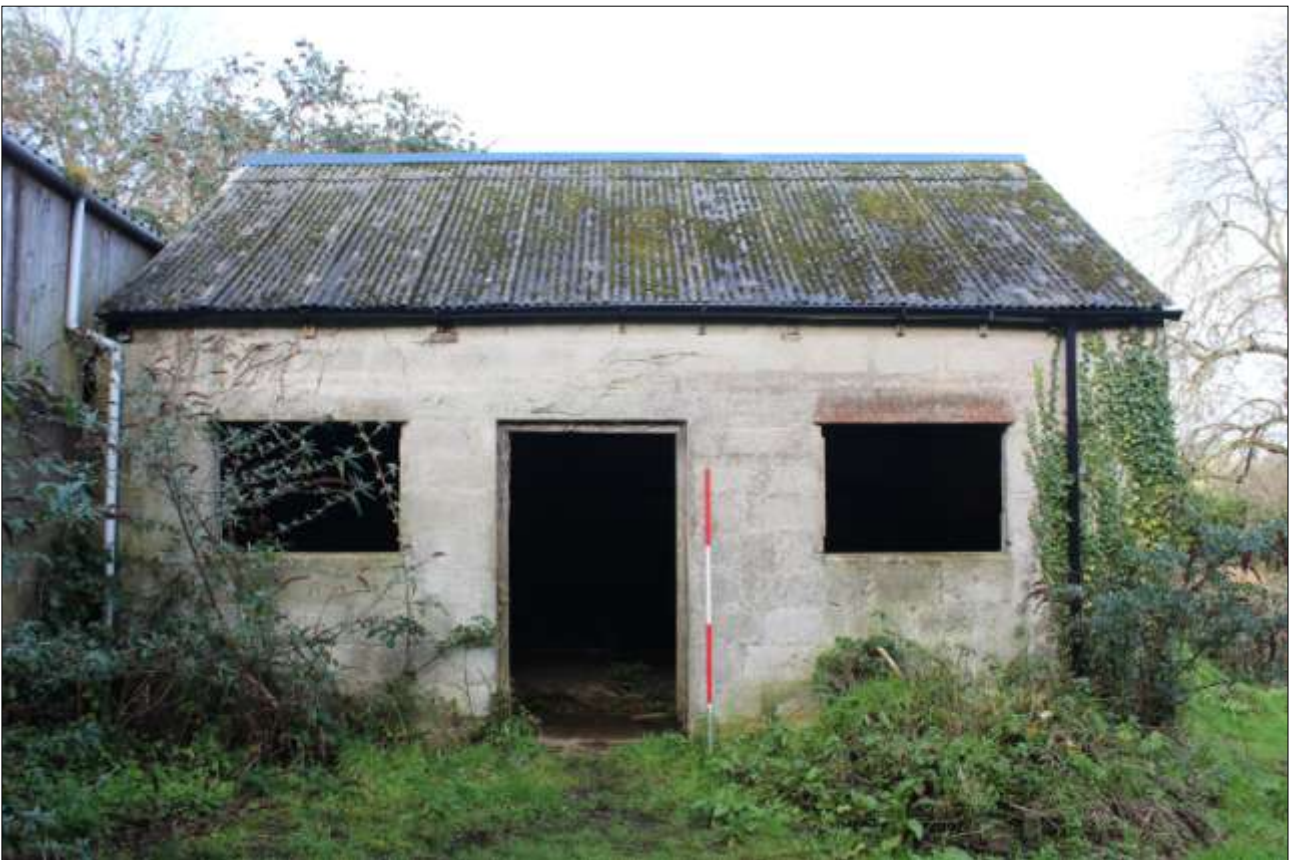
THE SOUTH ELEVATION OF FB3; VIEWED FROM THE SOUTH (SCALE 2M).

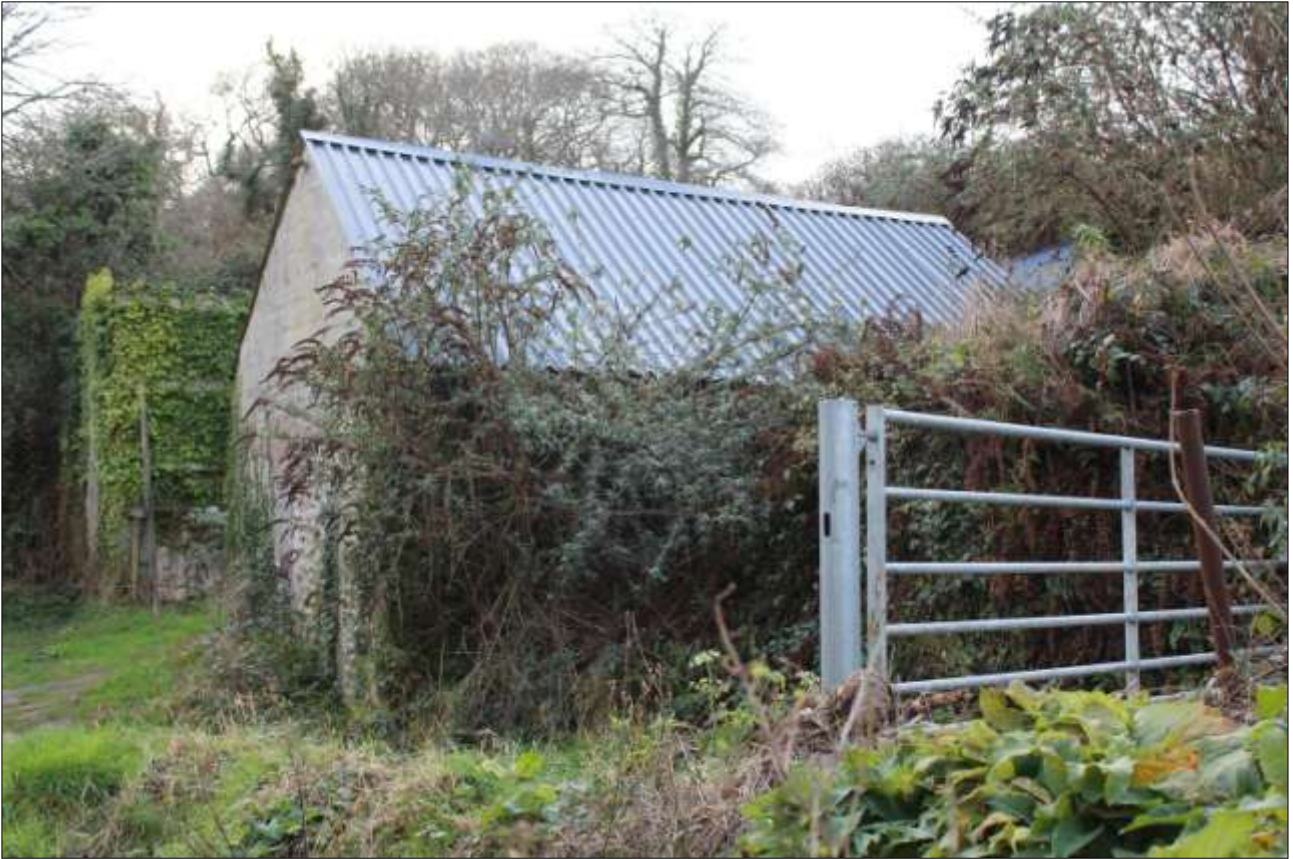
FB3; VIEWED FROM THE NNE.

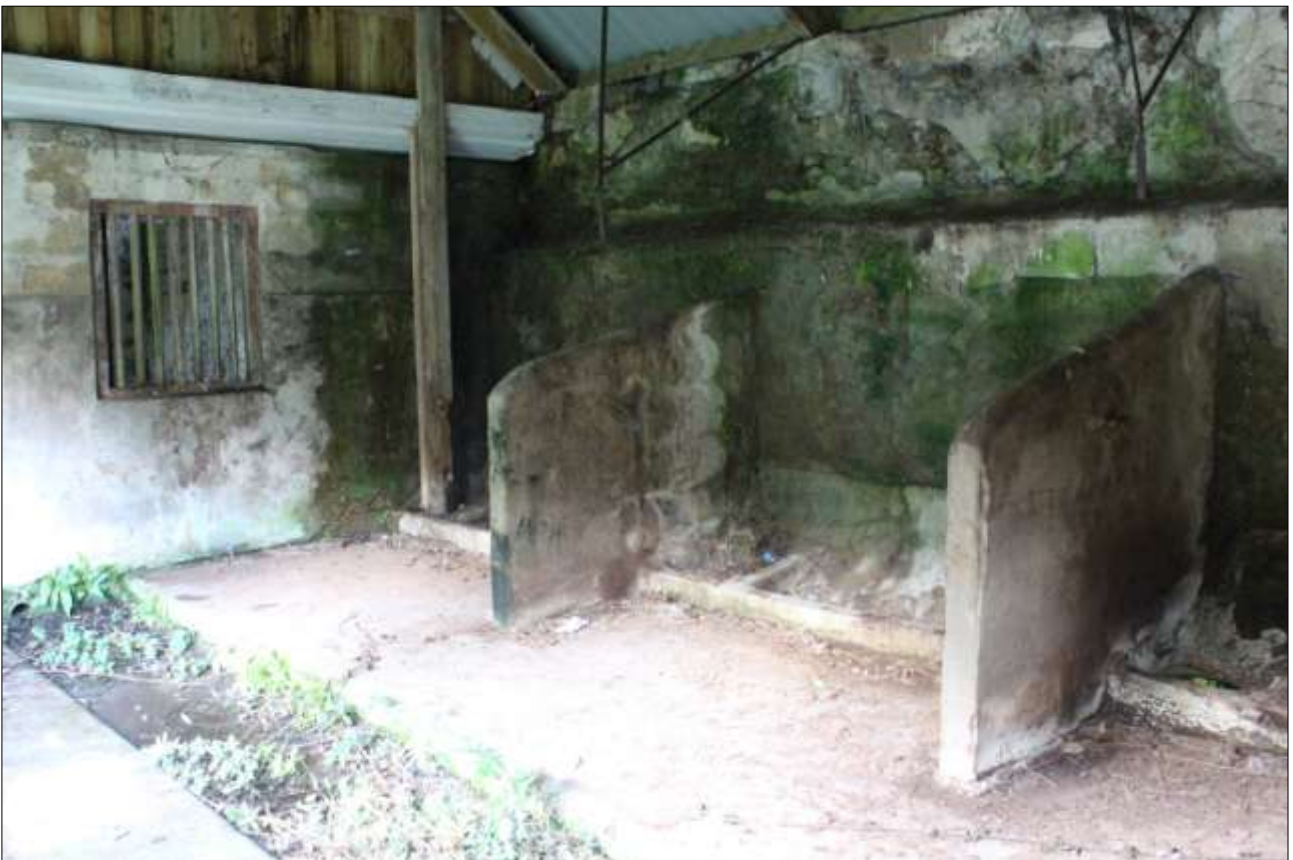
AS ABOVE, SHOWING THE CATTLE STALLS; VIEWED FROM THE SOUTH-EAST.

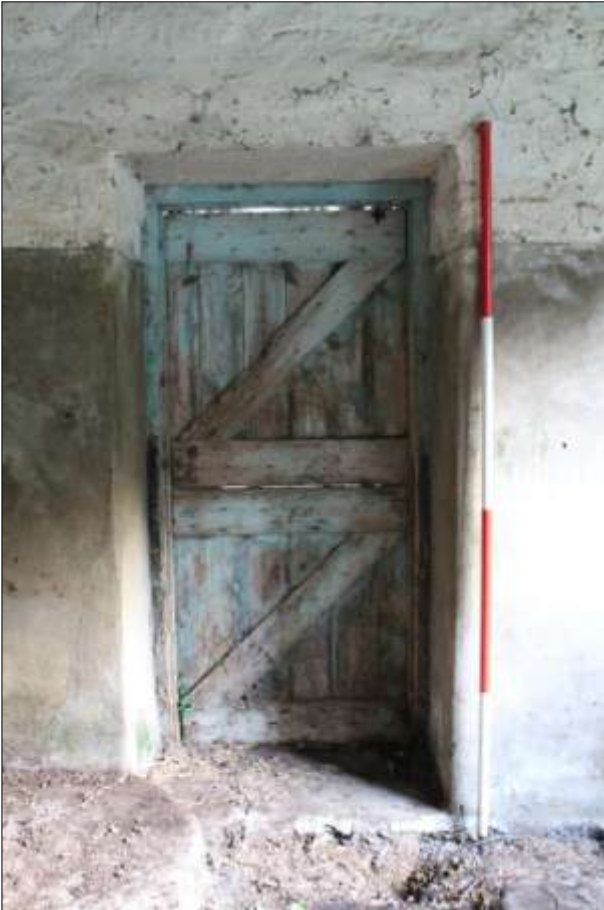
D8 IN FB3; VIEWED FROM THE WEST (SCALE 2M).

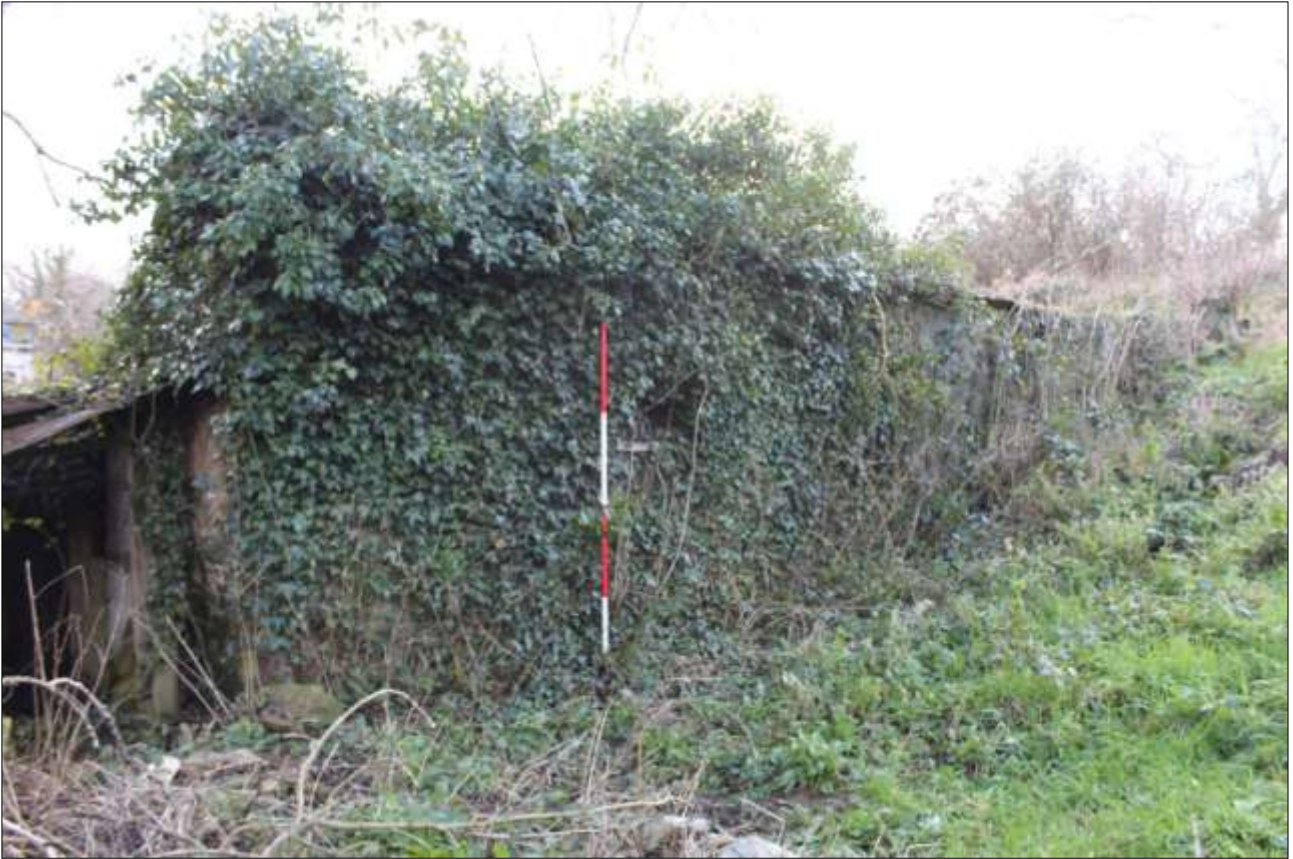
THE NORTH WALL OF FB4; VIEWED FROM THE NORTH-EAST (SCALE 2M).

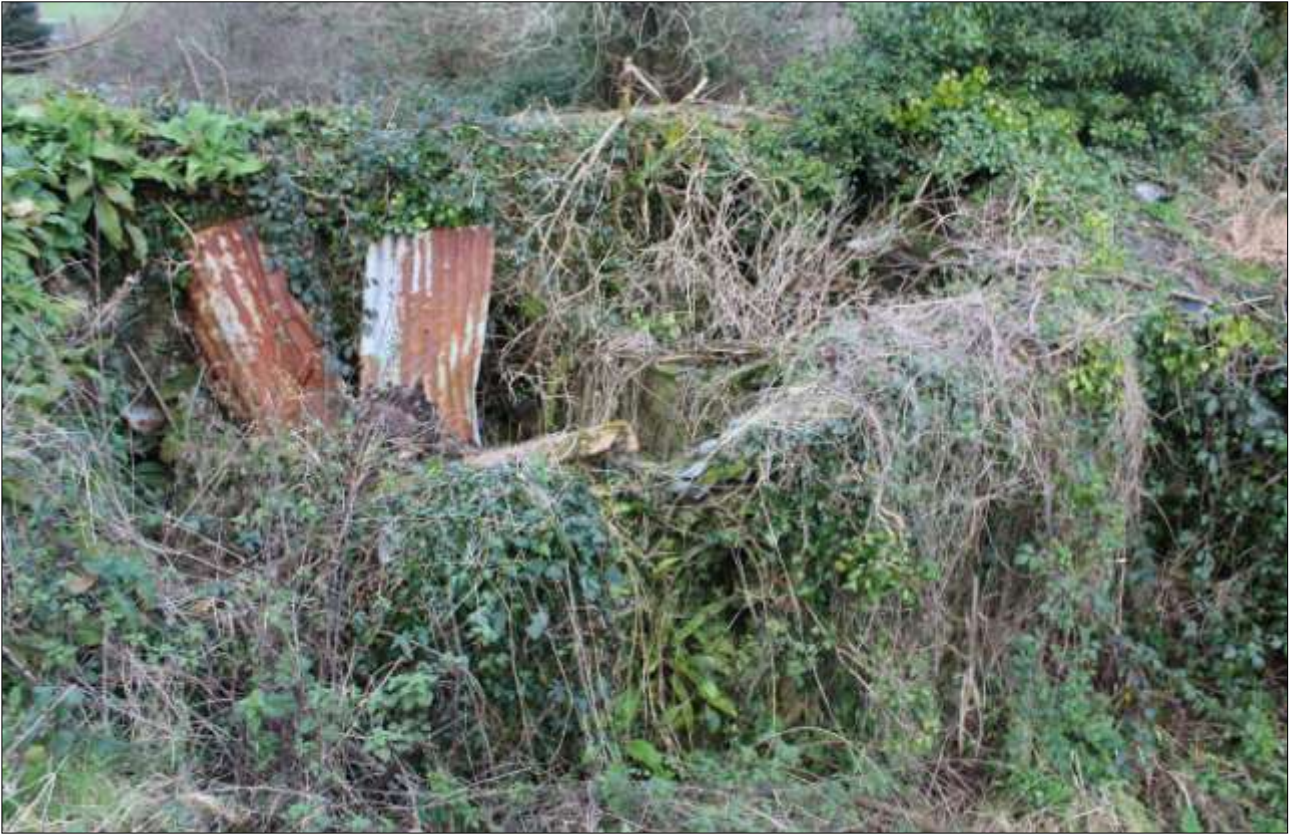
FB4A; VIEWED FROM THE SOUTH-WEST (NO SCALE).

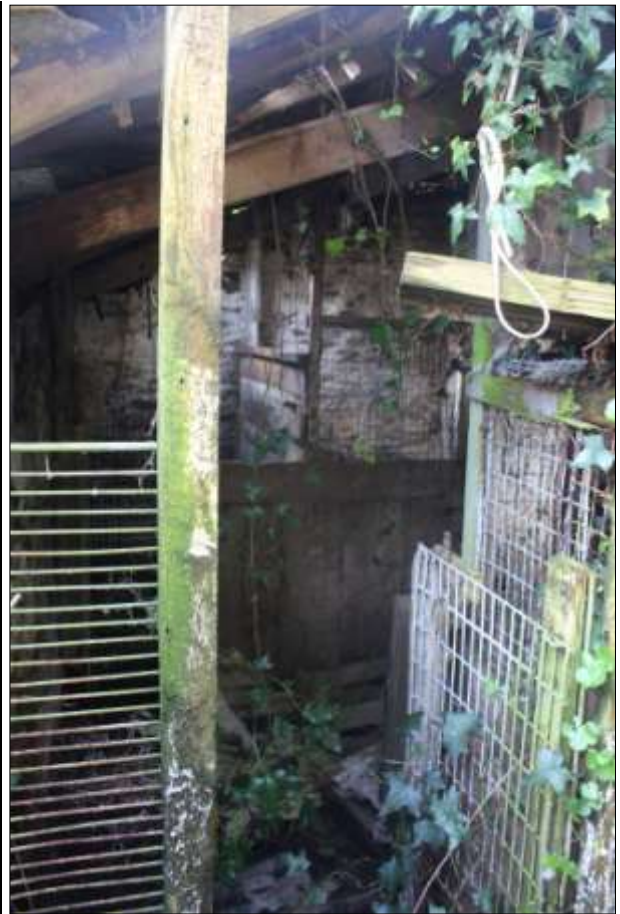
RIGHT: THE INTERIOR OF FB4B; VIEWED FROM THE EAST.

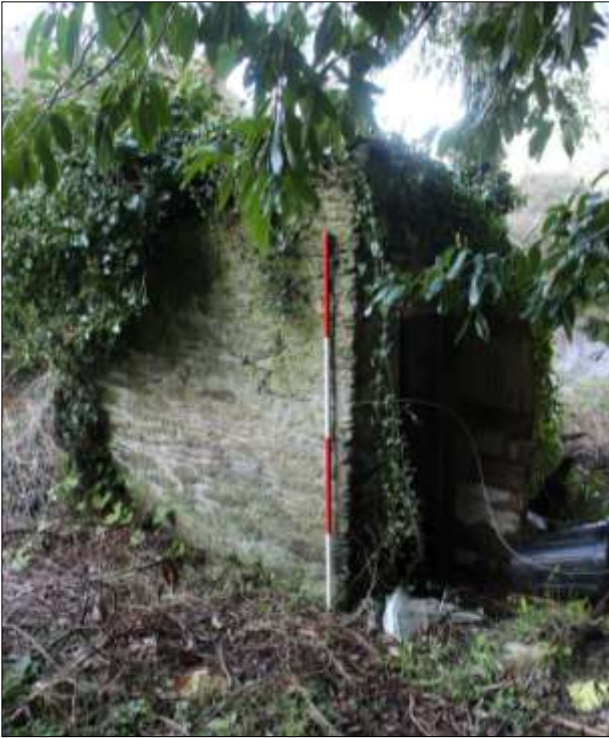
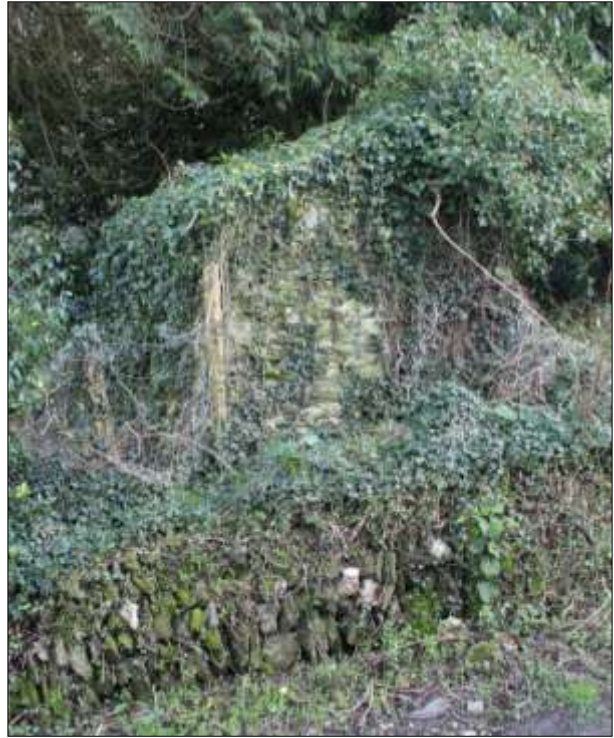
LEFT: B5; VIEWED FROM THE WNW.

RIGHT: B5; VIEWED FROM THE SOUTH-EAST (SCALE 2M).

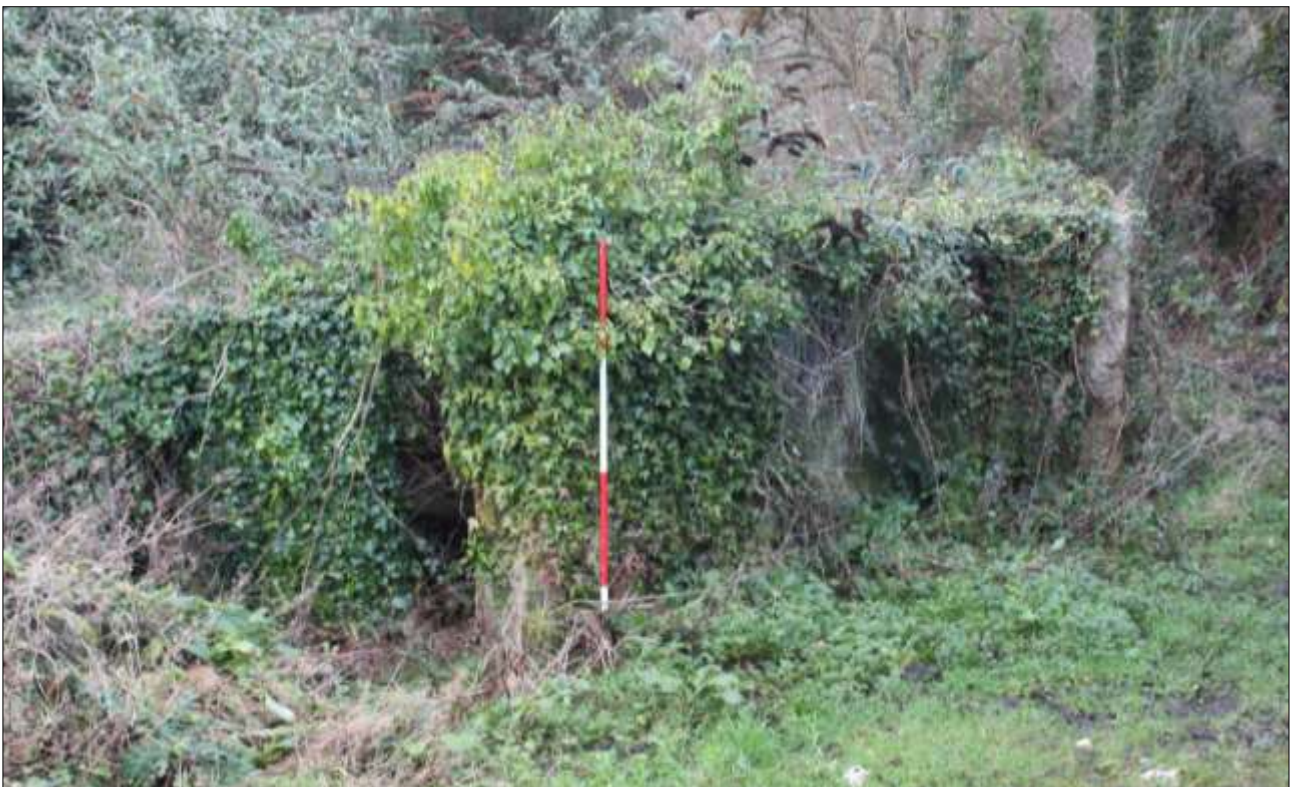
B6; VIEWED FROM THE NORTH-WEST (SCALE 2M).

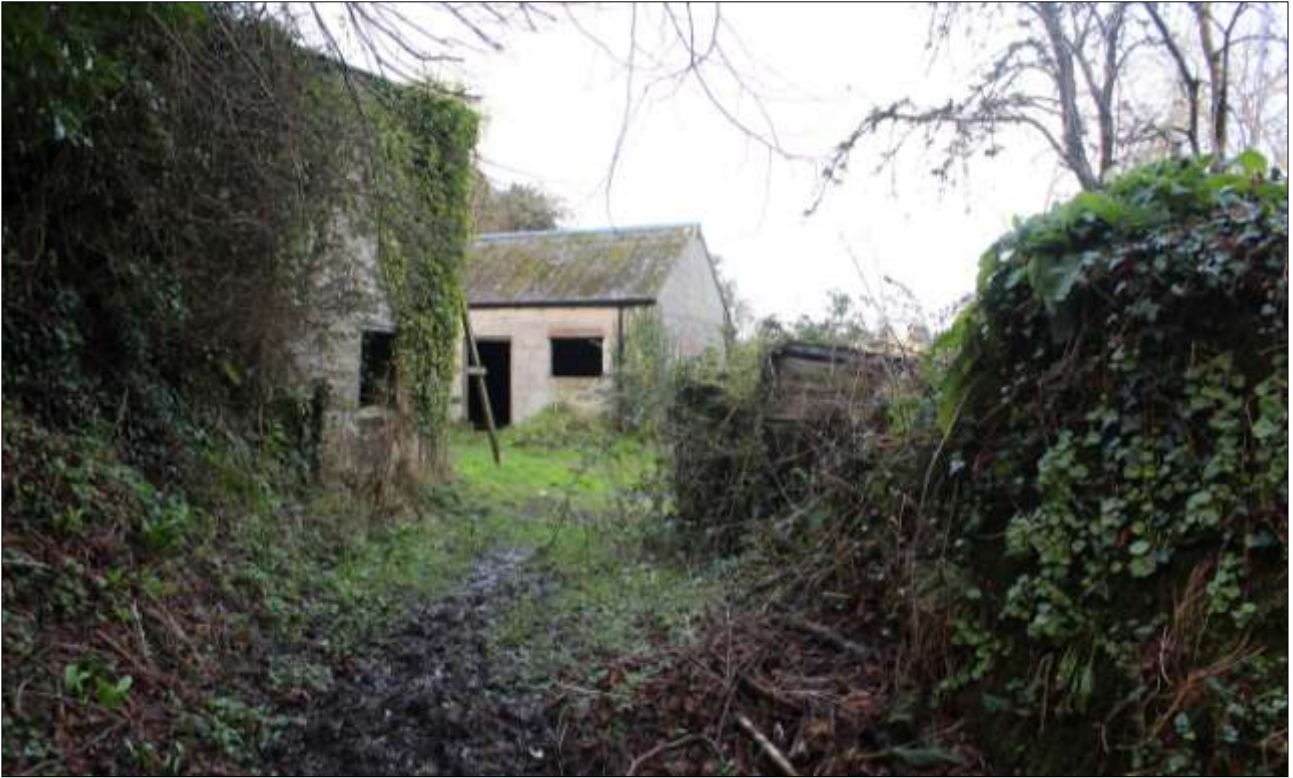
THE FARMYARD, VIEWED FROM THE SOUTH.

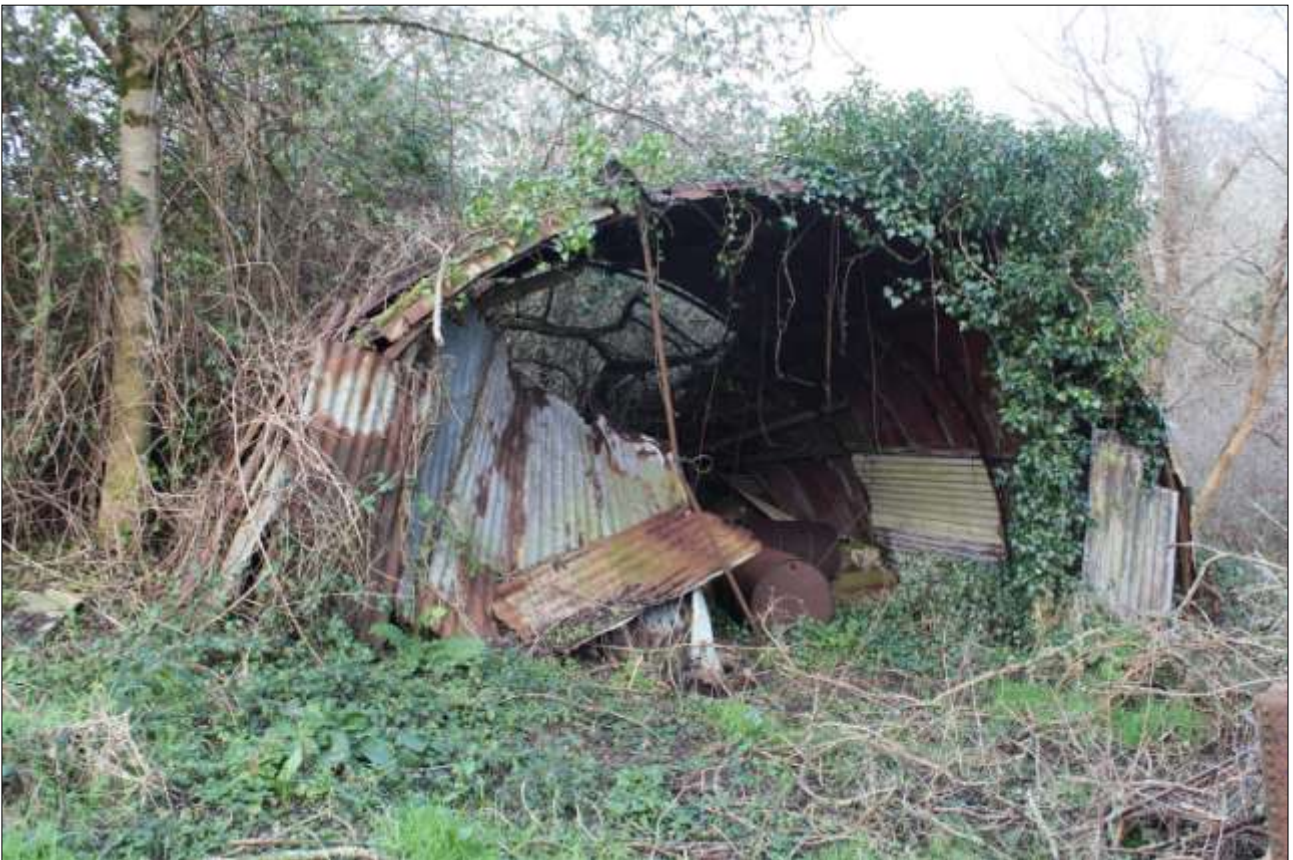
FB8, THE NISSEN HUT; VIEWED FROM THE SOUTH-WEST.
