**BELLHAY COTTAGE
CHURCH ROAD
CARDINHAM
CORNWALL**

Historic Building Recording & Archaeological Monitoring

South West Archaeology Ltd. report no. 191129

By E. Wapshott & A. Allen
Report Version: FINAL
Issued: 29th November 2019
Finalised: 9th December 2019

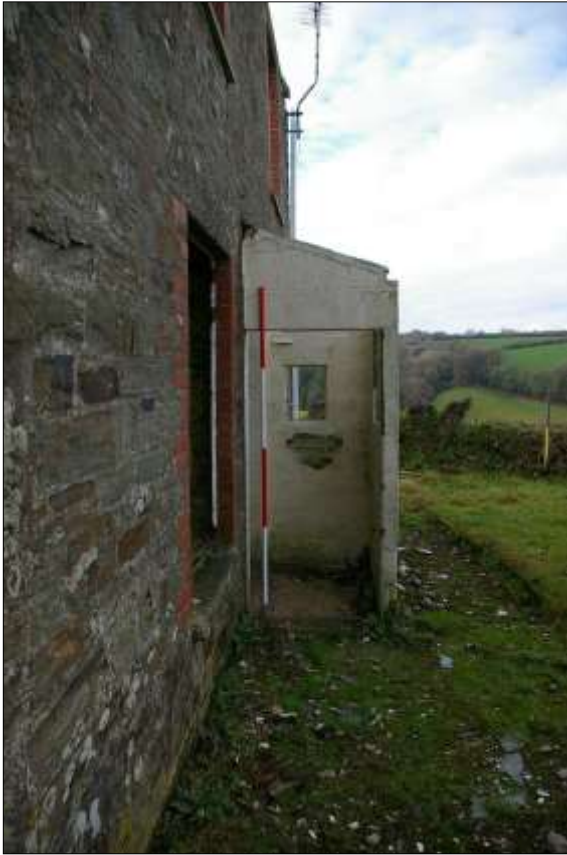
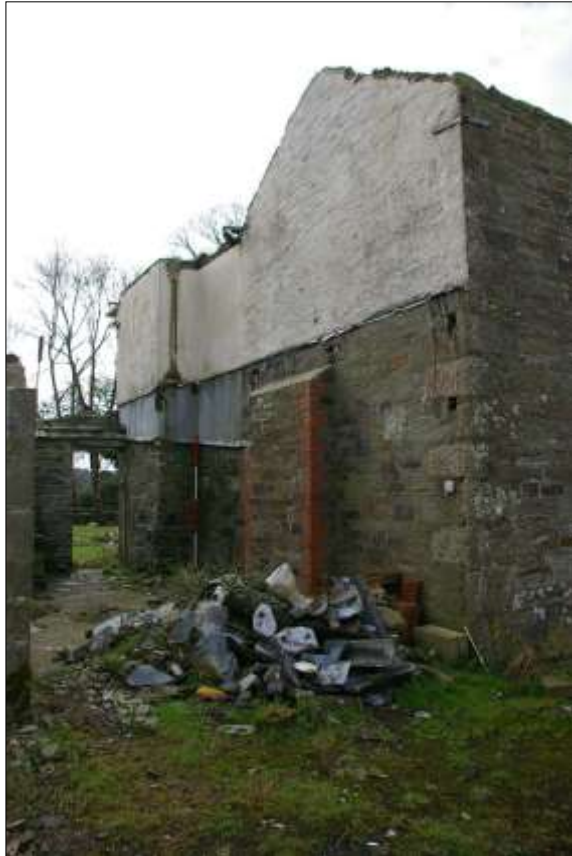
12. LEFT: THE REAR PORCH TO THE NORTH ELEVATION, CONCRETE BLOCK, 2M SCALE; FROM THE EAST. 13. RIGHT: THE EAST ELEVATION, BOTH THE EXTENSION AND HOUSE, WITH LARGE HISTORIC STACK TO SOUTH AND CAPPED NARROWER STACK TO NORTH EXTENSION, WITH 2M SCALE; FROM THE NORTH-EAST.

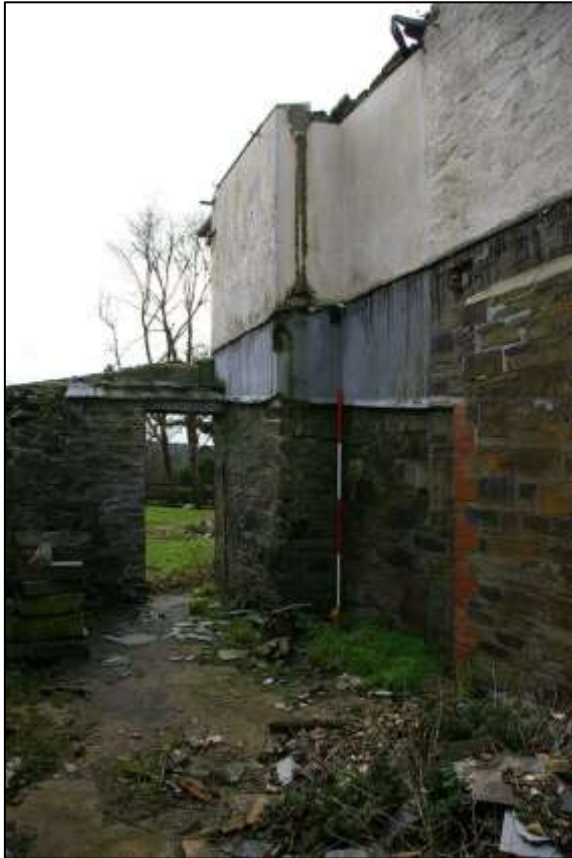
14. LEFT: DETAIL OF THE LARGE STACK TO THE MAIN HOUSE, WITH 2M SCALE; FROM THE NORTH-EAST. 15. RIGHT: THE RECENTLY CAPPED STACK WITH BRICK AND CEMENT REPAIRS, TO THE 19TH CENTURY EXTENSION, TO THE EAST, NORTH-EAST.

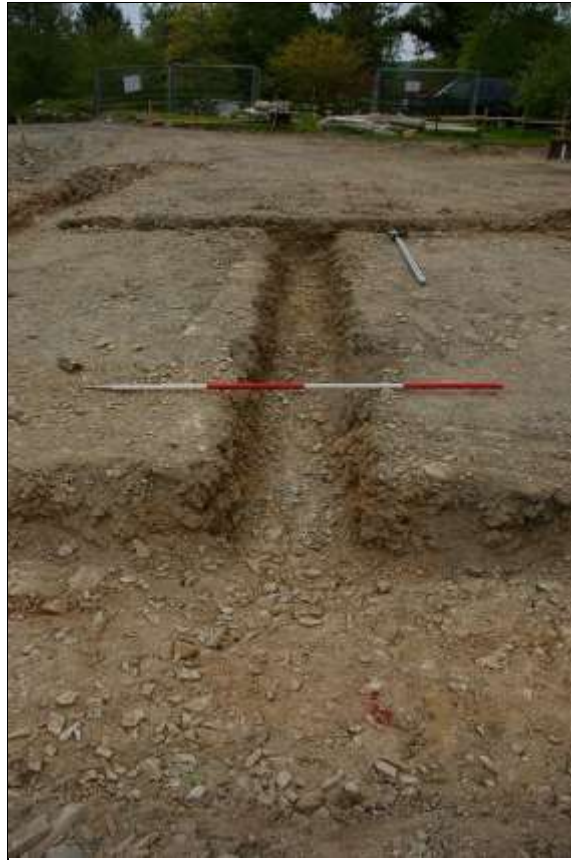
4. THE CENTRAL FOUNDATION TRENCH, FROM THE SOUTH (2M SCALE).
