# ASH HOUSE HENSTRIDGE SOMERSET

Historic Building Recording

South West Archaeology Ltd. report no. 190326

## Ash House, Henstridge, Somerset Historic Building Recording

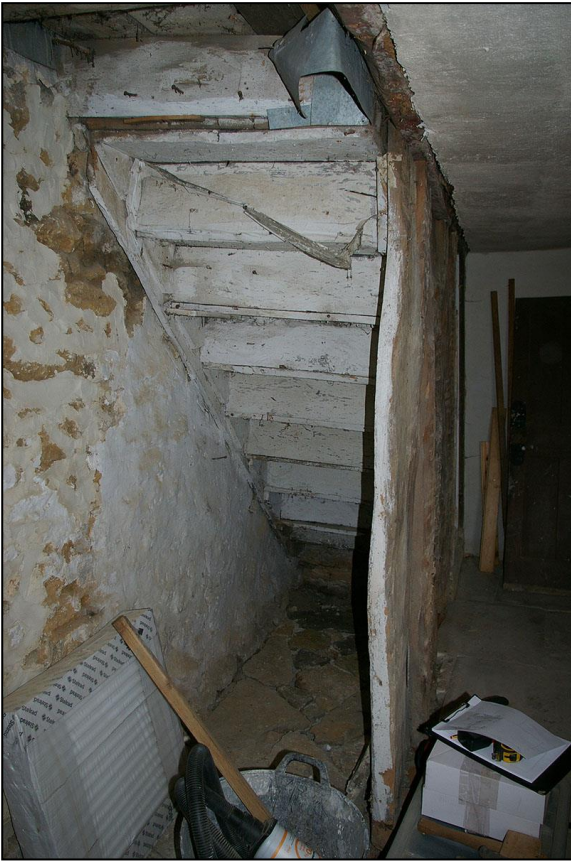
LEFT: R2, THE STAIRS (R14) SUPPORTED AND ENCLOSED BY A HEAVY RUSTIC SCREEN, WITH LOOSER RANDOM STONE PAVING BENEATH; VIEWED FROM THE SOUTH-SOUTH-EAST.

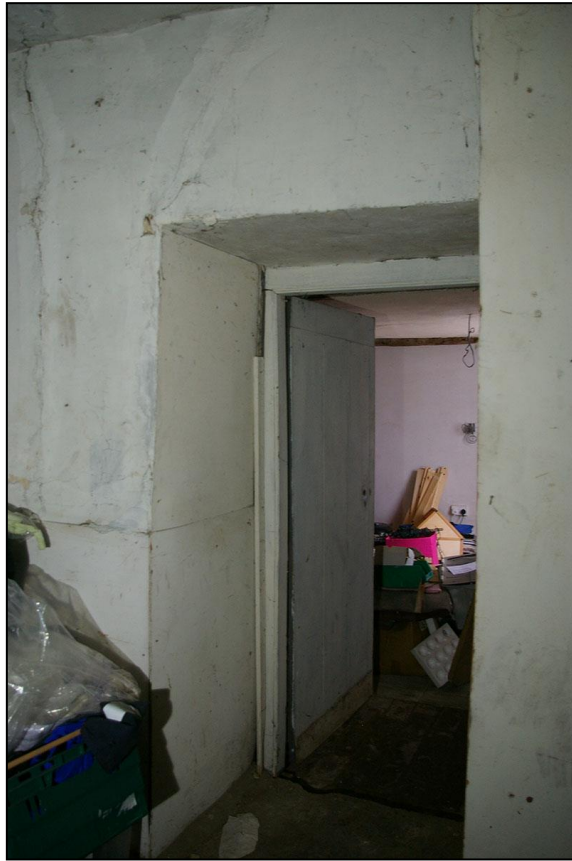
RIGHT: THE HEAVY BATTERED WALL BETWEEN R2 AND R3; VIEWED FROM THE SOUTH-WEST.

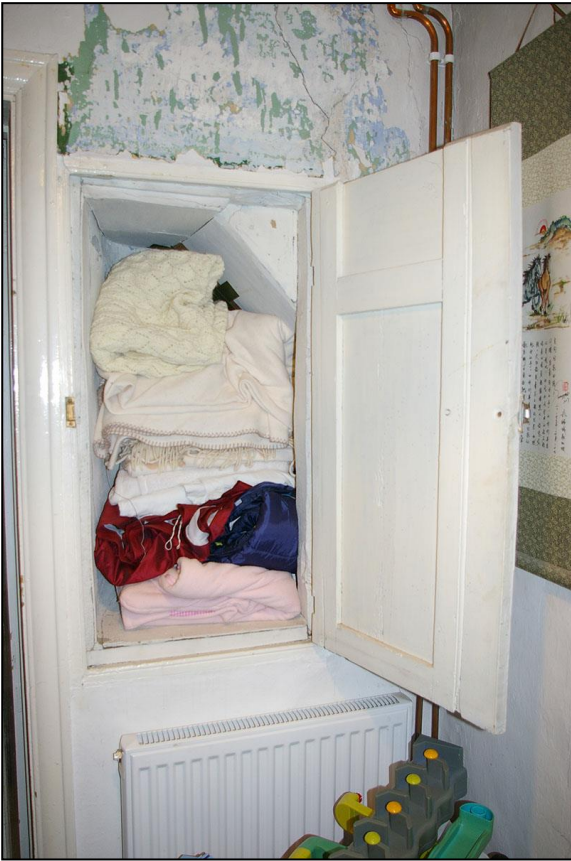
LEFT: R9, THE INTERIOR OF THE CUPBOARD; VIEWED FROM THE EAST-SOUTH-EAST.

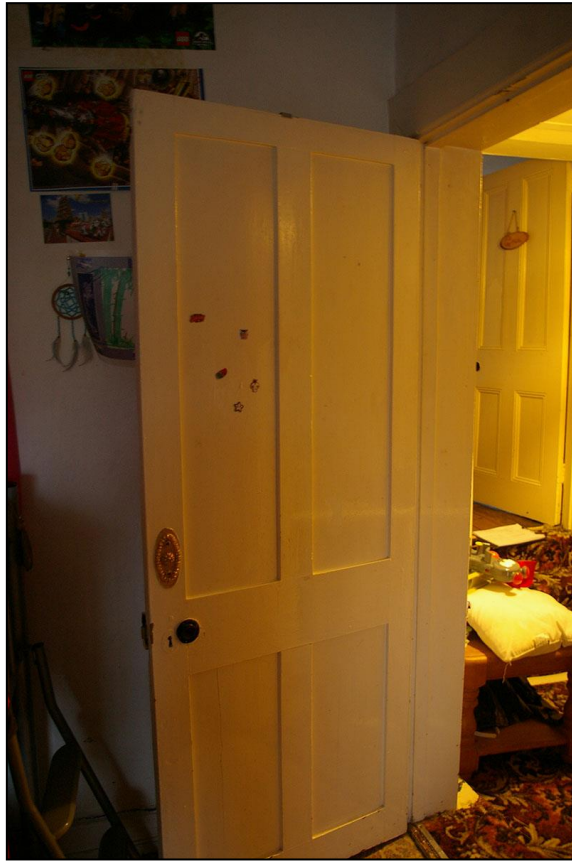
RIGHT: VIEW OF THE TALL PLAIN FOUR-PANEL DOOR TO R10; VIEWED FROM THE SOUTH-WEST.

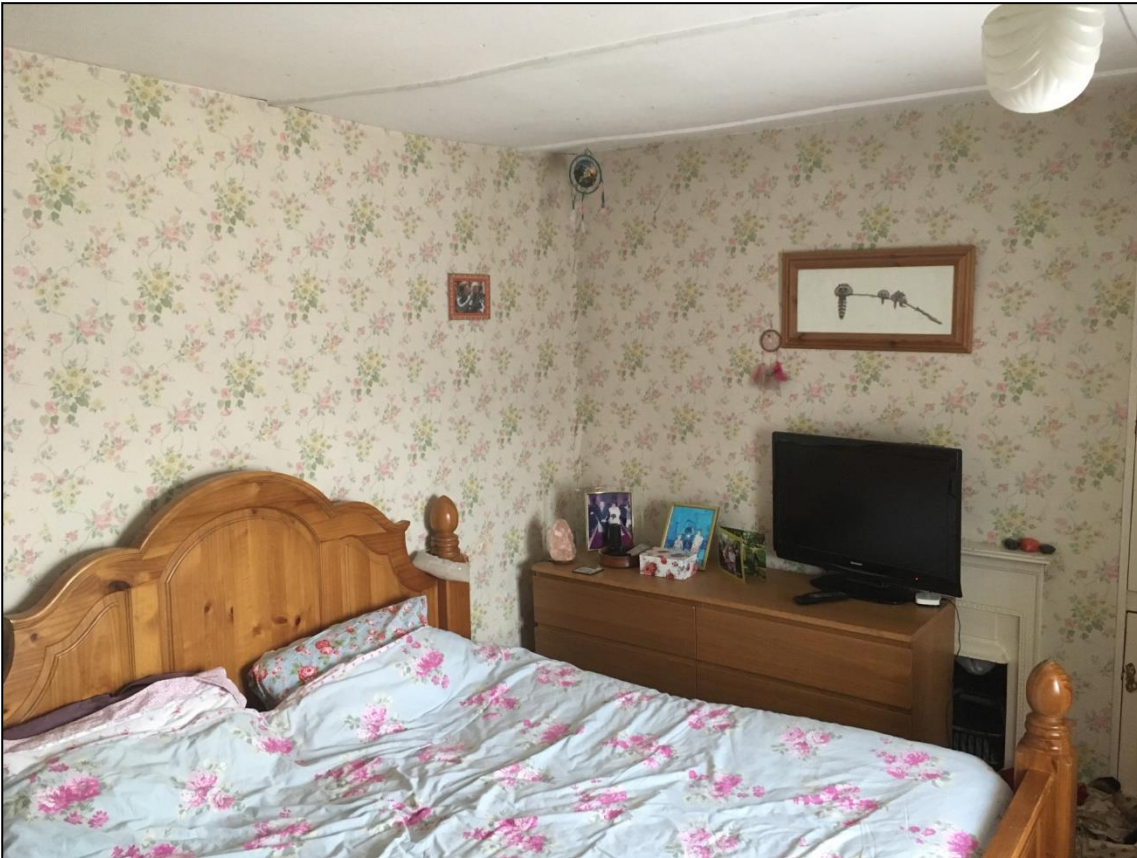
R11; VIEWED FROM THE SOUTH-WEST (SUPPLIED BY CLIENT).

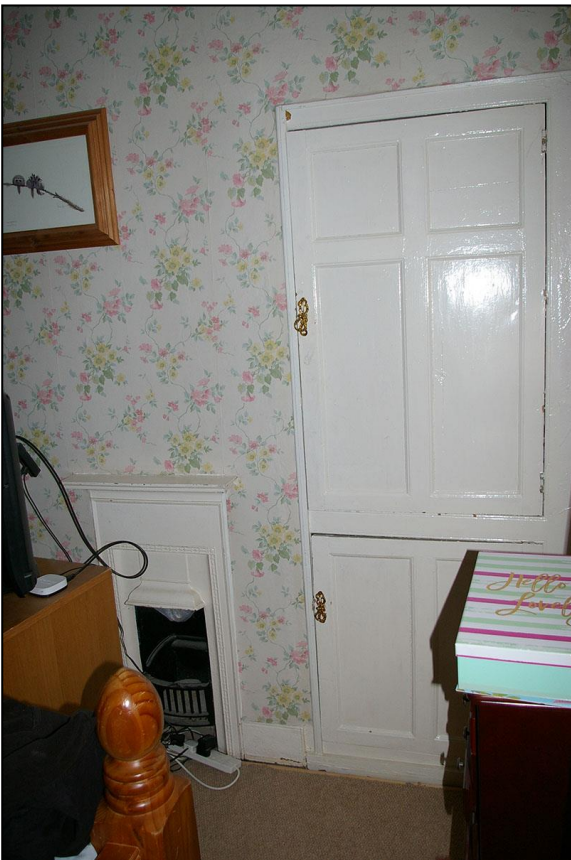
LEFT: R11, THE 18<sup>TH</sup> CENTURY PANELLED CUPBOARD SET INTO AN ALCOVE AGAINST THE STACK, AND THE SMALL EDWARDIAN GRATE INSERTED INTO THE FIREPLACE, LIKELY BLOCKING A LARGER OPENING; VIEWED FROM THE WEST-SOUTH-WEST.

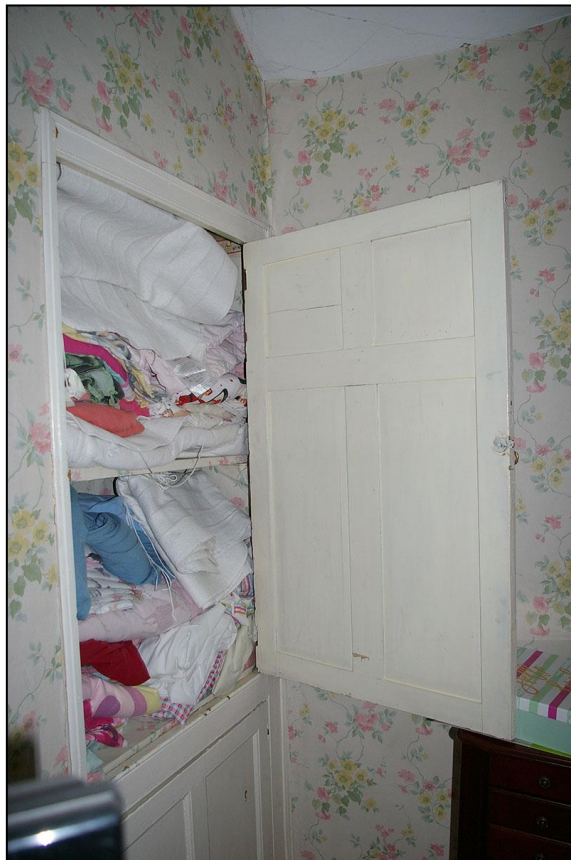
RIGHT: R11, THE RAISED PANELS OF THE FINE 18<sup>TH</sup> CENTURY CUPBOARD; VIEWED FROM THE NORTH-WEST.

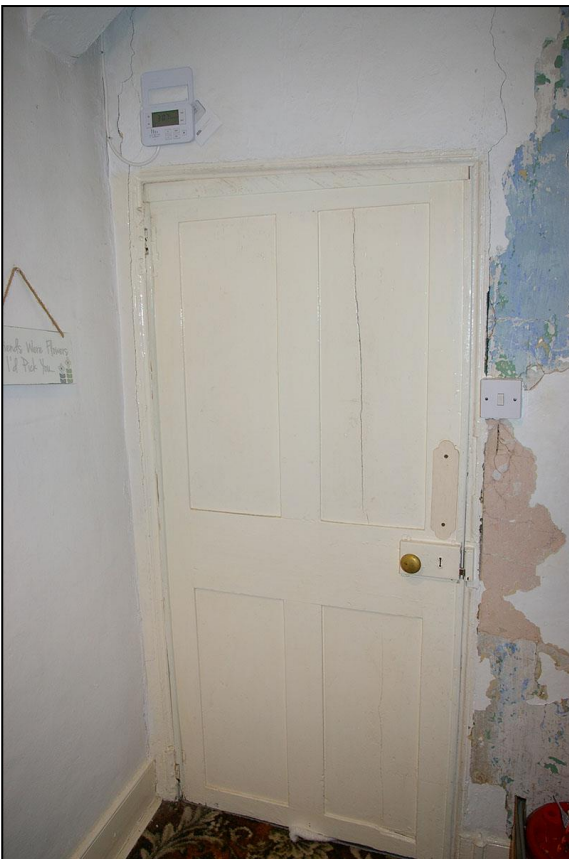
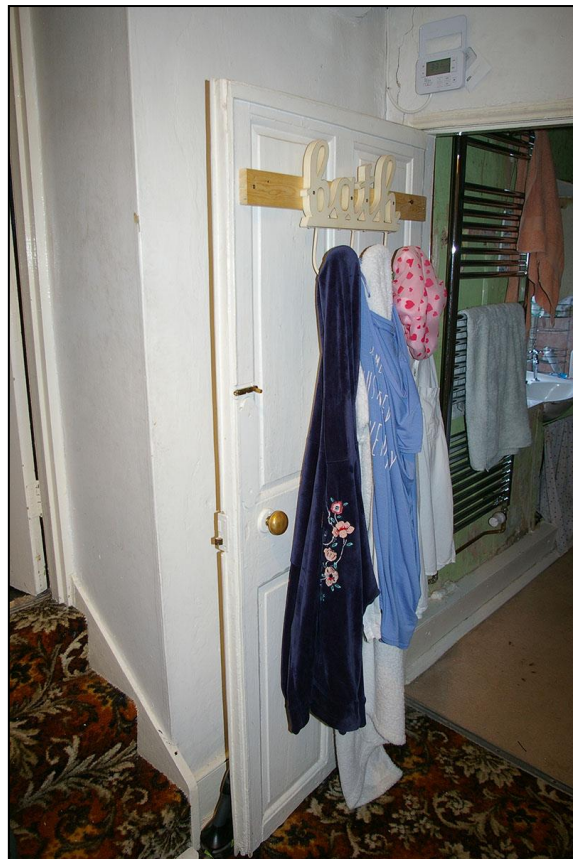
LEFT: R9, FINE 18<sup>TH</sup> CENTURY RAISED AND FIELDED PANELLED DOOR ON LH HINGES TO R12, NOW A BATHROOM; VIEWED FROM THE WEST.  
RIGHT: R9, THE PANELLED SIDE OF THE DOOR TO R12; VIEWED FROM THE WEST.

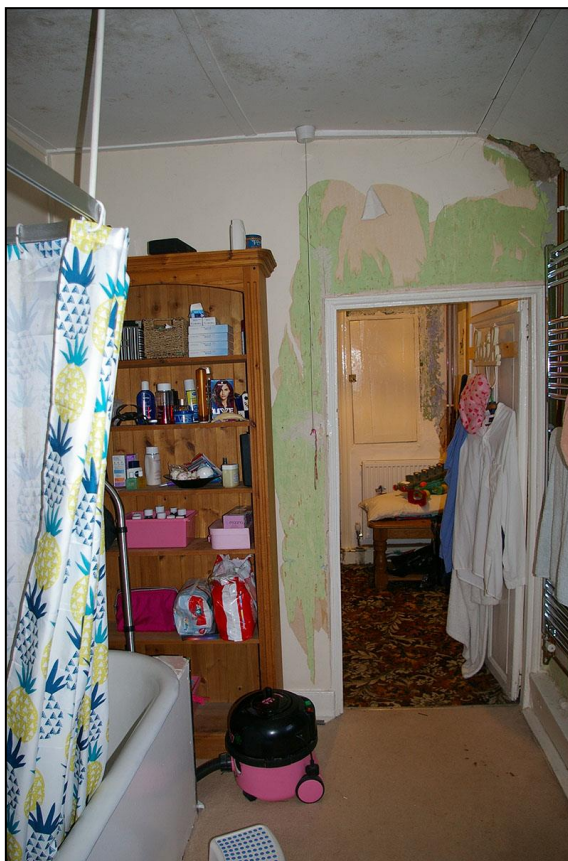
RIGHT: R12; VIEWED FROM THE EAST-NORTH-EAST.

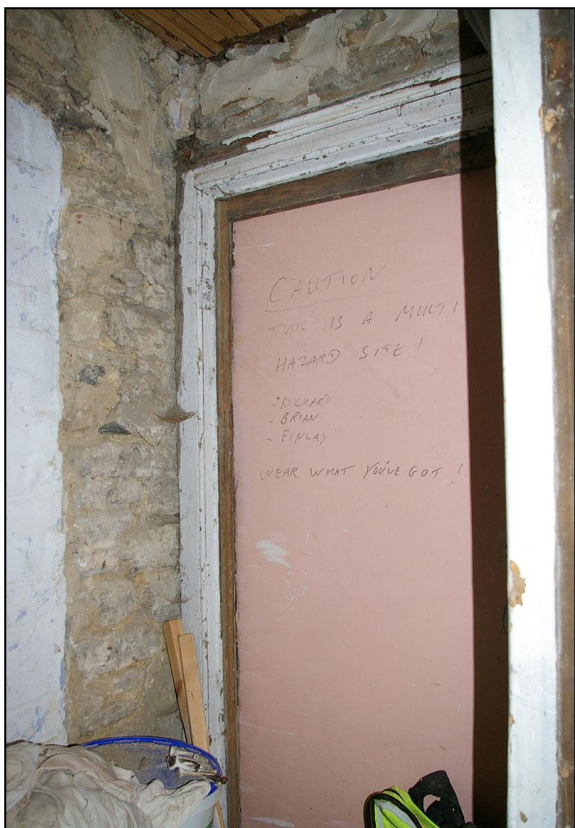
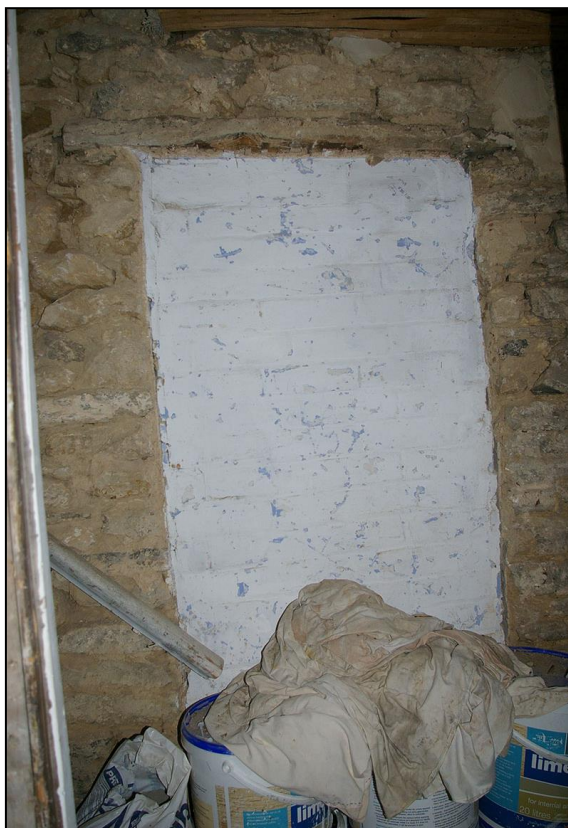
LEFT: R14, THE NARROW MOULDED DOOR FRAME SET IN A REDUCED OPENING IN THE NORTH WALL; VIEWED FROM THE SOUTH-EAST.  
RIGHT: BLOCKED DOORWAY IN THE WALL BETWEEN R14 AND R3, AT THE BASE OF THE STAIRS; VIEWED FROM THE EAST-SOUTH-EAST.

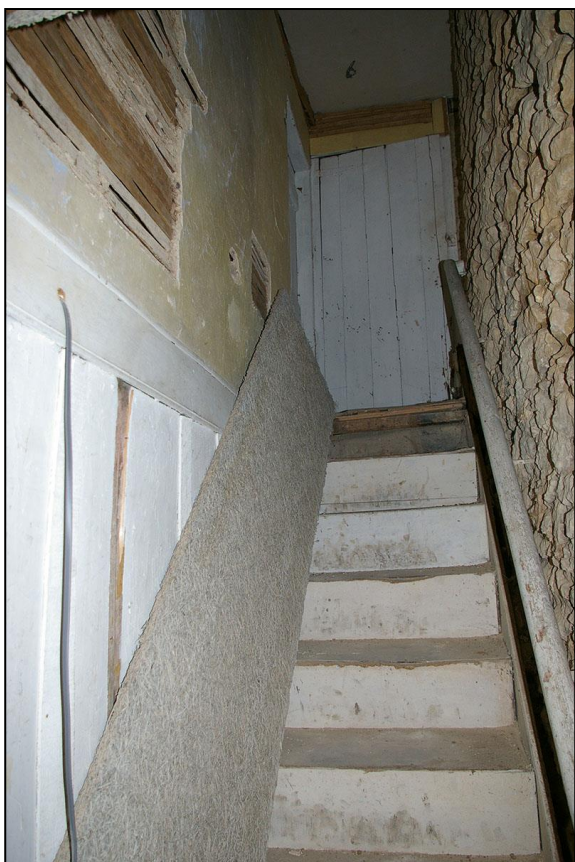
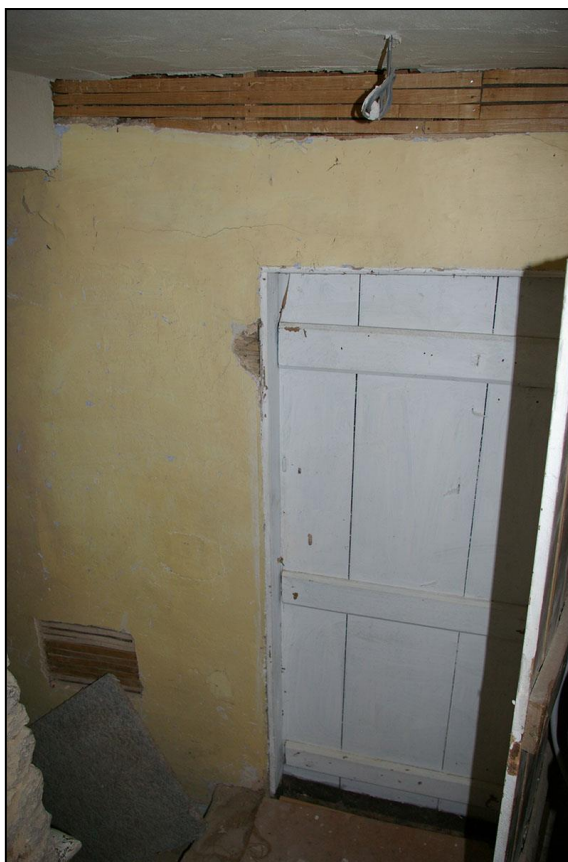
LEFT: R14, THE 19<sup>TH</sup> CENTURY STAIRCASE; VIEWED FROM THE NORTH.  
RIGHT: R14, THE DOOR OPENING ONTO R10 FROM THE TOP OF THE STAIRS; VIEWED FROM THE SOUTH-WEST.

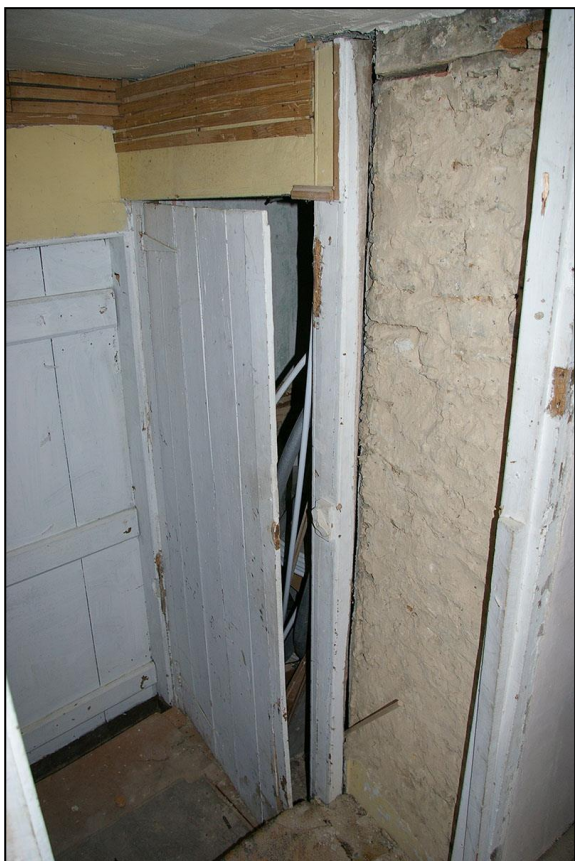
LEFT: R14, THE CUPBOARD AT THE TOP OF THE STAIRS; VIEWED FROM THE WEST.

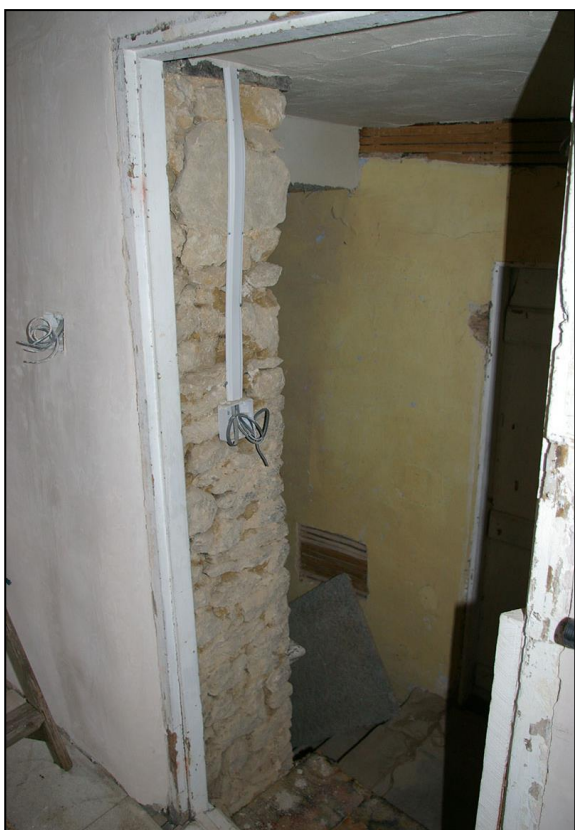
LEFT: VIEW FROM R15 INTO R14, SHOWING THE FORMER GABLE WALL; VIEWED FROM THE SOUTH-WEST.

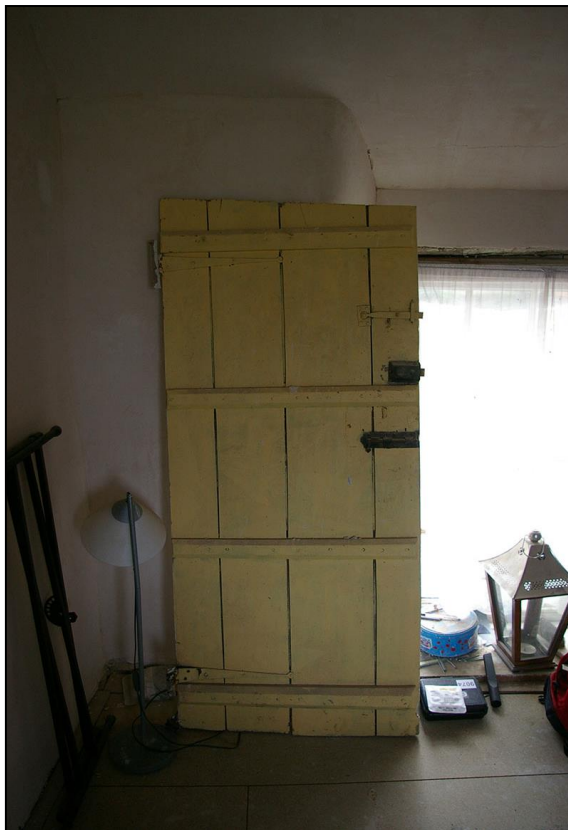
RIGHT: R15, THE GOOD PLANK DOOR WITH LEDGES AND STRAP HINGES THAT SERVED R15; VIEWED FROM THE NORTH.
