**TRAVIS PERKINS  
MAYOR'S AVENUE  
DARTMOUTH  
DEVON**

Desk-Based Assessment & Updated Historic Building Recording

South West Archaeology Ltd. report no. 190906

By E. Wapshott & B. Morris  
Report Version 03  
6<sup>th</sup> September 2019

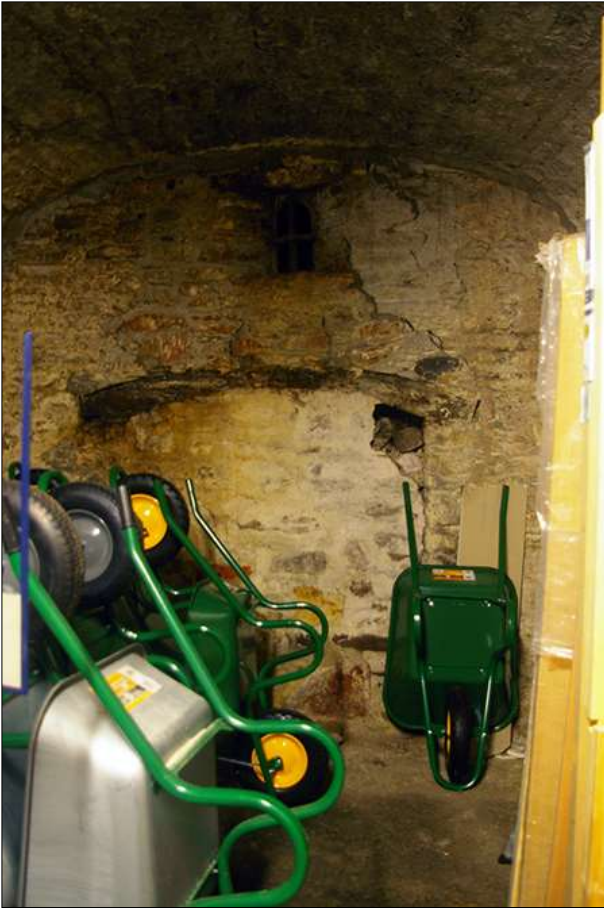
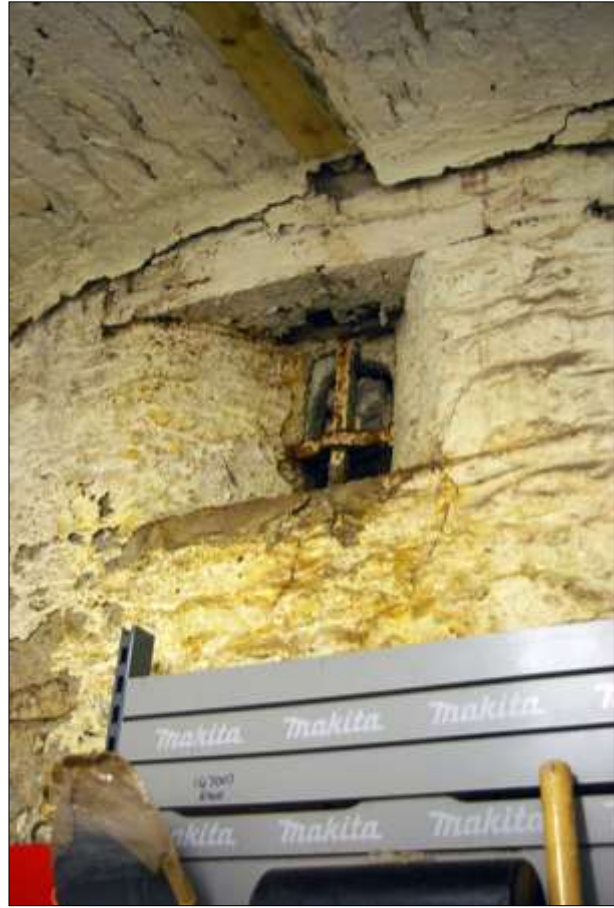
LEFT FIGURE 21: BO5 IN VAULT 5, WITH CURVING TIMBER LINTEL AND W5 ABOVE; VIEWED FROM THE EAST.  
RIGHT FIGURE 22: DETAIL OF W2 IN VAULT 2, WITH IRON *FERRAMENTA*; VIEWED FROM THE ENE.

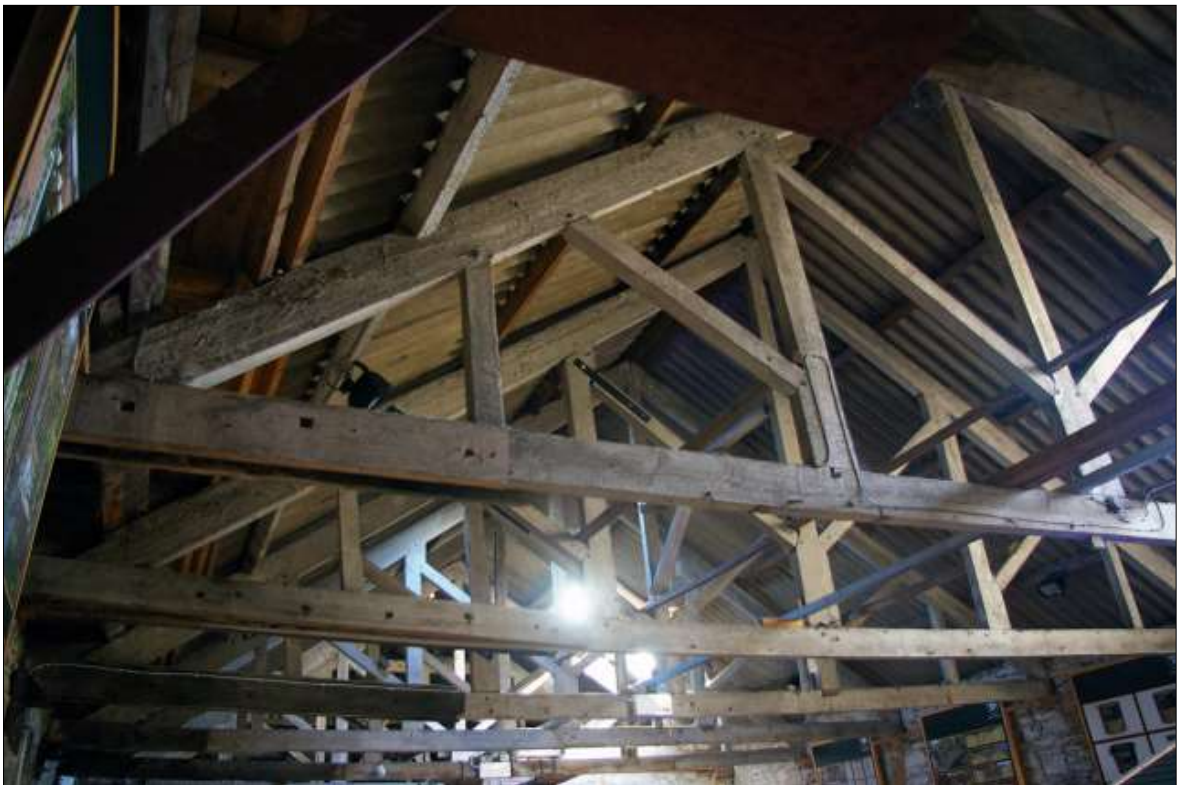
The south wall has been rebuilt or added later, narrower than the wall below (c.0.6m), and sports three openings: to the north a window (W9) with a heavy curving yoked timber lintel and an eight-over-eight sash window in a narrow pegged frame. To the south a second window (W10) with yoked lintel has been enlarged to form a loading door; between the two is a central forced double loading door (D16) under a thin timber lintel, with a pair of boarded, ledged and braced timber doors. Above D16 is a small forced opening (S15) that contains the cast-iron mounting for a motorised hoist, and historic photographs (1980s) show a projecting housing at roof level in corrugated tin sheet. As discussed above, the whole east wall has been rebuilt; at first-floor level there were six wide open bays separated by piers of mortared slatestone rubble with timber lacing; these open bays (presumably weather-boarded originally) were later infilled in stone (BO35-BO40). This wall very clearly leans out to the east, and the ends of the tie beams in the roof have pulled out of the wall and are now carried on modern steels.

FIGURE 25: THE KINGPOST ROOF IN B1 WITHIN R1; VIEWED FROM THE NORTH-EAST.

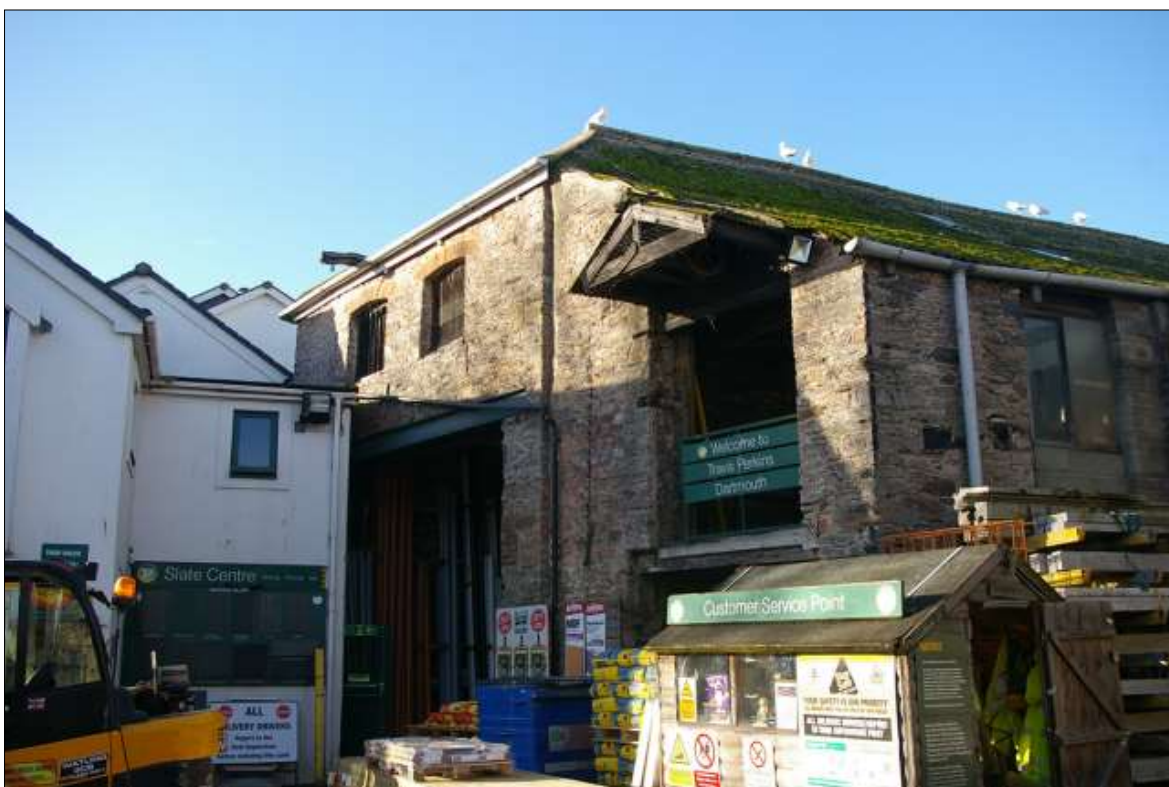
FIGURE 26: THE SOUTH ELEVATION OF B2 AND B3; VIEWED FROM THE SOUTH-EAST.

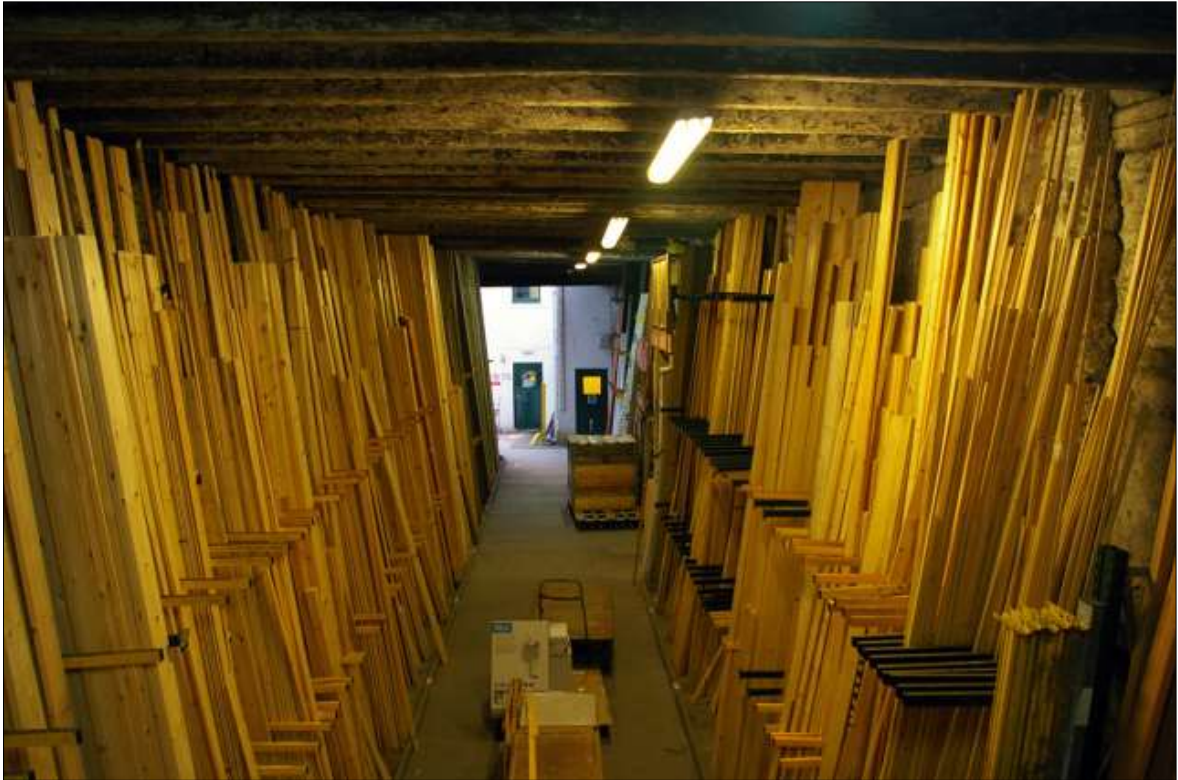
FIGURE 27: THE INTERIOR OF B2; VIEWED FROM THE NORTH.

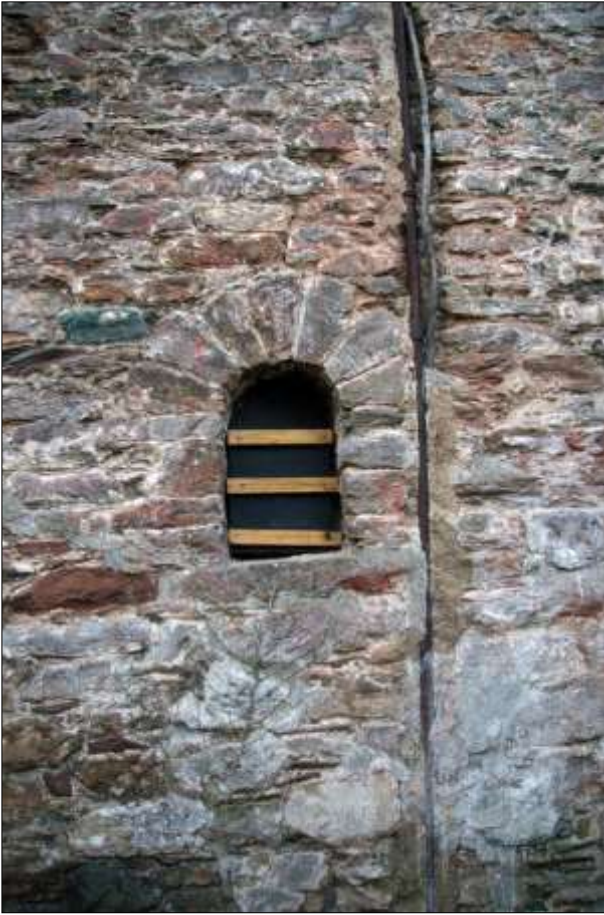
- 6. LEFT: THE NORTH WALL OF B1 SHOWING ORIGINAL GF WINDOW W7; VIEWED FROM THE NORTH.
- 7. RIGHT: AS ABOVE, SHOWING THE RELATIONSHIP WITH THE 1990S M&S BUILDING; VIEWED FROM THE NORTH-EAST.

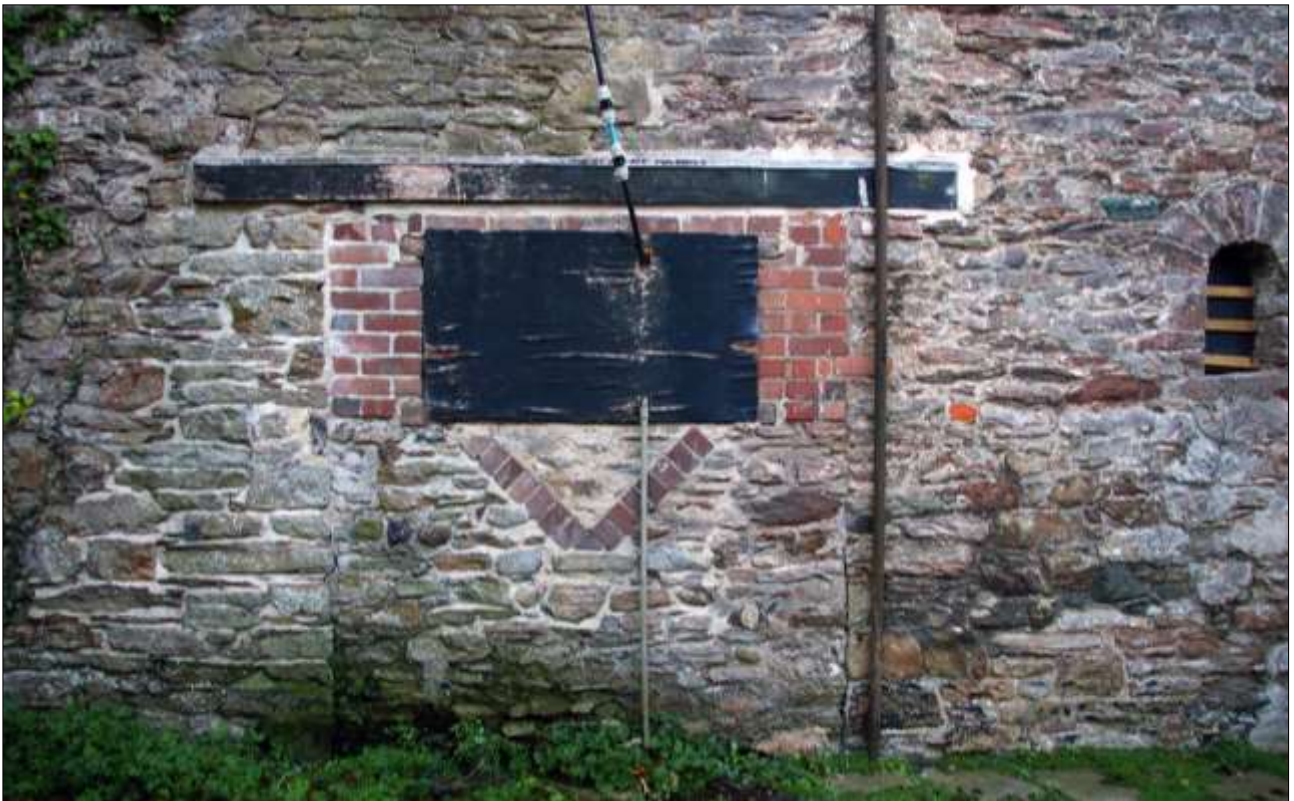
- 8. THE NORTH WALL OF B1, SHOWING THE GF BLOCKED OPENING 24 (BO24); VIEWED FROM THE NORTH.

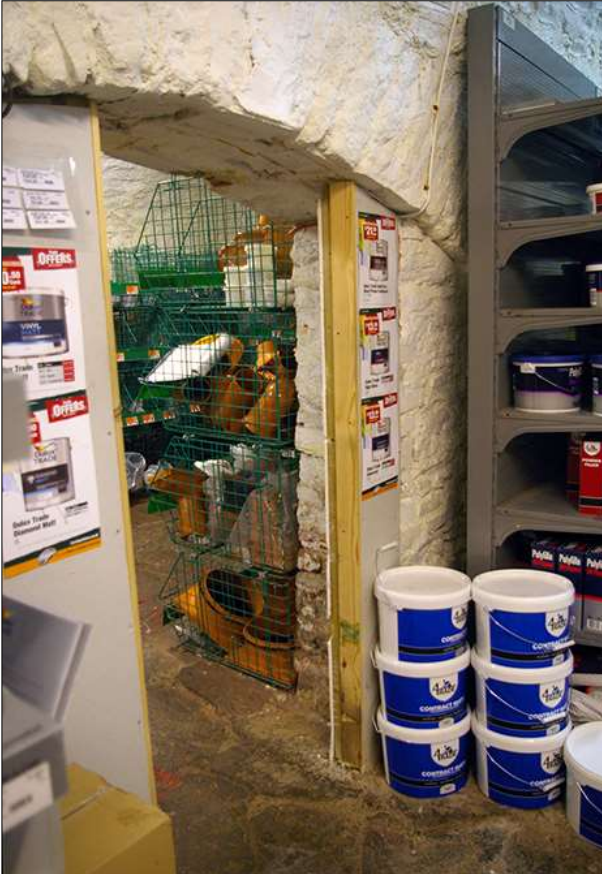
26. LEFT: B1 GF, D2/BO9 BETWEEN V1 AND V2; VIEWED FROM THE SOUTH-WEST.

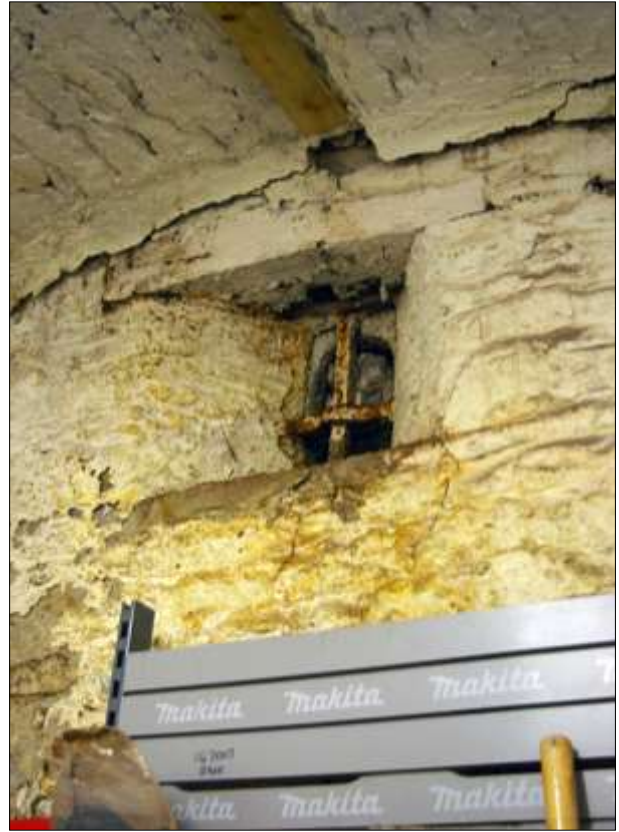
32. RIGHT: B1 GF, THE SOUTH END OF V2 SHOWING THE WINDOW W2 WITH ITS SURVIVING *FERRAMENTA*; VIEWED FROM THE ENE.

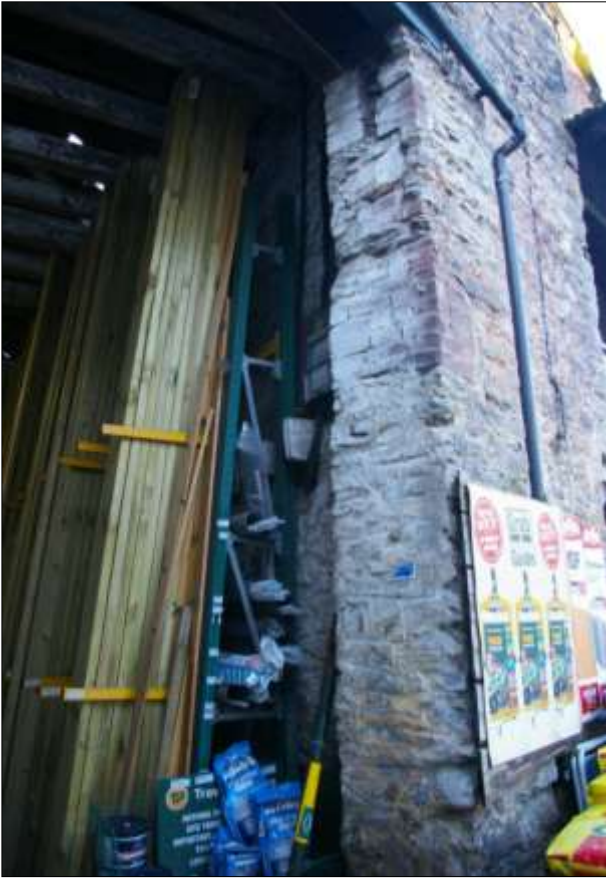
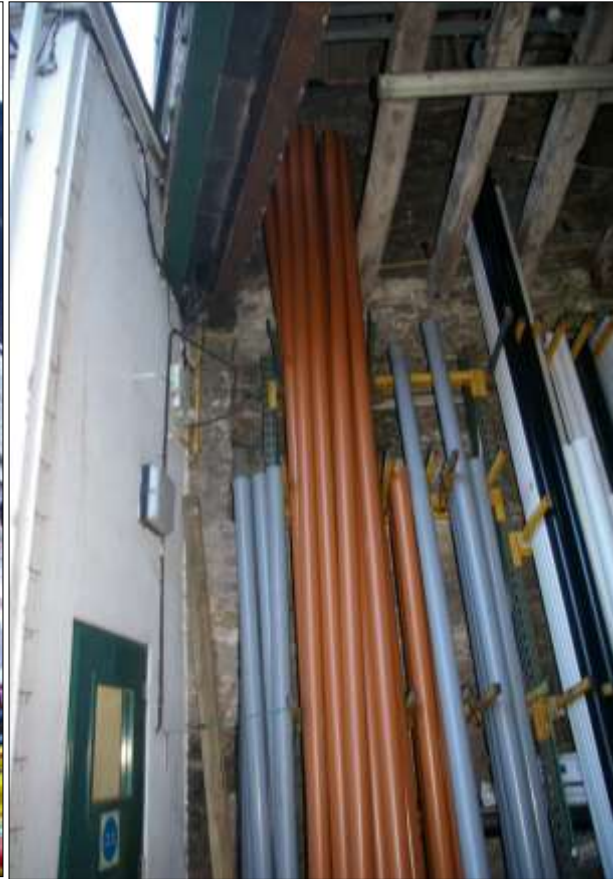
95. LEFT: THE REBUILT EAST JAMB OF D12; VIEWED FROM THE SOUTH-WEST.

96. RIGHT: THE REBUILT WEST JAMB OF D12; VIEWED FROM THE EAST.

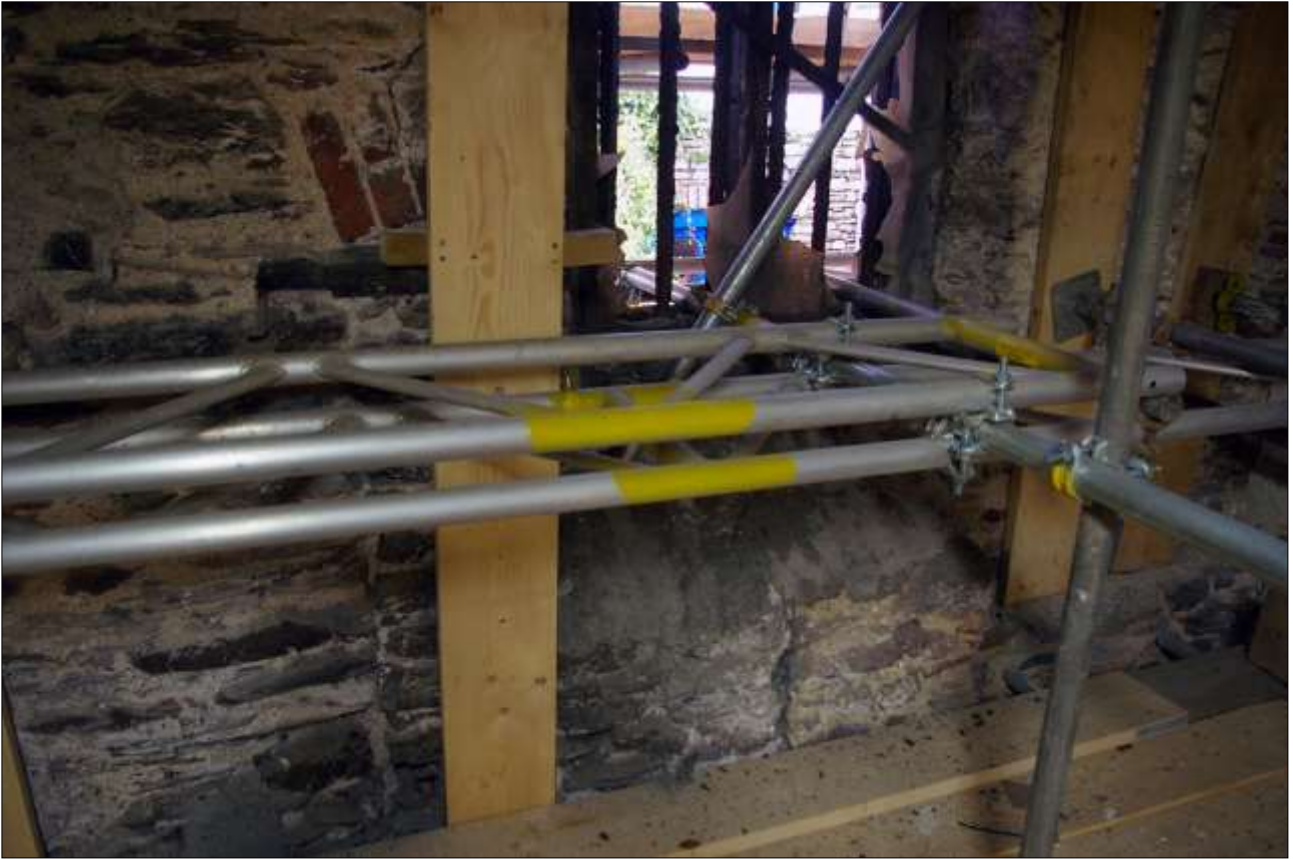
113. B2 FF INTERIOR, NORTH WALL, SHOWING W13 FORCED THROUGH THE BLOCKED FP2; VIEWED FROM THE SOUTH.

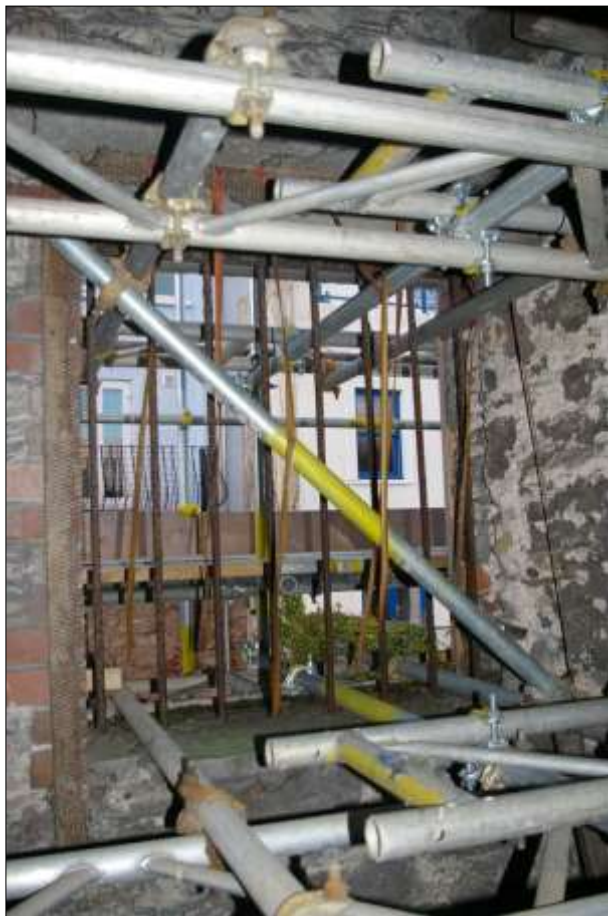
128. LEFT: B2 SF INTERIOR, NORTH WALL, SHOWING W20; VIEWED FROM THE SOUTH.

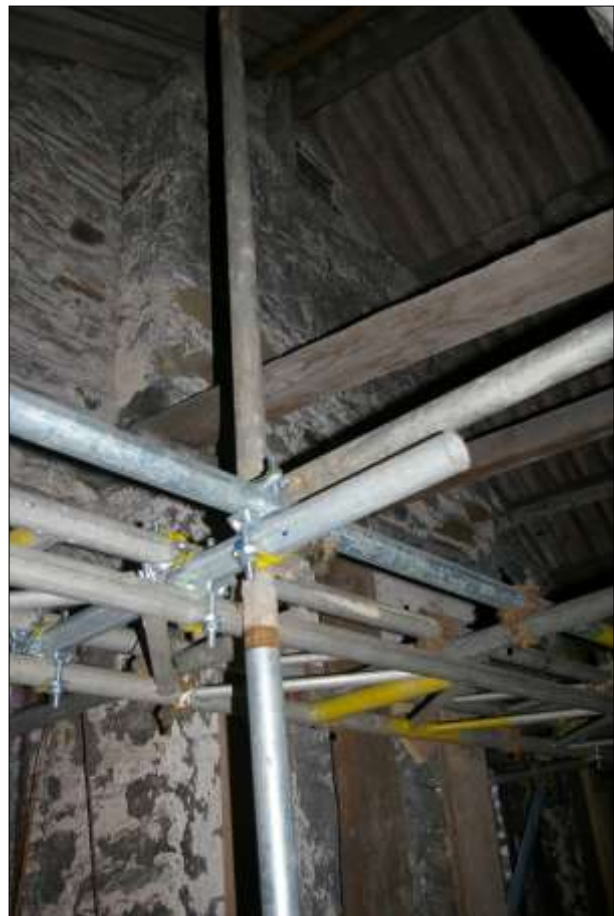
129. RIGHT: B2 SF INTERIOR, NORTH WALL, DETAIL OF THE STACK; VIEWED FROM THE SOUTH-WEST.

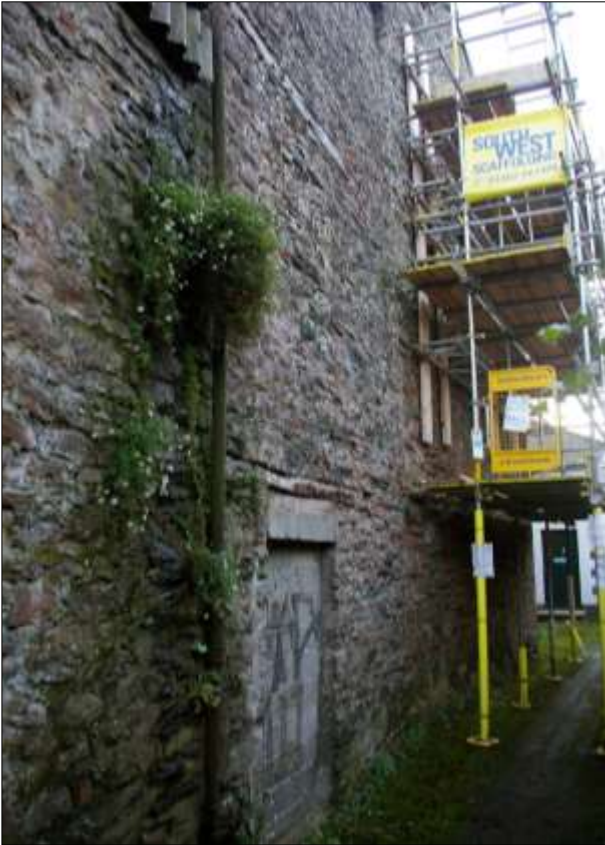
piers have failed through water damage the core build seems to be with a brownish-beige clay bond, possibly mixed with some lime. The north and south walls are of inferior mixed slatestone rubble set in a lime mortar. The bays between each pier are infilled with stone rubble, concrete block, with framed timber weather-boarding to the two northern bays (W16 and W17). The south wall features a forced or widened opening ground-floor level carried on a reused timber lintel (D13) with a slightly narrower loading door above (D19); above the loading door is a projecting gabled pentice of corrugated sheet steel covering a flywheel (S23); the timbers carrying the flywheel extend back to the first roof truss. The north wall has blocked doorways at ground- and first-floor level, with 17<sup>th</sup> century yoked timber lintels reused upside down (BO34 and BO46).

134. LEFT: THE NORTH WALL OF B3, SHOWING GF BO34 AND FF BO46; VIEWED FROM THE EAST.  
135. RIGHT: THE NORTH WALL OF B3 AND THE YARD WALL OF B4; VIEWED FROM THE WEST.

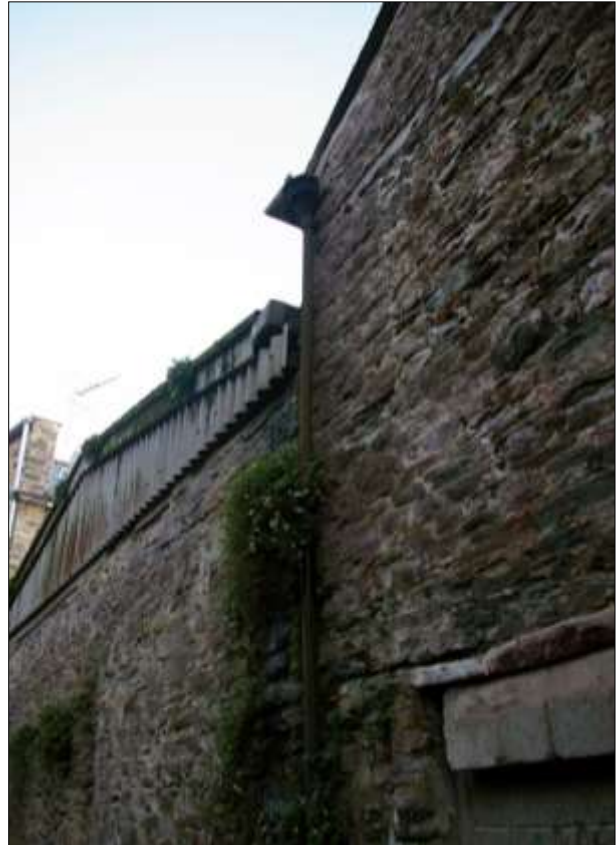
<b>B3 Exterior</b>		
<b>B3 Elevation NORTH</b>		Description
Fabric:		Reduced on the east side, patched with brick and hard cement mortars at the eaves. Repair to the north-east corner, infilling a damaged pier at the end of the open-fronted east elevation?
Blocked Openings:	BO34	GF blocked doorway with thin timber lintel to exterior, another possible yoked lintel to the interior. Blocked in concrete block. Poor quoins suggested this is forced.
	BO46	FF blocked loading door with timber exterior lintel. Shaped lintel to interior, used upside down; this may be a reused yoked lintel, or a reused structural timber (shaped upper section with clear sockets). Blocked with stone rubble.
Relationships:		Abuts B2; abutted by B4.
<b>B3 Elevation WEST</b>		Description
Relationships:		Built up against the east elevation of B2 (described above).
<b>B3 Elevation SOUTH</b>		Description
Fabric Description:		The south-west corner has been altered to incorporate a stack; brick and cement repairs.

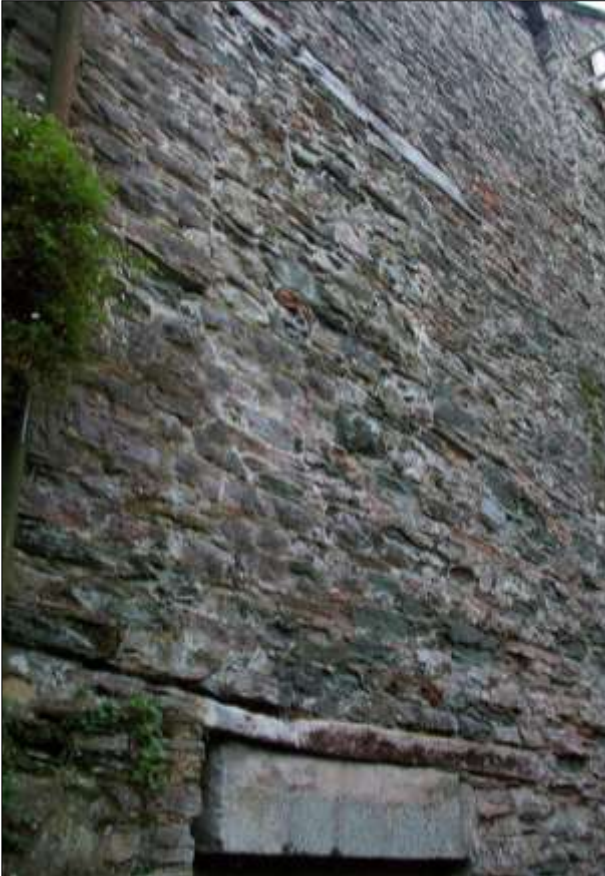
136. THE NORTH WALL OF B3 SHOWING FF BO46; VIEWED FROM THE NORTH-EAST.  
137. THE NORTH WALL OF B3 SHOWING BO34; VIEWED FROM THE NORTH-EAST.

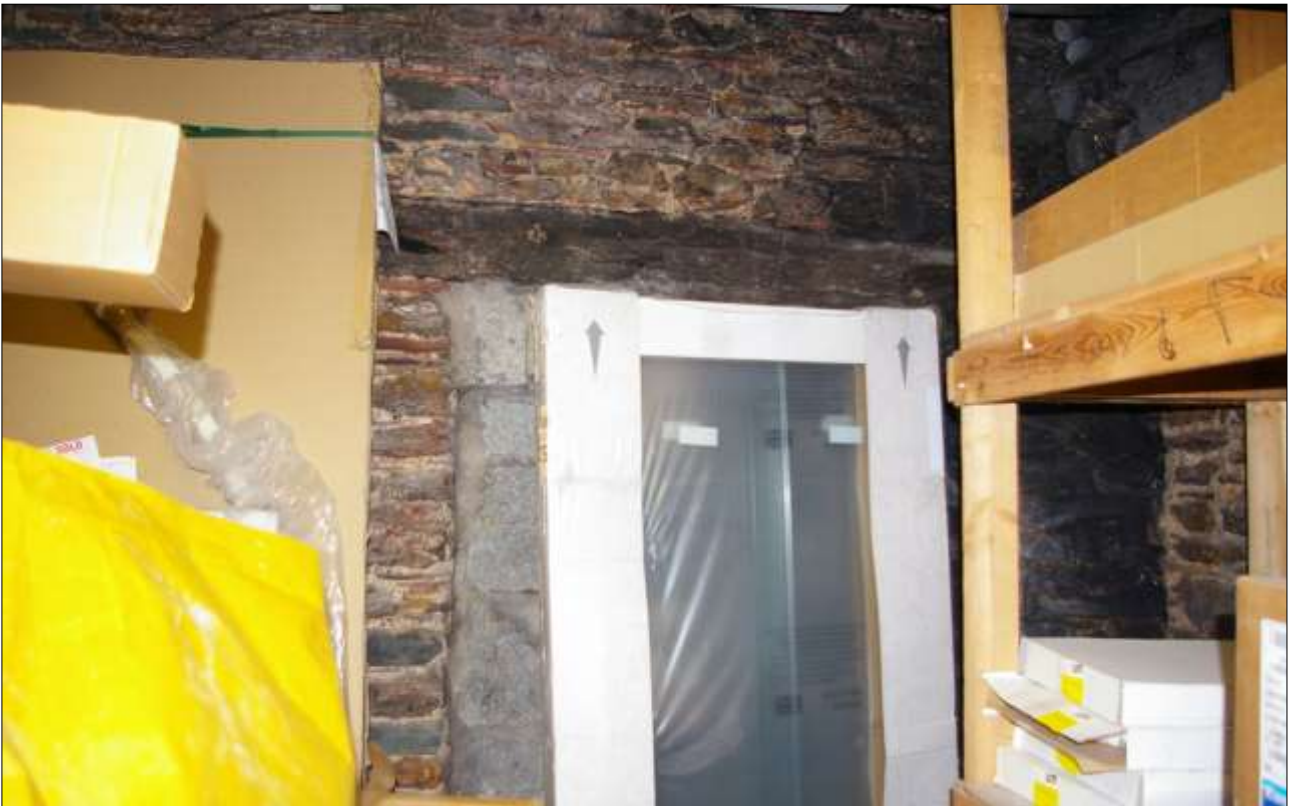
166. AS ABOVE, DETAIL OF BO34.
