TREVEDDA FARM
LANTEGLOS HIGHWAY
FOWEY
CORNWALL

Heritage Assessment

South West Archaeology Ltd. report no. 200510

Draft issued: 29th May 2020
Finalised: 9th June 2020

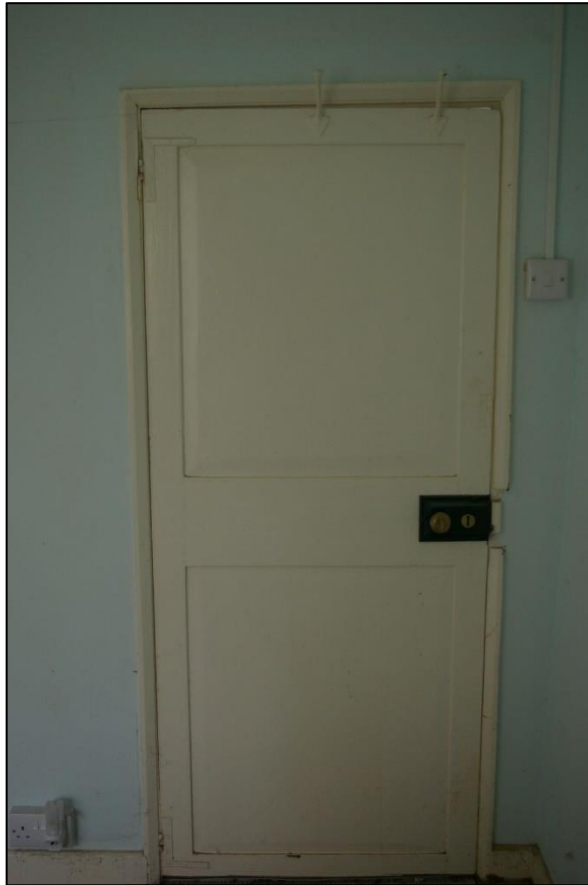
45. THE TWO-PANEL DOOR TO R11; FROM THE SOUTH.

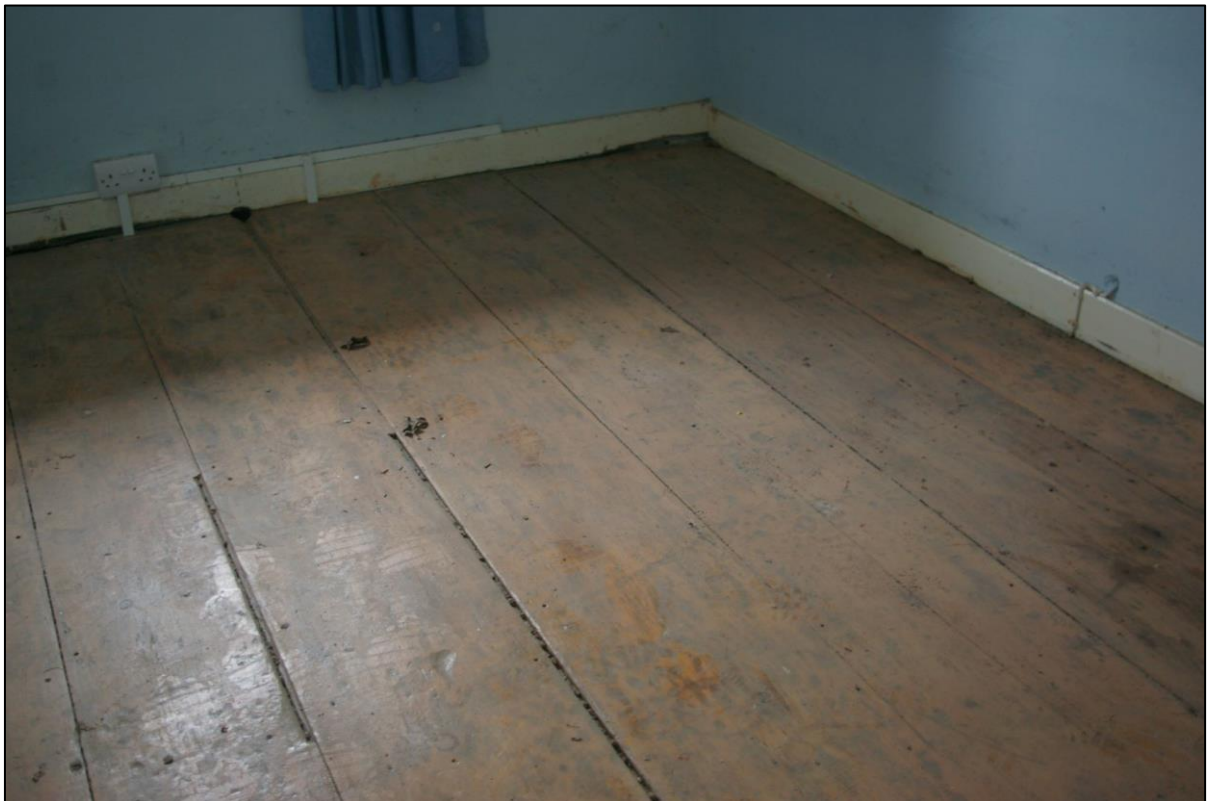
46. THE FLOOR IN R12; FROM THE EAST.

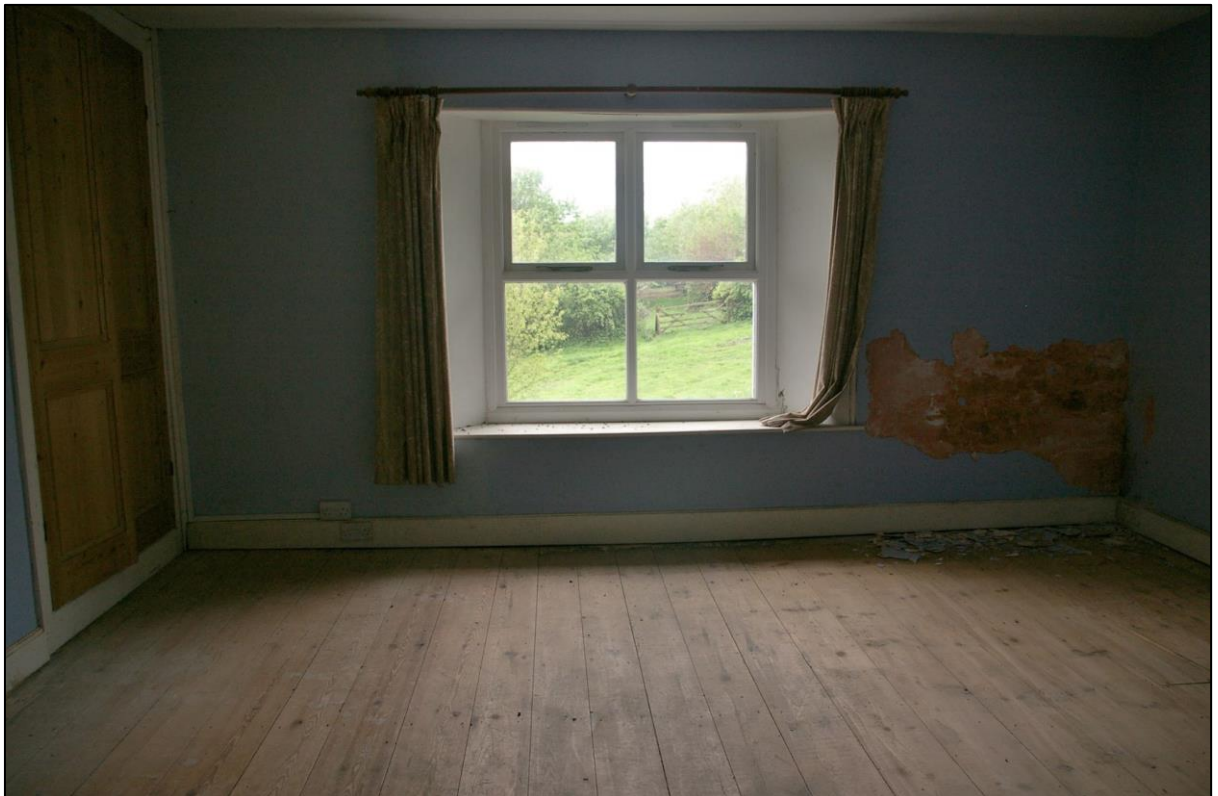
52. ROOM 15; THE SOUTH WALL; FORM THE NORTH.

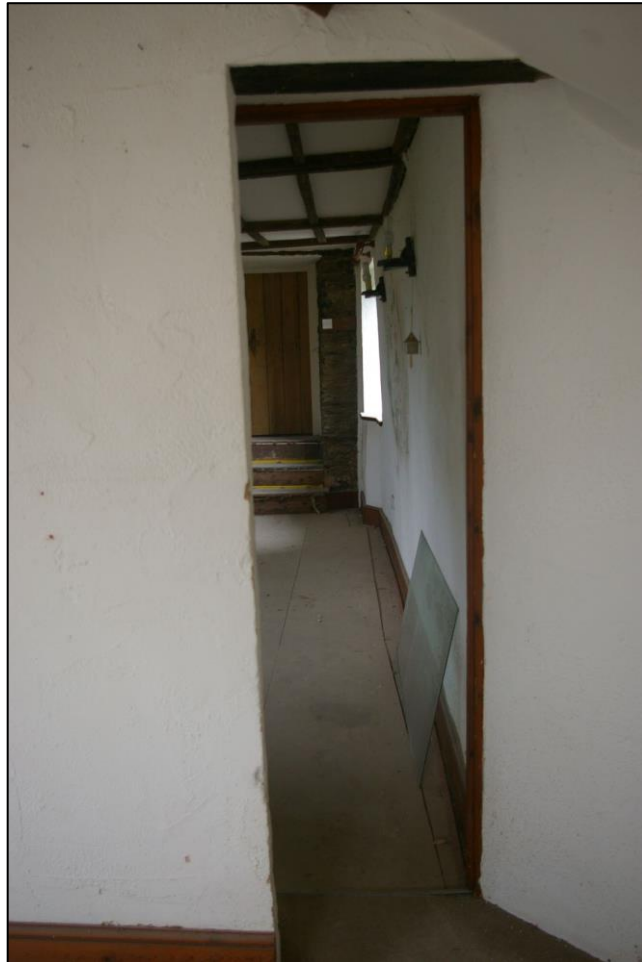
64. VIEW FROM ROOM 21, BACK INTO R20; FROM THE NORTH.
