**TREVEDDA FARM
LANTEGLOS HIGHWAY
FOWEY
CORNWALL**

Historic Building Recording

South West Archaeology Ltd. report no. 210120

Results of historic building recording

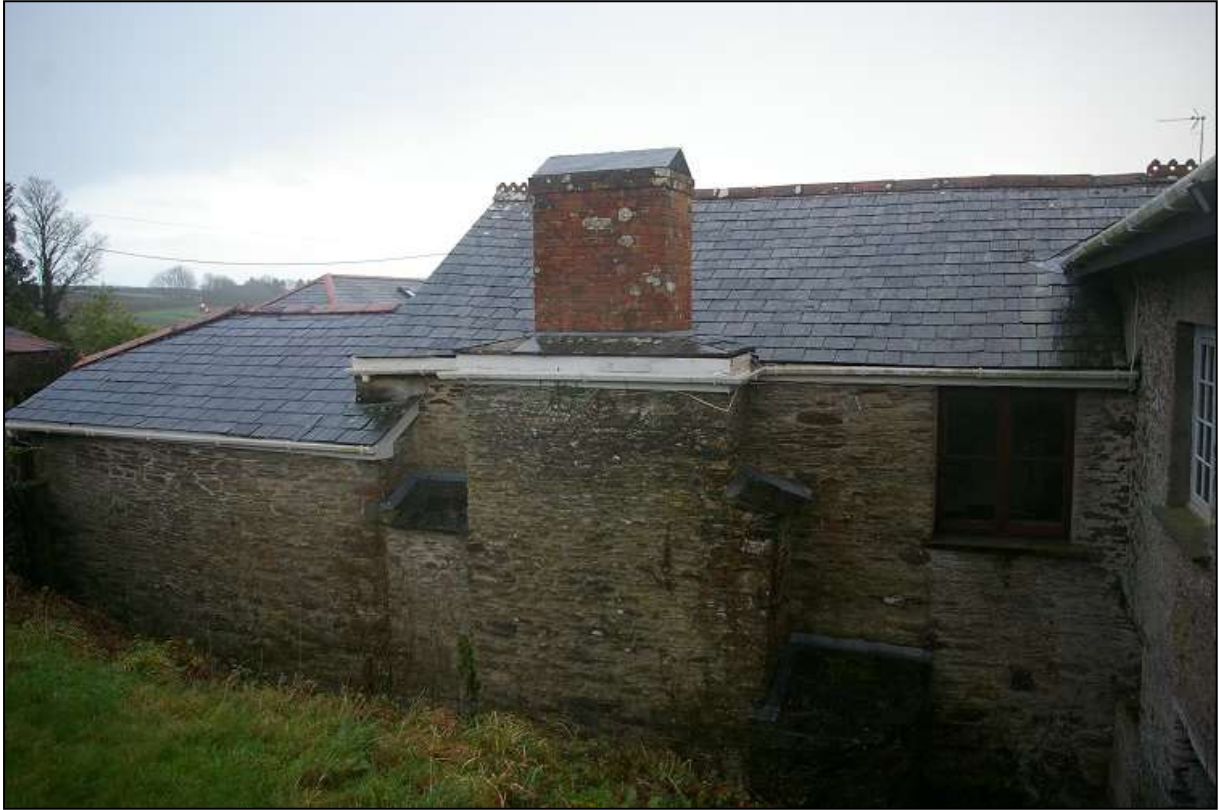
The north elevations of both elements of the service wing are gabled; the one and a half storey section is blind with slated eaves; with a possible blocked window to the east side. The single storey element is built onto the terraced slope of the bank and has an enlarged loading door now fitted a glazed modern conservatory-style access door. The west wall of the rear service wing is blind at the north end, with a blocked slit vent, the centre and south are dominated by a large lateral stack (Figure 11), with side tall projection containing a smoking chamber to the north and small altered bread oven to the south, both with slate capping. The bread oven appears to step out and be associated with a thicker wall at the base or the remains of foundations, suggesting the bread oven may predate the stack and there may be an even earlier phase of this feature. The chimney shaft is wide and deep, likely incorporating a first-floor fireplace and flue, it has been truncated and rebuilt in brick above the roofline and capped. To the south end of the wing, where it abuts the main range are the remains incorporated in the later wall of a short section of thicker battered stonework, with a build line and roofline scar, showing there was a narrow long linear projection along the rear of the main range. This has an enlarged window opening, now with a 20th century timber casement. This possible stair turret awkwardly abuts the north elevation of the west cross-wing, crowding an original timber mullion window.

FIGURE 11: THE REAR NORTH-WEST SERVICE WING; FROM THE WEST.

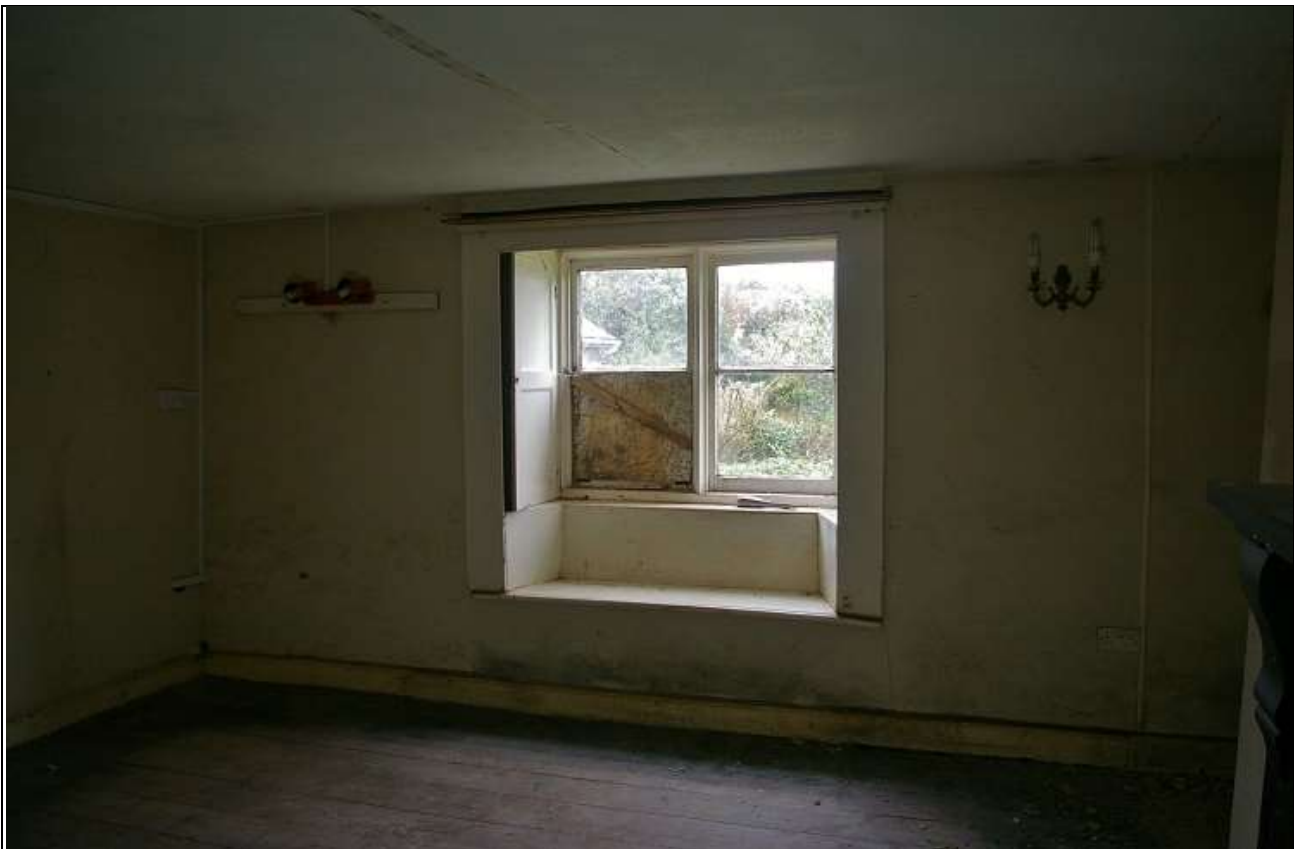
15. THE WINDOW IN THE NORTH WALL OF R4, WITH FINE SHUTTERS, MATCHING THOSE IN THE KITCHEN; FROM THE SOUTH-EAST.

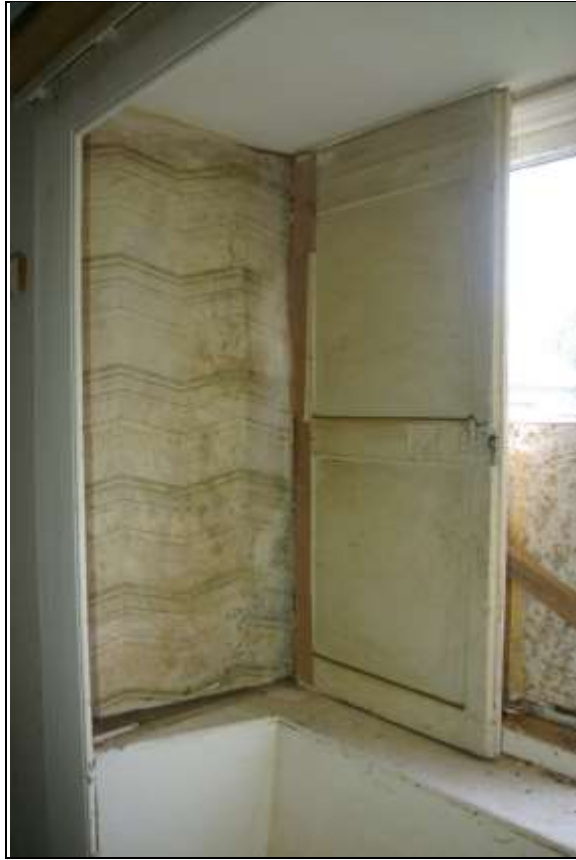
16. THE HISTORIC WALLPAPERS SURVIVING WITHIN THE SHUTTER BOXES IN R4; FROM THE EAST-SOUTH-EAST.

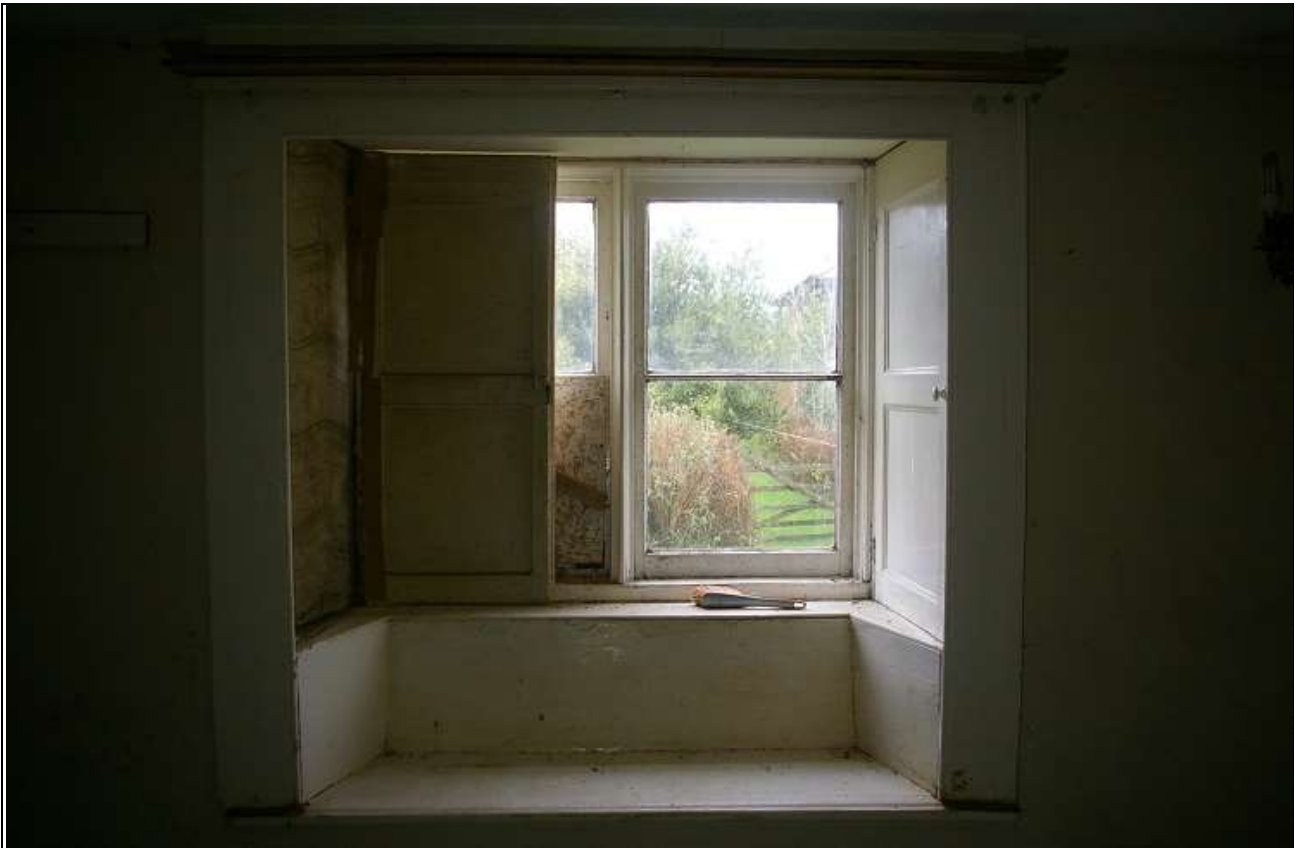
17. ANOTHER VIEW OF THE FINE WINDOW IN R4; FROM THE SOUTH.

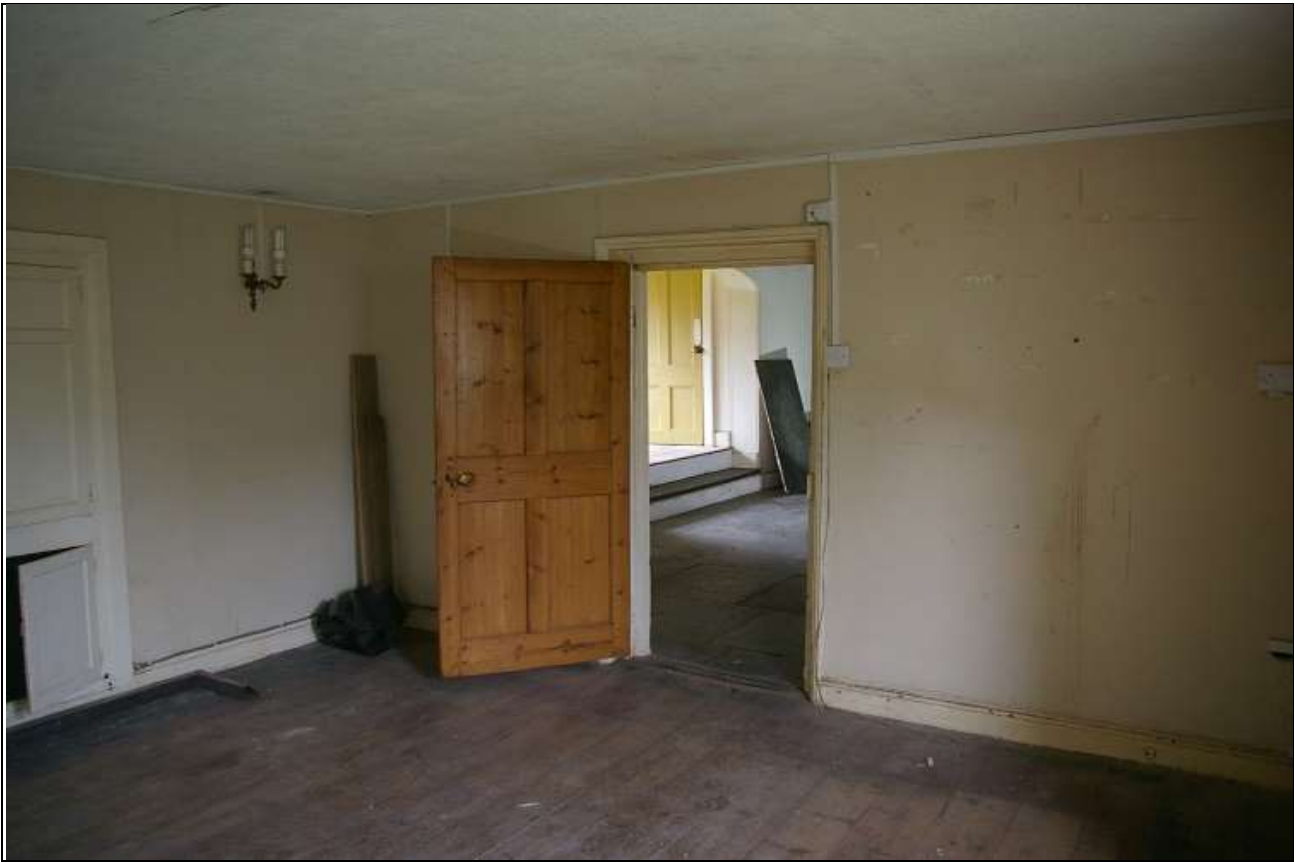
18. THE DOOR TO R2A THE KITCHEN IN A CHUNKY PARTITION WALL, A SMALLER FOUR PANEL DOOR; FROM THE NORTH-EAST.

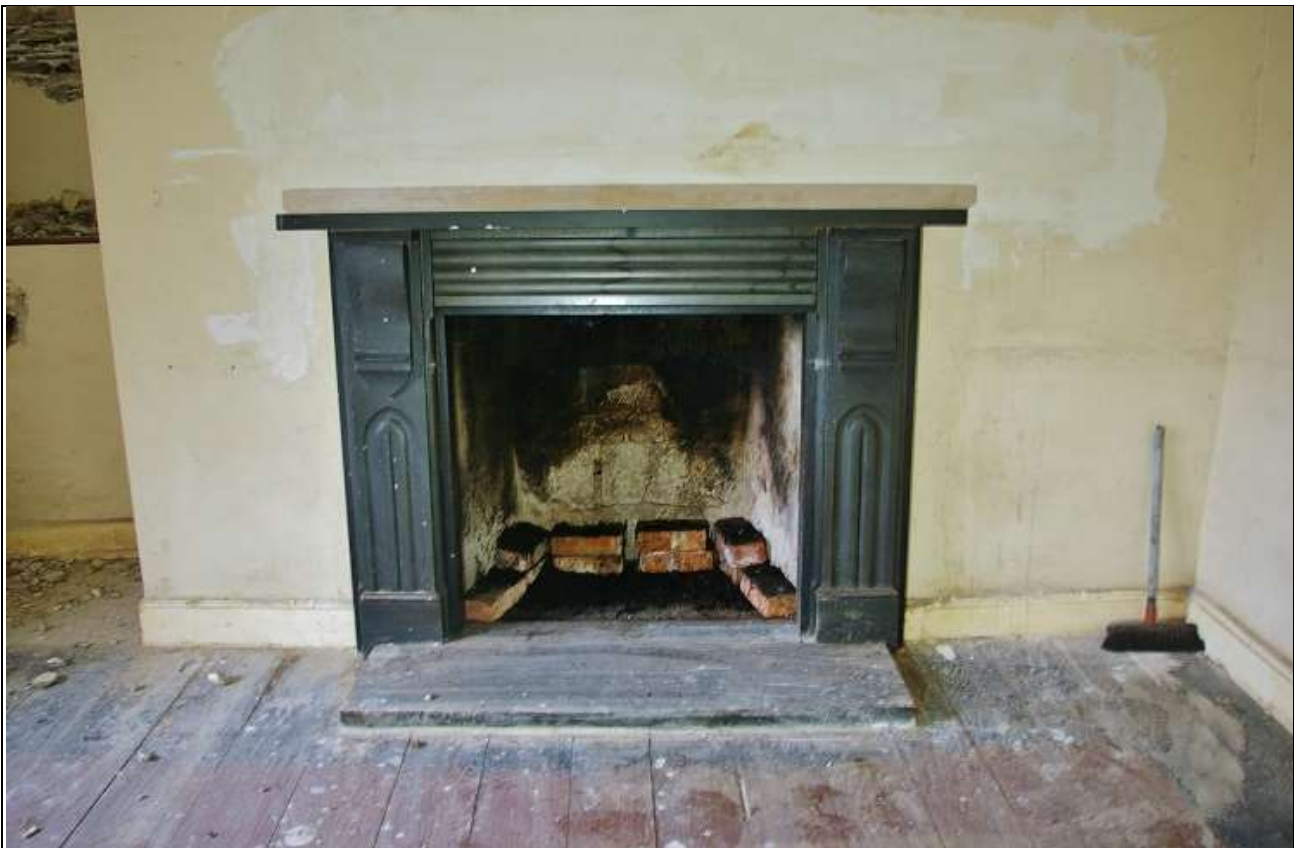
Fireplace:		Small box hearth the sides lime plastered but lined in brick, slate projecting hearth stone, scroll bracket to mantel on fluted shallow flat pilasters. The mantles surround is of a heavy dark smoothly grained black stone (serpentine?). This fireplace sits offset within a massive stack built within the footprint of the room, against the thick battered east wall. Scarring on the plaster above the mantle indicate repairs but there is also shadowing showing there was a much larger open hearth here, which has been in-filled.
Significant Details		There is an odd alcove to the north side of the stack, with thick section of wall to the base, now forming a ledge with plank sill. This may be a removed bread oven or blocked opening of some kind. On the south wall there is a panelled cupboard set into a blocked doorway; two-panelled paired doors to the main-upper cupboard and a single panel paired set of doors to the lower half. The inner face of the panels are raised. Cupboard doors feature small ceramic knobs, wooden catches and two deep timber shelves to the panelled interior. The frame of cupboard displays convex and bead moulding. Stylewise this is very similar to the cupboards in the kitchen, R2a.

19. THE HEAVY BLACK STONE, POSSIBLY SERPENTINE FIREPLACE IN R4; FROM THE WEST.

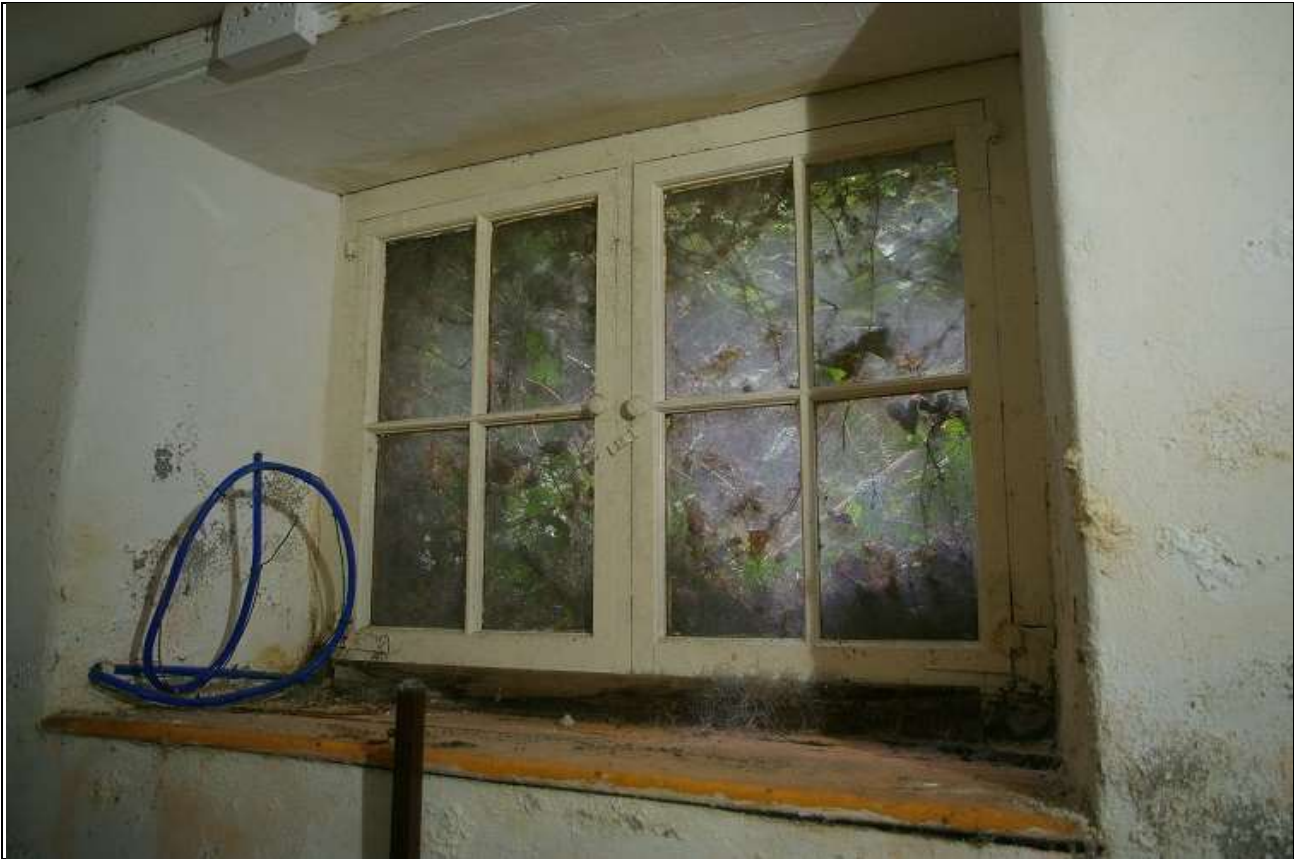
23. R6, THE CASEMENT WINDOW IN THE WEST WALL; FROM THE EAST-NORTH-EAST.

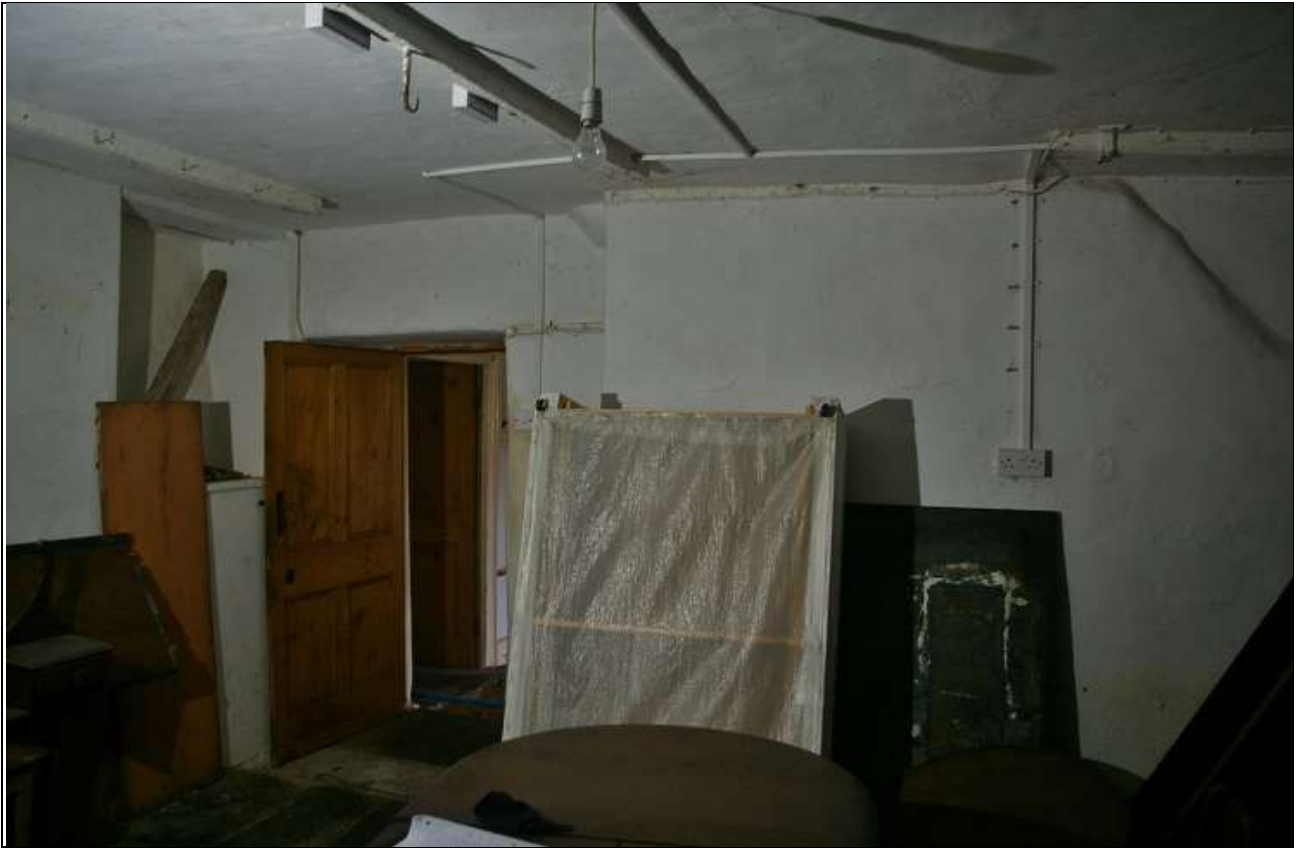
Room 6 (R6)		
Description		
Function:		Service Room/ Dairy / Scullery
Ceiling		Features historic whitewashed beams and braced timbers, connected with clenched nails with iron hooks and loops for hanging meat, cheese etc. Lath and plaster ceiling, at least 19 th century as very weathered. Damage to the south west corner with obvious plasterboard replacement.
Walls		The north wall is slightly battered, lime plastered and whitewashed. It has a central window with window seat, a blocked window to the northeast behind the door and a large slate-lined keeping place to the north-west. The west wall is significantly battered, lime plastered and whitewashed. The south wall is lime plastered and whitewashed, it is blind. The east wall is lime plastered and painted, a lath partition and a large inserted stack, which is shouldered/hacked and patched to the south side. There is a blocked fireplace in this stack, now plastered over. Door to R2a to the north-east corner.

25. THE SERVICE ROOM, POSSIBLY THE FORMER INNER ROOM, R6; FROM THE WEST-SOUTH-WEST.

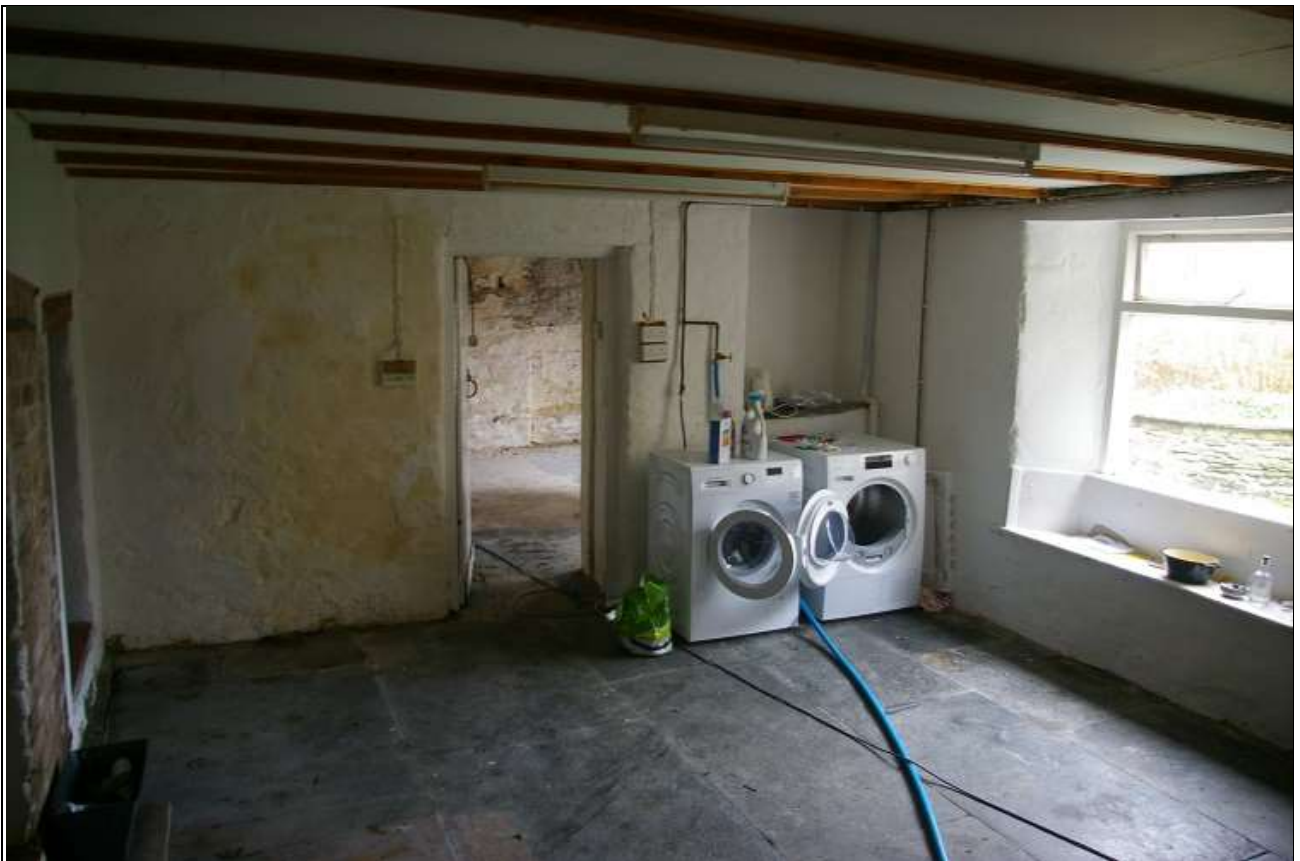
26. R7A, THE PURPOSE BUILT KITCHEN, WITH ADDITIONAL SERVICE ROOM BEYOND. THIS ROOM HAS A GOOD PLANK DOOR AND WINDOW SEAT, WITH FLAGSTONE FLOOR; FROM THE SOUTH-WEST.

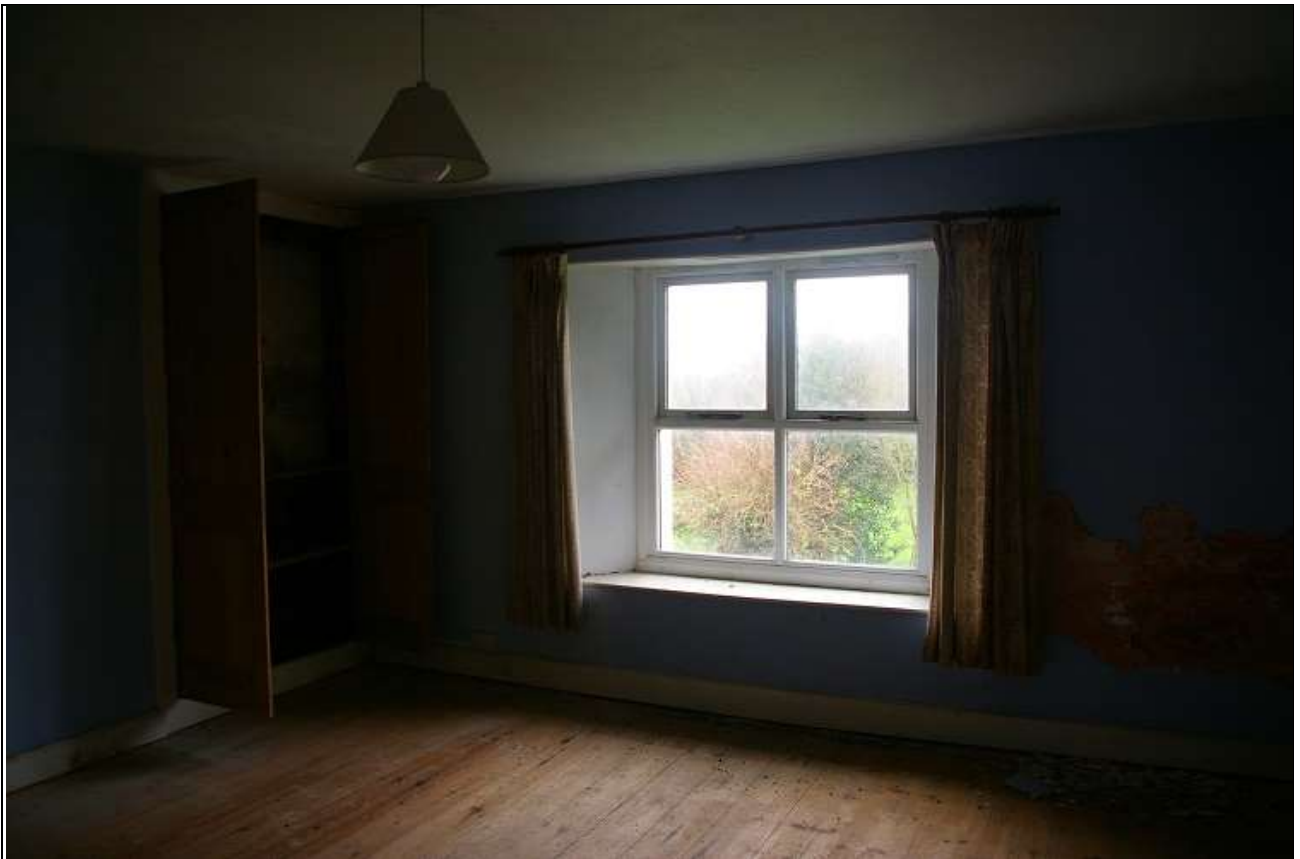
39. THE WINDOW IN THE SOUTH WALL OF R11; FROM THE NORTH-WEST.

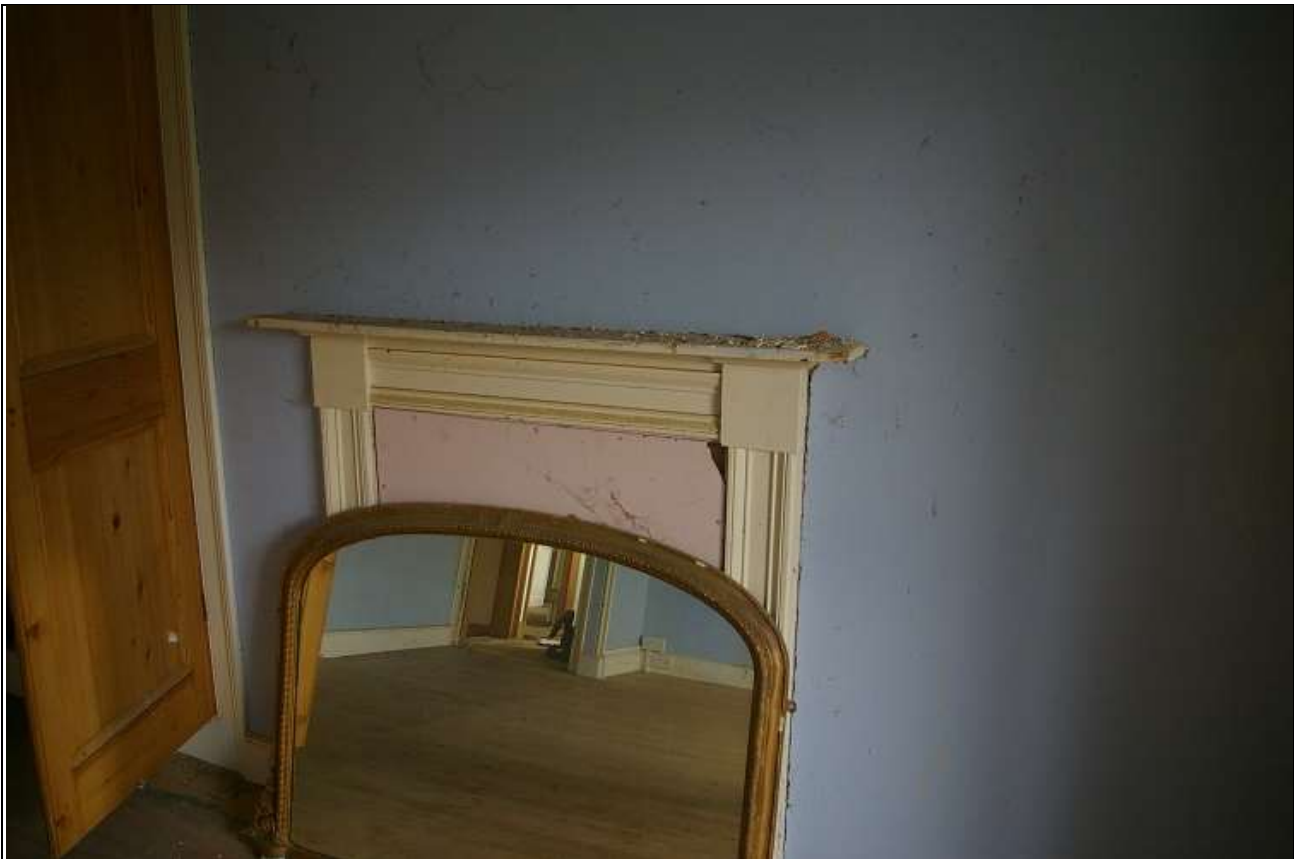
41. MANTLED FIRE SURROUND; FROM THE SOUTH-WEST.

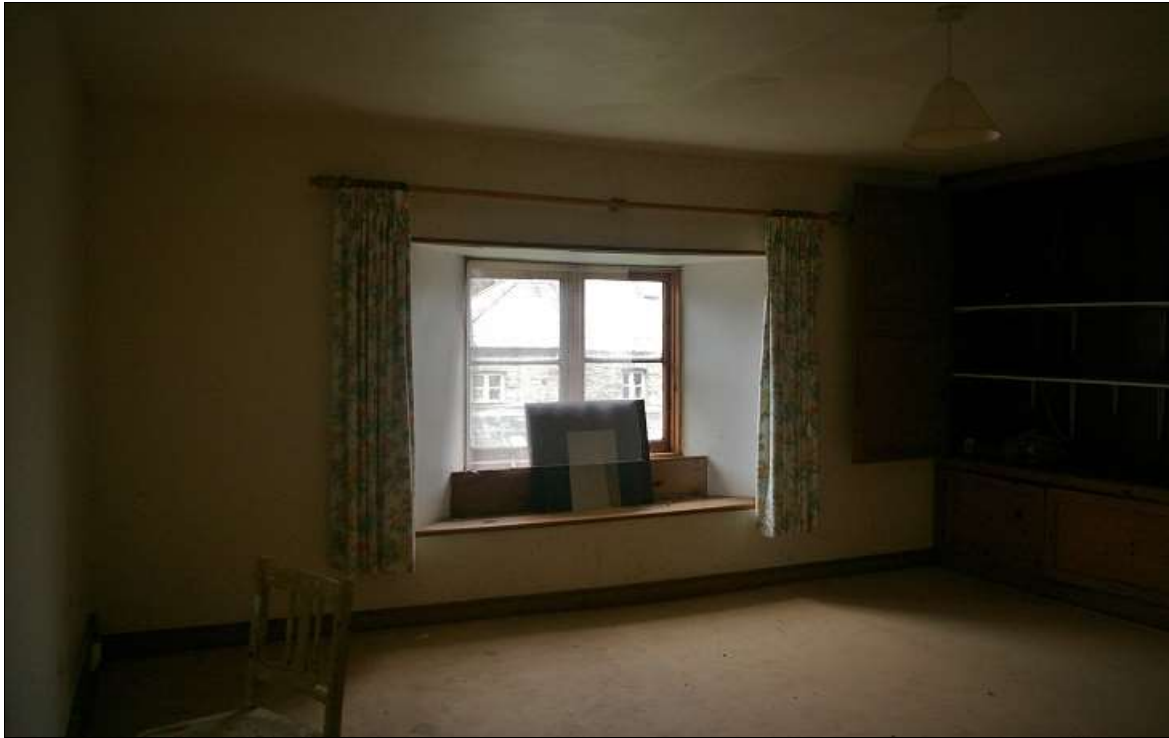
44. THE WINDOW IN THE NORTH WALL OF R12; FROM THE SOUTH-WEST.

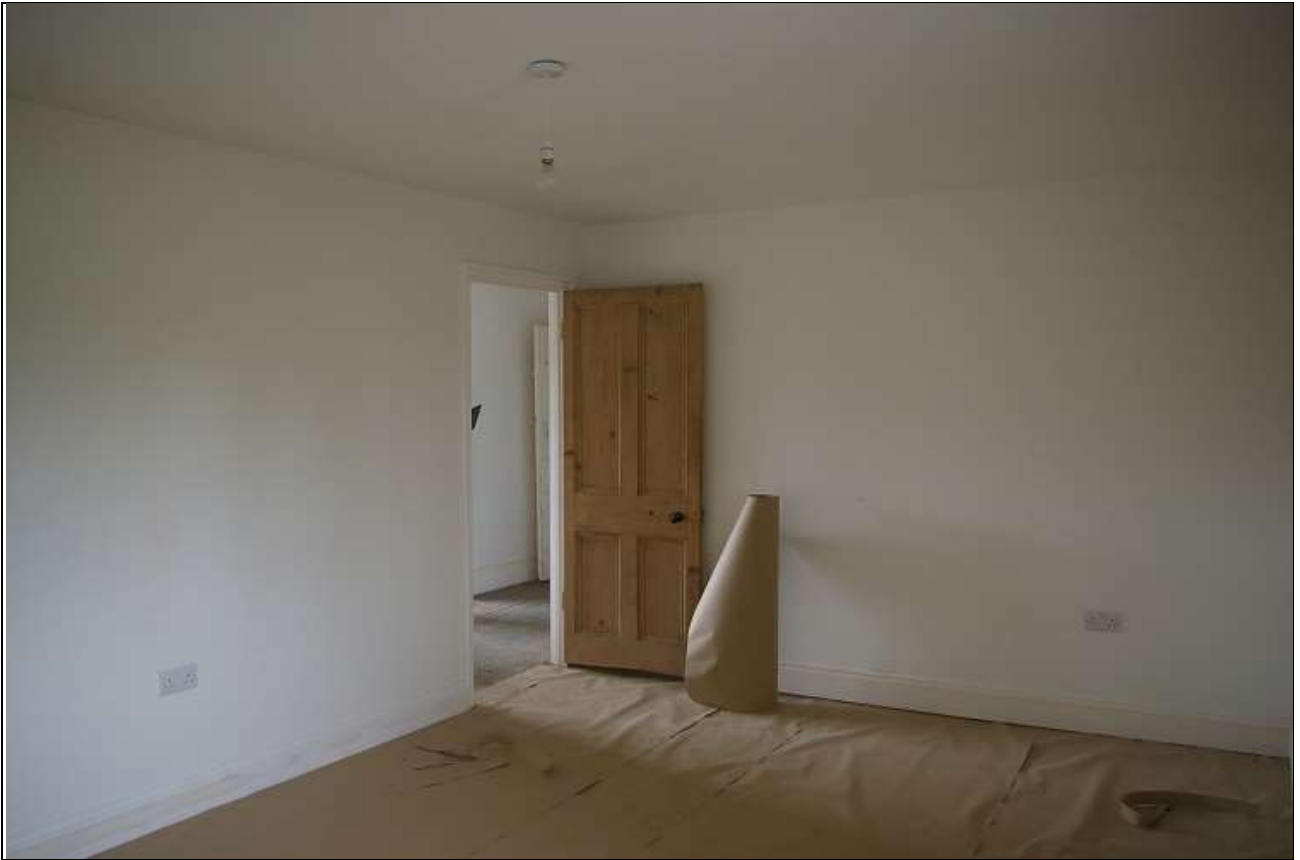
50. R13, CHAMBER OVER HALL; FROM THE NORTH-EAST.
