DERELICT COTTAGES OLD PORTREATH ROAD REDRUTH CORNWALL

Historic Building Recording

South West Archaeology Ltd. report no. 231020

Derelict Cottages, Old Portreath Road, Redruth, Cornwall

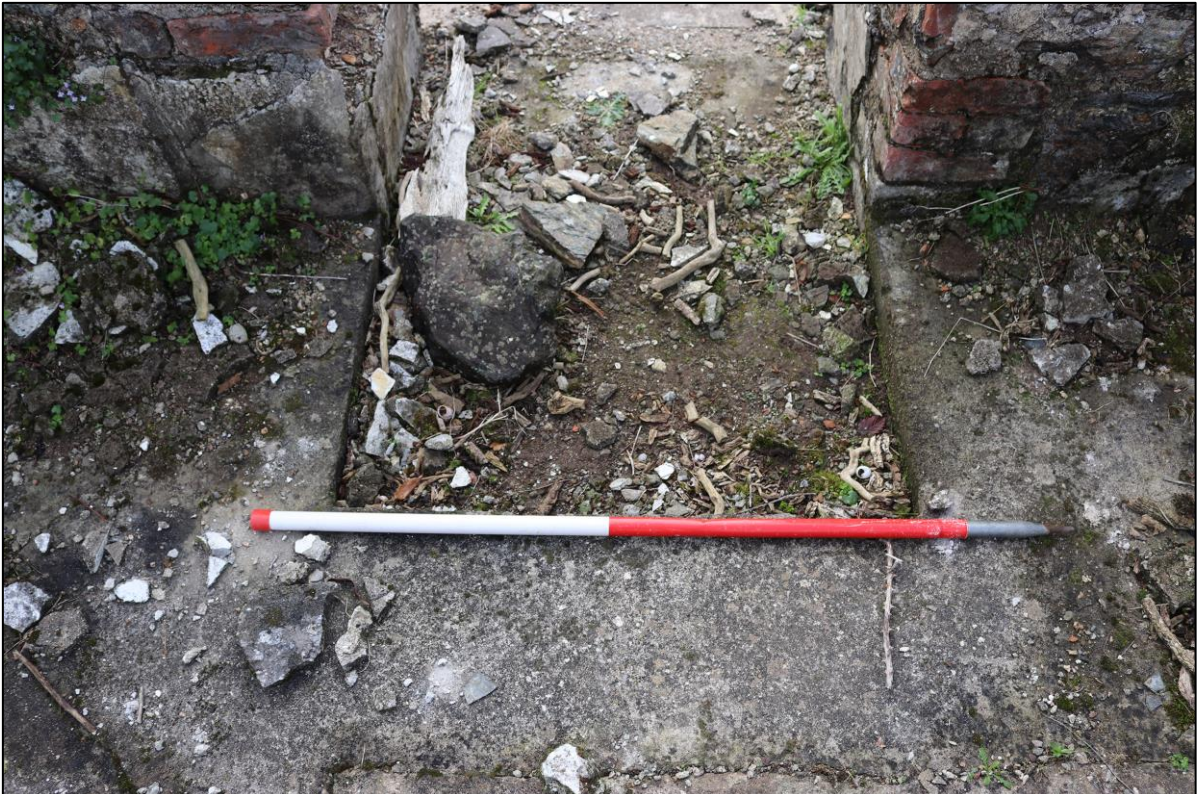
28. SCREED STEP UP TO LEAN-TO FOR C2.

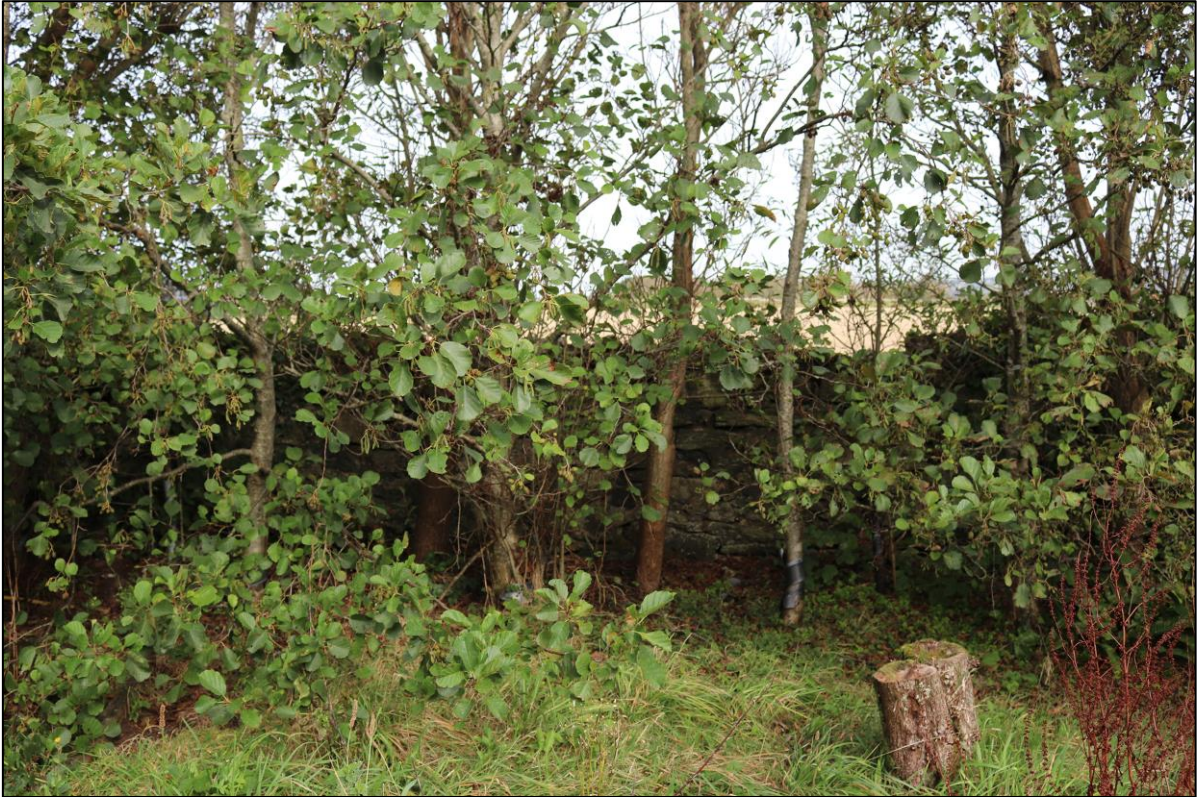
41. THE NORTH BOUNDARY WALL OF EAST GARDEN FROM THE SOUTH.
