**HISTORIC BUILDING RECORDING & WATCHING BRIEF:
THE MANOR HOUSE
THE GREEN
CULWORTH
NORTHAMPTONSHIRE**

NGR: SP 5425 4708

December 2012

ASC: 1566/CMH/1

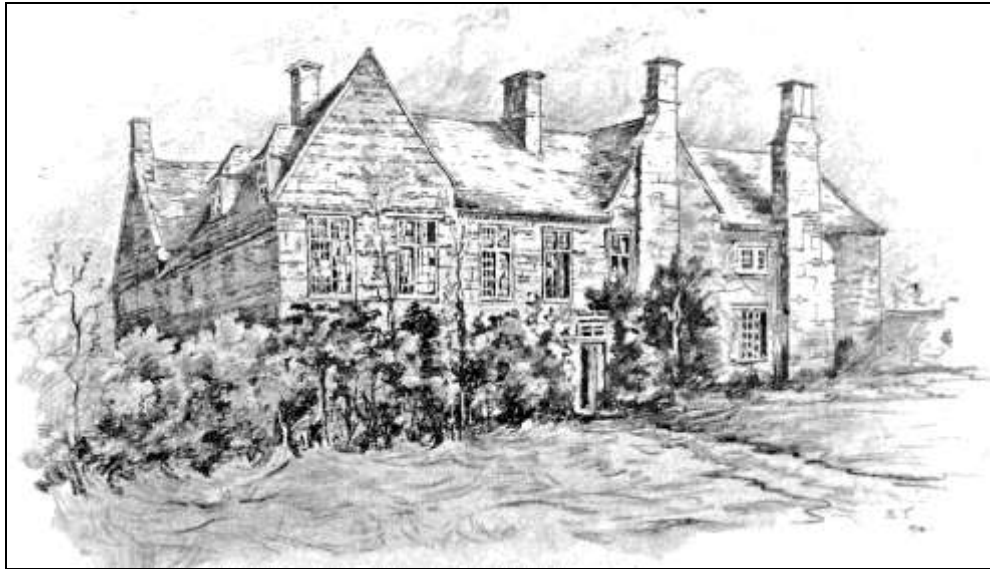
Figure 8: Thornton's drawing in Macnamara, 1895

The west elevation as depicted in Macnamara's history of 1895 shows a window between the two chimney stacks where there is now a door into the hall and a door to the north of northern chimney stack. Any further openings at ground floor level are obscured by vegetation (Fig. 8). The first floor window to the south of the northern chimney stack had not yet been installed.

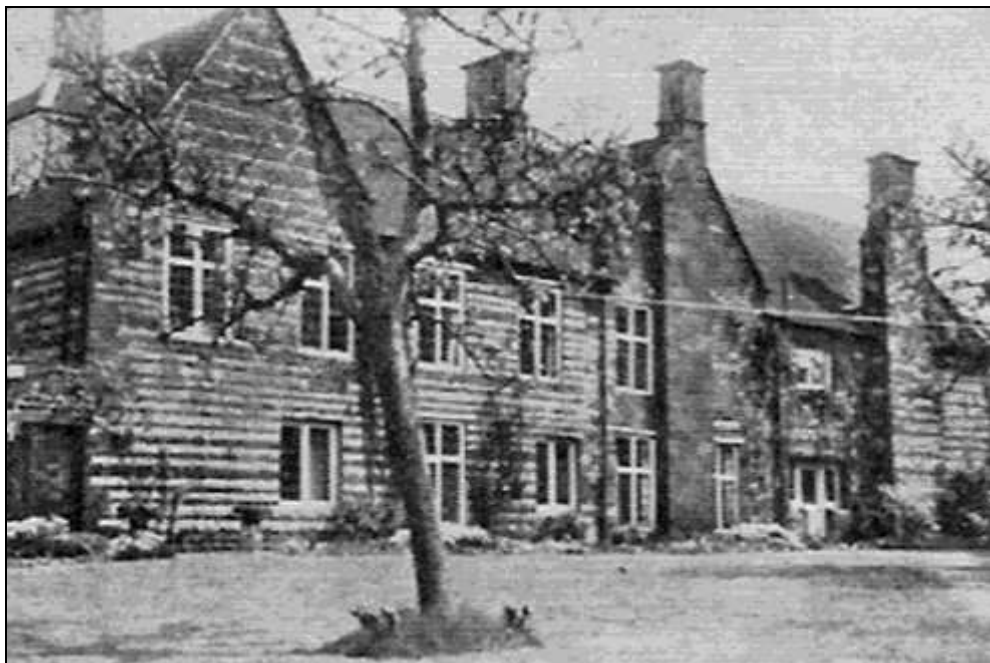
Figure 9: Photo from the sales particulars, 1956

The photograph accompanying the sales particulars of 1956 shows the west elevation very clearly. The present door had been installed to the hall and the windows beyond the northern chimney stack alternate between the tall mullion and transom windows and 2-light casements. The present door to the kitchen and the window to the north of it are as yet missing (Fig. 9).

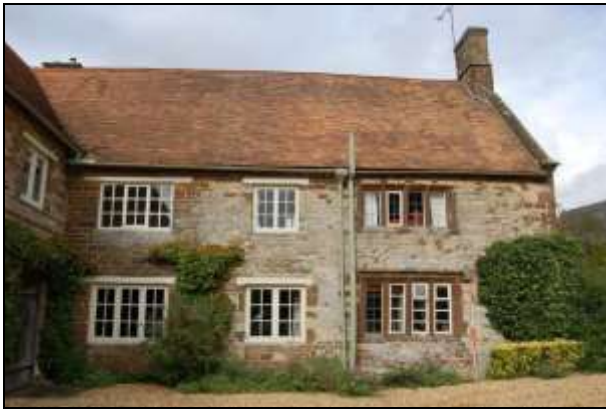
Plate 1: South elevation

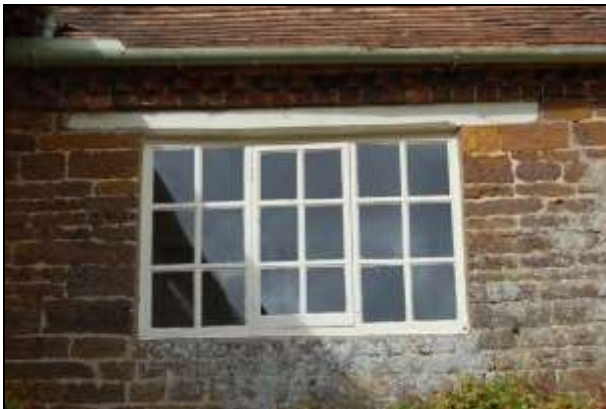
Plate 3: South elevation: timber window

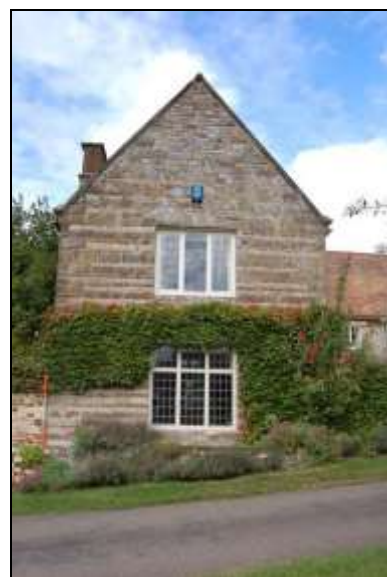
Plate 6: West range: south elevation

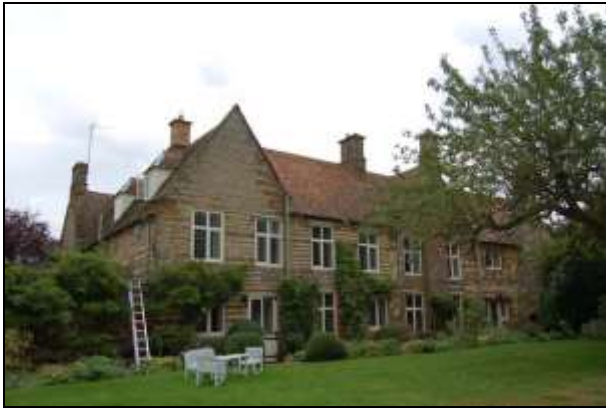
Plate 7: West range from the northwest

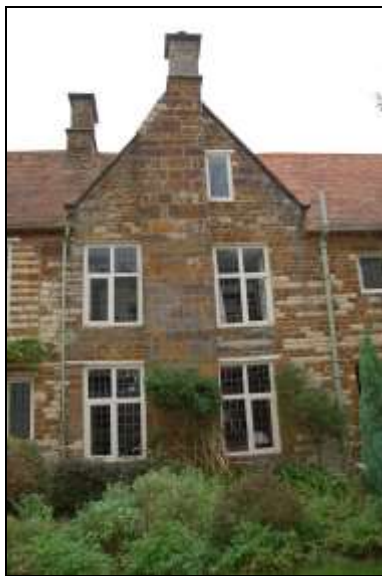
Plate 9: West elevation: central gable

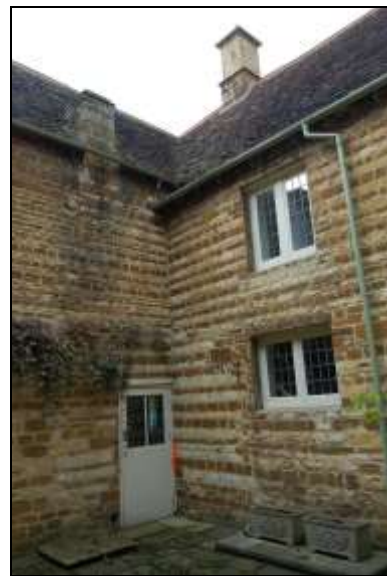
Plate 10: Internal Courtyard: northwest corner

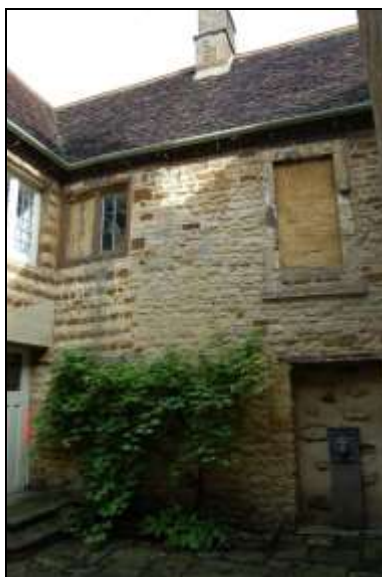
Plate 11: Internal Courtyard: northeast corner

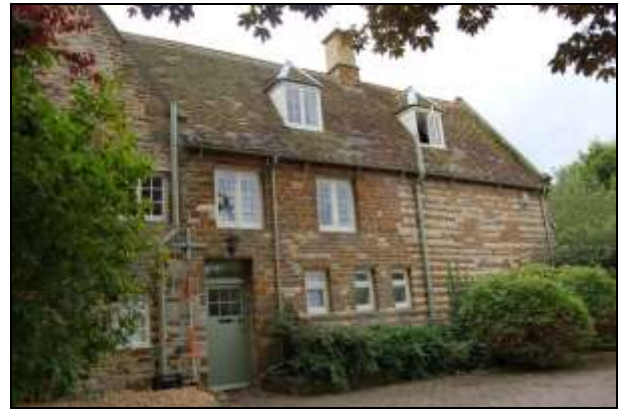
Plate 14: North elevation

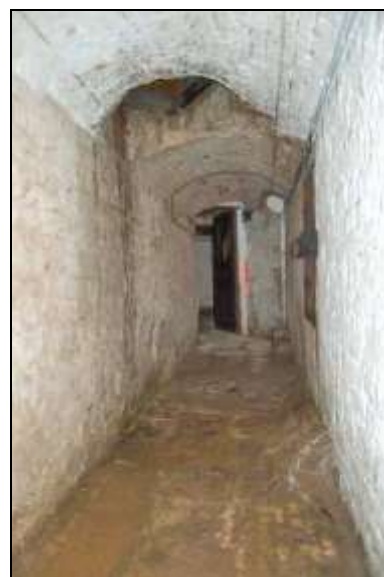
Plate 18: Passage between Cellars 1 & 2

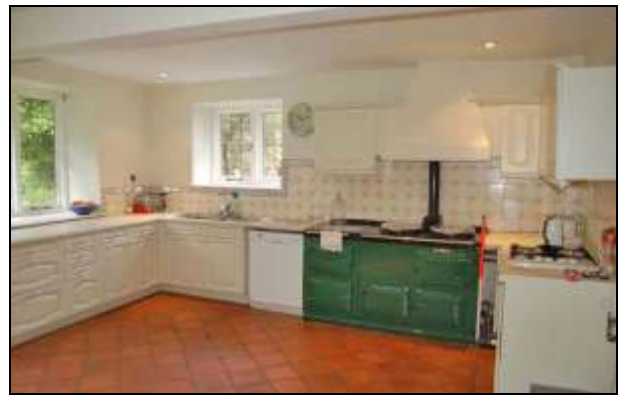
Plate 22: Room G1: north wall

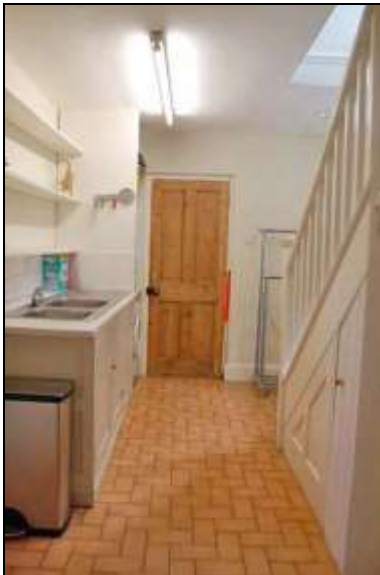
Plate 27: Room G3: looking east

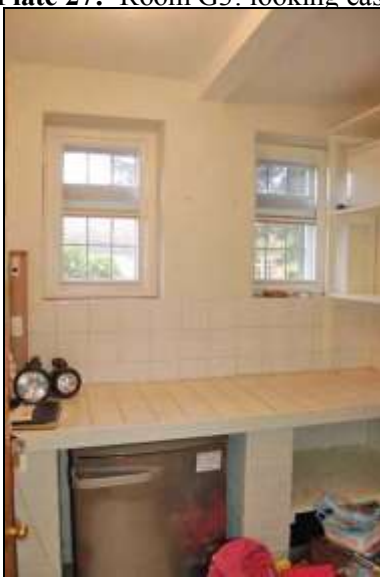
Plate 29: Room G4: north wall

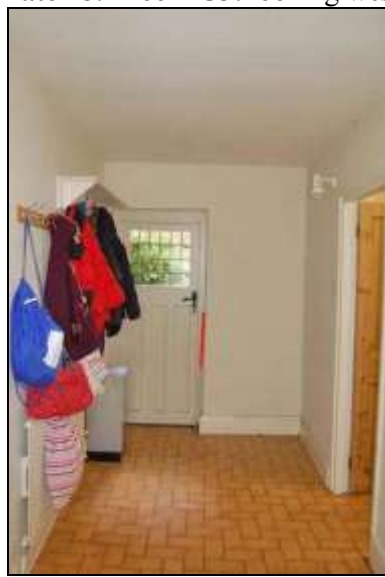
Plate 30: Room G5: looking east

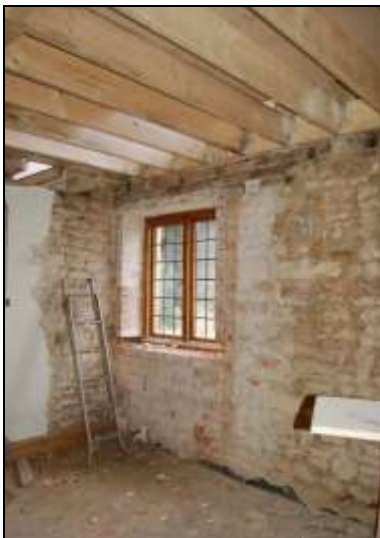
Plate 103: Room G2: modern brickwork below the southern window

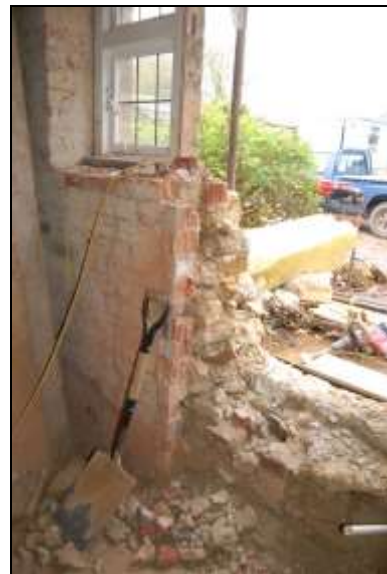
Plate 104: Room G6: wall fabric
