HISTORIC BUILDING RECORDING ALL SAINT'S CHURCH CROYDON CAMBRIDGESHIRE

on behalf of Croydon Parish Council

September 2005

ASC: 707/CAS/1

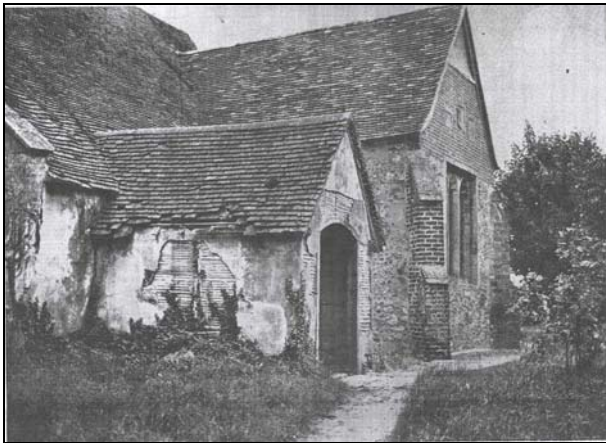
Plate 1: South side of church in 1937

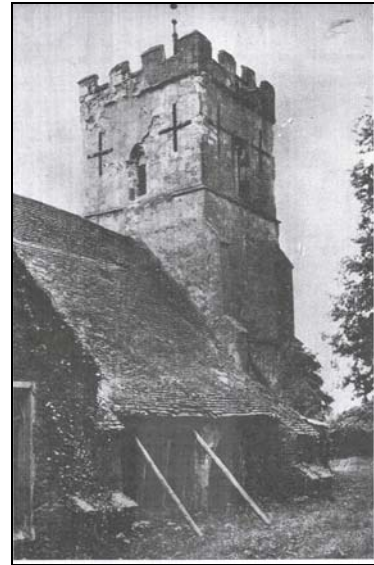
Plate 2: North side & tower in 1937

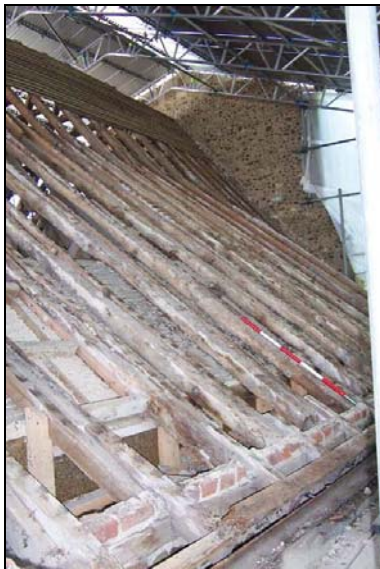
Plate 3: North side of roof

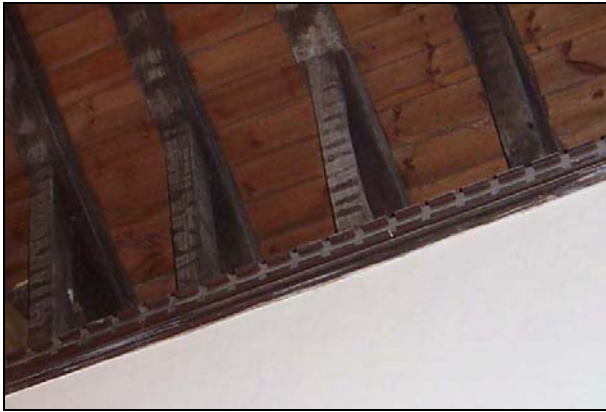
Plate 13: Dentilation in Strethall church

The chancel roof in St. Mary's Church, Strethall is an excellent example of a trussed rafter roof with no ceiling. In form it is identical to the nave ceiling at All Saint's, Croydon, down to the dentilated wallplates and new tiebeams, which in this case are less than five years old. Both this and the nave roof are said to be of 15th century date (Church leaflet,) as is the soulace braced roof in St. George's Guildhall, King's Lynn (Plate 21). Both have been extensively restored, and it is of interest to note that there had also been considerable lateral movement in the wall of the Guildhall. This was addressed with the addition of king posts (now removed) and five massive buttresses on the north wall (Richards 1992; www.touruk.co.uk/houses/housenorf_stge.htm).

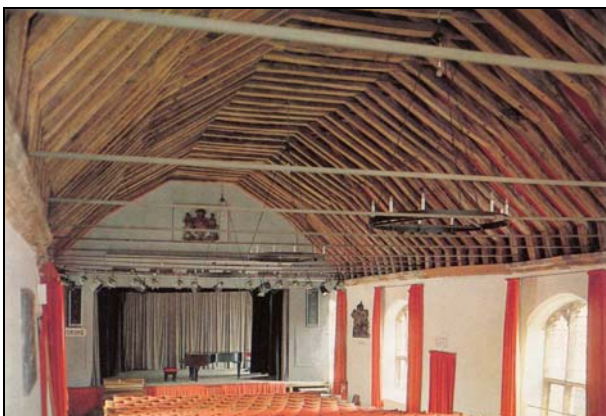
Plate 23: St. George's Guildhall, King's Lynn
