**HISTORIC BUILDING RECORDING
ST. DENIS' CHURCH
EAST HATLEY
CAMBRIDGESHIRE**

on behalf of South Cambridgeshire District Council

December 2005

ASC: 717/EHC/1

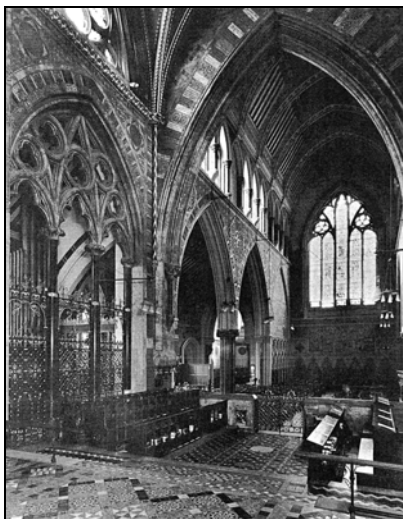
- 5.2** His buildings are highly distinctive and range from the simple colour schemes of most of his churches, including those at Tadlow and East Hatley, to the screaming polychromic effect of All Saint's, Margaret Street (Plate 5). His objectives on restoration projects were to improve the structural and environmental elements of the building to make it safe and warm as well as re-arranging the interior as necessary to allow a better use of space for liturgical purposes (Thompson 1971, 415). His philosophy was to maintain as many of the medieval elements of a building as possible, designing fixtures and fittings if necessary, to remove all unnecessary post-reformation material unless it was of a high standard and to carry out sympathetic restoration rather than just repair, re-using as much of the original material as possible.

Plate 5: All Saint's Church, Margaret St.

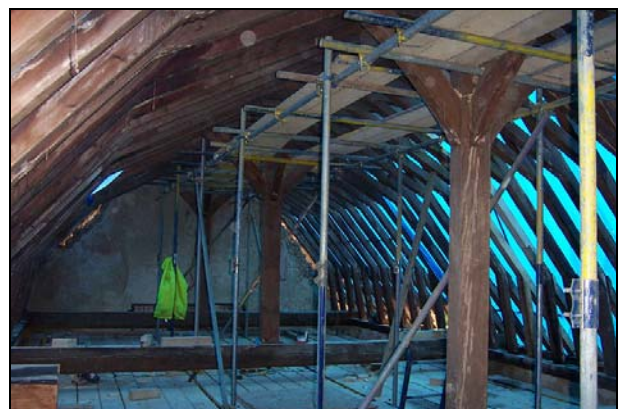
Plate 6: Nave roof, looking west

The structural evidence suggests that the rebuilding of the church was slightly more extensive than initially envisaged. The nave roof was not repaired but completely rebuilt using predominantly Baltic pine, possibly the Memel fir specified in the Schedule of Works (Plate 6). The style appears to have been maintained although the terminology has changed since the mid 19th-century; today the roof would be described as a crown post rafter roof, a fine medieval example of which is to be found at the church of St. Michael and All Angels at Copford, Essex (cf. Brunskill 1994, 173). Butterfield reduced the number of tiebeams from 4 to 3.

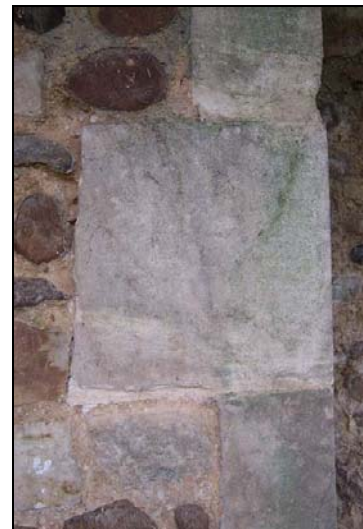
Plate 10: Stone dressing to chimney
