HISTORIC BUILDING SURVEY REPORT:

BRUMBY RESOURCE CENTRE, BRUMBY, SCUNTHORPE, NORTH LINCOLNSHIRE

By
Allen Archaeology Limited
Report Number AAL2016006

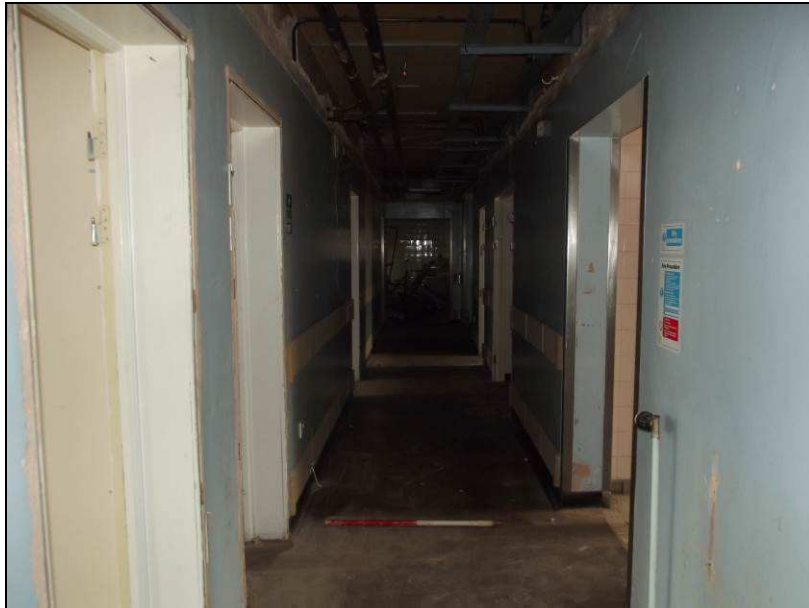
- 6.9 The ground floor of the main part of the building appears to have been largely in use for catering or similar tasks, due to the use of the space as part of a catering training facility. A series of rooms of varying shapes and sizes are arranged around a central corridor running east-west (Plate 11). The original staircase is to the west of the building in the corridor (Plate 12). For the purposes of the report, the building has been divided into a series of areas (B1 – B8) defining different areas of use.

Plate 11 (shot 129): Main corridor of Barton House, looking east

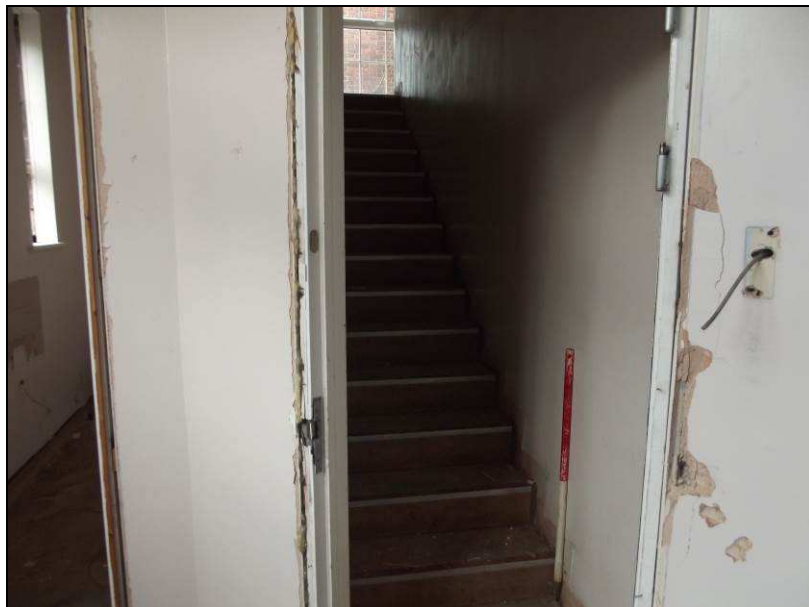
- 6.10 Area B1 is the eastern extension and has been used as an entrance into the building which has now been blocked (Plate 13). The space provides access to the upper floors (Plate 14) and the eastern extent of the building (Plate 15), two lavatories are also present on either side of the entrance.

Plate 14 (shot 95): Staircase in B1, looking west

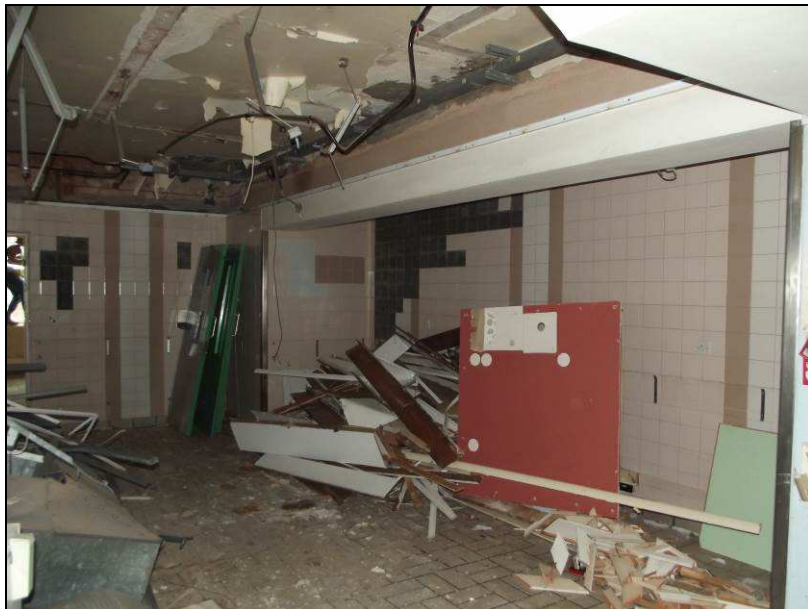
- 6.12 B3 is a continuation of B2 and consists of two conjoined spaces, filled with demolition material at the time of the survey (Plate 17). The space is tiled throughout which can be seen clearly at the southern extent of this space (Plate 18). To the west is an entrance with double doors, now boarded up (Plate 19).

Plate 18 (shot 104): Tiled area in B3 looking southeast

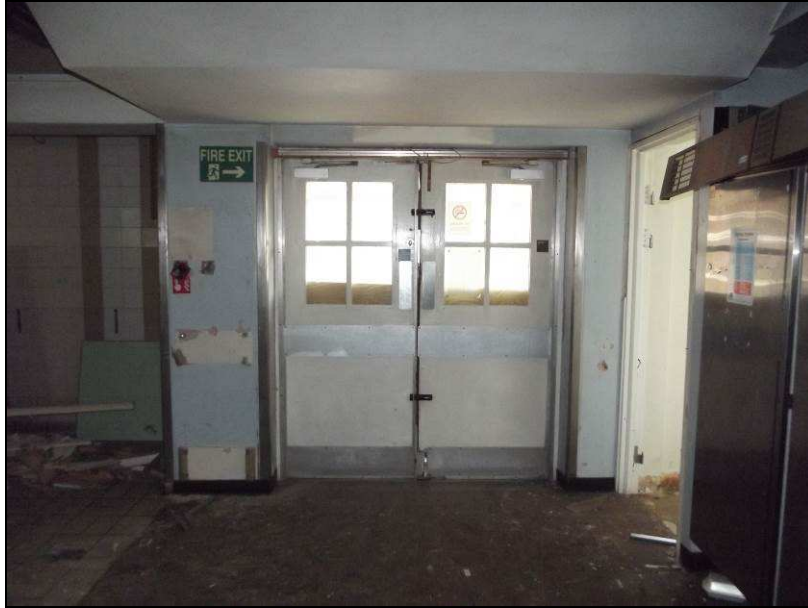
Plate 19 (shot 106): Entrance to the south of B3, looking south

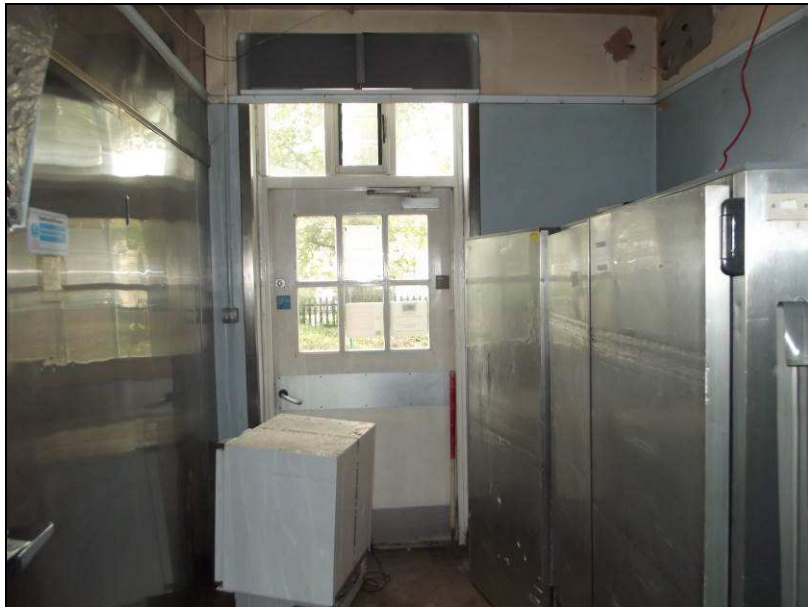
Plate 20 (shot 110): Storage spaces in B4, looking north

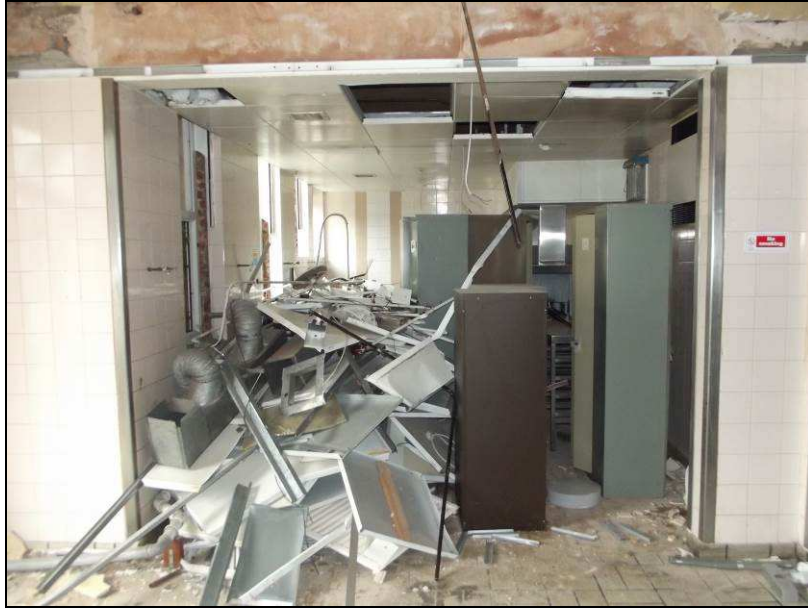
Plate 21 (shot 132): Tiled areas in B5, looking west

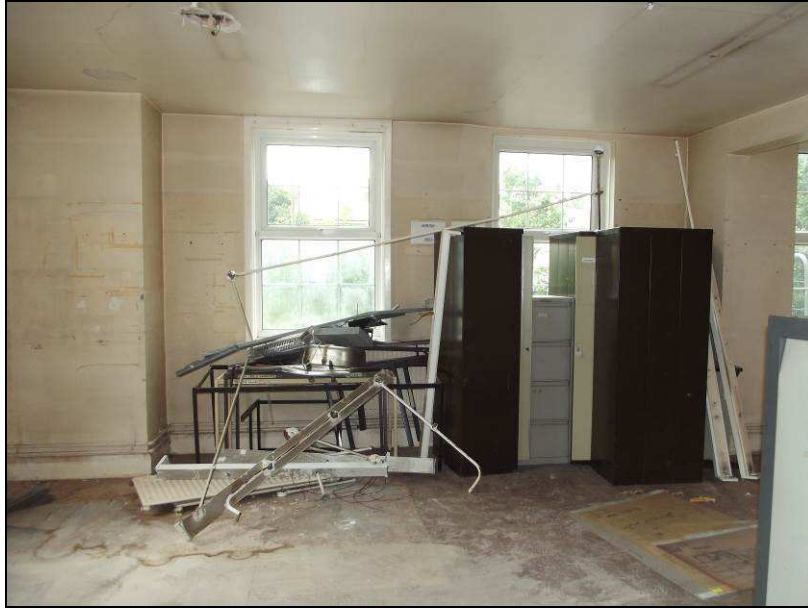
Plate 23 (shot 85): B7, probably used as a classroom or office, looking west

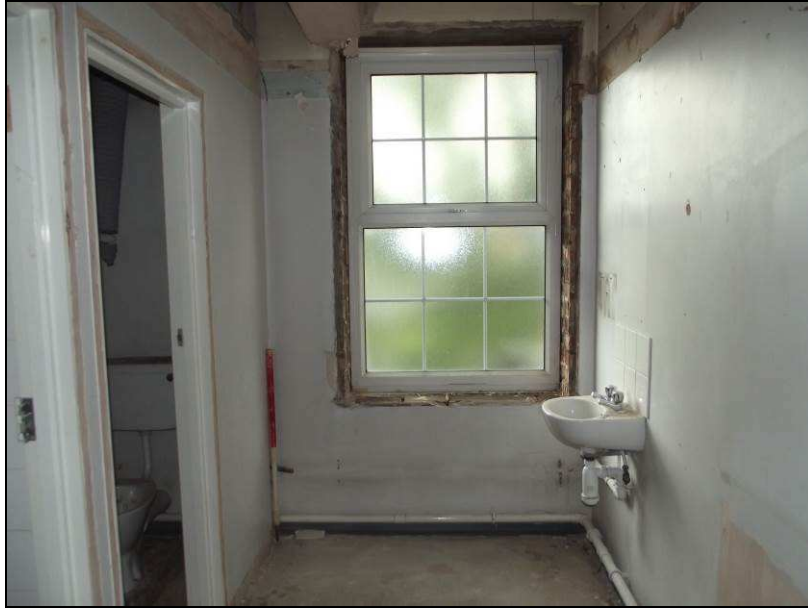
Plate 27 (shot 178): Example of a lavatory in B9, looking north

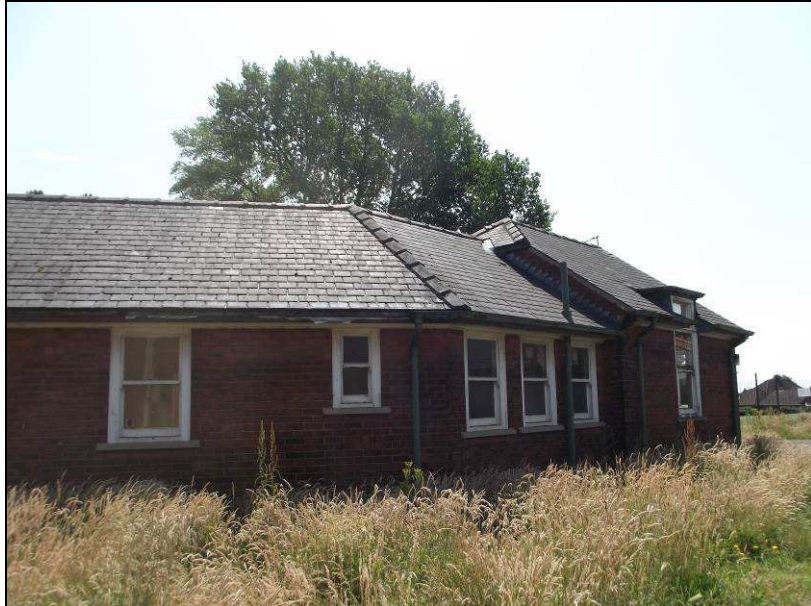
Plate 40 (shot 277): Crosby House, looking southeast

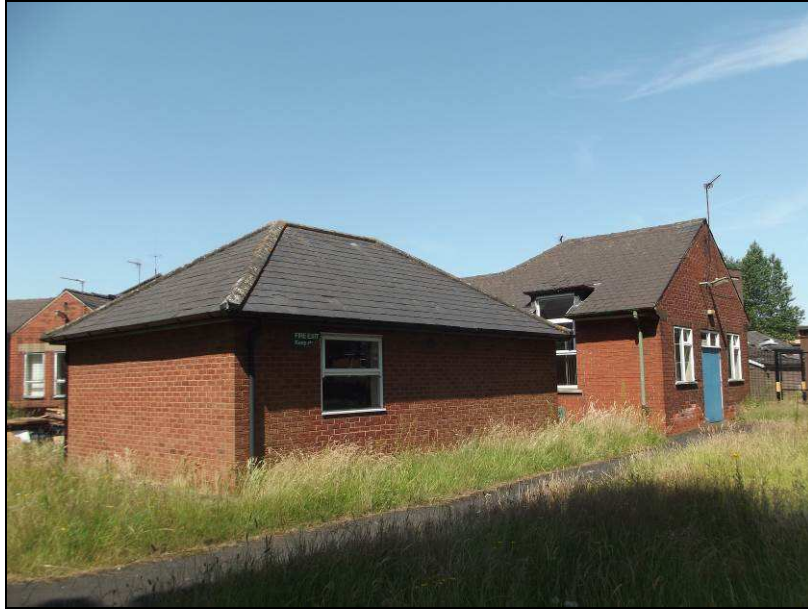
Plate 43 (shot 271): Showing extension at northeast end of Crosby House, looking northwest

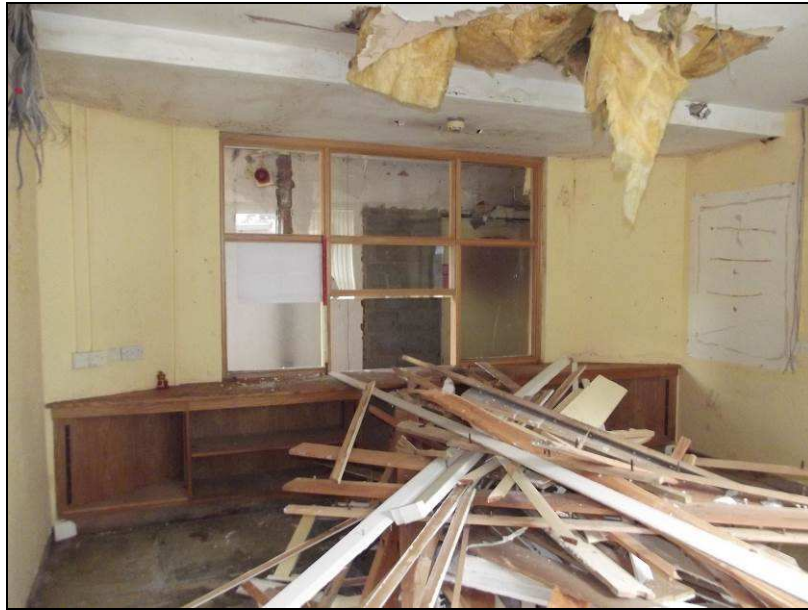
Plate 45 (shot 243): Reception room in the Crosby building, looking northwest
