BUILDING SURVEY REPORT:
TOWNGATE HOUSE FARM, TOWNGATE WEST,
MARKET DEEPING, LINCOLNSHIRE

Planning Reference: N/A
NGR: TF 13258 10852
AAA Site Code: MADE 09
LCCM Accession Number: 2009.004
Oasis Reference: allenarc1_56812

Allen Archaeological Associates
Report Number 2009/011

March 2009

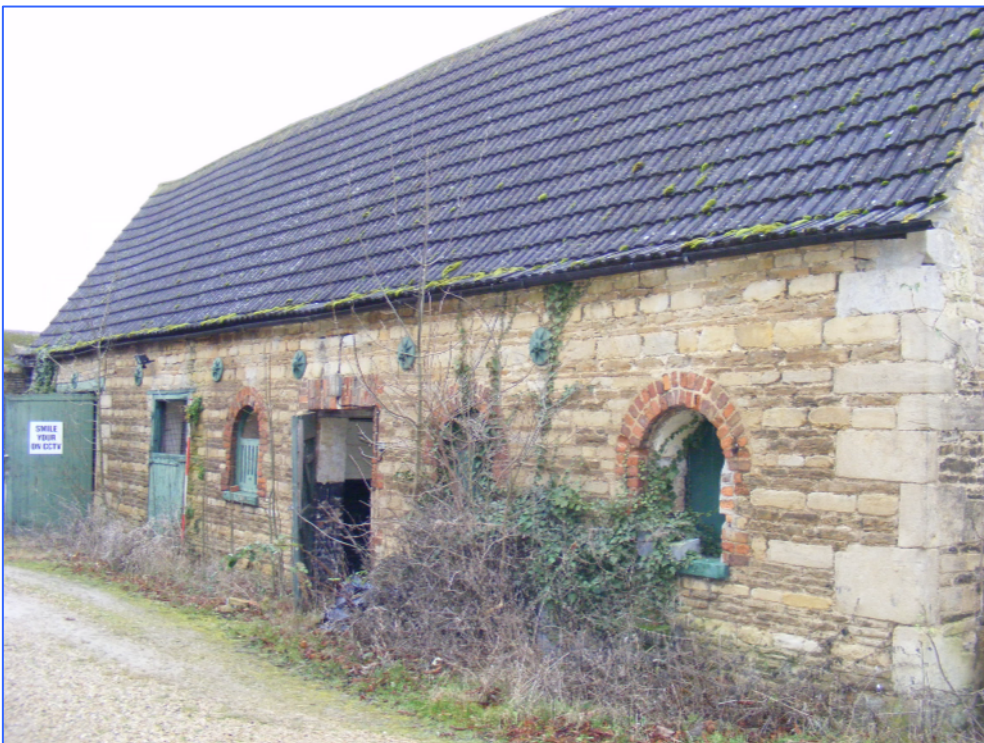
Plate 14 (Shot 43): South elevation of Building B, looking west-north-west.

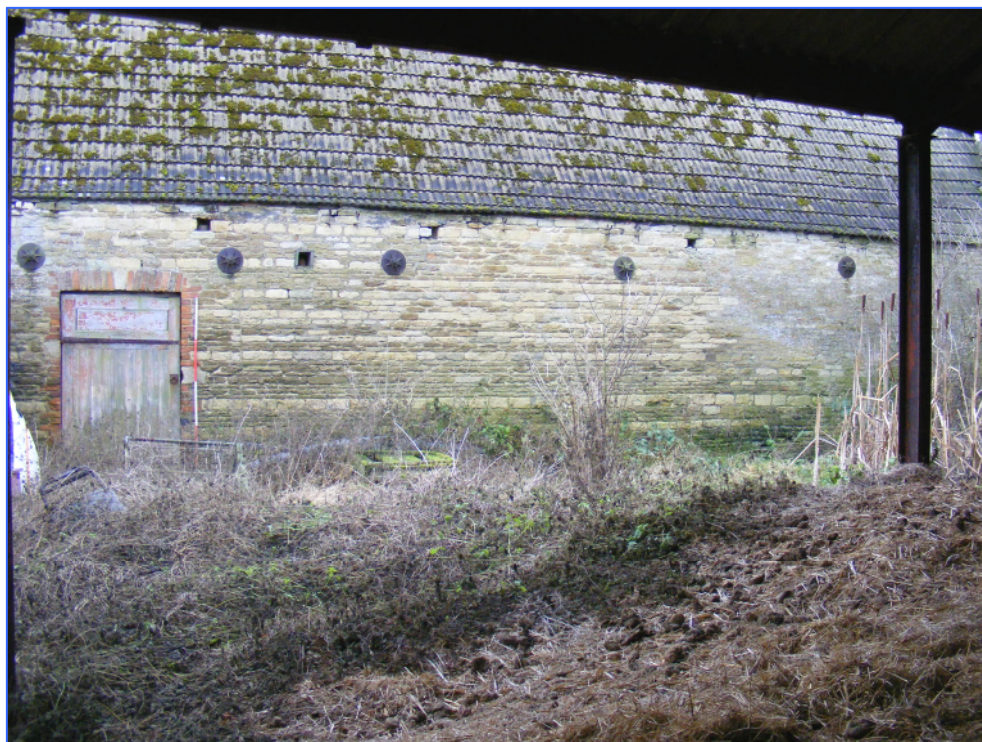
Plate 16 (Shot 51): North elevation of Building B, looking south-south-west.

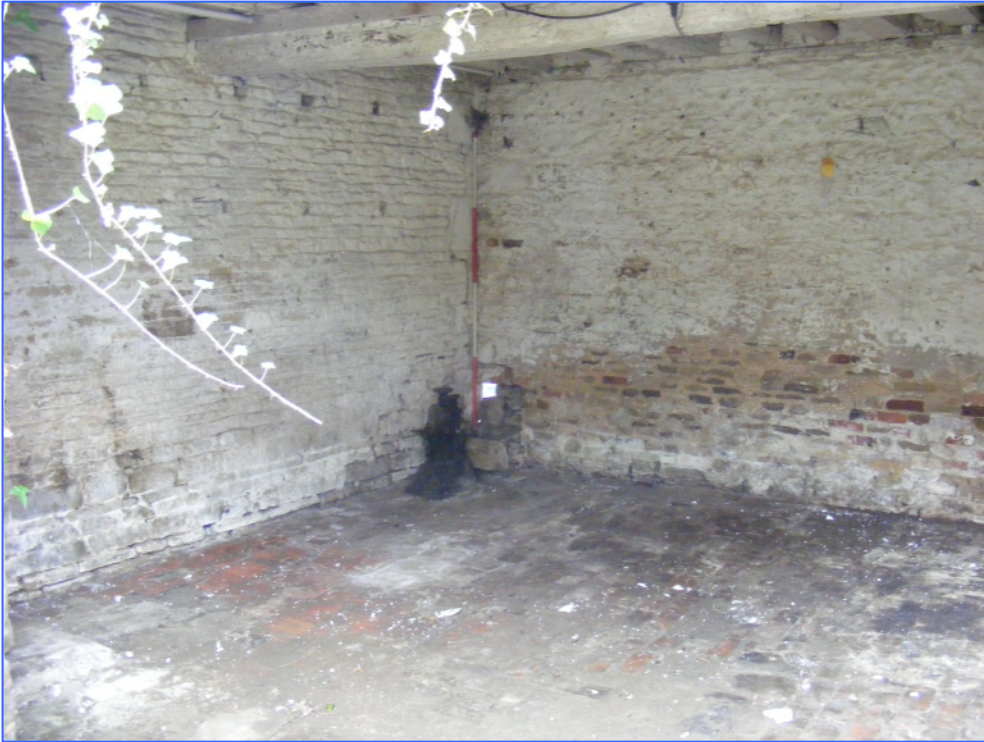
Plate 19 (Shot 45): Western room of Building B, looking north-west.

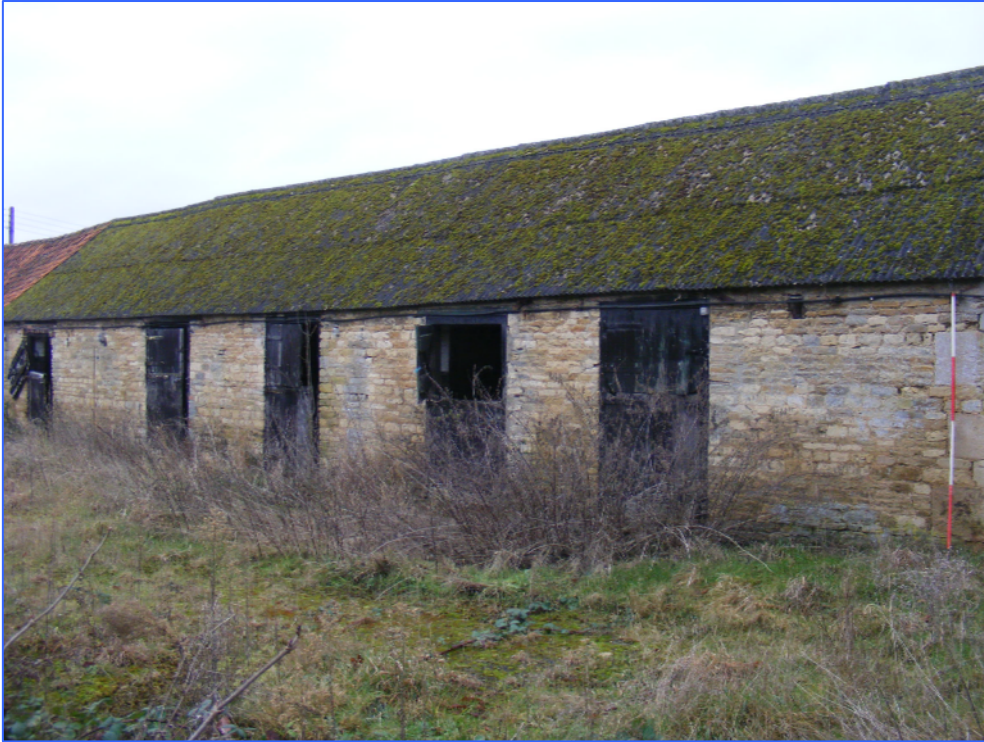
Plate 29 (Shot 5): West elevation of Building D, south end, looking north-east.

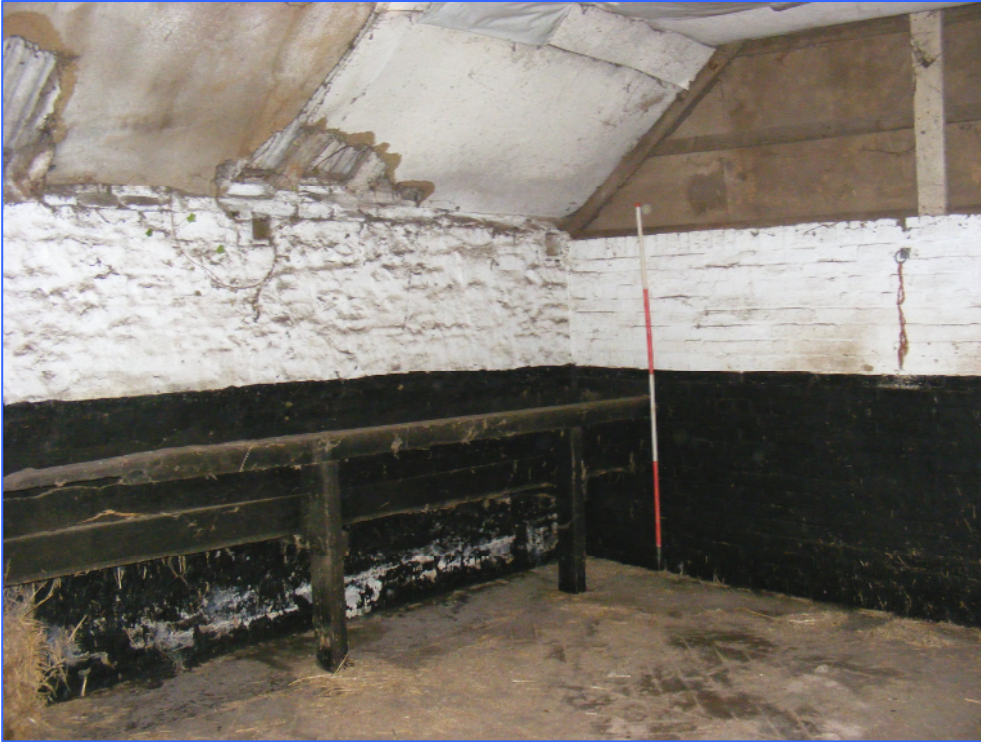
Plate 31 (Shot 6): Interior of room D1, looking south-east.

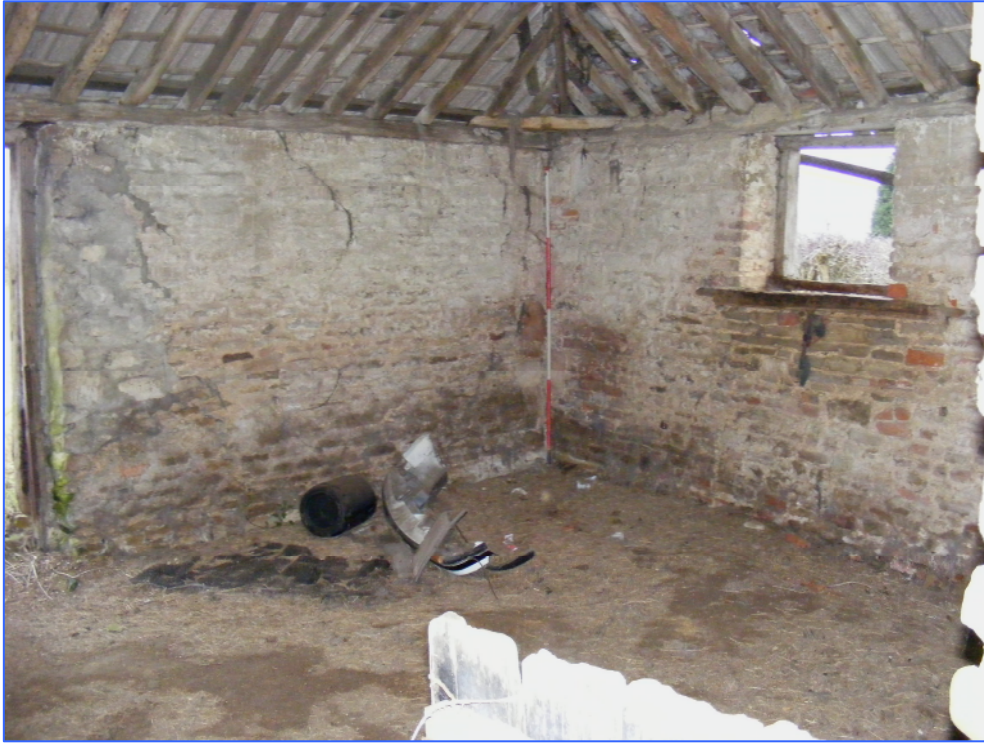
Plate 33 (Shot 15): Room D10, north end of Building D, looking north-east.

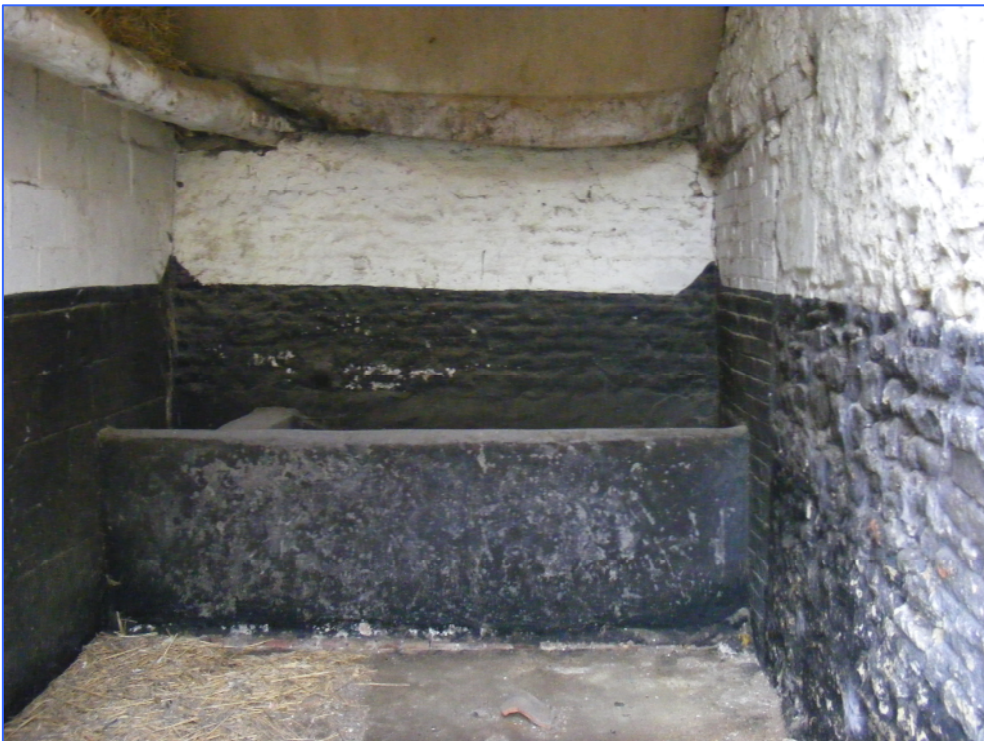
Plate 36 (Shot 21): Room E1, looking north-north-west.

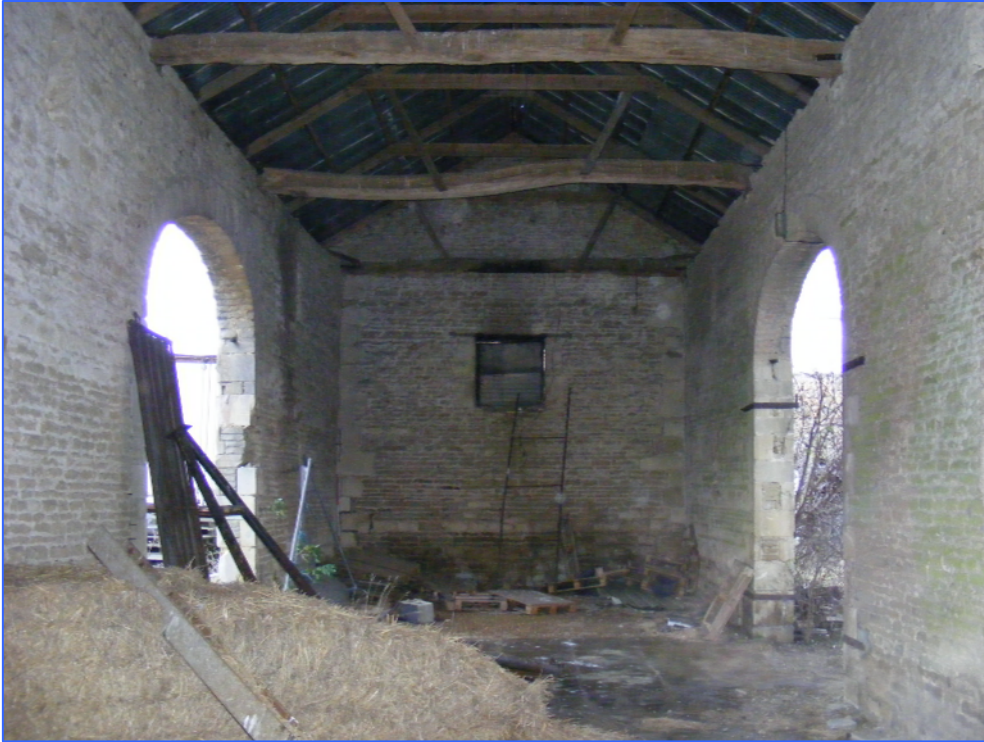
Plate 45 (Shot 62): Interior of Building G, looking north-north-west.

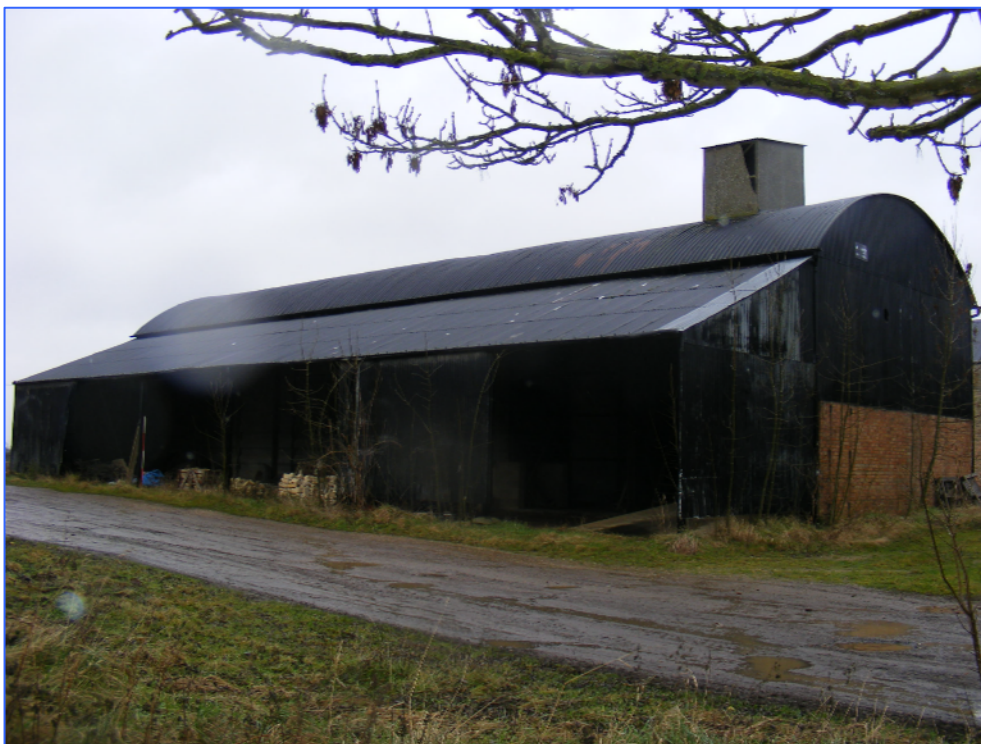
- 5.11.1 These two large buildings represent modern barns located to the west of the main farm complex.
- 5.11.2 Barn L is a large brick and steel framed barn filled with modern farm machinery. It has a central component with a curved corrugated steel roof and brick walls at its north and south ends. This is flanked on its east and west sides by steel framed structures with pitched corrugated steel roofs (Plate 54).
- 5.11.3 Barn M is located north of Building A (the oast house), and is a square steel framed structure entirely clad in corrugated steel sheeting (Plate 55). The 1899 and 1913 Ordnance Survey maps show an L-shaped structure in this location (Figures 11 and 12); however this structure is clearly of a much more recent construction, of probable later 20th century date.

Plate 54 (Shot 99): Modern barn, Building L, looking north-east.

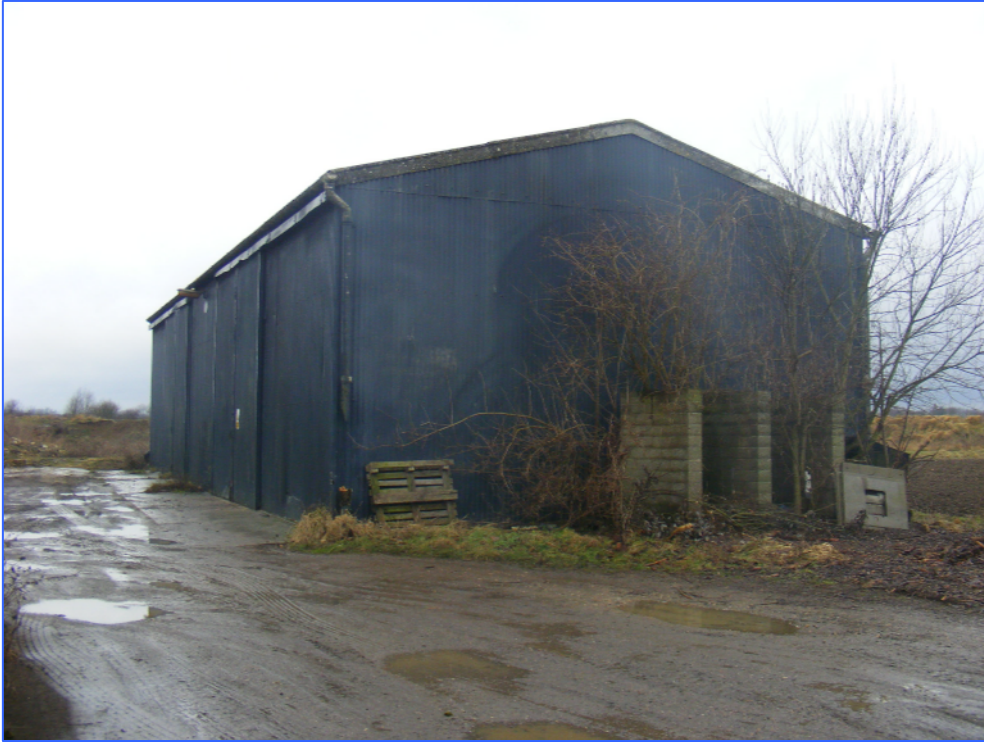
Plate 55 (Shot 115): Modern barn, Building M, looking west.
