# The Old George, High Street Stony Stratford Milton Keynes

*Historic Building Recording*

CA Project: MK0097

October 2019

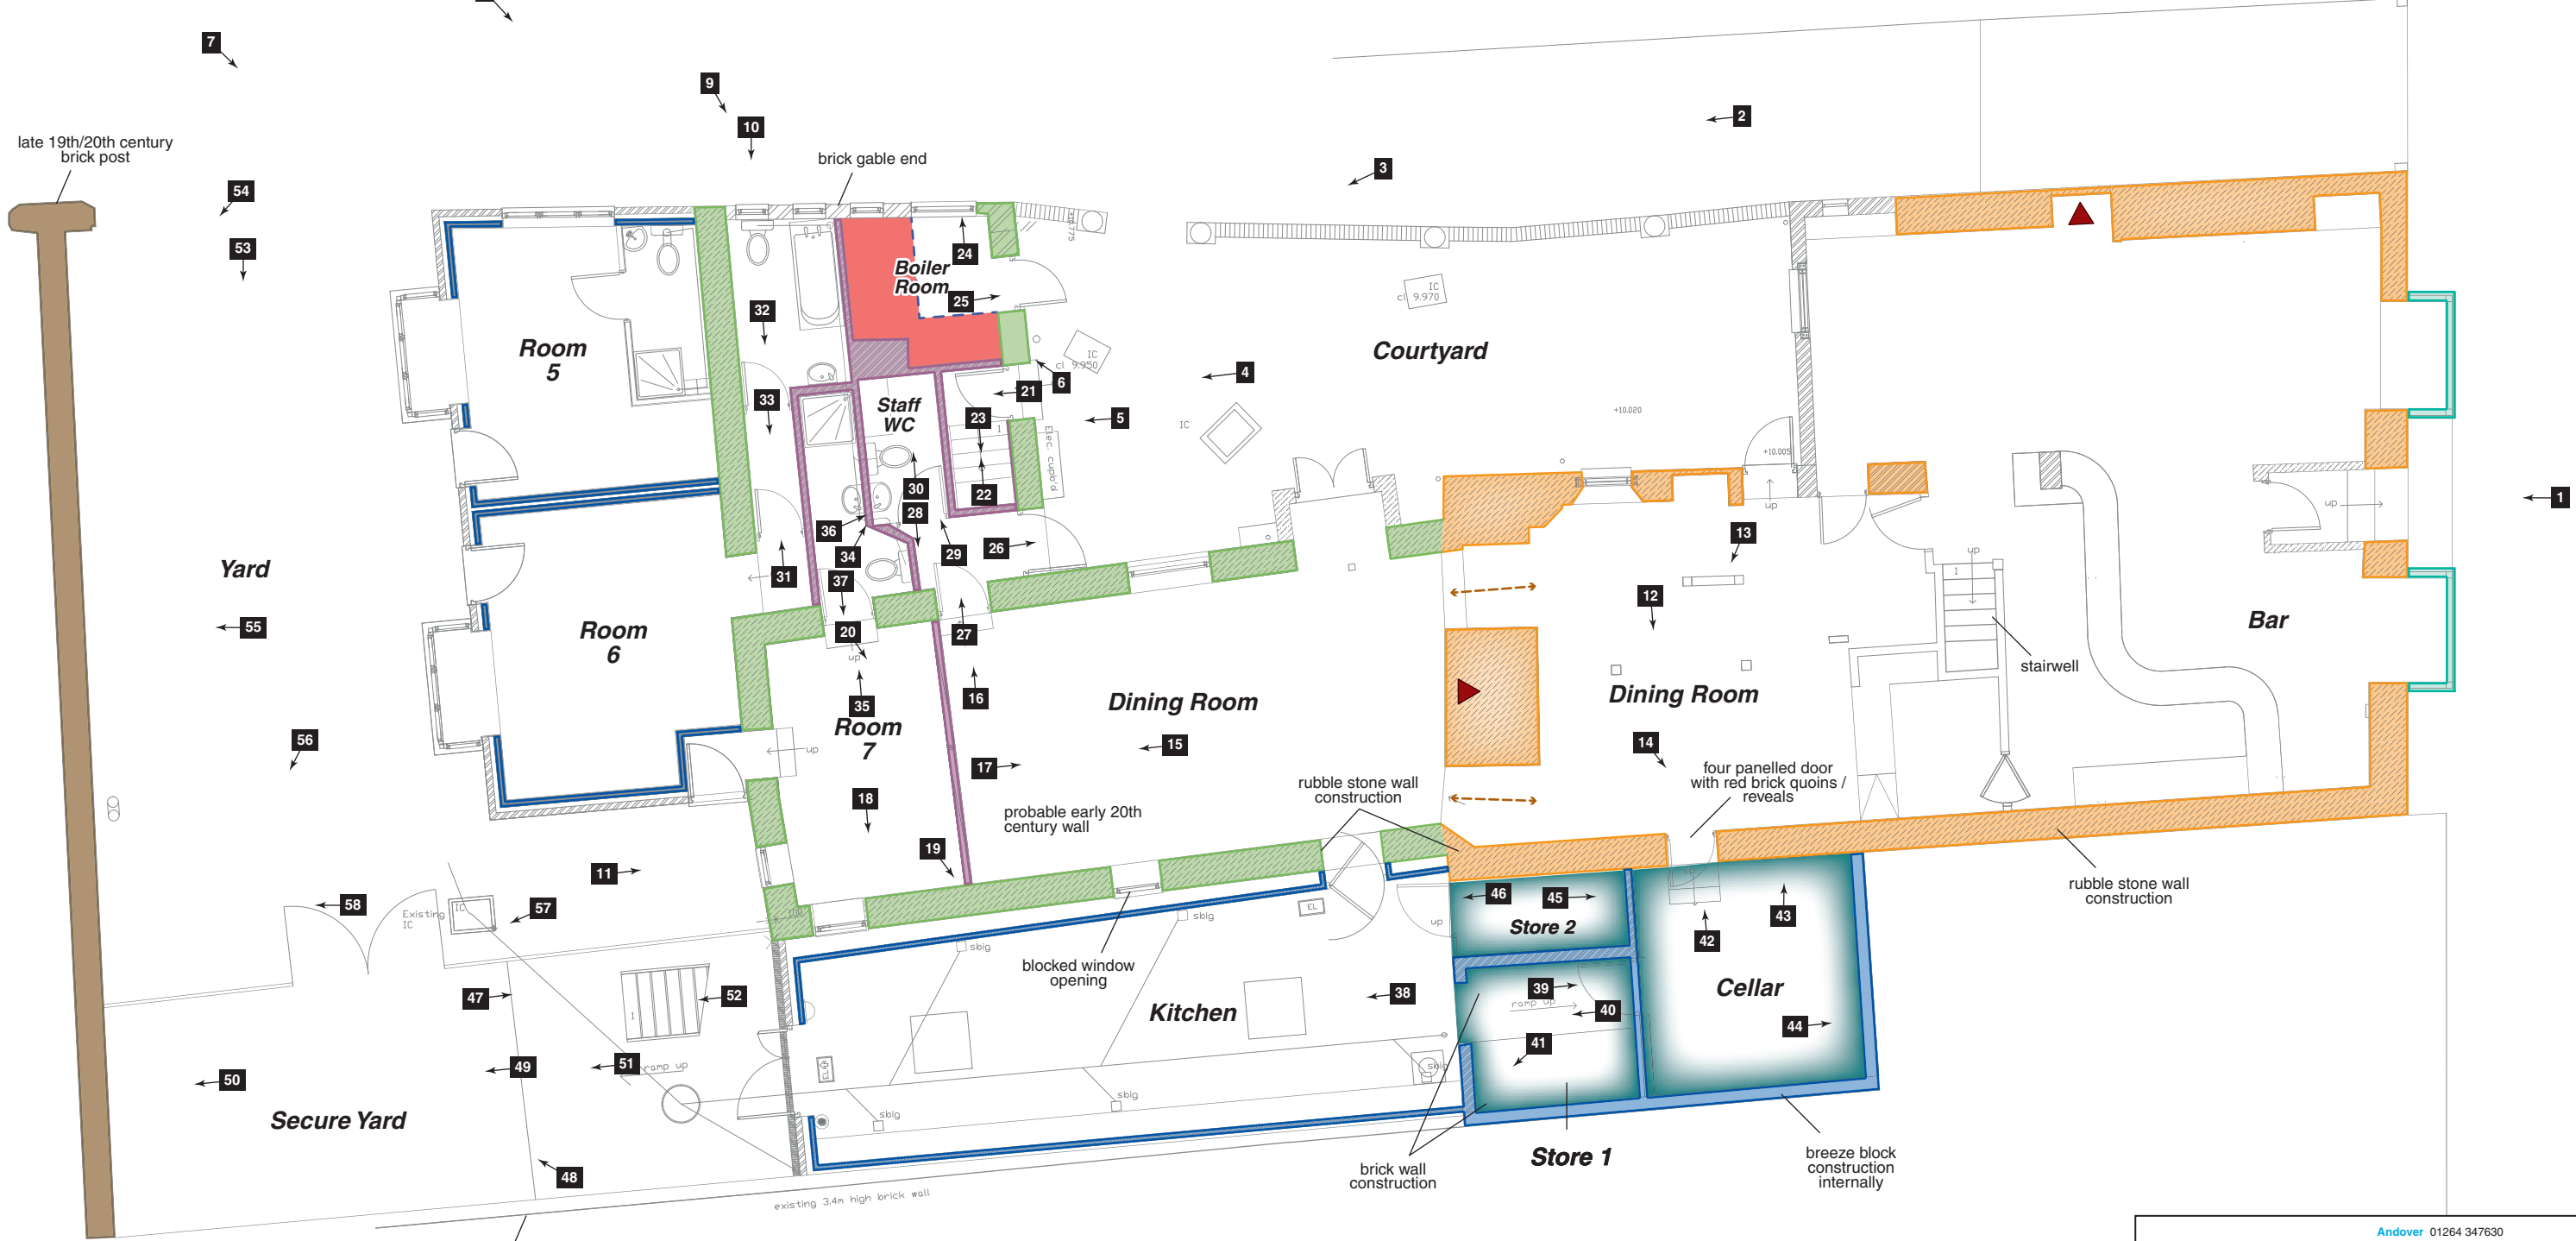
**GROUND FLOOR PLAN**

- 4.1. The ground floor of the 17th -century Building comprises a large open room to the street frontage with a bar in the south-eastern corner (Figure 2). To the south of the street frontage room is a regular shaped room (Dining Room) which has an exposed timber ceiling (Photos 12 and 13). The timbers display evidence of hand-hewn construction and it is possible that these timbers date to at least the 17th-century. The spinal beam has chamfered edges and is approximately 30cm wide and supports eight hand-hewn timber joists. The spinal beam is supported by two timber posts, the southern of which appears to be a more recent insertion (Photos 12 and 13).

- 4.3. The southern extent of the Dining Room (Figure 2) falls within the footprint of the late 18th century/early 19th-century Building (Photos 15 and 17). The room extends across the entire width of the rubblestone hall of the late 16th/ 17th century structure and the ceiling is supported by four boxed-in beams (Photos 15 and 17). There is no evidence of a spinal beam continuing from the northern extent of the dining room into the southern extent and the position of the beams combined with their substantial size spanning the entire width of the Building suggests that they are likely to have been later insertions associated with the construction of the first-floor bedrooms in the 20th century. A further beam is visible within Room 7 (Photo

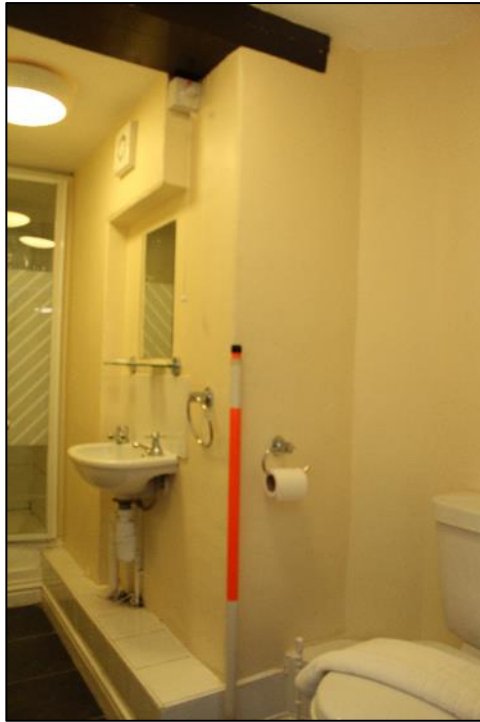
- 4.9. The en-suite bathrooms of Rooms 6 (Photos 31 to 33) and Room 7 (Photos 34 to 37) contain a number of substantial timbers aligned on a broadly north to south axis. The timber within Room 7 (Photos 34 and 36) appears to have been boxed in and the brick walls constructed around the timber, whilst the timber within Room 6 has been left un-boxed (Photo 32). These timbers are not apparent within the Boiler Room and the Staff WC but it is possible that they form part of the ceiling/floor structure associated with the rebuilding of the gable end of the late 18th/ early 19th

**Photo 34: The en-suite bathroom of Room 7.**
