Bridgehouse Mill, West Linton Scottish Borders

Standing Building Survey & Watching Brief

Report No. 3156

Author	Michael Cressey BA MSc PhD MifA FSA Scot
Illustrator	Kevin Hicks BA (Hons) FSA Scot
Editor	Bruce Glendinning BSc PgDip MifA
Commissioned by	Bergmark Architects Ltd on behalf of Mr and Mrs Wood
Date issued	July 2014
Version	0
Planning Ref	12/01527/FUL
Grid Reference	NT 1435 5240
Oasis Ref No.	cfaarcha1-178387

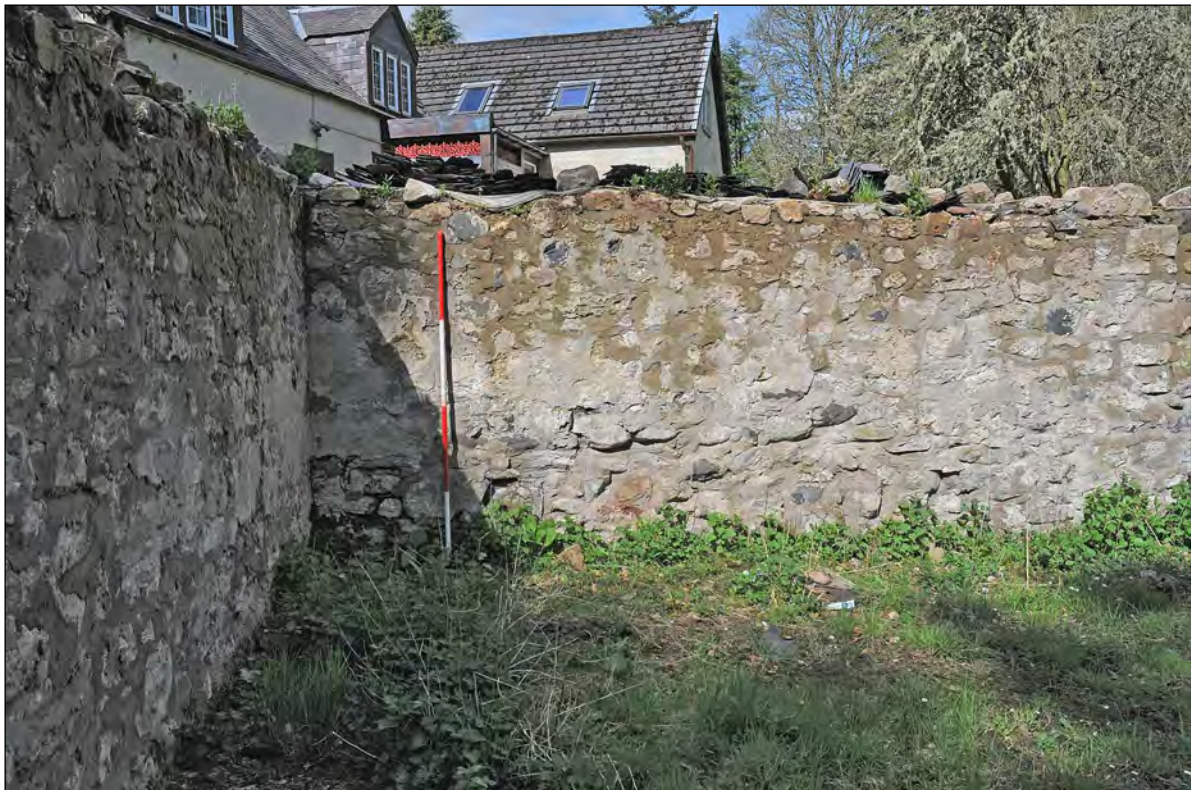
Plate 8 – Internal east-facing elevation (southern end)

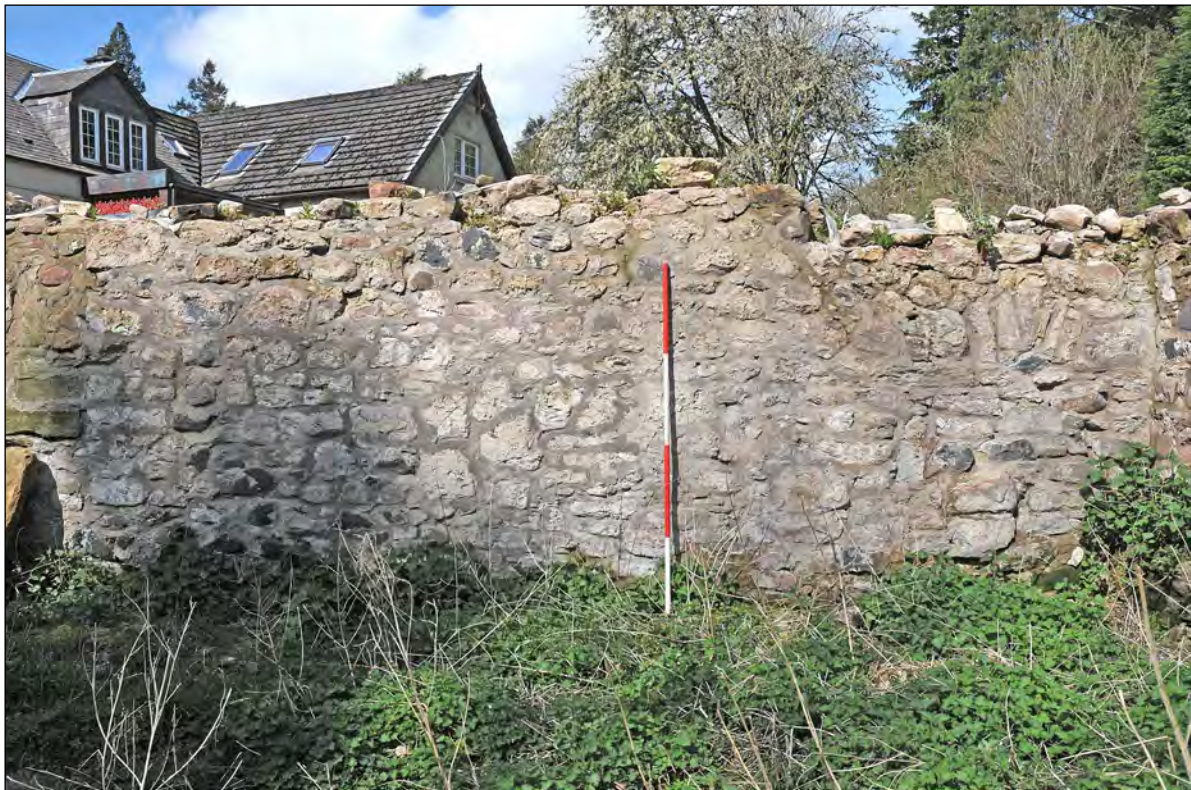
At the north end of the east-facing elevation there appears to be the remains of a relieving arch (Plate 10) comprising five blocks of stone set vertically in the wall. This appears to be not connected to a window but is the result of a recent rebuild judging by the nature of the modern grey cement that is holding the stonework together.

Plate 10 – Internal east-facing elevation (northern end)

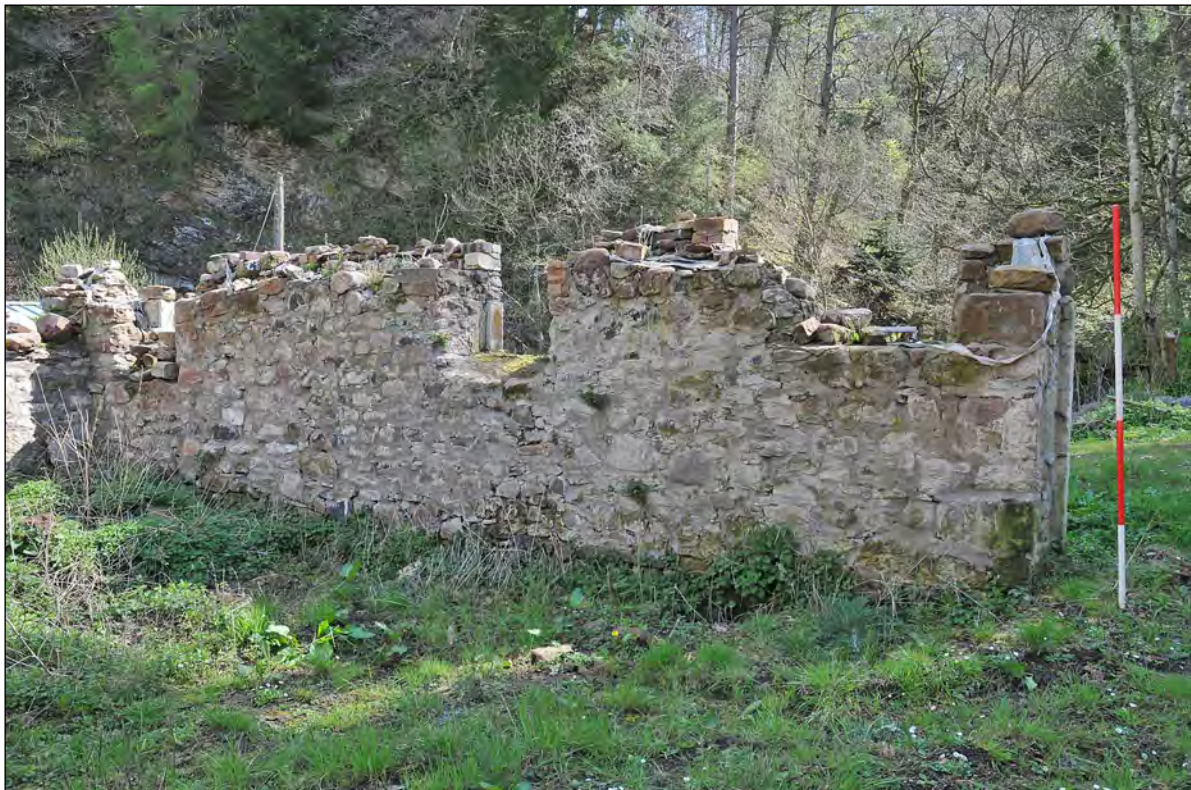
Plate 12 – Internal west-facing elevation

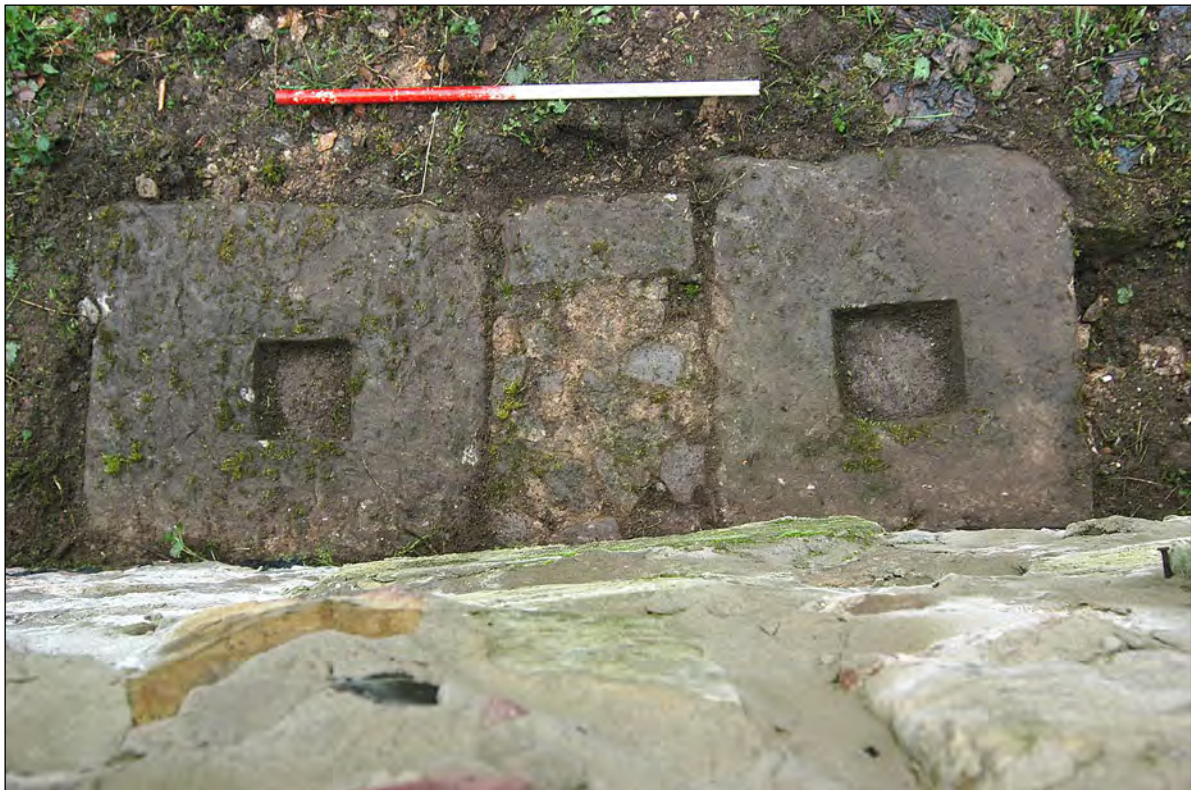
opening for a wheel shaft associated with a small cast-iron wheel. The presence of a waterwheel is supported by the presence of two Hurst frame plinths (see Fig 3, Plates 9, 13-14) that were in situ at the base of the wall and more or less in line with the blocked opening. Each plinth comprised hewn sandstone blocks measuring 0.75m by 0.70m and 0.85m by 0.75m respectively. At the centre of each was a square socket (0.2m x 0.2m) which had been carved to a depth of 0.05m.

Plate 14 – Vertical shot of the Hurst plinths
