Bonnington Mill, 70-72 Newhaven Road Edinburgh, Historic Building Survey & Architectural Watching Brief

Report type: Data Structure Report
Report No. 3814

**Bonnington Mill,
70-72 Newhaven Road, Edinburgh
Historic Building Recording
&
Architectural Watching Brief**

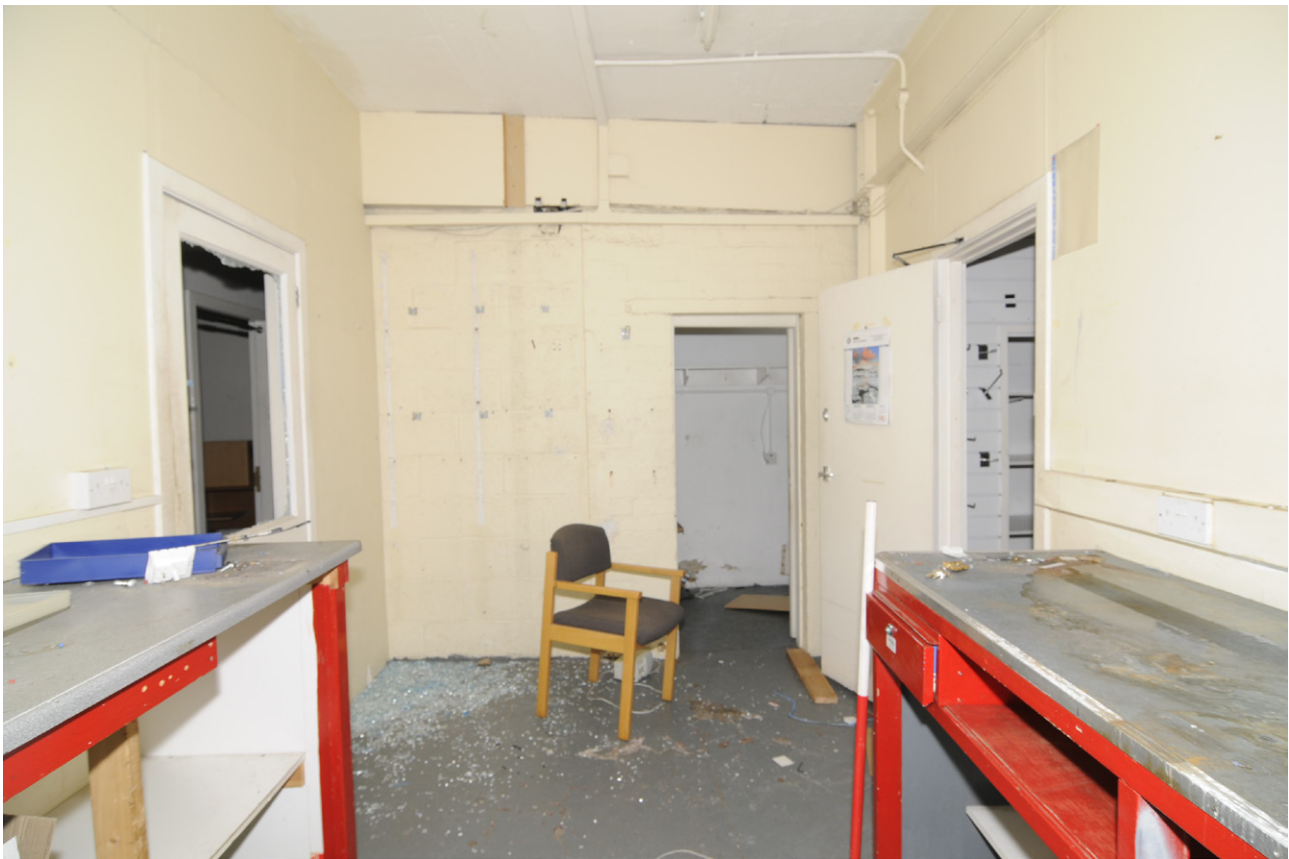
Fig. 20: Former locksmith's workshop (Building G Room G6)

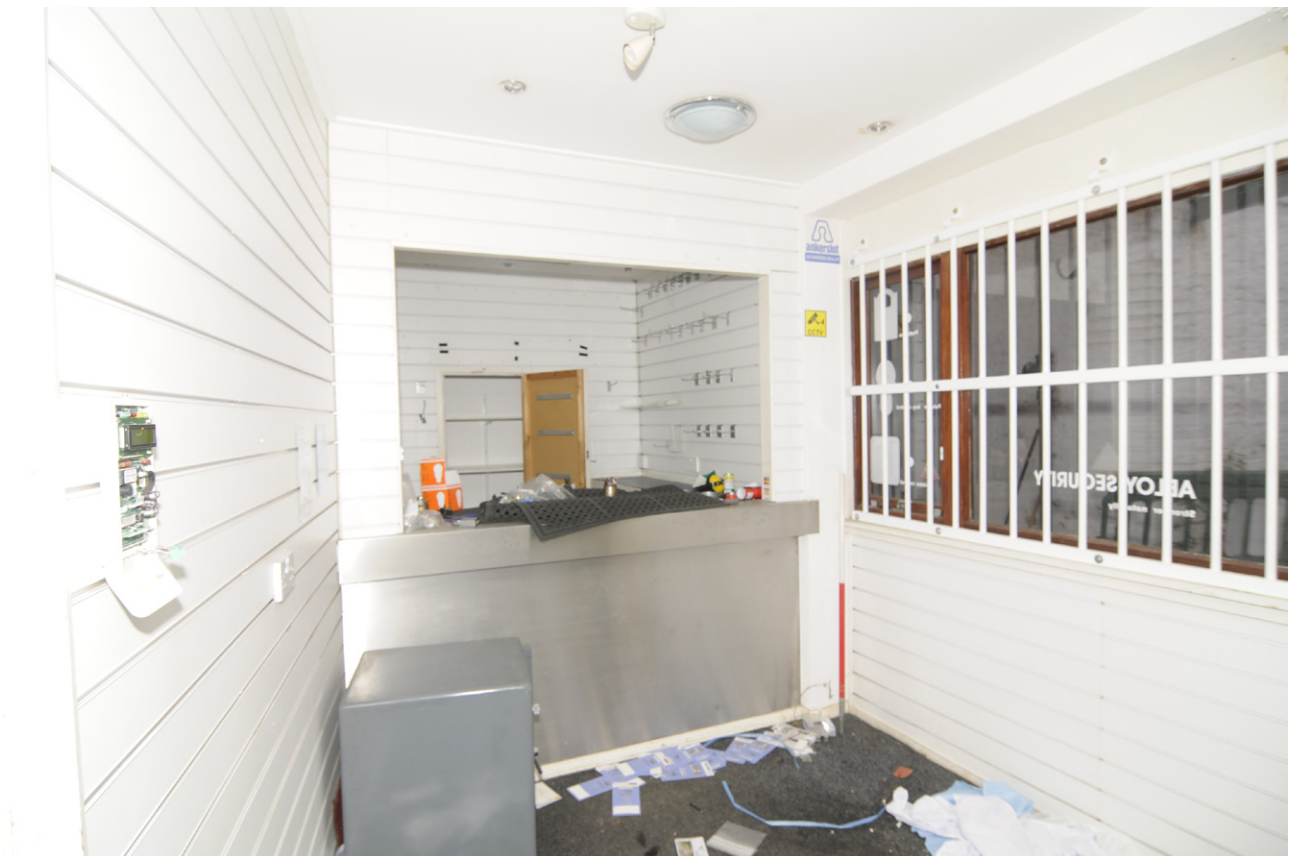
Fig. 21: Former locksmiths shop in Building G (Room G7)

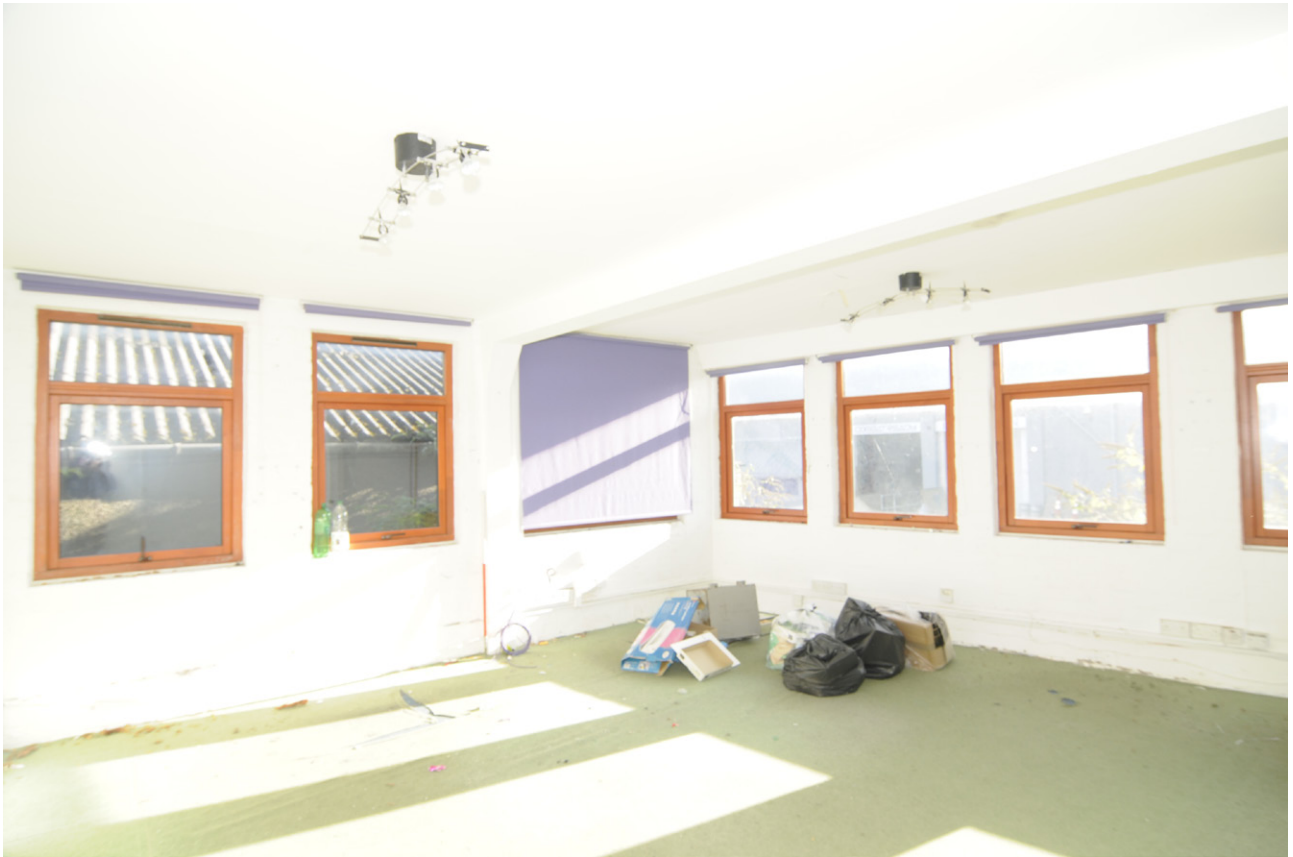
Fig. 26: A typical first floor office in Building I (Room I9)

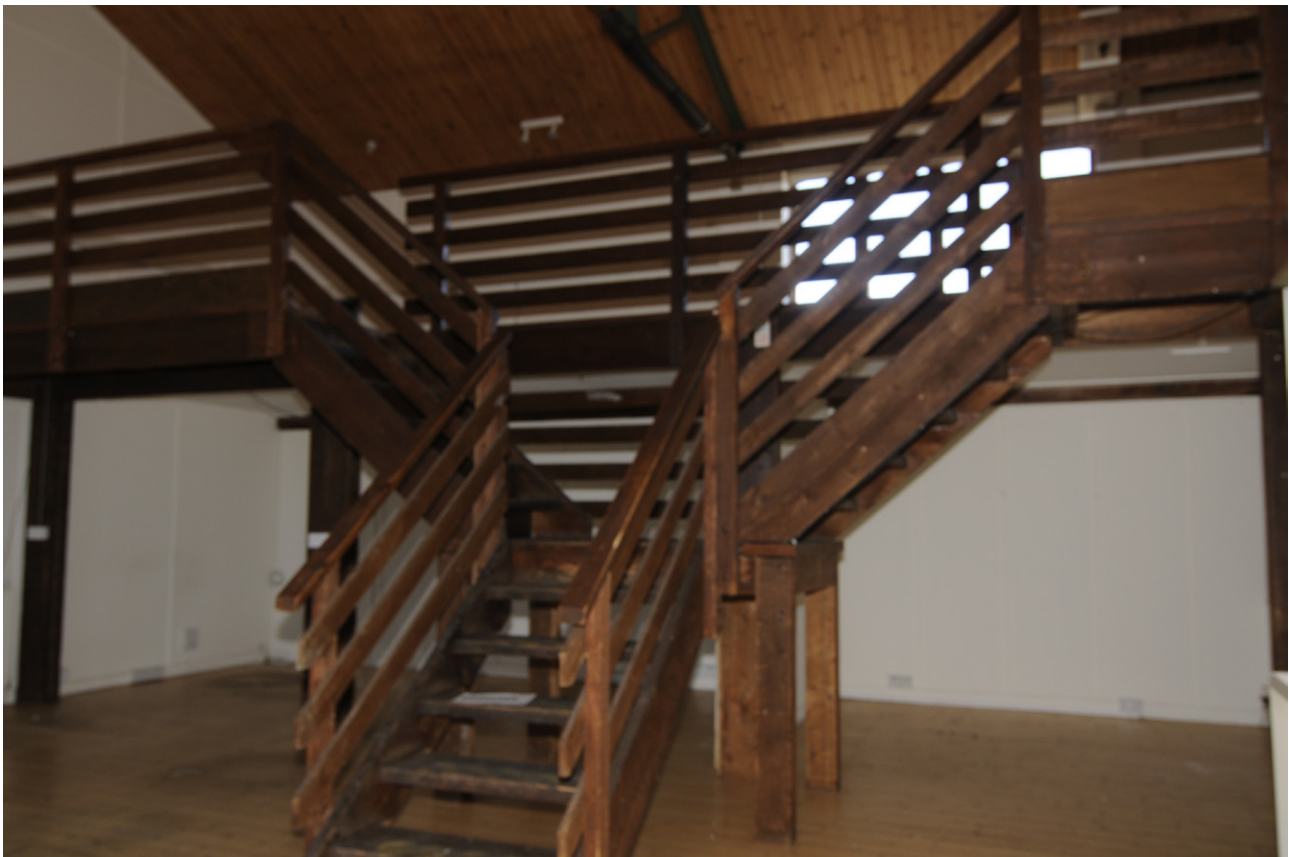
J Figs 3c, 29 & 30	<p>Building J was a large rectangular brick-built structure forming a modern office with mezzanine floor (Fig 29) at the north end (J1). Approximately two thirds of the block was a single storey garage incorporating a storeroom (J2), a service area (J3) with counter and the main drive-in workshop (J4) accessed by a large roller door. A small oil storage room was also present (J5)</p>	Early 20th footprint century with later compartments dating to the late 20 th century.

Fig. 29: Interior view of the office at the north end of Building J (Room J1)

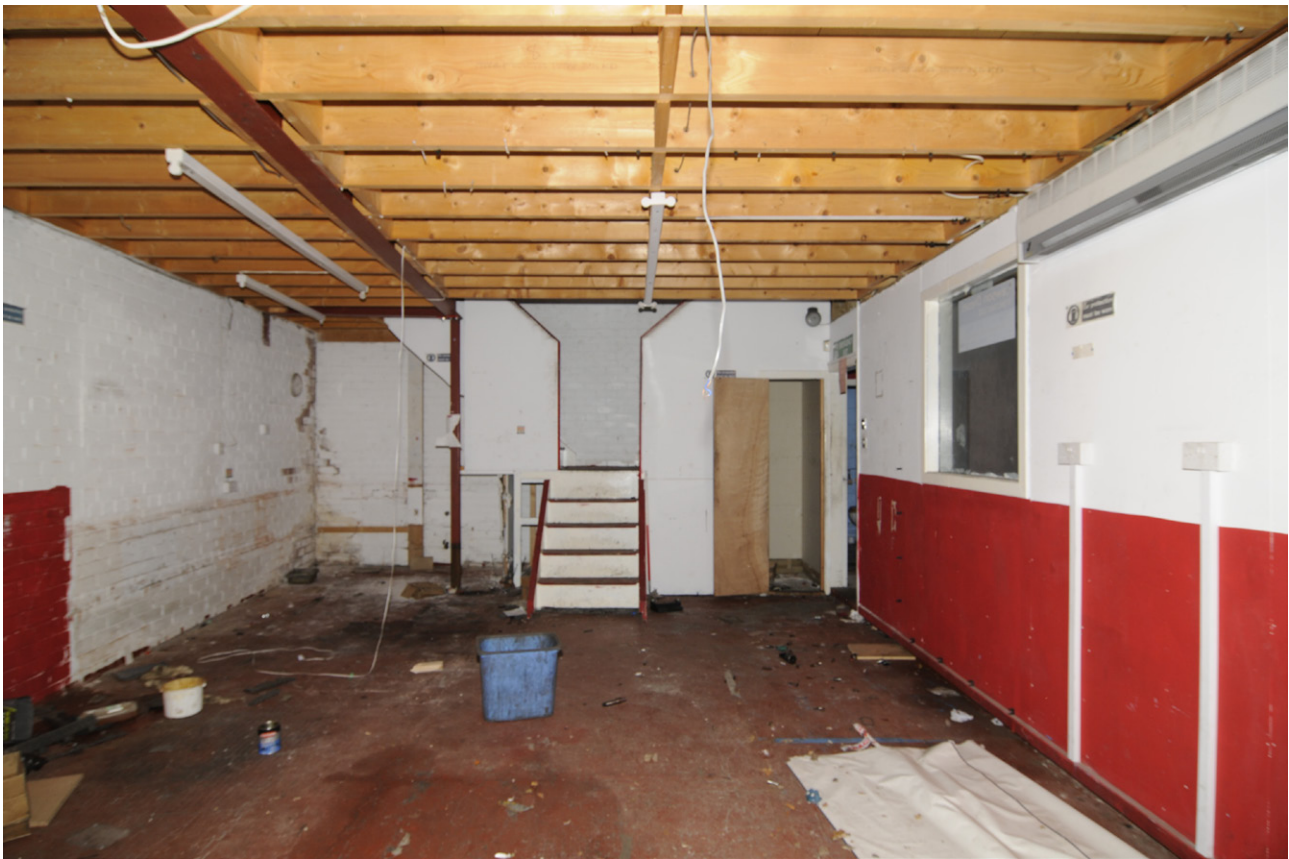
Fig. 30: Interior view of the garage work shop at the south end of Building J (Room J4)

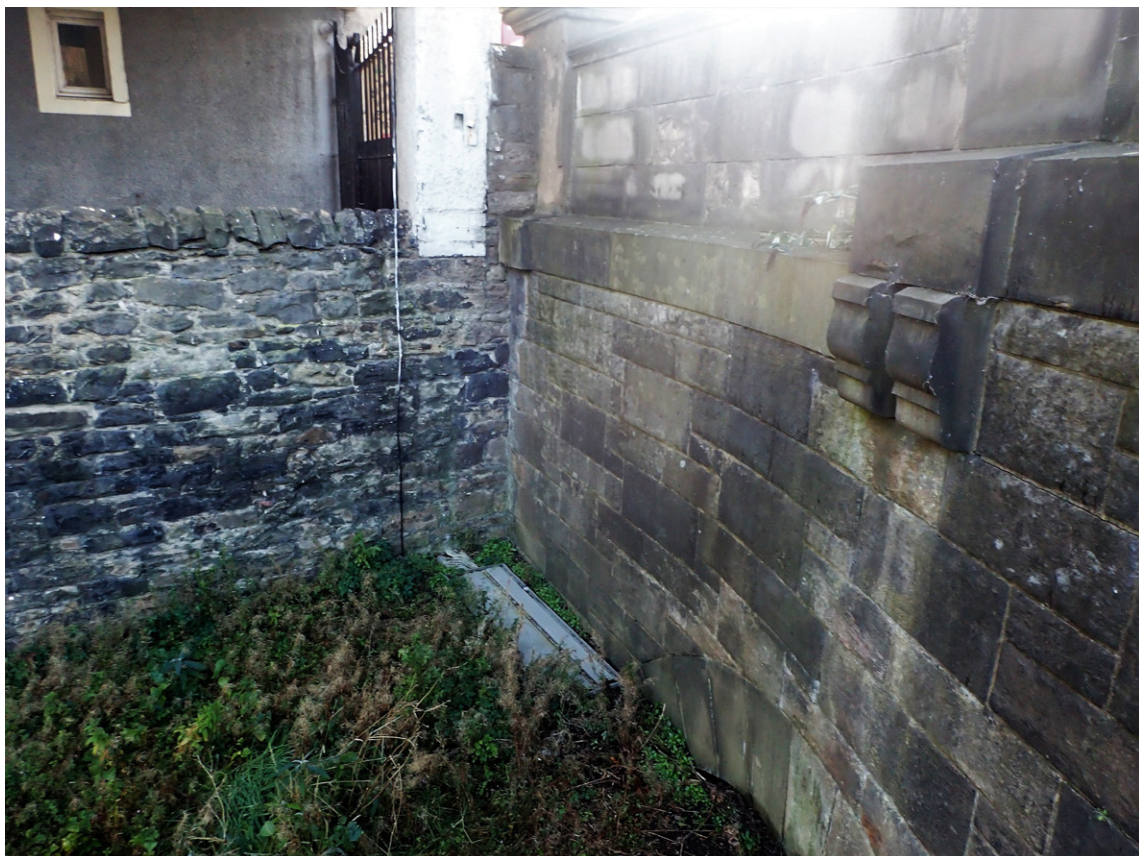
Fig. 31: General view of the North Lade at the base of Bonnington Bridge

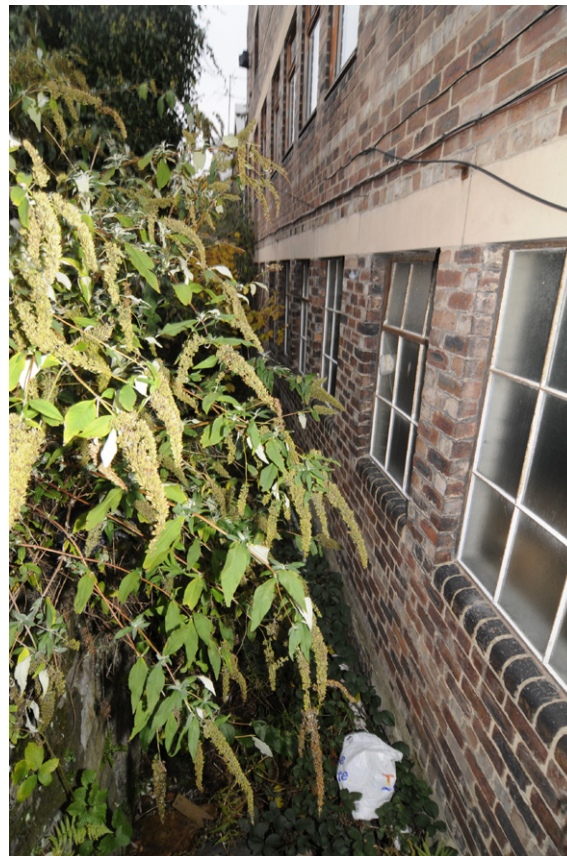
The south lade ran directly at the foot of the south-facing elevation of Buildings E, G-J and was approximately 3m deep and 2m wide and is still visible despite it being very overgrown (Fig 33). It is likely that this was an outflow or byewash lade from the corn mill situated on the west side of Bonnington Bridge and its route shown on the 1896 map (Fig 39h) and depicted on the 1914 OS map as a corn mill (Fig 39I). The Bonnington paper mill would have needed a high volume of clean water as part of its manufacturing process. The mill could have drawn water from the lade and also discharged waste water back into the Water of Leith that was nothing less than a foul water drain at this time.

Fig. 33: General shot of the South Lade running at the foot of the main south-facing elevation of the Bonnington Mill complex prior to demolition
