Historic building recording at Crowbridge Farm, Chappel Hill, Halstead, CO9 1JS

June 2021

CAT Report 1686
July 2021

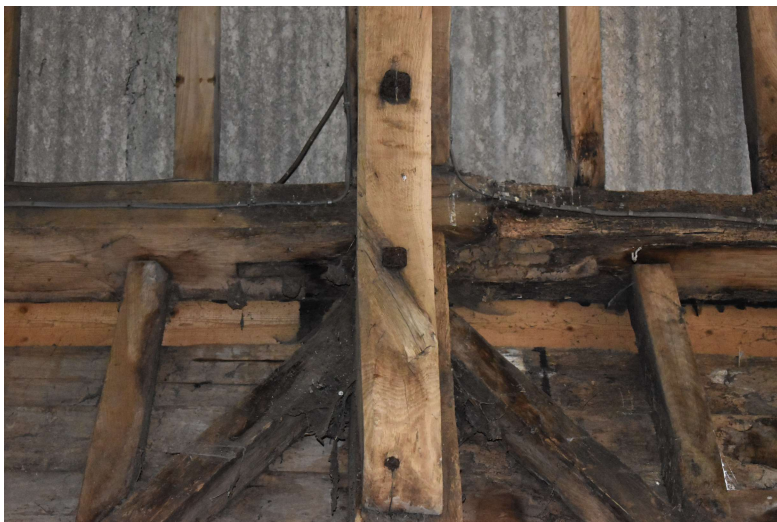
HSCF21_Photograph_060Rotting scarf joint on southern wall-plate between ba...
