**CAT Report 1934
issued May 2023**

**Historic building recording of two WWII-era huts at
Great Easton Manor, Dunmow Road, Great
Easton, Essex, CM6 2DL**

**CAT project ref.: 2023/03f
ECC code: GEAGE23**

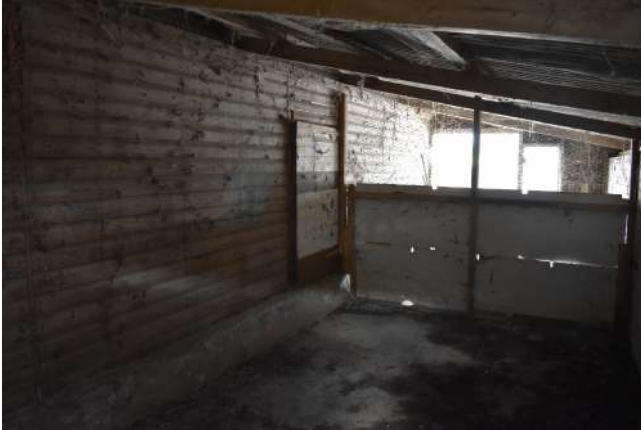
GEAGE23_PhotoGraph_052.JPG Internal view of extension 1. Photograph taken facing north.
